TECHNICAL REPORT 4321

IN - BORE PREMATURE  
MALFUNCTION INVESTIGATIONS  
OF THE  
81 MM HIGH EXPLOSIVE MORTAR CARTRIDGES  
WITH THE  
M526, M524A5 AND XM176  
POINT DETONATING FUZES

FEBRUARY 1972

PICATINNY ARSENAL  
DOVER, NEW JERSEY

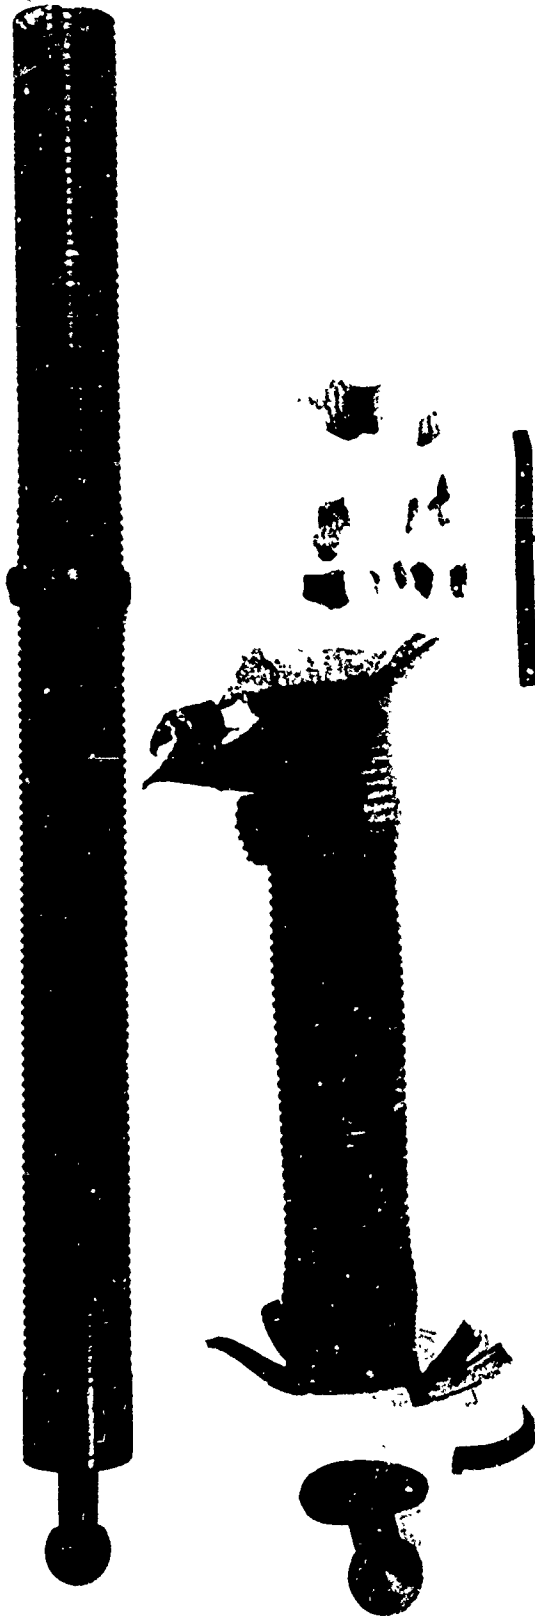
Voids in the HE Filler Near the Base -- An in-bore premature occurred at Jefferson Proving Ground, during an acceptance test of an M374 Cartridge. The round was fired at Charge 9. An x-ray of the round, taken before the malfunction, indicated a large void in the HE filler near the base. Test rounds were specially prepared to duplicate the malfunctioned round, and fired at various charges. The test data (Table 2) confirms that an in-bore premature can occur with this condition at high charge. The fragments of the mortar tubes used in the tests are shown in Figures 7 and 8.

Figure 8 Mortar tube before and after premature functioning of test round with void in HE filler and fired at charge 12

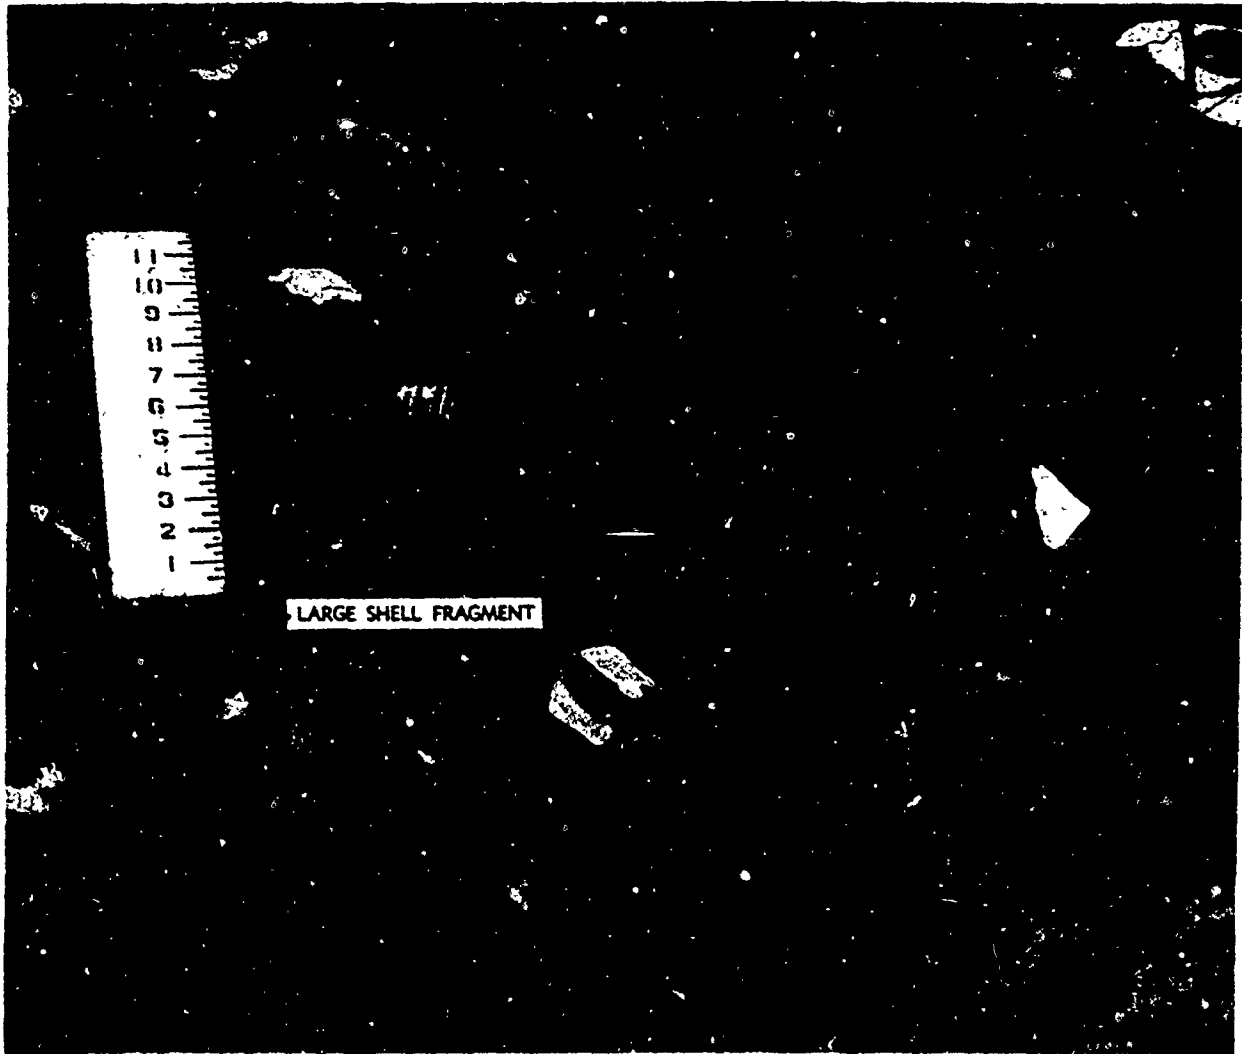
Figure 10. Tube and shell fragments from test round with holes through side wall of shell (side view)

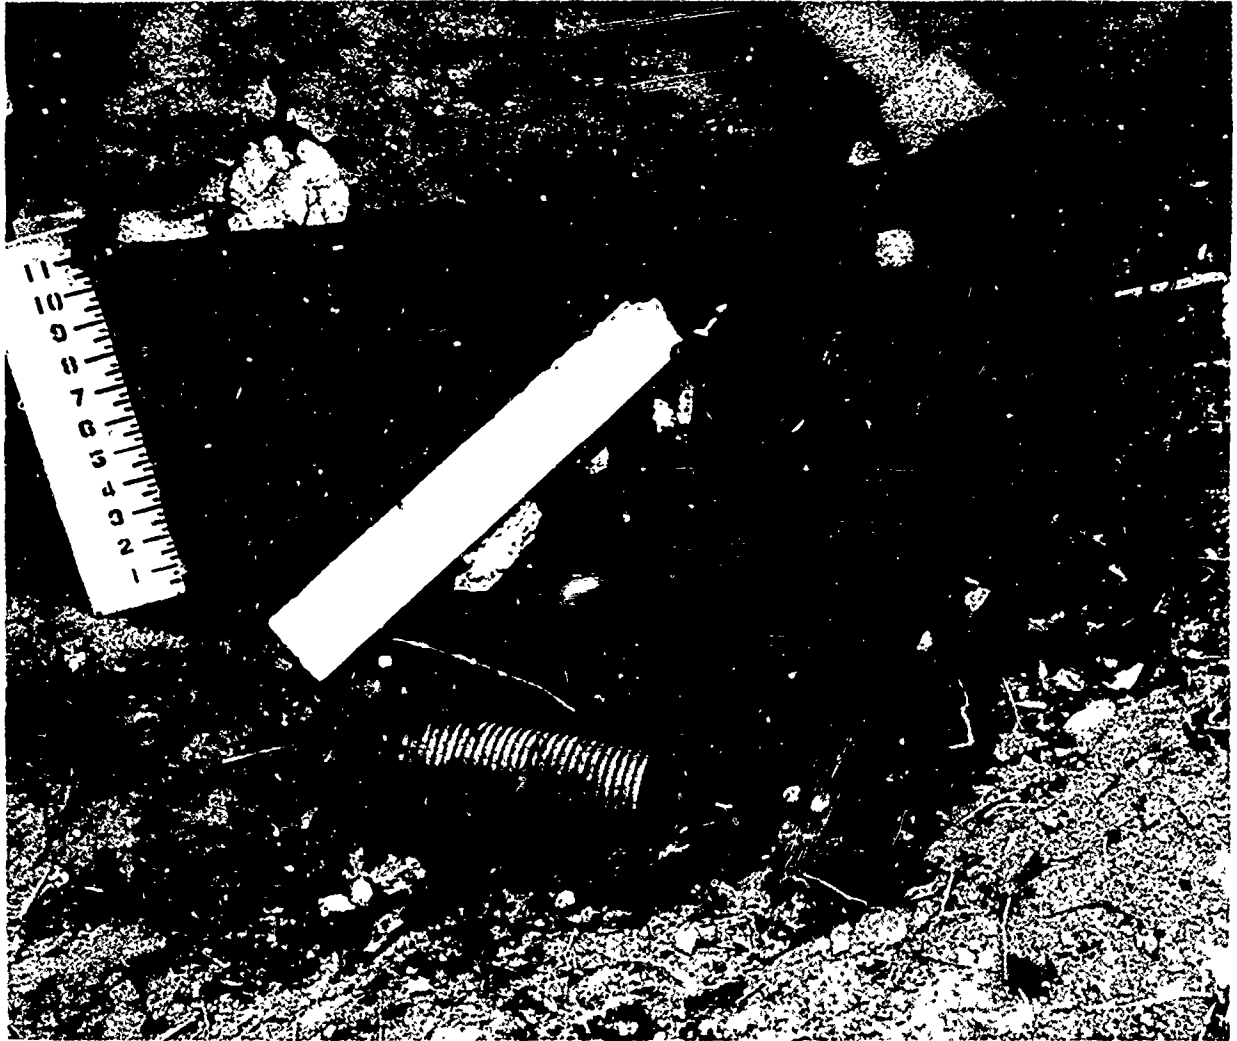
Figure 11. Tube fragments after premature functioning  
of test round with holes through side wall of shell

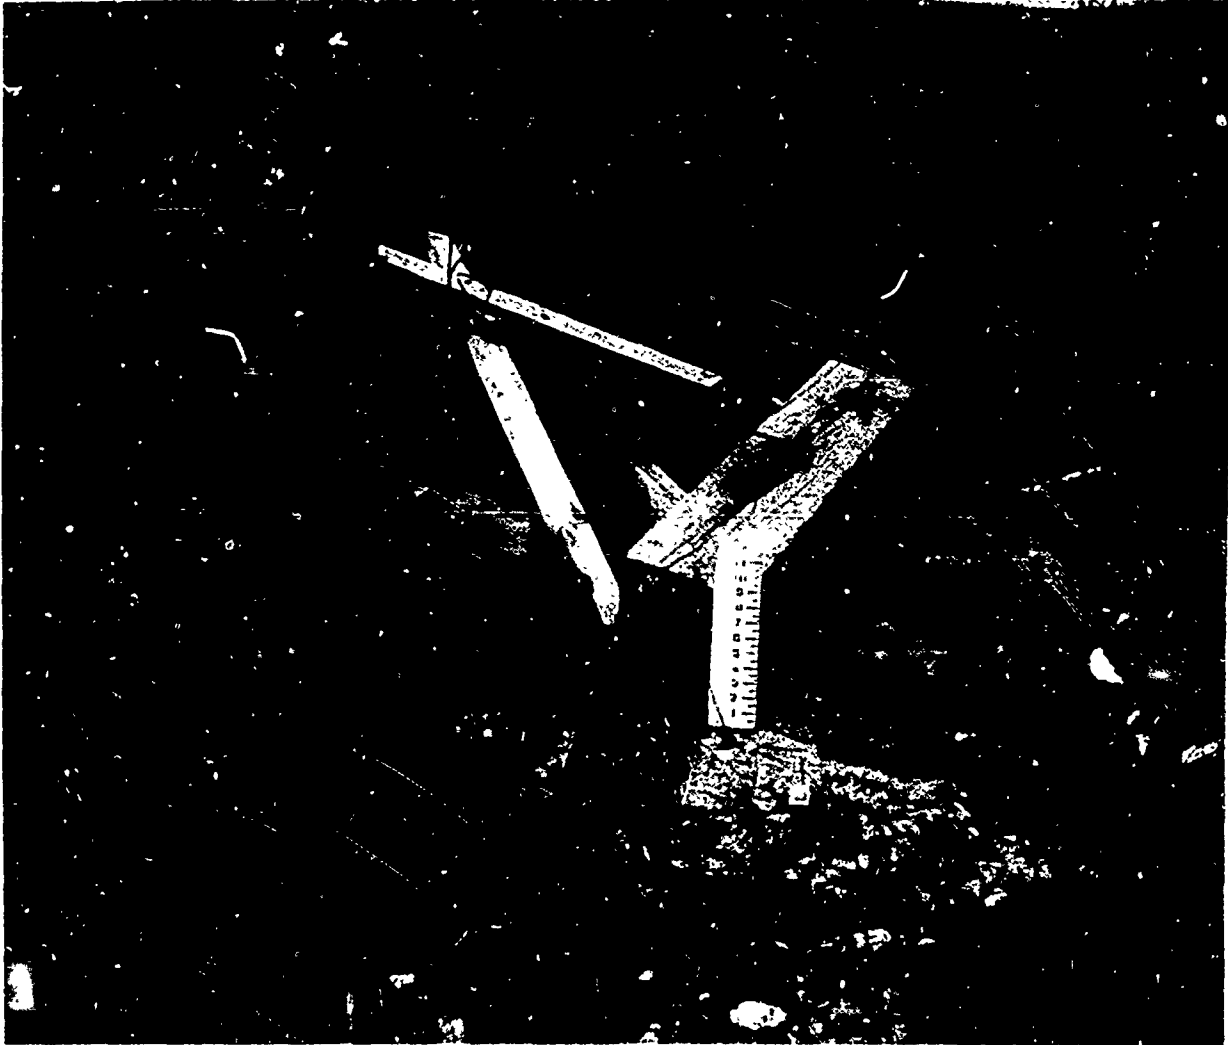
Loose-Fitting Base Plug in Cast Shell Body of the M374 Cartridge -- Previous tests, conducted with a low propellant charge, indicated that the HE filler in 81mm mortar ammunition cannot be initiated by propellant gases in the weapon as a result of loose-fitting base plugs (Reference 4). Additional tests were conducted by the Ammunition Maintenance Engineering Division by preparing sample rounds with loose-fitting base plugs. All rounds were HE-loaded and assembled with dummy fuzes. The test data indicated that a loose fitting base plug is a more serious defect than 1/16-inch holes through the shell base and will cause in-bore prematures (Table 3).

Figure 12. Tube fragments after premature functioning of test round with holes through base of shell

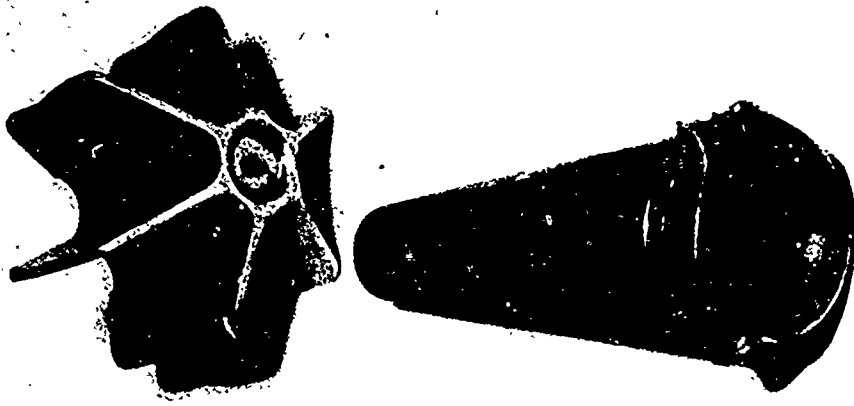
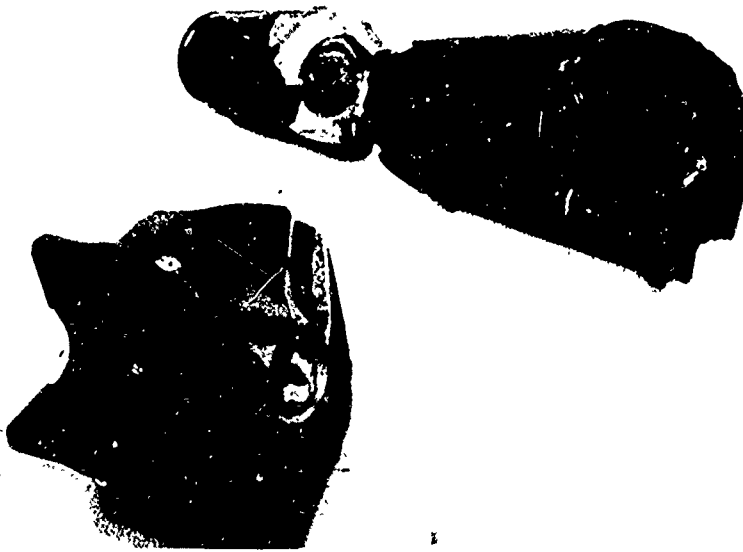
FIELD MALFUNCTION  
(MIF A-155-68)

TEST ROUND WITH HOLES  
THROUGH BASE

Figure 14. Large fragments from base of shell and fin assemblies

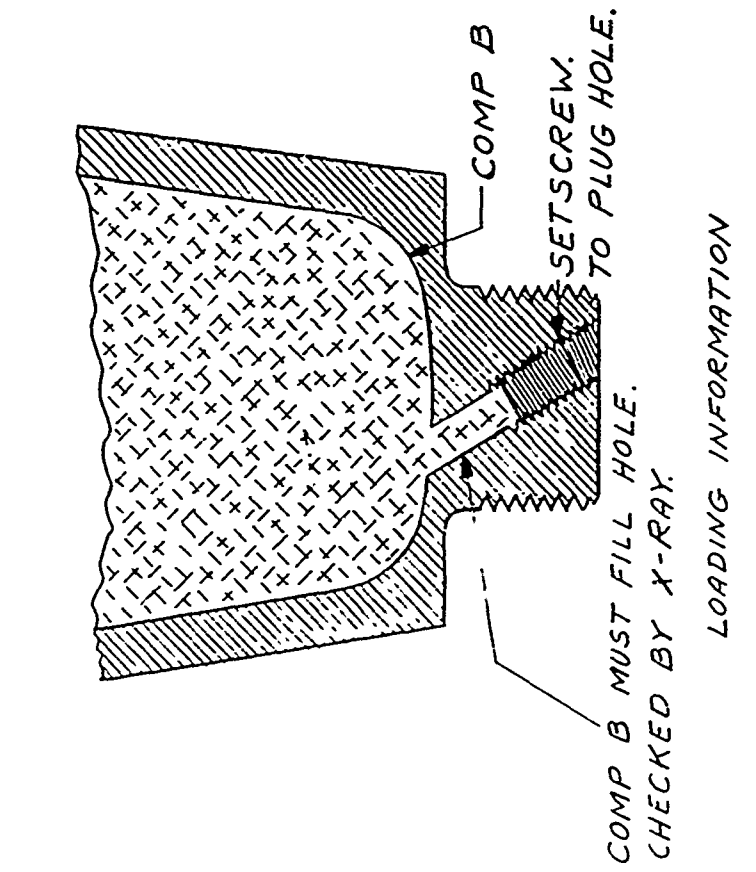
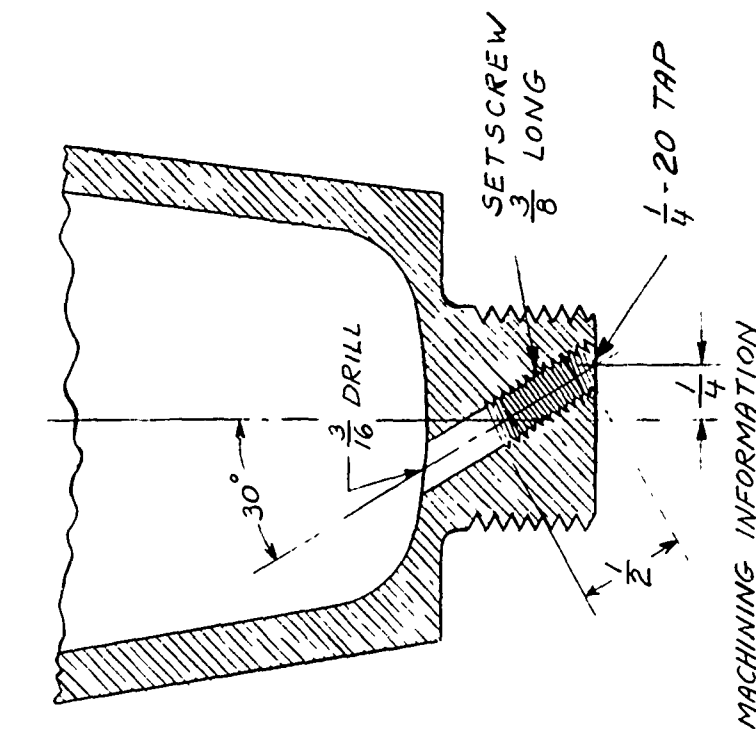
Cavity in the Inside of the Shell Body at the Base -- 100 sample rounds were prepared by drilling a 3/16-inch diameter hole into the inside base of the shell body, approximately 3/8-inch deep, 30° from the longitudinal axis (Figure 15) before loading with Composition B and assembling with dummy fuzes. All samples were x-rayed to assure that Composition B had filled the cavities. All samples were fired at Charge 9. The tests indicated that cavities in the inside wall of the shell body did not cause the HE filler to be "pinched" -- when setback forces were developed during ignition -- sufficiently to cause an in-bore premature.

Figure 15. Test rounds prepared with cavity in the inside of the shell body at the base

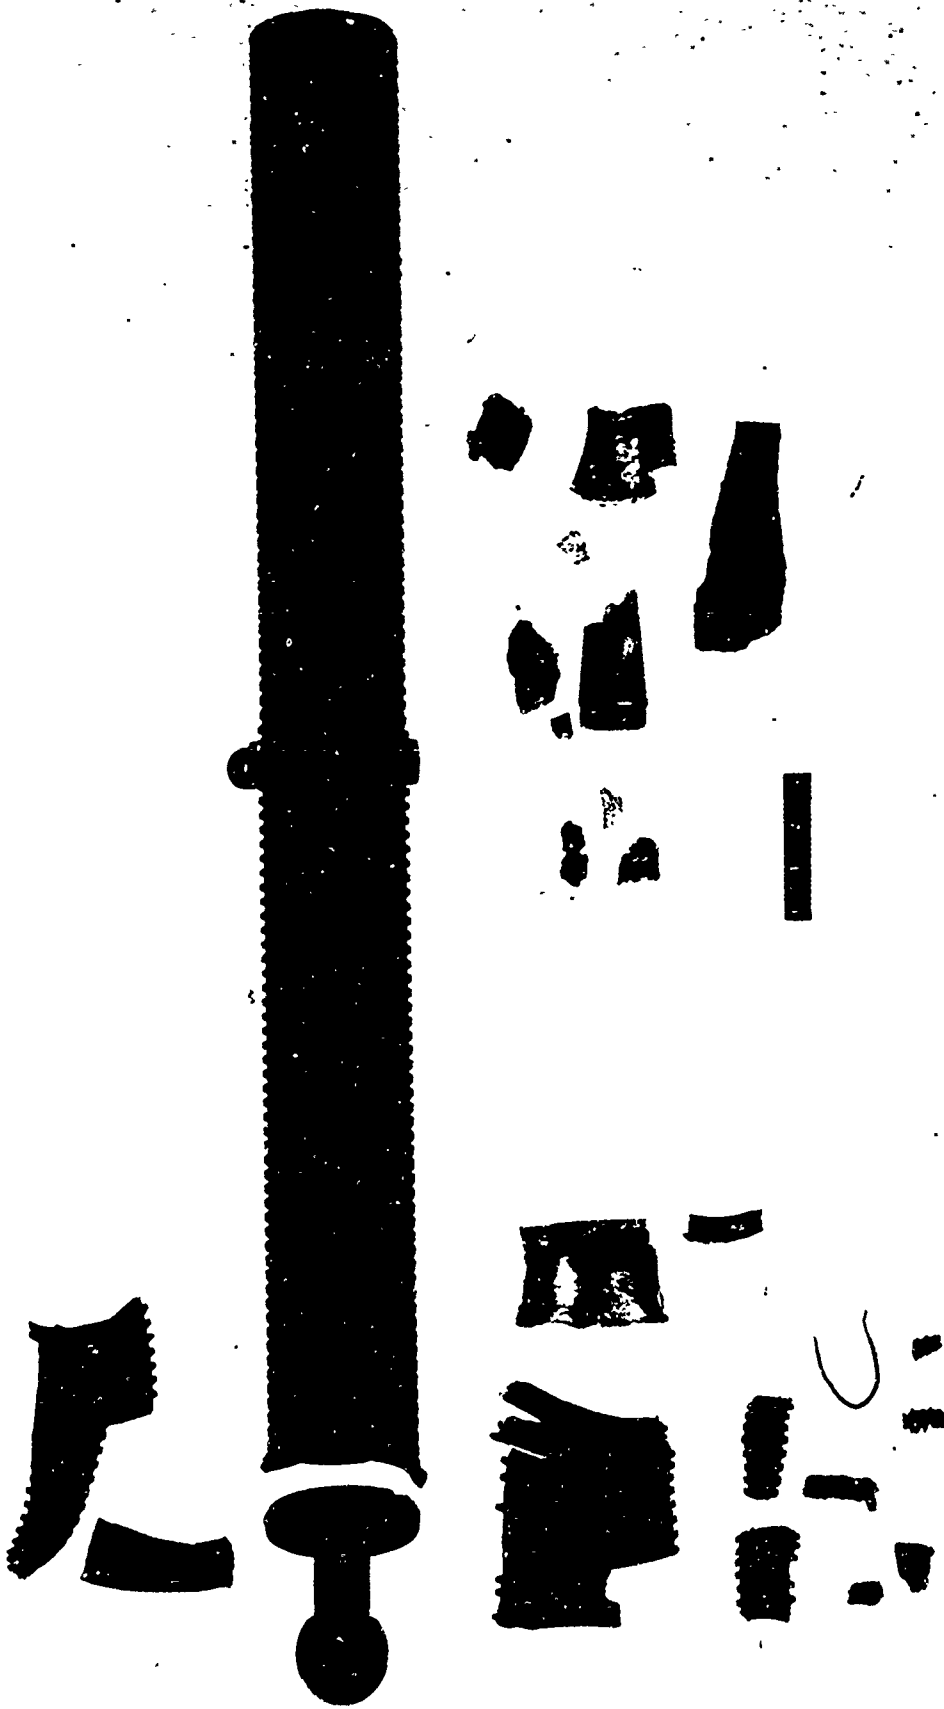
Figure 19. Tube and shell fragments from double loading test of HE ammunition

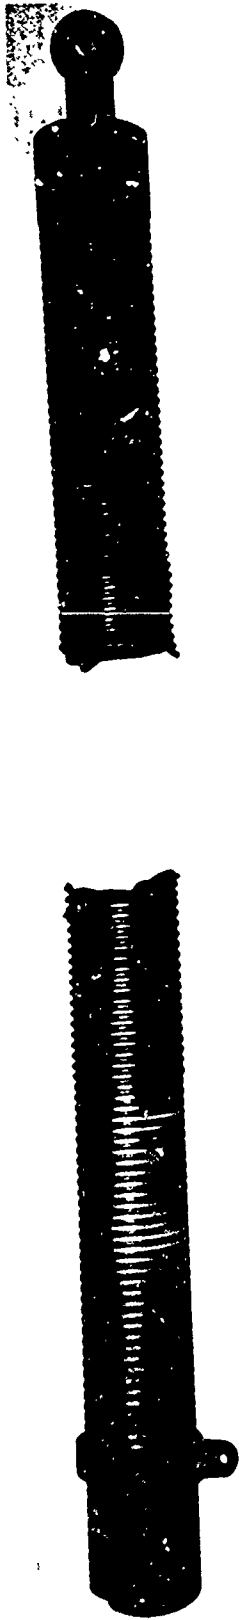
Figure 22. Fragments of tube involved in in-bore premature malfunction (MIF A-155-68)

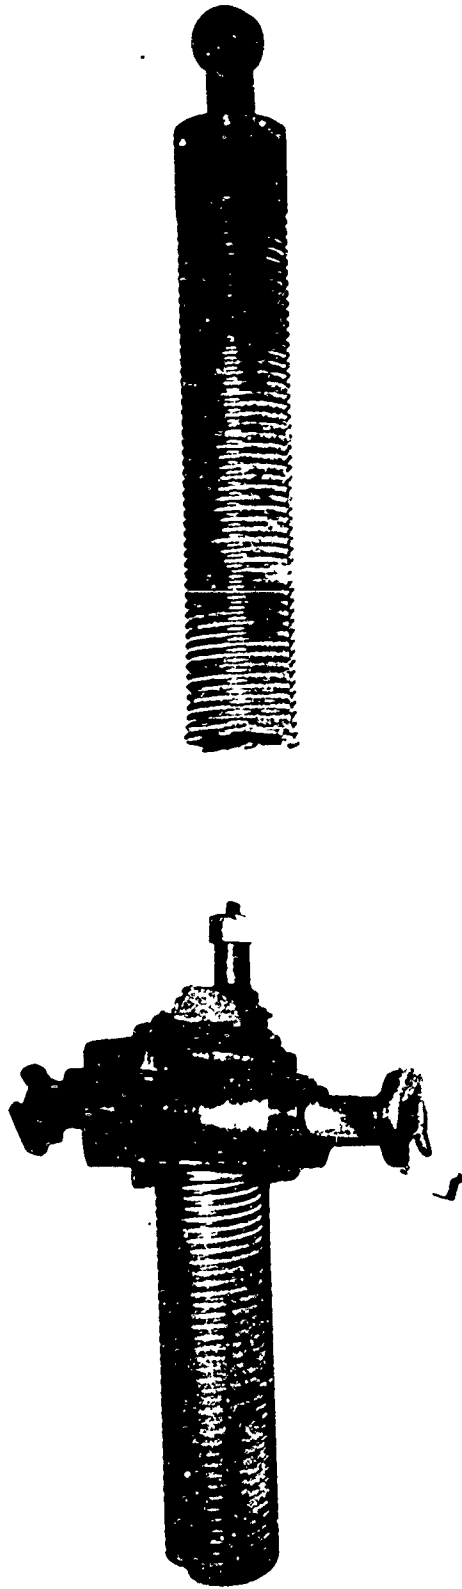
Figure 26. Fragments from tube involved in in-bore premature malfunction (MIF A-41-69)

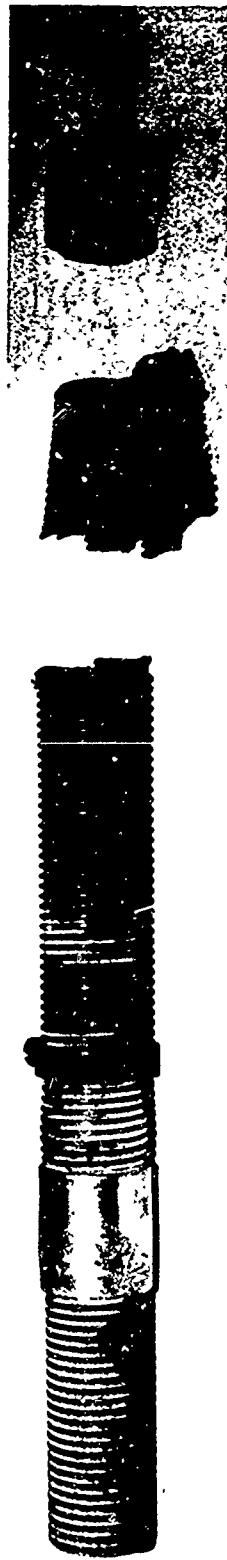
Figure 29. Fragments from tube involved in in-bore malfunction (MIF A-129-70)
