FTC-TR-71-26

CATEGORY II ICING TEST OF THE HH-53C HELICOPTER

TECHNICAL REPORT No. 71-26
JUNE 1971

AIR FORCE FLIGHT TEST CENTER
EDWARDS AIR FORCE BASE, CALIFORNIA
AIR FORCE SYSTEMS COMMAND
UNITED STATES AIR FORCE

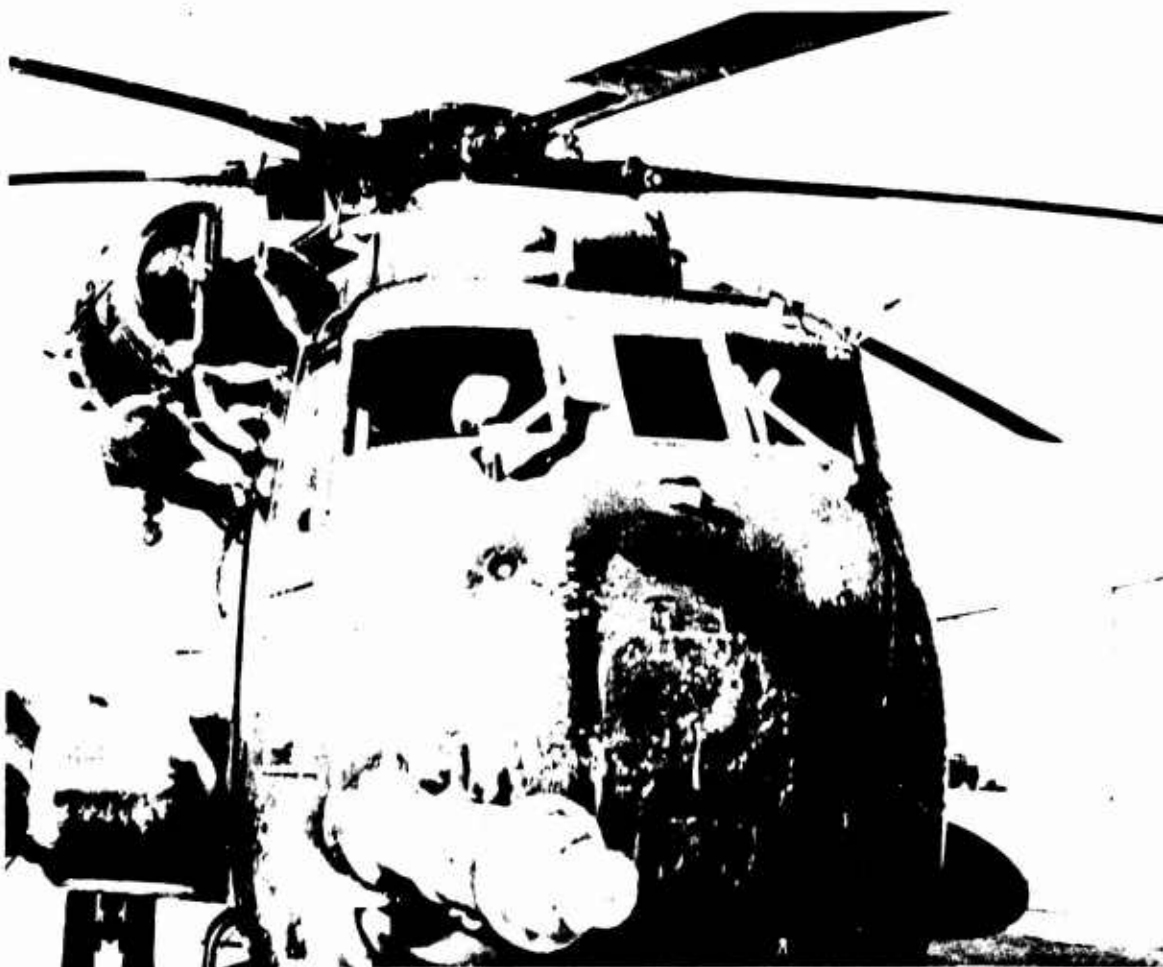
Figure 4 Typical Ice Accumulation on HH-53

Ice accumulated on the vertical pylon, horizontal tail, rotor hub, flight controls, refueling boom, external sponsons, tanks and aircraft nose (figure 4). The rescue hoist accrued heavy ice throughout most of the test conditions. Maximum ice thickness of 1-1/4 to 1-1/2 inches was accrued on the previously mentioned airframe areas from artificial icing conditions of icing flights 9, 14 and 15. No structural damage was inflicted on the HH-53C airframe during all icing tests. Ice accumulation did not hinder flight control operation.

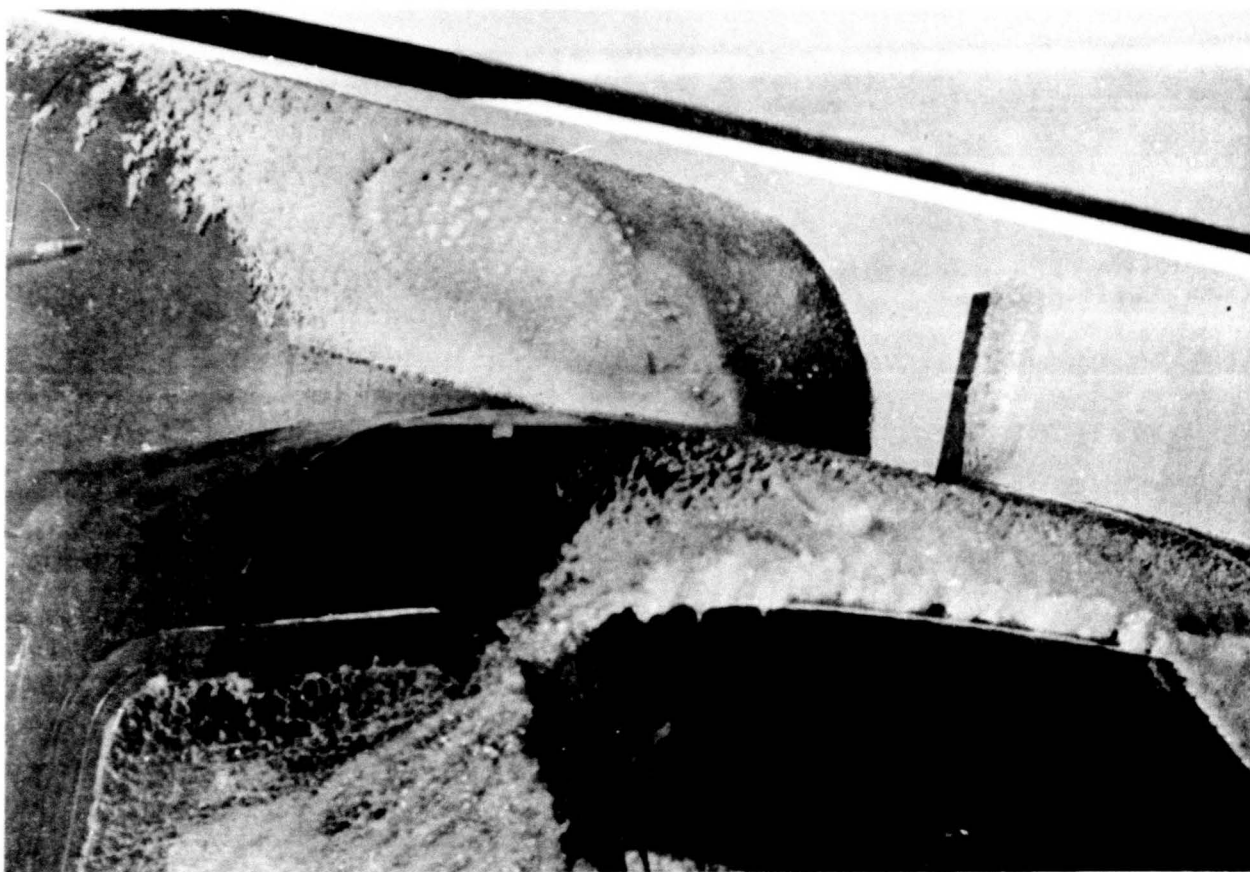
Figure 5 Iced-Over Heater Inlet Duct Screen

The cabin heater inlet screen had an estimated 75 to 90 percent airflow blockage on icing flights 8 and 9 respectively, due to glime ice formation on the screen (figure 5). Subsequent tests conducted at colder outside air temperatures (OAT) had minor (10 percent) blockage of the heater screen area (icing flights 14 and 15). The cabin heater was inoperative throughout part of the artificial icing tests; however, it was believed that this condition did not significantly change the pattern of the ice buildup on the heater screen (appendix II). The heater inlet screen could be totally blocked off by ice formations should light or moderate icing conditions at OAT's from 0 degrees C through -13 degrees C be encountered for extended periods of time. The heater was inoperative during most of the flights when significant ice accretions on the heater inlet occurred. Possible heater system damage or erratic operation due to reduced airflow might result from heater operation after the heater inlet duct was iced over. If reduced airflow from the heater outlet ducts is realized while flying in icing conditions the heater should be turned off to preclude possible heater damage. A NOTE to this effect should be included in section IX of the Flight Manual. (R 1)¹

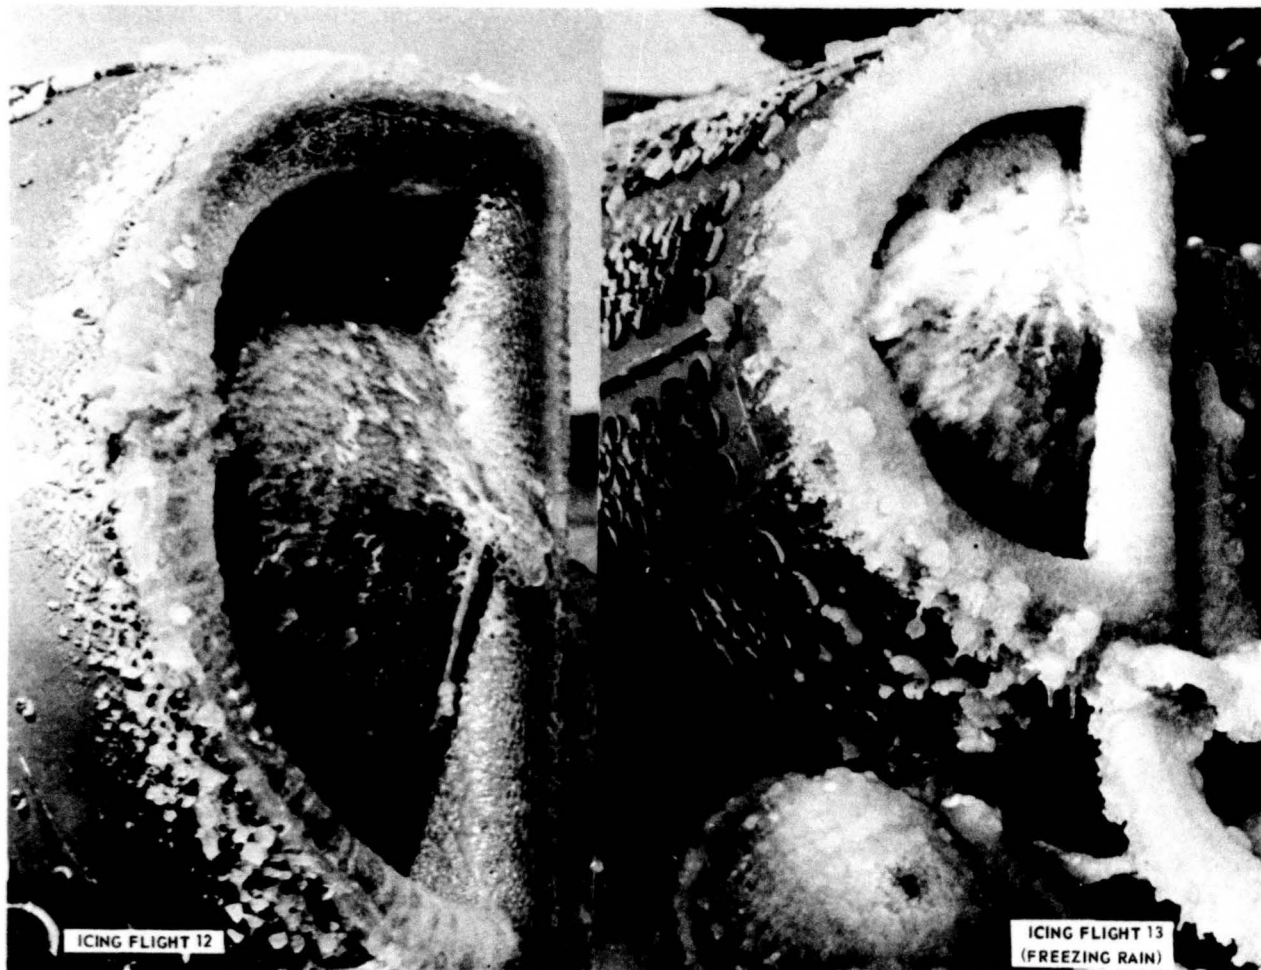
Figure 8 Solid Sheet of Ice on EAPS Lips and Doors

Icing flights 12 through 15 were conducted with EAPS doors closed. Ice accumulated 15/16 inch and 1-1/2 inch thick on the EAPS inlet lips during icing flights 12 and 14 respectively (appendix II). A solid sheet of ice formed over the doors and lips during icing flights 12 and 14

(figure 8). The approximate maximum thickness of ice on the doors was 3/4 inch on icing flight 14. No ice was noticeable inside the EAPS during the artificial icing tests with the doors closed. Ice fingers formed on the leading edges of the mini screens on the bottom and the vertical inboard EAPS panel (figure 9). Maximum EAPS mini screen ice blockage was estimated at five percent on icing flight 14, appendix II.

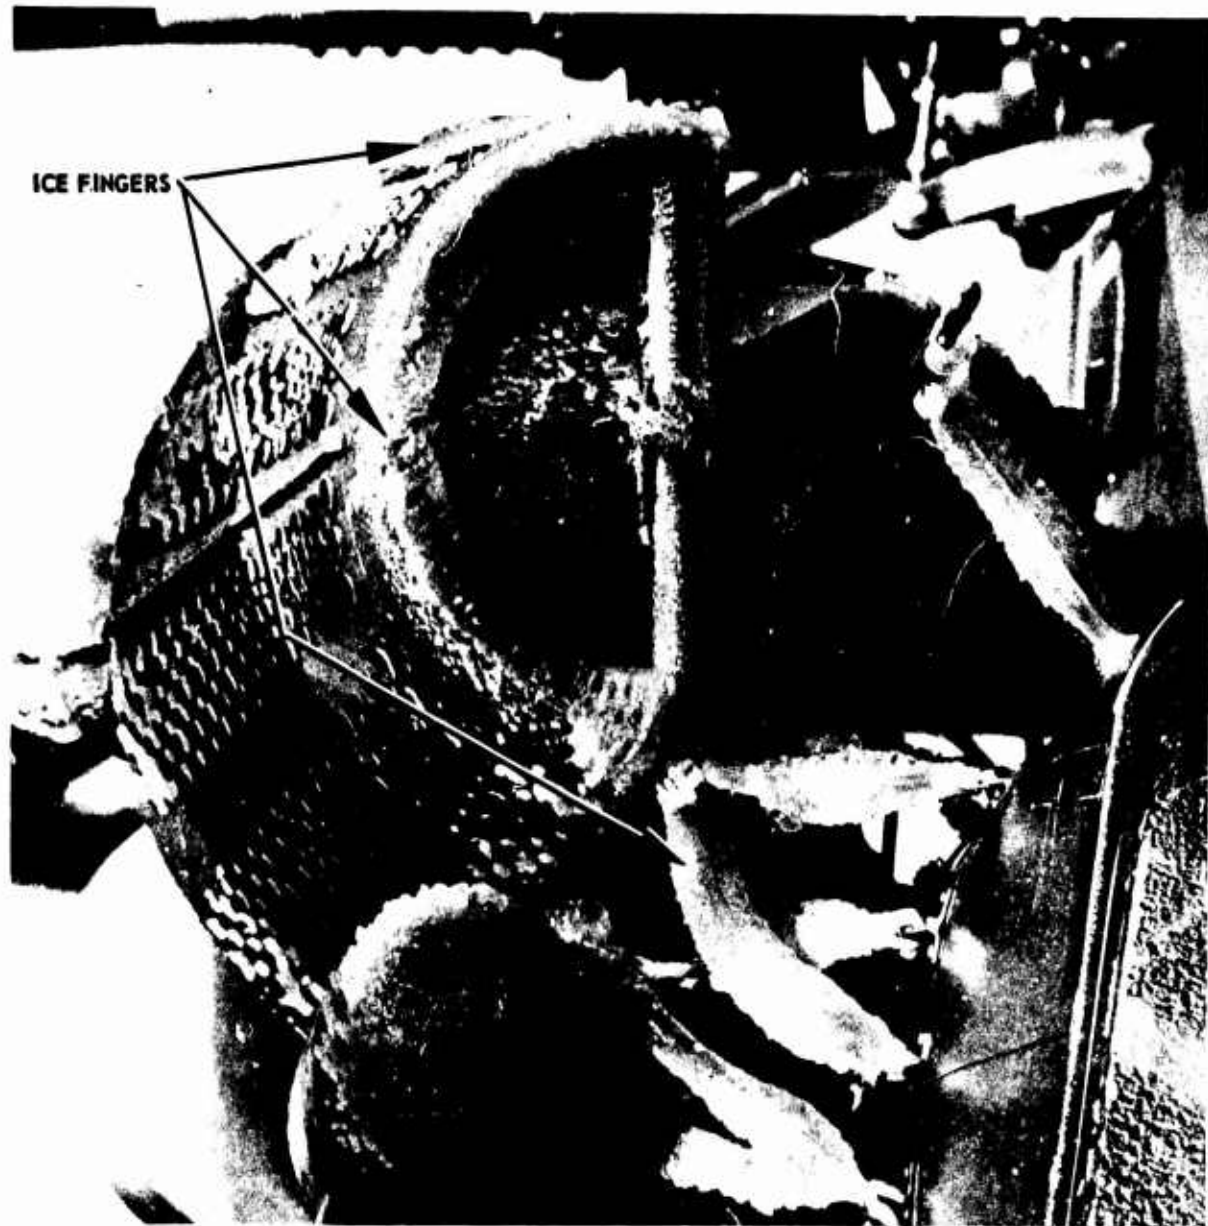
Figure 9 Ice Fingers on EAPS

Approximately 20 of the 759 EAPS mini screens were blocked with 1/8 inch ice on icing flight 13 (appendix II). The inboard EAPS panel was 30 percent blocked off with ice. Ice fingers were 1-15/32 inch long on the leading edge of the mini screens and on parts of the screens on the forward 1/3 of the EAPS. Ice was 5/16 inch thick inside of the closed EAPS on the forward lower surface, due to water runback.

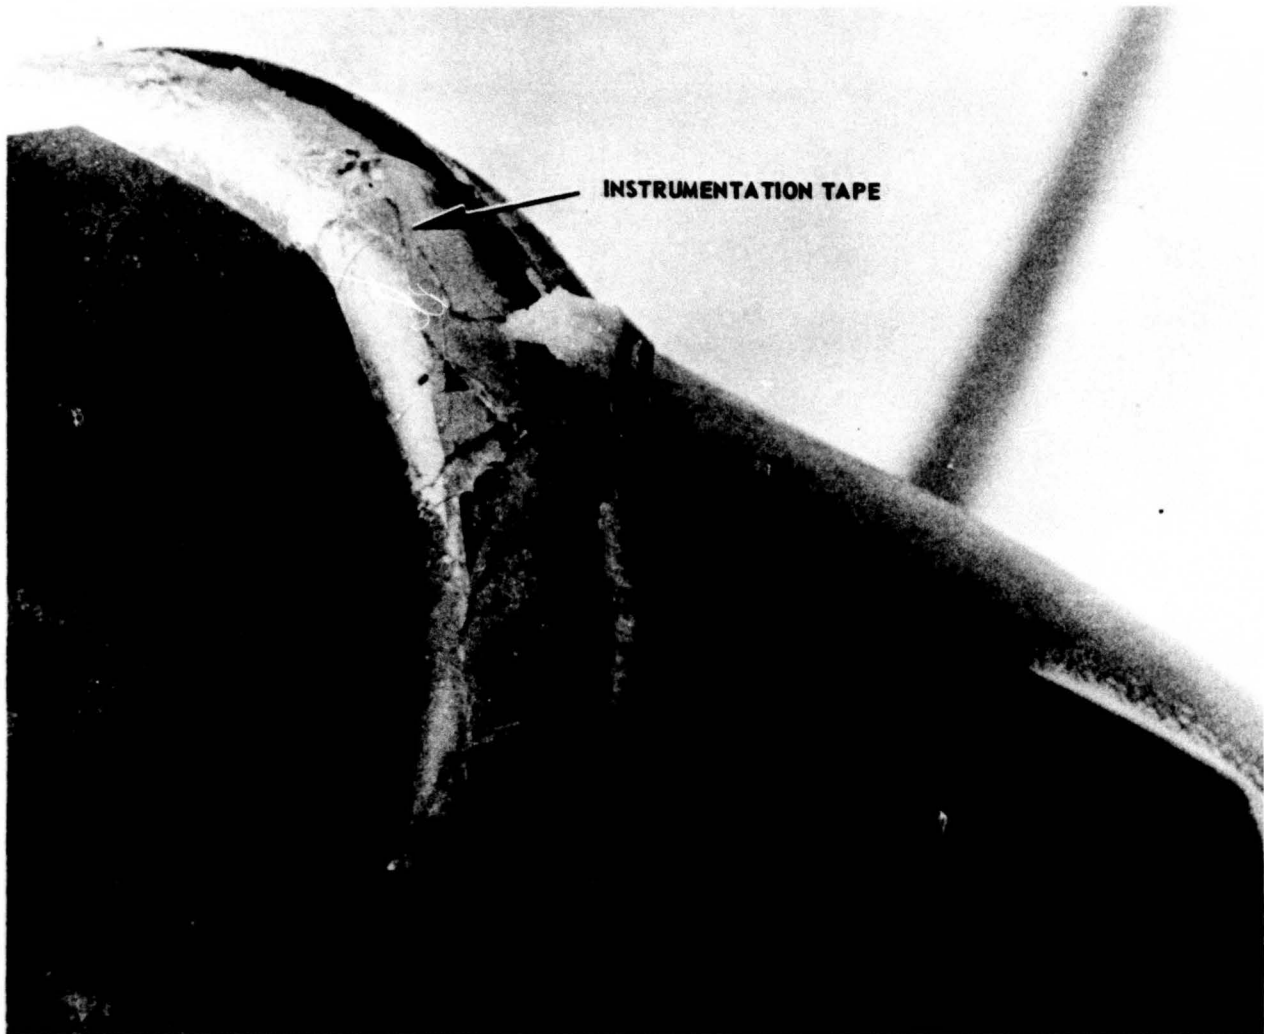
Figure 10 Natural Ice on EAPS Aft Support Rings

The EAPS performed satisfactorily under all natural icing and snow conditions encountered. The EAPS doors were usually left in the open position during cruise until the first indications of icing were observed. At that time, the doors were closed and left closed until the inlet lips and doors were visually checked to be ice free. The maximum amount of natural ice was collected on the EAPS on icing flight 21. About 30 percent of the leading edges of the mini screens on the inboard (vertical) EAPS panel were observed to have rime ice formations.

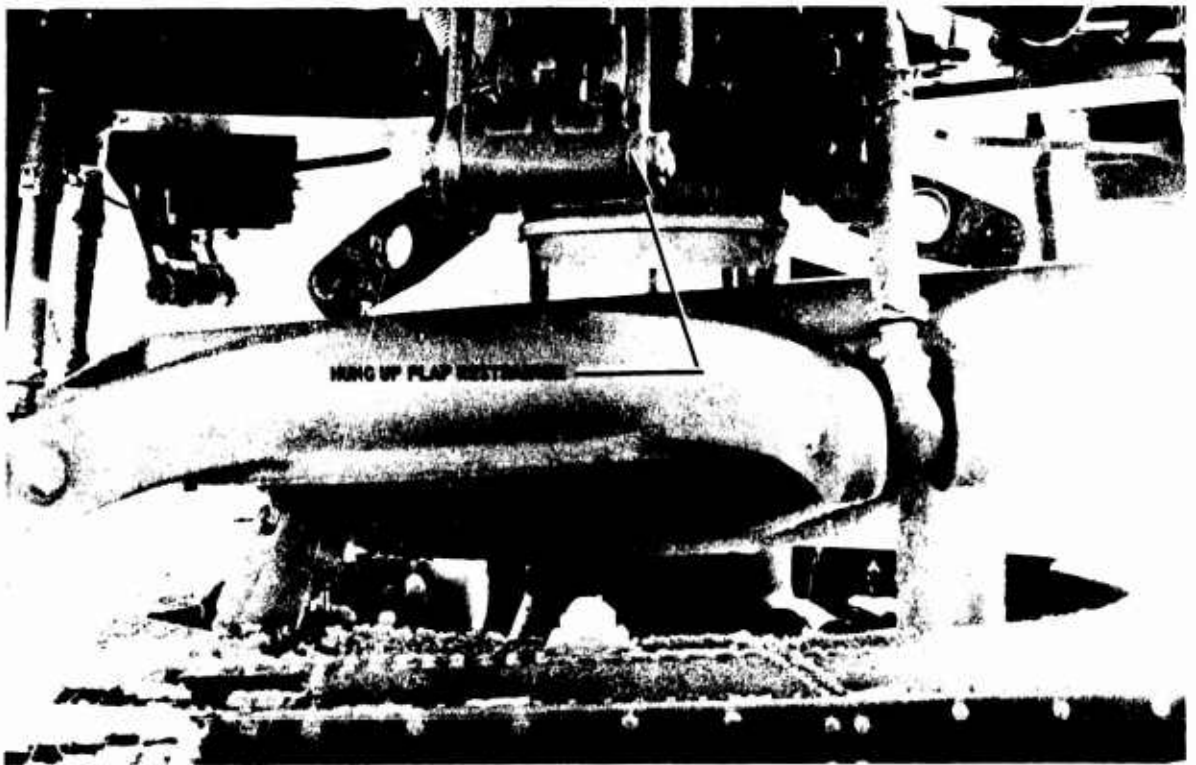
Figure 20 Ice on Flight Servos and Anti-Flapping Restrainers

During artificial icing flights when significant depth of ice was accumulated (1/4 to 1/2 inch, light icing for five minutes and all moderate icing flights) one or more of the main rotor blade anti-flap restrainers hung out in the flight position during rotor shutdown (figure 20). This represented no operational or safety problems during the icing tests since there was no significant wind blowing during shutdowns. The anti-flap restrainers returned to the non-flight position as soon as the ice melted. Pilots and ground crewmen should be alerted for main rotor blade flapping during rotor shutdown in windy conditions after ice has accumulated on the main rotor head. Under these circumstances it will be necessary to park into the wind to minimize chances of blade/fuselage or rotor head damage during shutdown. A CAUTION should be placed in the Flight Manual describing procedures to follow on rotor shutdown after icing conditions have been experienced. (R 9)

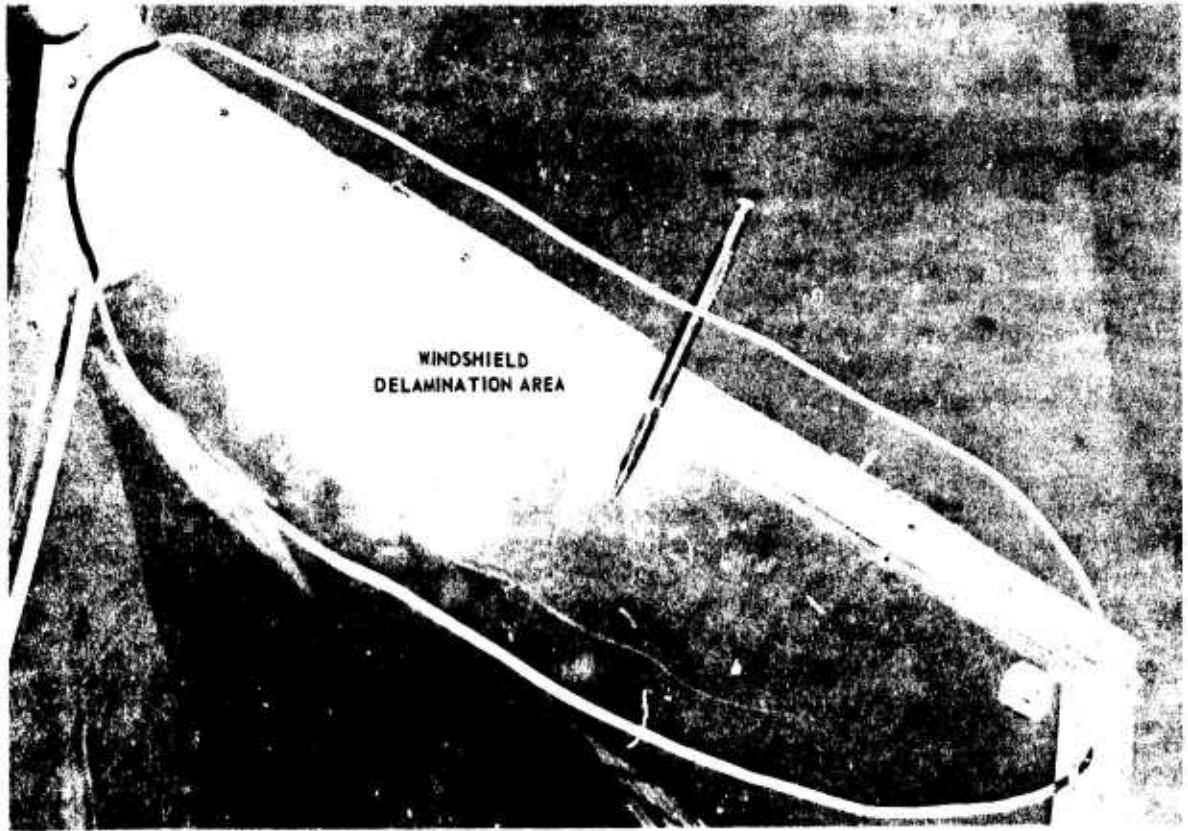
Figure 22 Windshield Delaminations

One third of the center windshield lost all anti-ice capability after icing flight 9. This portion of the windshield had a delamination

in which a burned or smoky area, immediately adjacent to the imbedded bus bar, was visible. The windshield anti-icing systems were in use for approximately 7 hours during the artificial icing tests and approximately 10 hours during the natural icing tests. As evaluated, the windshield anti-icing system was highly effective in maintaining ice free vision up to and including moderate icing conditions when turned on one minute prior to encountering icing conditions. The windshield was unsatisfactory in terms of its extremely short service life when using the anti-ice heating capability, due to frequent delaminations. The quality control inspection procedures employed during manufacturing and acceptance should be improved and/or the windshield design improved to eliminate the delamination problem. (R 19)

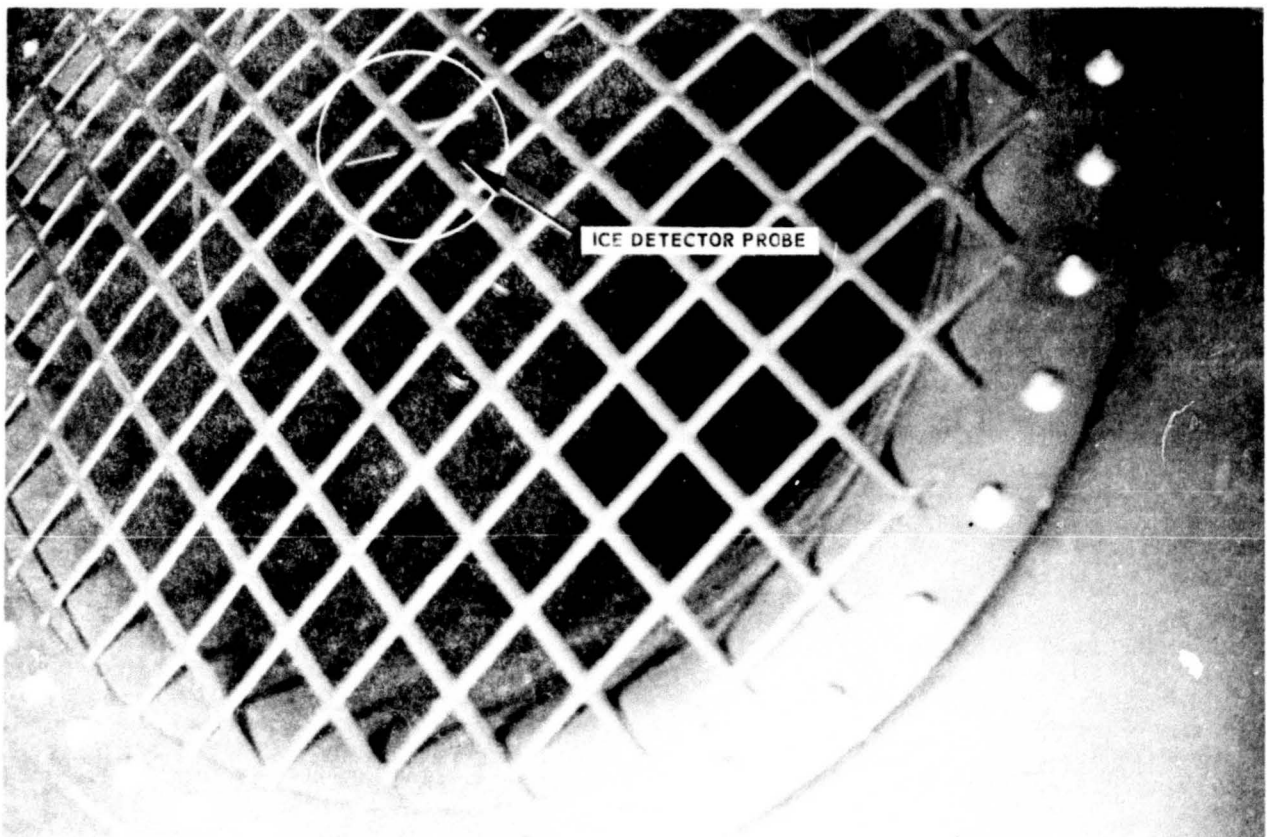
Figure 24 Heater Inlet Screen with Ice Detector Probe Inside

The ice detector probe, located in the cabin heater inlet duct, was unreliable during the test program (appendix VII). During test point 12, an artificial icing condition, the ice detector system did not activate until it had been in a light icing condition for 8 minutes and on other flights it activated frequently, prior to entering the icing cloud. Also, during a flight in search of natural icing, the ice detector system activated in clear air, with no icing evident. The cabin heater was inoperative during part of the artificial icing/freezing rain tests, but was operational during the natural icing test phase.

The intermittent operation of the ice detector probe was possibly caused by its location within the cabin heater duct, and/or air flow blockage due to ice accumulation on the heater screen (figure 24). The ice detector system was unreliable. The operation of the ice detector probe should be checked and the sensor relocated to an area that would be more conducive to ice accretion in unrestricted airflow. (R 27)
