UH-1N

# CATEGORY II AIRFRAME AND SUBSYSTEMS EVALUATION

TECHNICAL REPORT No. 71-37

AIR FORCE FLIGHT TEST CENTER  
EDWARDS AIR FORCE BASE, CALIFORNIA  
AIR FORCE SYSTEMS COMMAND  
UNITED STATES AIR FORCE

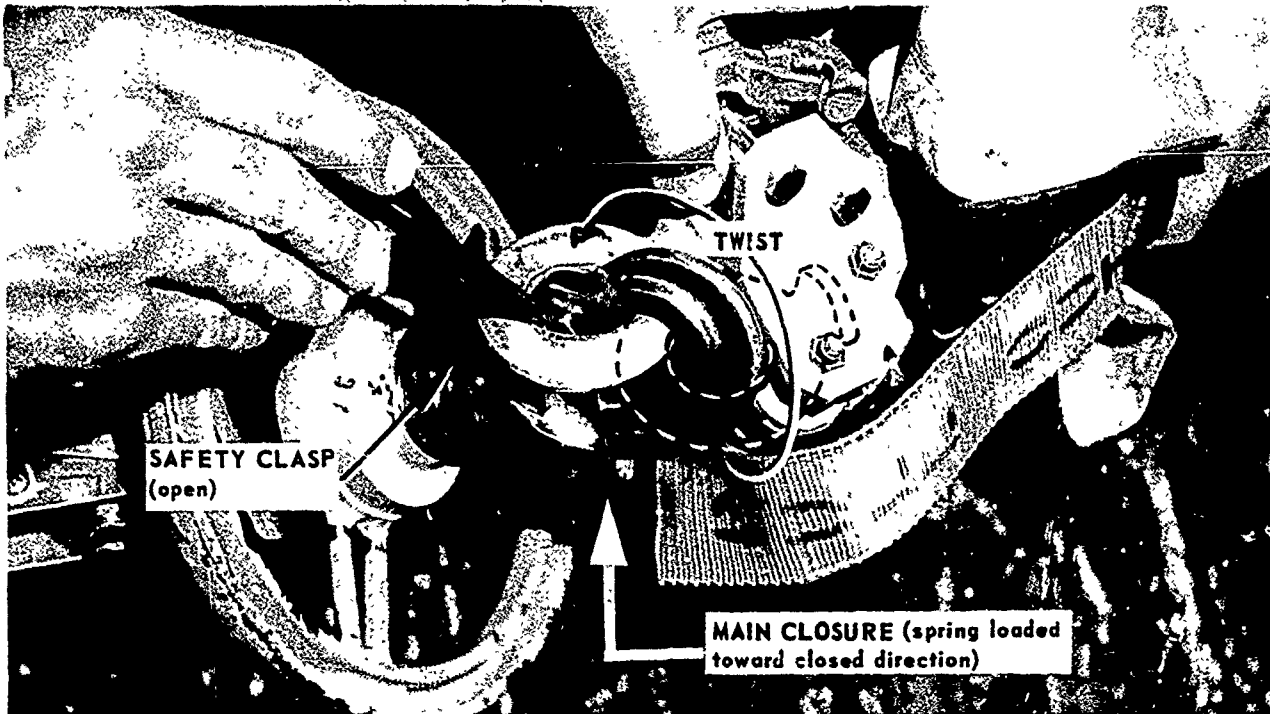
**Figure 2 Hoist Hook with Forest Penetrator Attached**

The suspension hook on this hoist featured a two-piece assembly intended to retain attached accessories. The main hook closure was spring loaded in the closed direction (figures 2 and 3). A safety clasp was provided to prevent inadvertent opening of the main closure. This clasp was held in place by dimples stamped into its sides. These were not adequate to retain the clasp reliably. With the clasp open, it was found that the forest penetrator could be twisted so as to push the main closure aside, releasing itself from the hook. Such a condition is likely to occur during impact with the ground or tree branches, causing possible loss of the penetrator. A positive locking hook closure should be incorporated to eliminate this possibility. (R 8)

Figure 3 Self-Release of Forest Penetrator

8. Concur with intent. ASD has procured an ECP to provide positive closure lock of the rescue hoist hook using a "pip pin".
9. Concur with intent, but not with recommended action. ASD will change procedures to pre-position the non-essential bus switch to MANUAL before using the hoist. Modification is not warranted, so long as electrical power is assured.

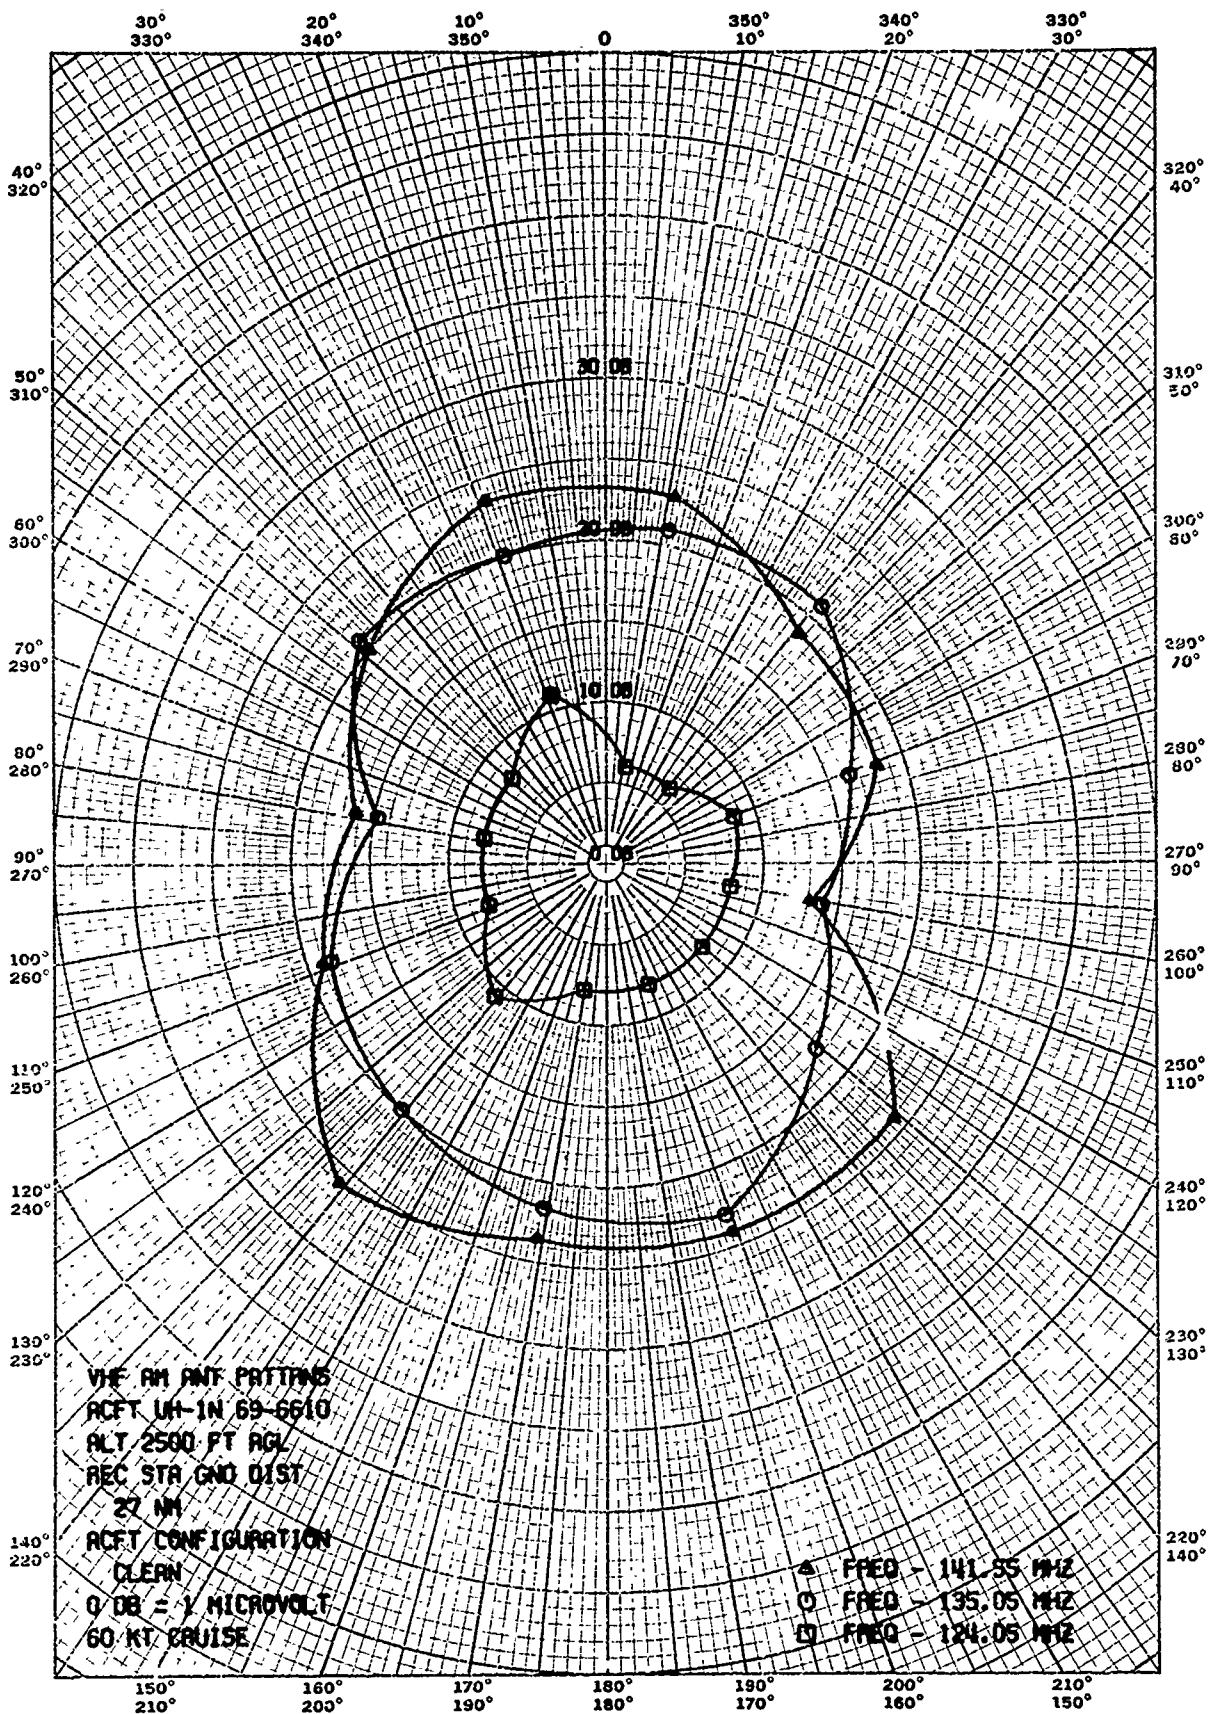
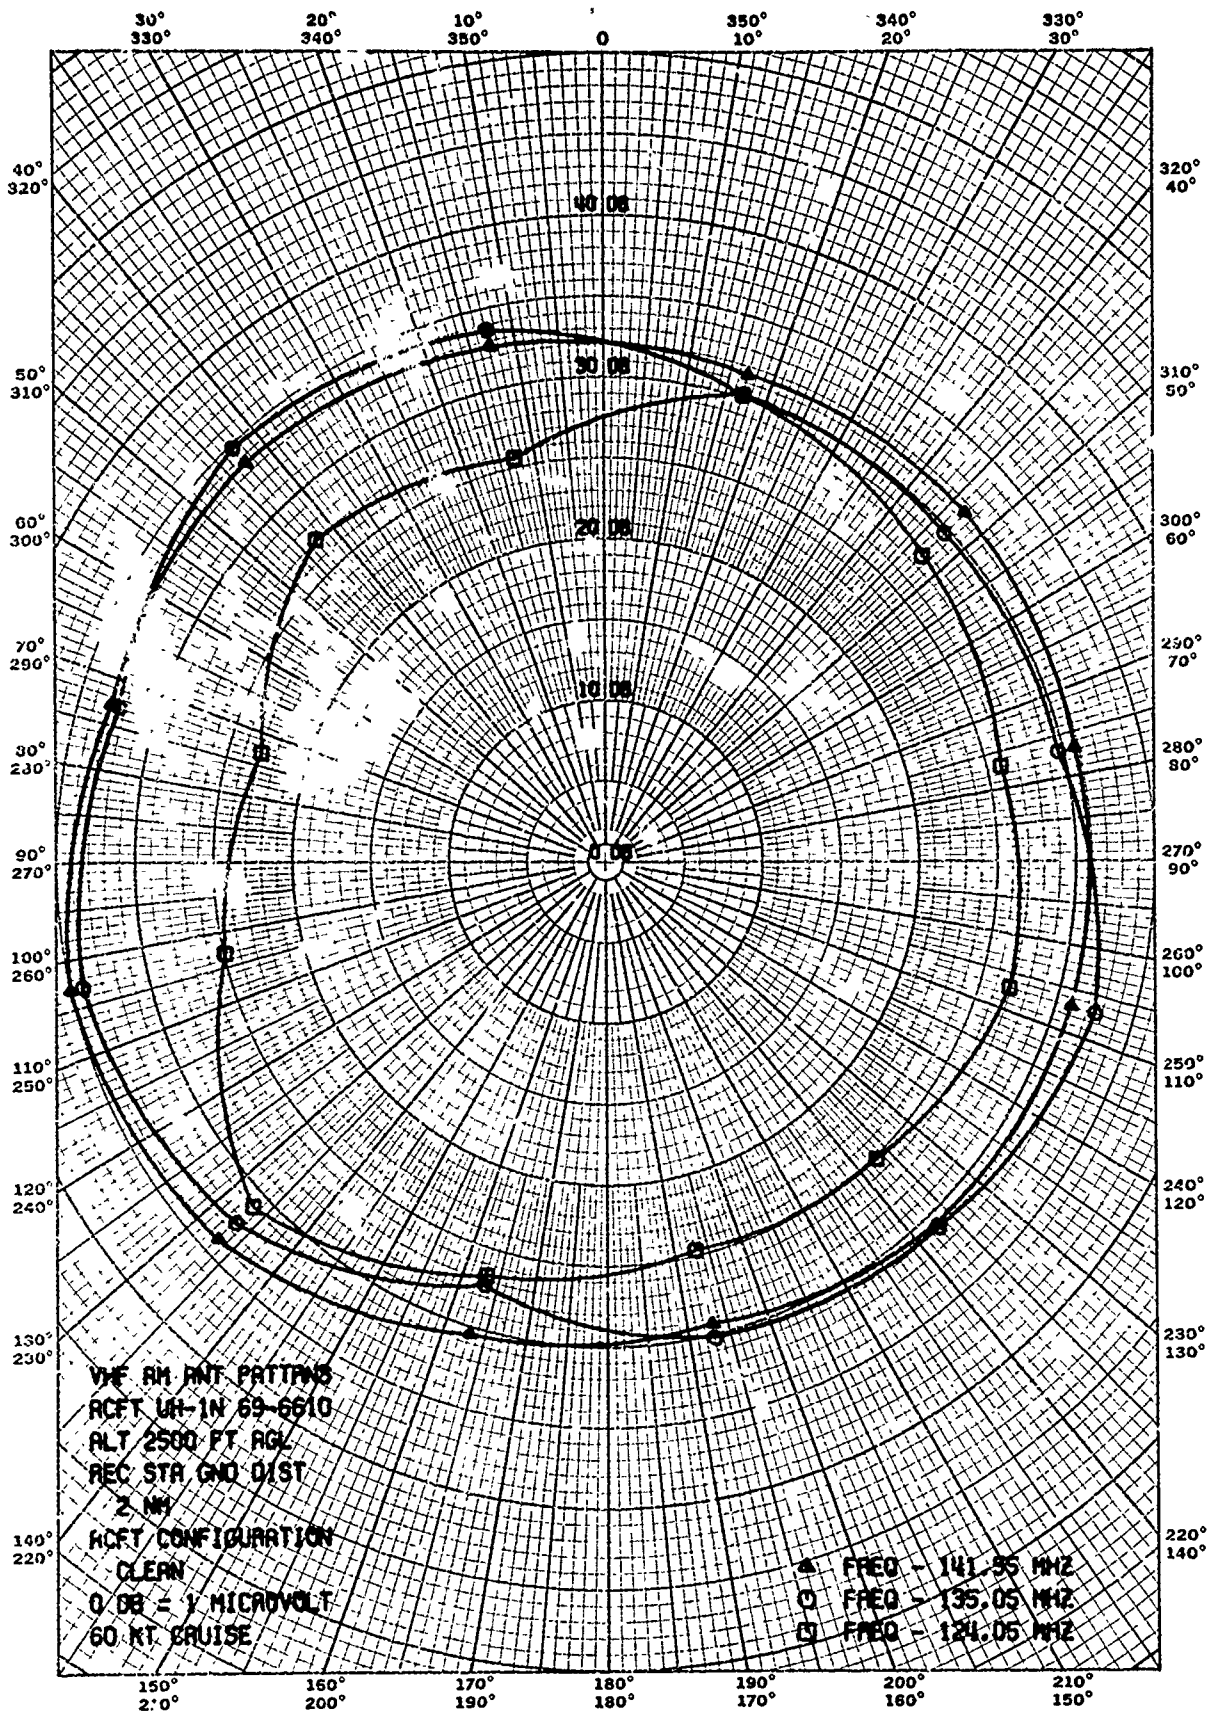
Figure 7 Post-ECP VHF-AM Antenna Patterns

Ground tests were performed in the same manner as in pre-ECP ground tests. The VHF-AM power output on the 10 frequencies tested was 9 watts or greater at the RT, and the VSWR was acceptable; the largest VSWR was 2.21:1 measured at the antenna (table IV). Specification SCL-T-0045B (reference 15) was met. Table V presents the percentage increase in power measured at the antenna for each frequency. The average power output improvement for all frequencies observed was 81 percent.

Specification SCL-T-0045B required that no more than one half of the VHF-AM pattern nulls may be more than 6 decibels below the maximum signal strength. Figures 7 and 8 show the antenna radiation patterns obtained. It was noted that at the 2-NM distance the nulls were considerably less pronounced and coverage was excellent in all quadrants.

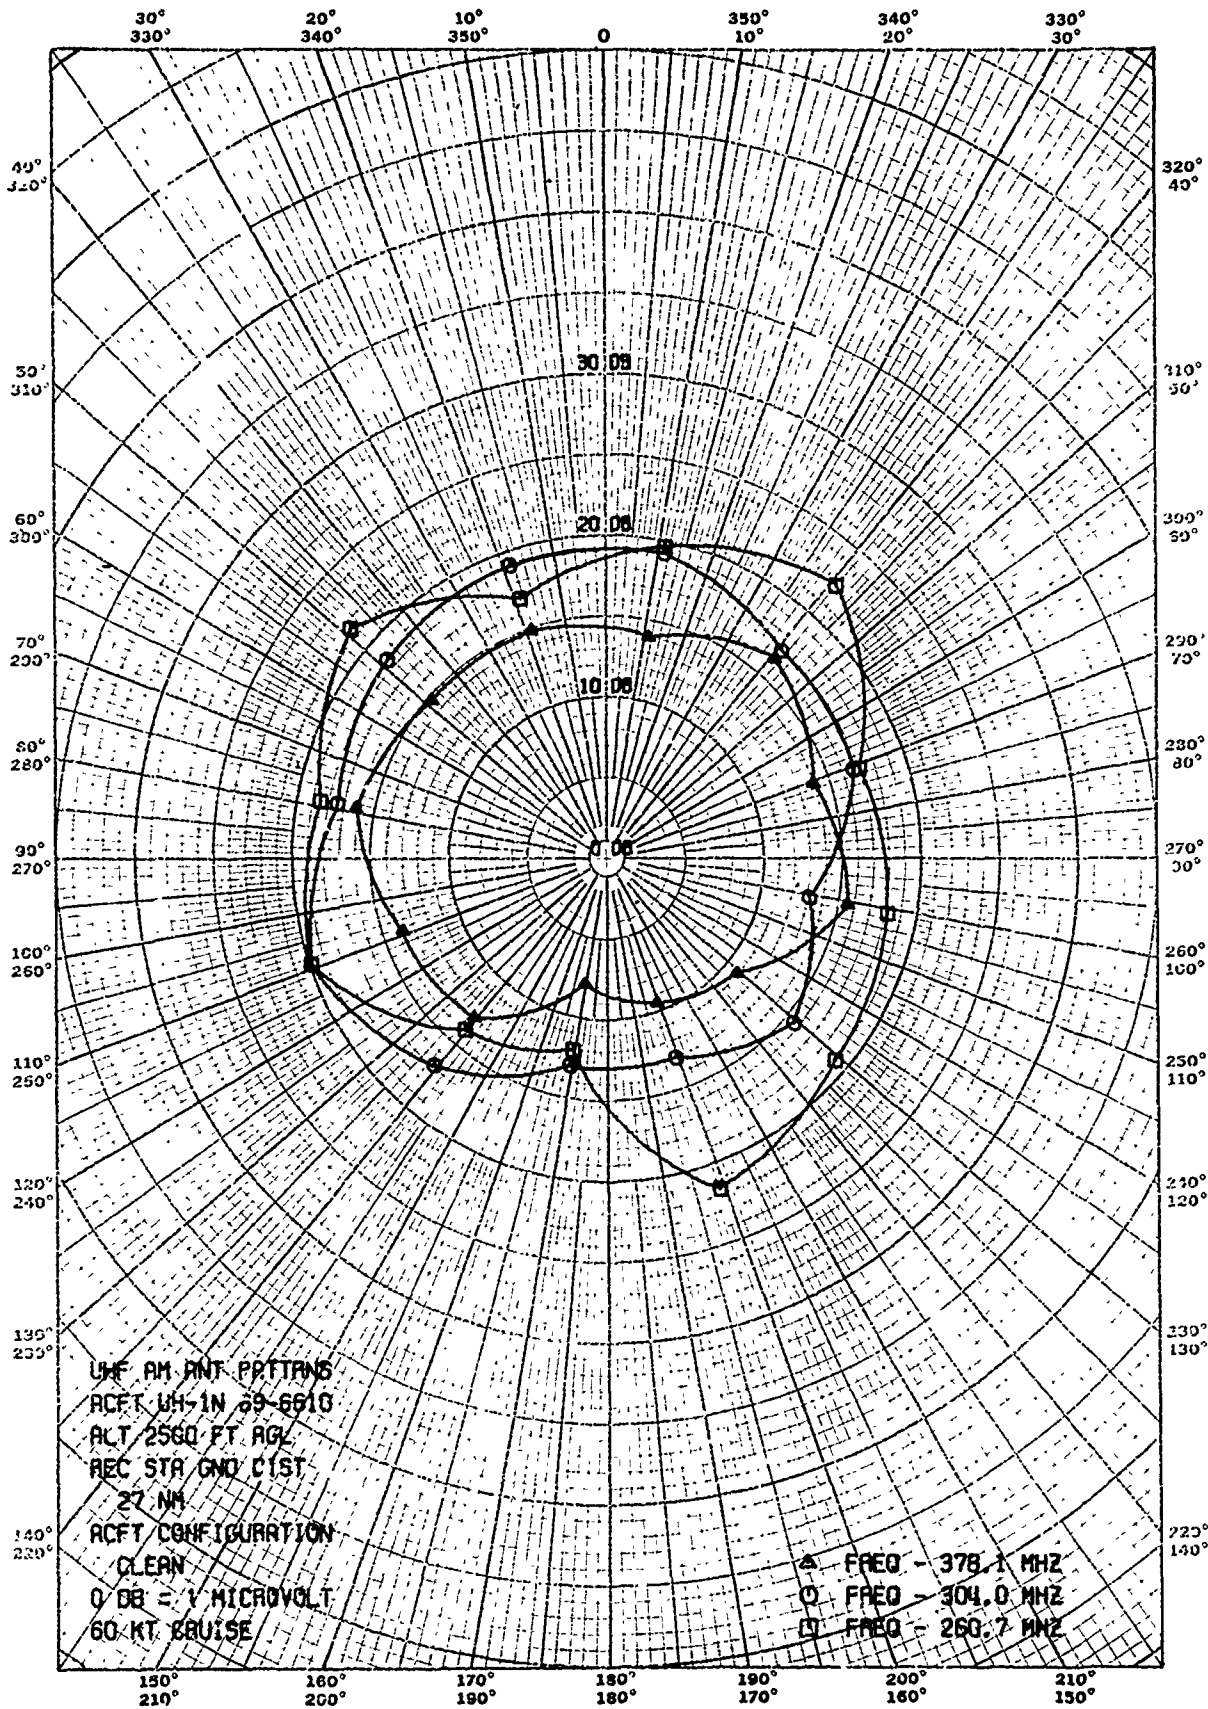
Figure 9 Post-ECP UHF-AM Antenna Patterns

ARC-116 power output and VSWR test results are presented in table VI. Power output on 7 of the 11 frequencies tested at the RT failed to

satisfy specification. The VSWR measured at the antenna did satisfy the specification. Percentage improvements for the 11 frequencies tested are presented in table VII. An overall average of 35-percent improvement in power to the UHF antenna was observed over the frequency range.
