UH-1N SALT WATER SPRAY INGESTION TESTS (CATEGORY II FOLLOW-ON TEST PROGRAM)

TECHNICAL REPORT No. 72-39

OCTOBER 1972

**AIR FORCE FLIGHT TEST CENTER
EDWARDS AIR FORCE BASE, CALIFORNIA
AIR FORCE SYSTEMS COMMAND
UNITED STATES AIR FORCE**

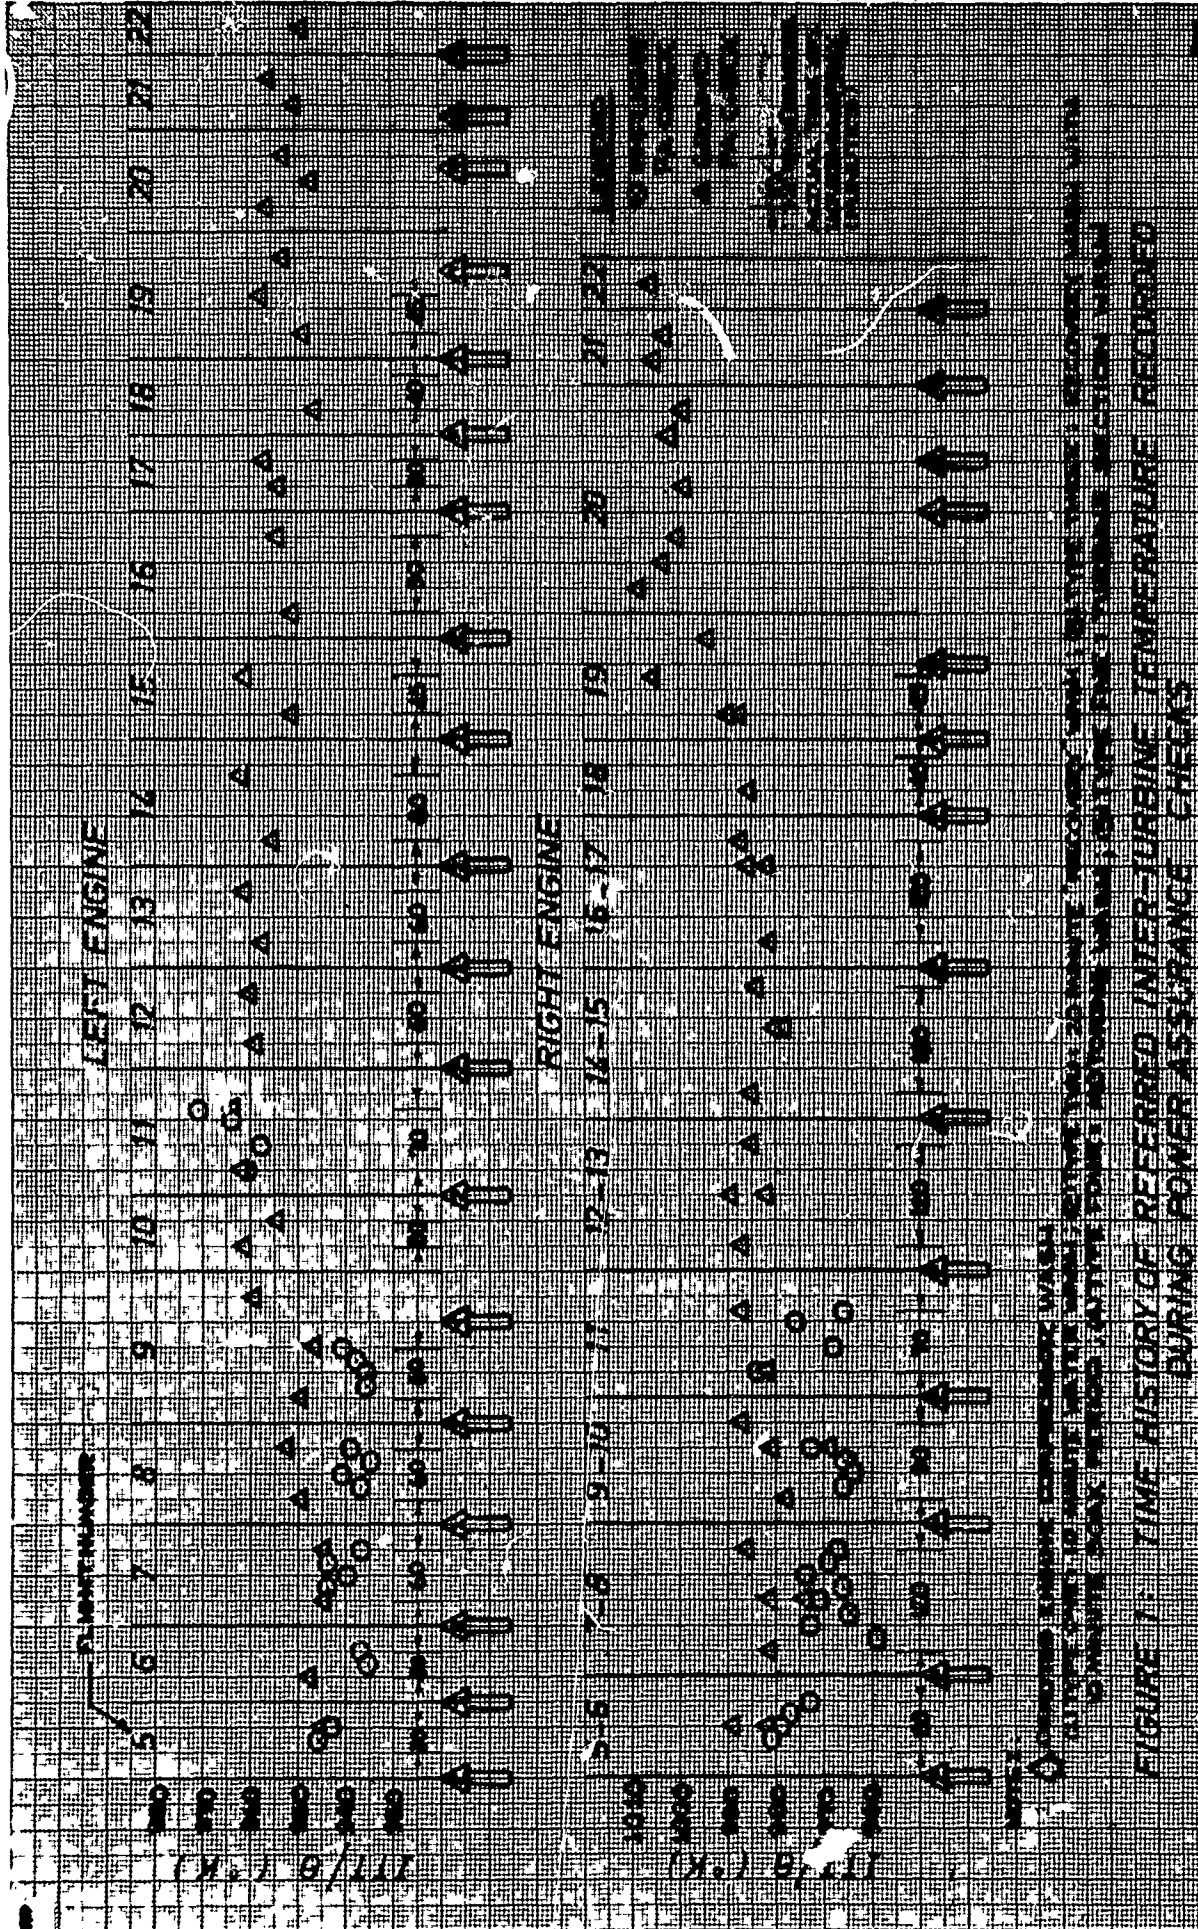
FIGURE 1. TIME HISTORY OF REFERRED INTER-TURBINE TEMPERATURE RECORDED DURING POWER ASSURANCE CHECKS

Inflight power assurance checks did not correlate with the inflight topping power checks. During flight 7, the left engine lost approximately 1 percent torque during successive topping checks while the ITT decreased approximately 7 degrees C during power assurance checks. During flight 9, the left engine ITT increased 5 degrees C while topping checks showed almost a 2 percent loss in topping power torque. Flight 11 was flown almost entirely in wind conditions insufficient to cause salt water spray impingement on the helicopter. During this flight the left engine showed no torque degradation, but the ITT increased 10 degrees C during successive power assurance checks.

A similar lack of correlation existed on the right engine. During flights 7 and 8, the right engine exhibited no power loss for the first 1 1/4 hours, then showed a decrease in torque of almost one percent after 1 1/2 hours and almost 2 percent after 1 3/4 hours. The inflight power assurance checks did not reflect the same marked change in ITT during the second hour of the hover, but showed an increasing/decreasing variation within a 10-degree C band for almost the entire flight and a consistent decreasing trend during the last 30 minutes of the hover. During flight 11, the right engine also showed no loss of topping torque; however, the right engine ITT decreased almost 20 degrees C during power assurance checks.

Although there may be some merit in attempting to gauge engine condition by power assurance checks, obviously a check performed on the ground does not satisfy the requirements of determining power degradation in flight. Further, a relatively small increase in ITT of 5 to 10 degrees C corresponded to power losses on the order of 2 percent torque. The power assurance check was therefore not sensitive enough to detect small (1/2 to 1 percent torque) power losses.

Successive power assurance checks were not adequate indicators of engine power degradation resulting from the ingestion of salt spray. Power assurance checks should not be used as a basis for engine rejection due to power deterioration below minimum acceptable values. (R 1)¹

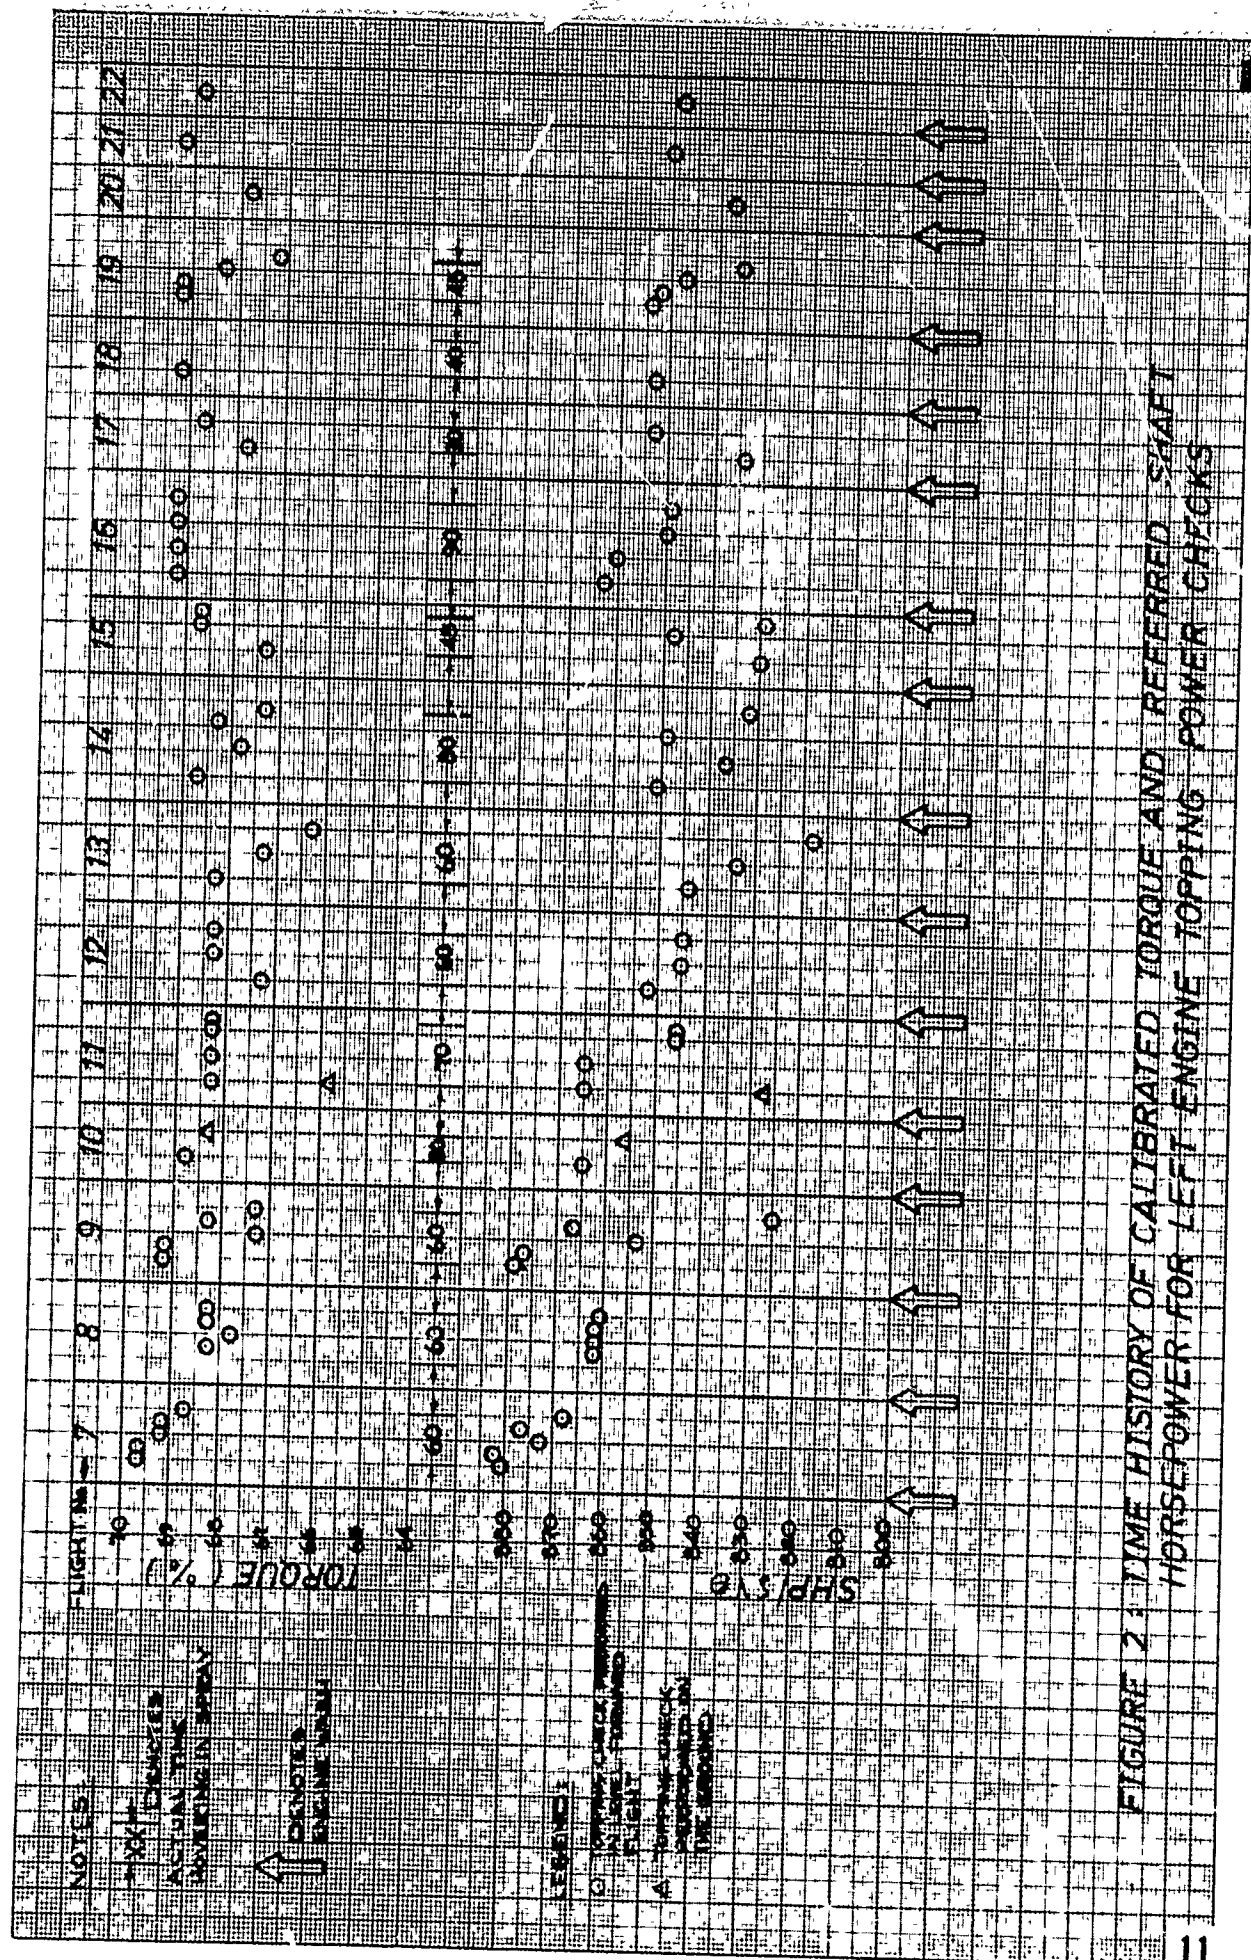
FIGURE 2: TIME HISTORY OF CALIBRATED TORQUE AND REFERRED SHAFT HORSEPOWER FOR LEFT ENGINE TOPPING POWER CHECKS

The more frequent wash given the left engine is reflected in the fact that no power deterioration was experienced during flights 8, 11, 12, 15, 16, and 17. The right engine experienced no power loss only during flight 11 which was flown almost entirely in wind conditions too light to cause spray impingement on the test aircraft.

The left engine experienced a 2 percent torque loss after 1 hour during flight 13 and a similar loss after only 45 minutes during flight 19. A 1.4 percent loss was noted during the 80-minute flight 14. Torque losses of approximately 1 percent were experienced during the 60 minutes of flight 7 and 45 minutes of flight 9. Torque losses of 0.6 percent and 0.5 percent were experienced during flights 10 and 18, respectively.

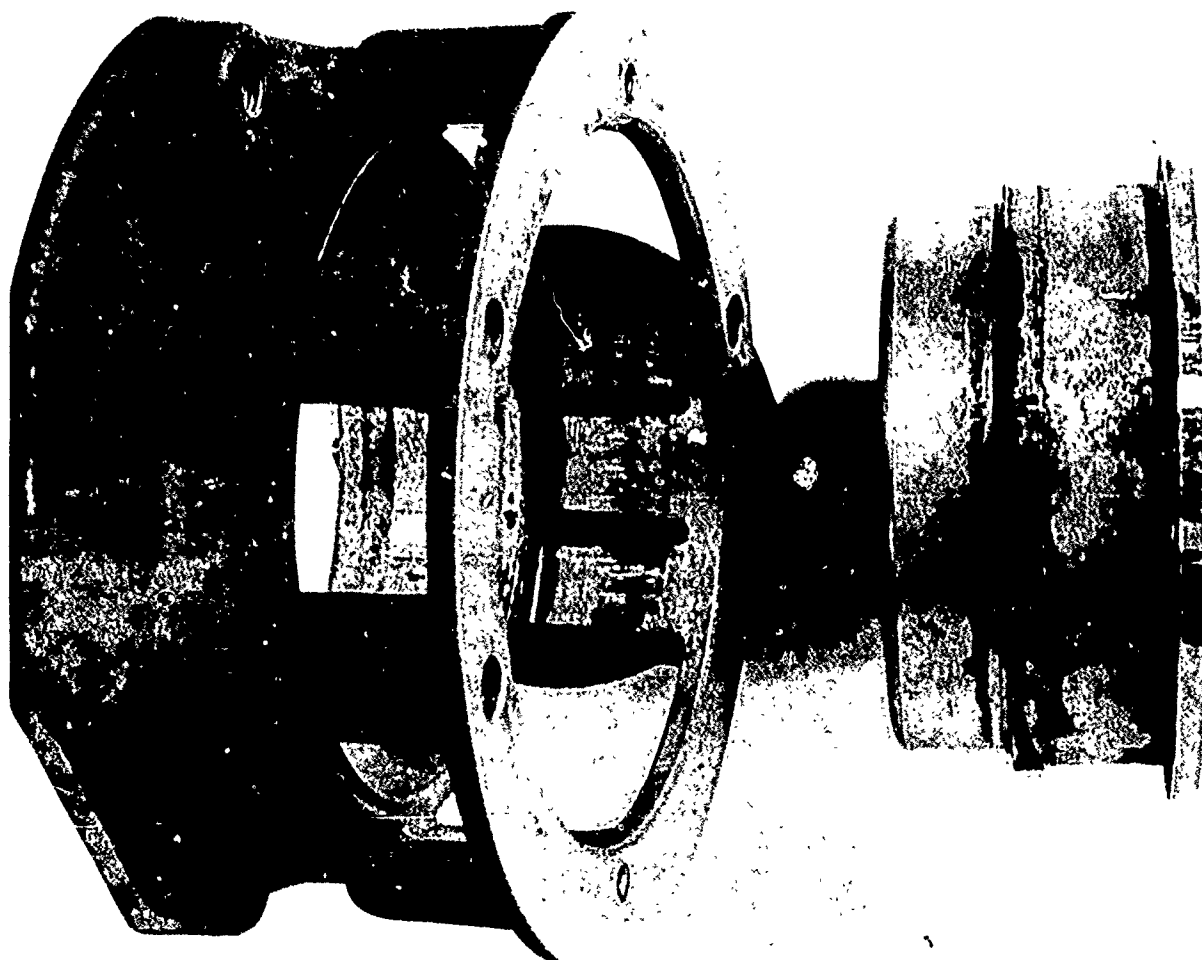
Figure 6 Disassembled Right Engine Compressor Bleed Valve

The removed bleed valve was found to be worn and scored where the valve was sticking in the valve sleeve. No evidence of salt water corrosion or other evidence of detrimental effects of hovering in the salt spray were found on the bleed valve. Figure 6 illustrates the scoring on the disassembled bleed valve.

The malfunctioning bleed valve is felt to have been responsible for the continued decline of the right engine after the test team returned to Edwards. It is not believed to have been totally responsible for the loss of power during flight 19 and subsequent flights through 22. This is evidenced by the behavior of the engine after the bleed valve was changed.

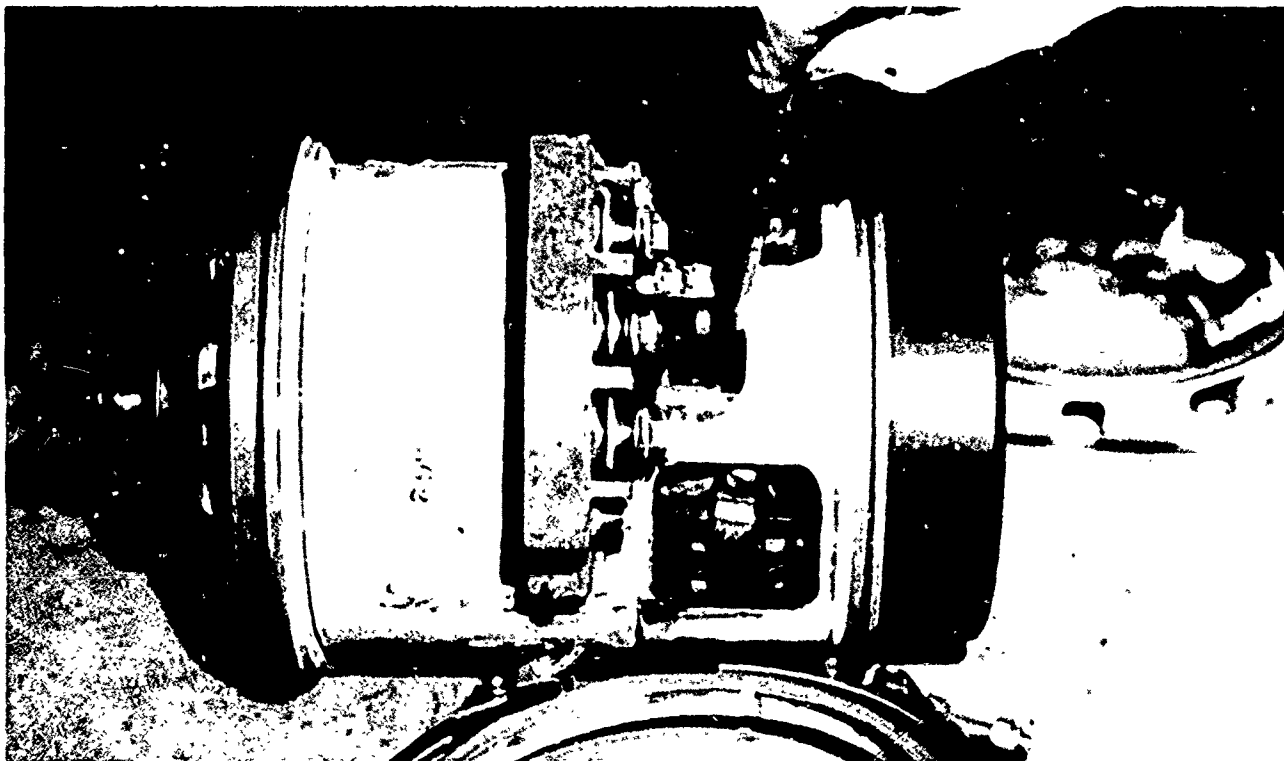
Figure 11 Corrosion of Left Engine Starter-Generator

The exact condition of the generator prior to initiation of the test program is not known. It cannot be positively concluded, therefore, that the corrosion found on the generator was caused by hovering in salt spray. However, the possibility that this was the case is strong enough that it cannot be ignored.

It can be positively concluded that hovering in salt spray will cause extensive aircraft corrosion unless adequate corrosion control is practiced on a daily basis. This corrosion may be obvious or insidious and may prove to be a more serious problem than engine power degradation resulting from sustained hovering in salt spray. Hovering in salt spray should be kept to the minimum time required to accomplish an operational mission and hover altitude should be as high as is practical for that mission. (R 10)
