OPERATION BUSTER

PROJECT 9.1 a

F.C.D.A. FAMILY SHELTER EVALUATION

FEDERAL CIVIL DEFENSE ADMINISTRATION

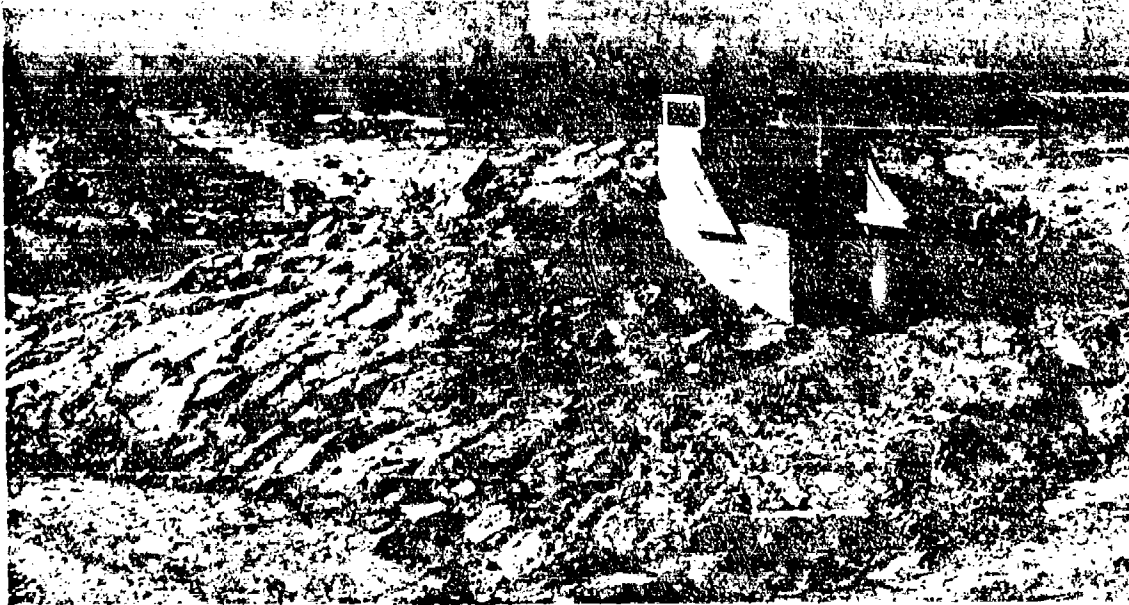
Fig. 4.9 Shelter A-9 After Shot Baker (partly above-grade lightened-frame)

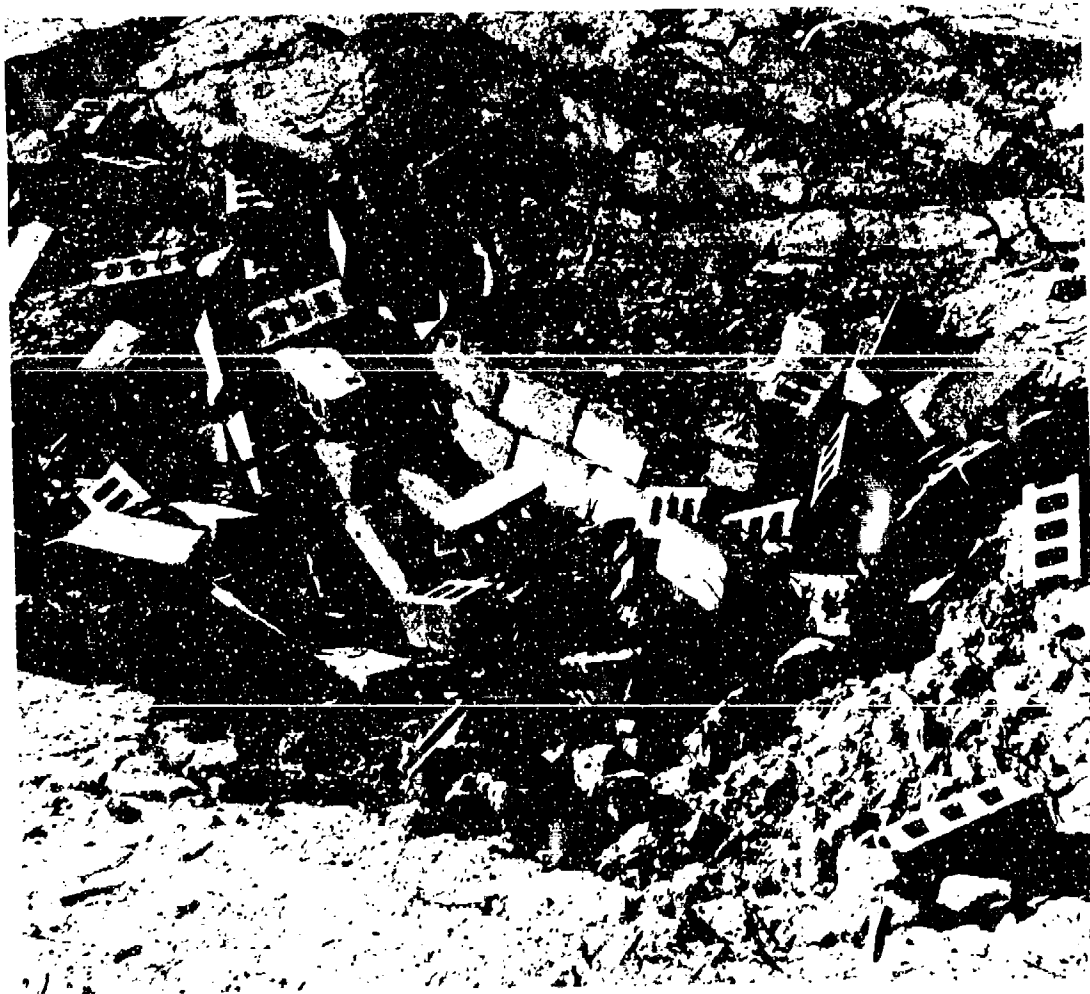
The complete destruction of simulated basement lean-to shelters (D-1 and D-2) is shown in Fig. 4.18. These structures were designed to determine whether fastening a lean-to section to a basement wall would afford greater protection than if the top of the lean-to were left free. However, destruction was so complete, no information could be obtained on wall failure or reaction of the lean-to.

Fig. 4.18 Remains of Structure D-1 After Shot Baker (simulated basement lean-to)

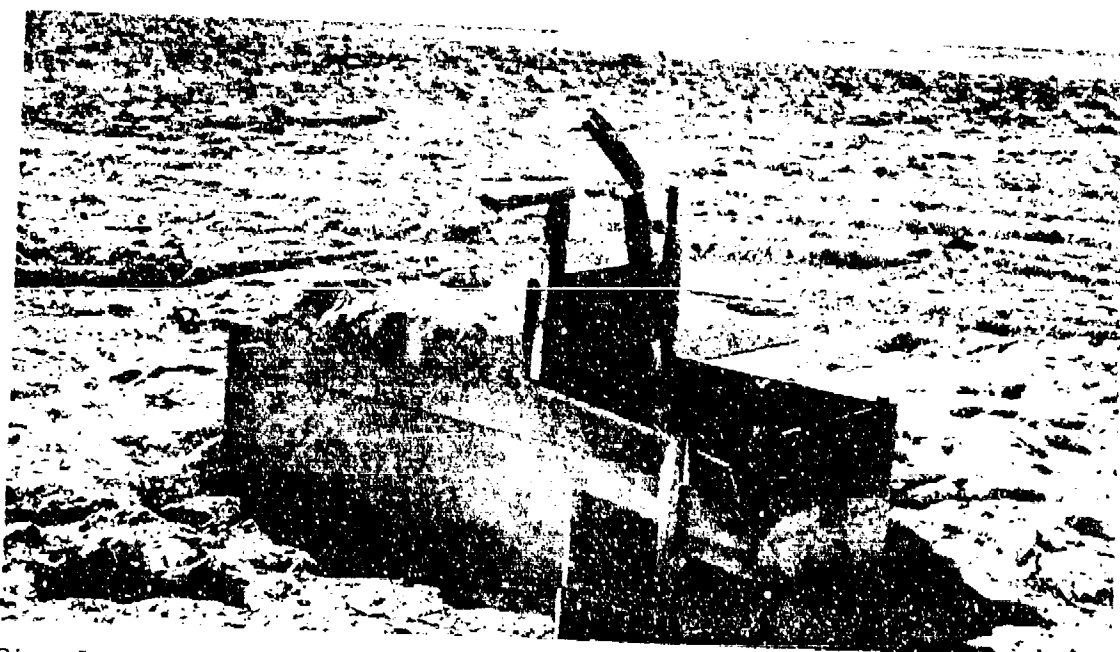
The partly above-grade covered trench shelters suffered much more damage. Although the structures remained intact, earth cover was swept down to natural grade (Fig. 5.4). Entrances suffered greater damage (Figs. 5.5 and 5.6).

Fig. 5.4 Shelter A-9 After Shot Charlie (partly above-grade lightened-frame)

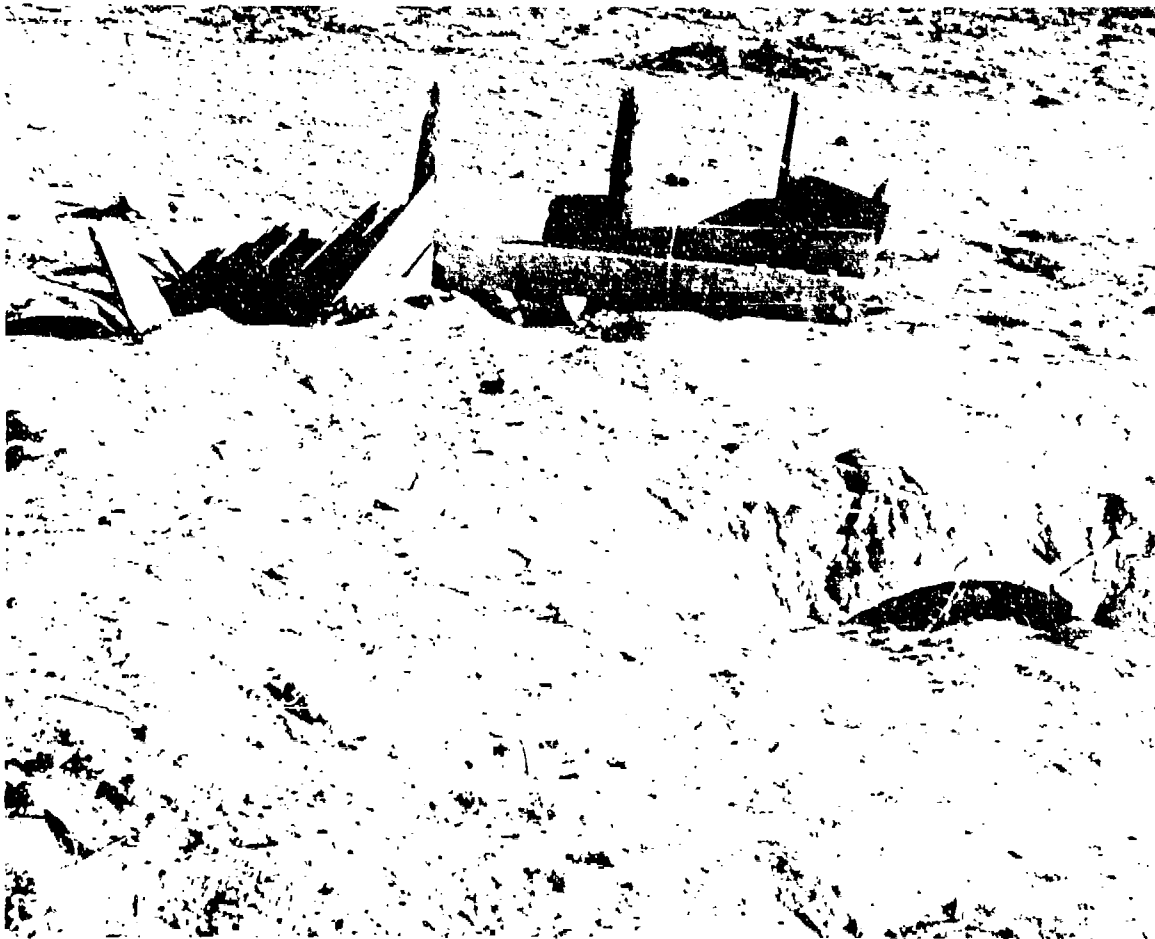
Failure of stakes to hold the end section of the metal-arch shelter in the previous explosion contributed to its destruction (Fig. 5.7). Entrance sections were weaker than those of the covered-trench type, but the metal-arch and walls survived.

Fig. 5.7 Shelter B-1 After Shot Charlie (metal-arch shelter below-grade)

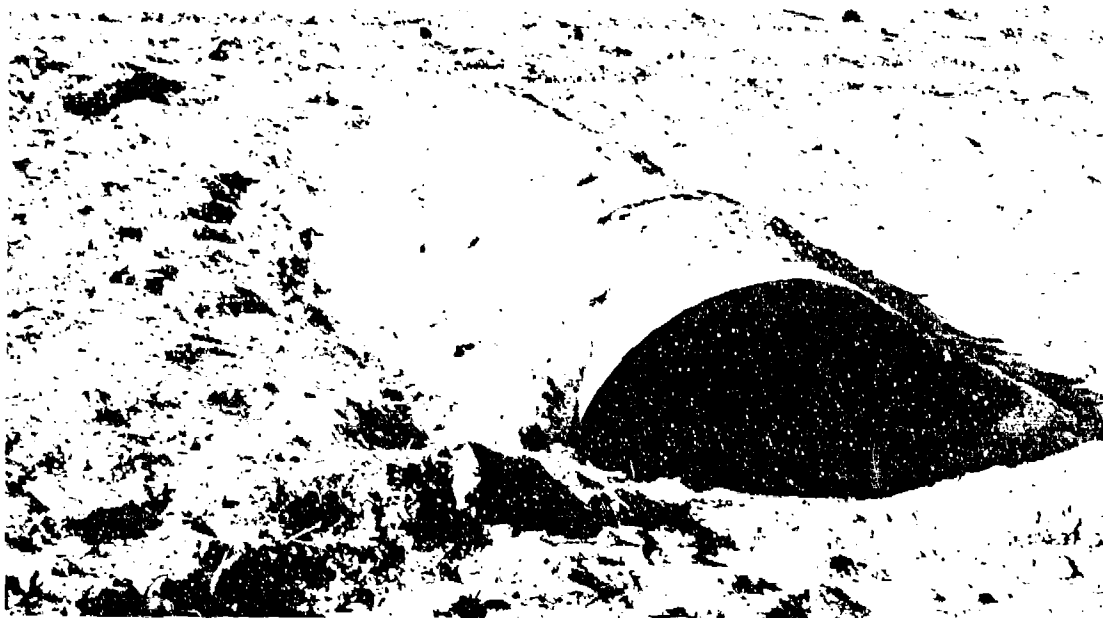
Figures 5.8 and 5.9 show effects of the blast on metal-arch sections in a ground level concrete footing. Virtually all cover was swept away, but the metal arch was not affected by blast.

Fig. 5.8 Structure B-2 After Shot Charlie (metal-arch - 2 ft. of earth cover)

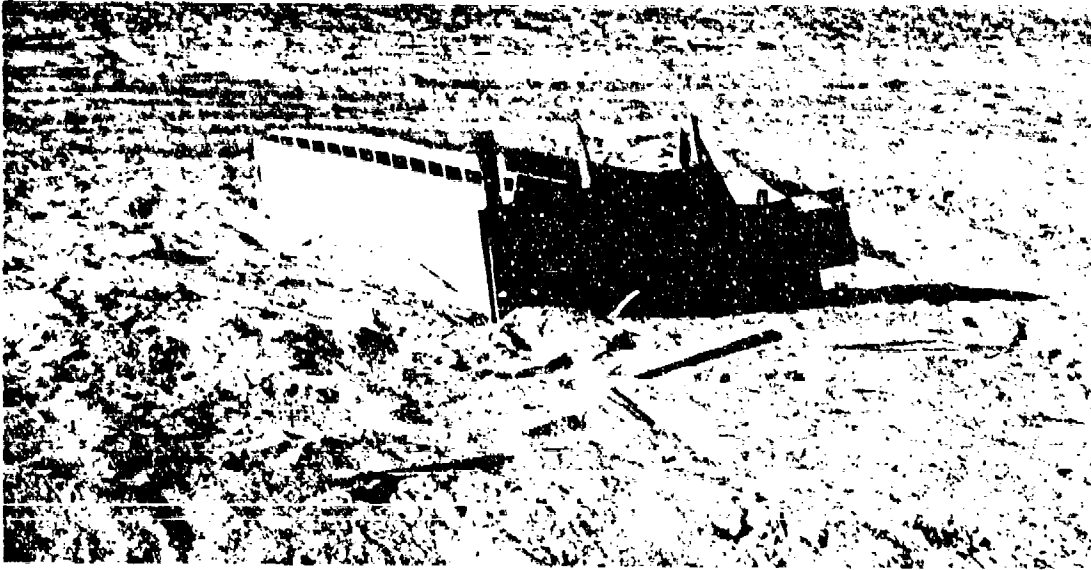
Earth cover was swept away to ground level and wood-arch shelters collapsed completely as a result of Shot Charlie (Figs. 5.10 and 5.11). Arch folded and in some cases pulled sidewalls in with them.

Fig. 5.10 Shelter C-1 After Shot Charlie (wood-arch)

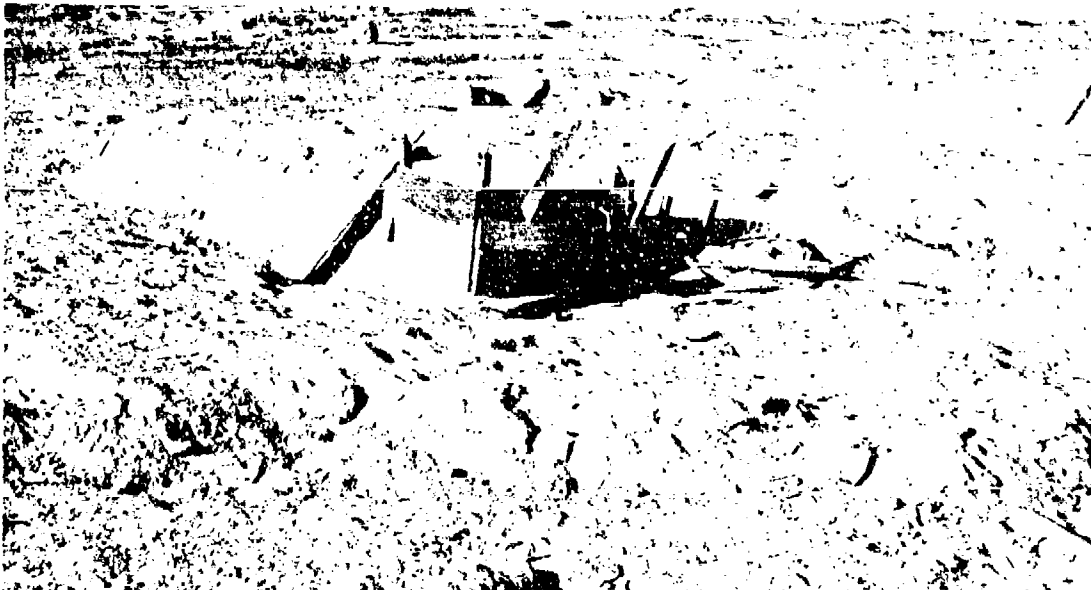
Fig. 5.11 Shelter C-3 After Shot Charlie (wood-arch)
