ZINC INORGANIC SILICATE COATINGS: FIVE YEARS

MARINE ATMOSPHERIC EXPOSURE

Technical Report R-776

Carl V. Brouillette and A. F. Curry

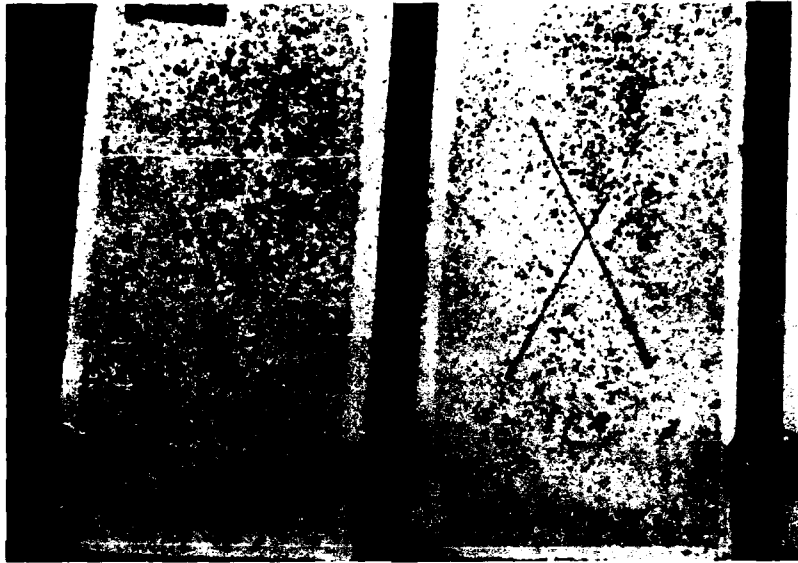
The manufacturer of the zinc inorganic silicate System 65 (self-cured) requested that the MIL-P-15328B wash primer not be used over this coating. The scribed panels of this system failed at Kwajalein during 18 months of exposure, at the Kaneohe Upper Site during 2 years, at the Kaneohe Lower Site during 4 years. After 5 years the scribed panel of System 65-0 was giving good protection at Port Hueneme Site 1. The unscribed panel of System 65-0 failed at Kwajalein during 4 years, but the oil-base coating is giving good to excellent protection to all panels at Port Hueneme and Kaneohe except for the scribed panel of System 62-0, which failed at Kaneohe after 4 years of exposure. At Kwajalein the scribed panels failed in 4 years for Systems 68-0 and 69-0 and in 3 years for System 62-0. The unscribed panel of System 62-0 was giving good protection after 5 years at Kwajalein. The unscribed panels failed at Kwajalein for System 68-0 in 5 years and for System 69-0 in 4 years. The failures were related to cracking and flaking of the topcoat system, and probably to the alkaline conditions originating at the zinc bulges beneath the topcoating (Figure 7).

Figure 7. System 68-0 (self-cured, with oil-base topcoat) exposed 5 years at Kwajalein. Note flaking of topcoat from zinc inorganic primer.

The specification oil-base coating, as expected, is not a satisfactory topcoat for zinc inorganic silicate coatings. This topcoat appeared to deteriorate and flake off of the surface of the zinc inorganic substrate. Although the zinc inorganic silicate primer coat continued to protect the steel test panel, the condition of the oil-base topcoat gave a poor appearance to the coated surface.
