DRDC-RDDC-2014-L96

Produced for: Marine Systems Engineering Officer, HMCS PRESERVER.

Scientific Letter

Inspection of three forged wire rope clips from the port 15 tonne crane aboard HMCS PRESERVER

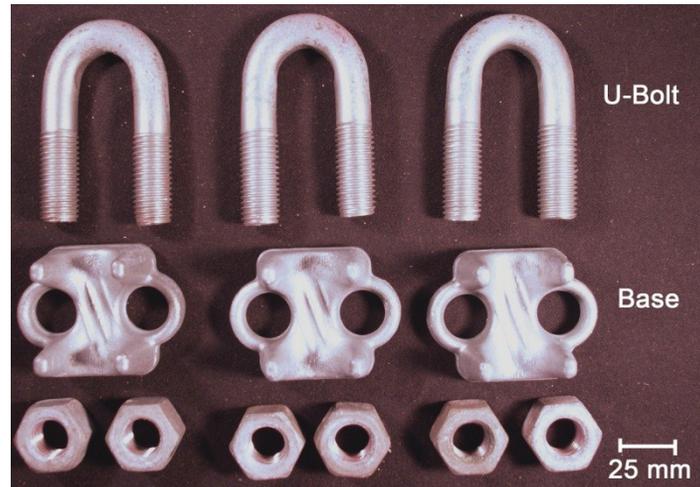
Figure 2: Forged wire rope clips provided to DRDC Atlantic Research Centre for inspection (after cleaning).

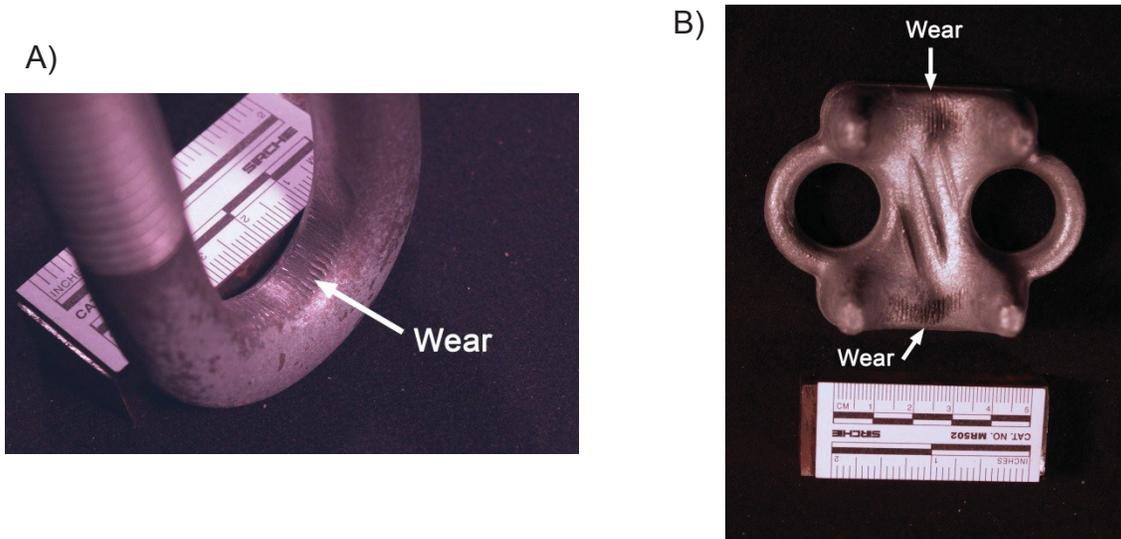
Wear was visible in the U-bolt and base of all three clamps, as shown in **Figure 3**. The lack of corrosion on the worn areas indicated that the damage occurred recently. The wear surfaces were consistent with what would be expected to occur when the cable pulled through the clamps.

Figure 3: Examples of wear on the A) the U-bolt and B) the base of the forged wire rope clamps.

It is recommended that all of the forged wire rope clips in the crane assembly be inspected, to confirm that the U-bolt side of the clips are on the cut-end of the crane and the torque on the nuts is correct. Periodically testing the nuts to ensure the torque is correct could prevent similar failures in the future.

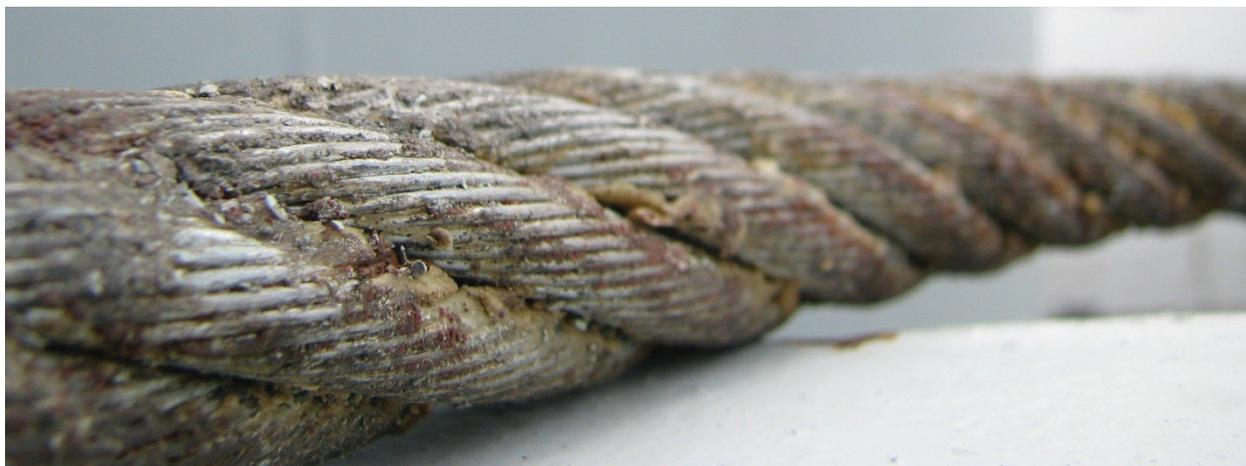
An *in-situ* visual inspection was conducted on the section of the cable involved with the failure. Certain features on the cable, such as broken strands or wear, could indicate the cause of the failure [Ref C]. The inspection was conducted to see if there were any signs of corrosion, wear, broken strands or strand protrusions that would indicate the cause of the failure. The cable appeared to be in good shape: No strands were broken or protruded; wear and corrosion were minimal. **Figure 4** shows section of the cable with the most corrosion. It can be seen that the corrosion is minimal, and has not caused any of the exterior strands to fracture.

Figure 4: Example of mild corrosion on the cable.
