SIO Shipyard Representative Bi-Weekly Progress Report		
Project: AGOR 28	Contract No.: N00014-12-C-0305	Shipyard: Dakota Creek Industries
Prepared by: Paul D. Bueren Scripps Institution of Oceanography (SIO) 297 Rosecrans St. San Diego, CA 98106	Date: 15 February, 2016	Program Officer: Robert (Tim) Schnoor Office of Naval Research 875 Randolph St ONR 321 Arlington, VA 22203-1995
Distribution Statement A: Approved for public release; distribution unlimited.		Report No. A002.094

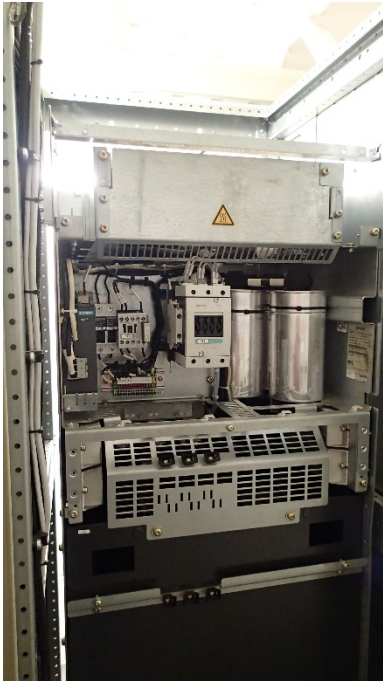
- Blue Drives – AIM, ALM and DC Links Breaker installed
AIM – Dockside testing successful. UW tomorrow morning for grooming and full power testing.

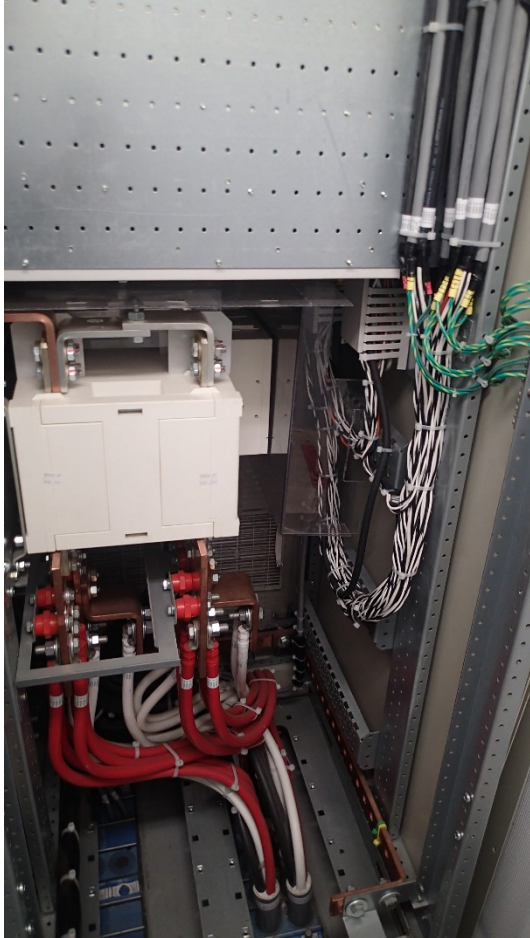
DC Links Breaker – DC will relug and reroute some of the DC Links Cables to eliminate the areas where the bend radii were deemed to be unsat.

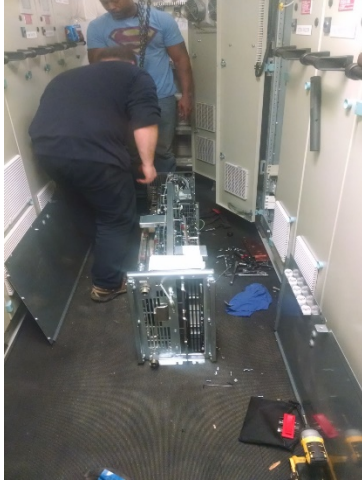
Work continues on ALM/AIM install. Unit dock tested Sat today...U/W as planned tomorrow.

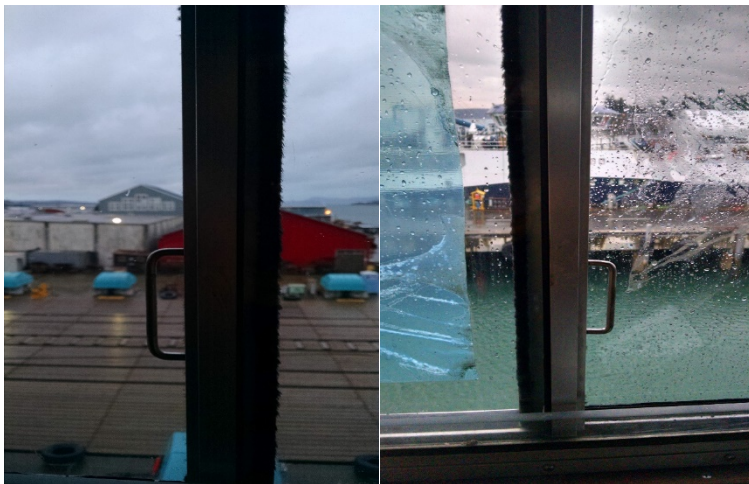
Handles for Bridge port and stbd side sliding windows reinstalled with better adhesive. Should be good now. Have to remember to lift up on handle before attempting to slide.

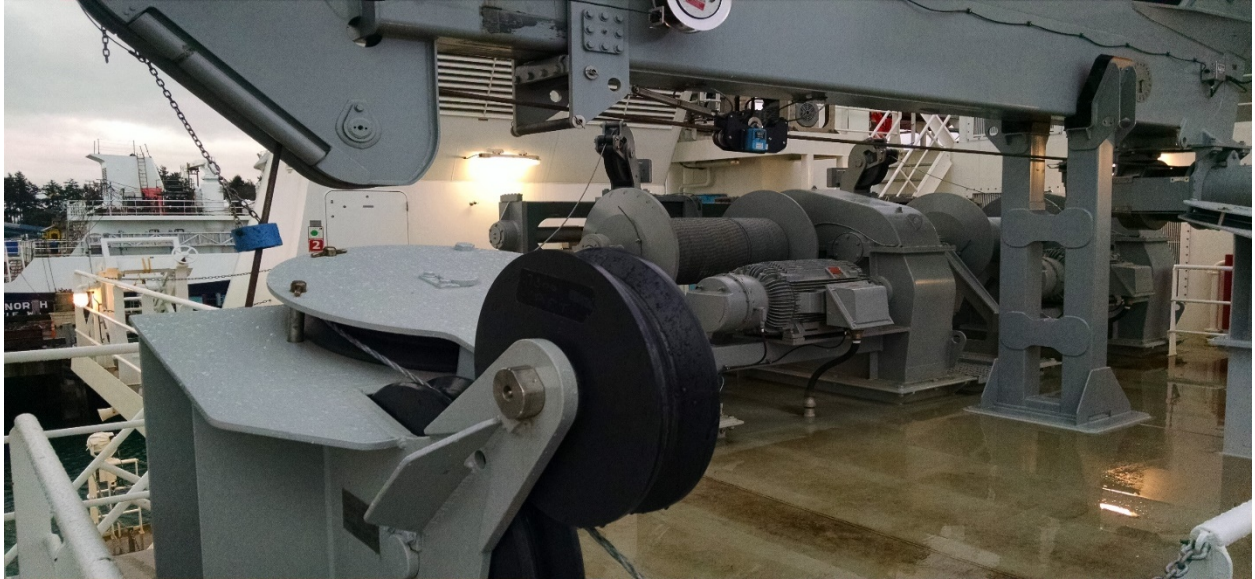
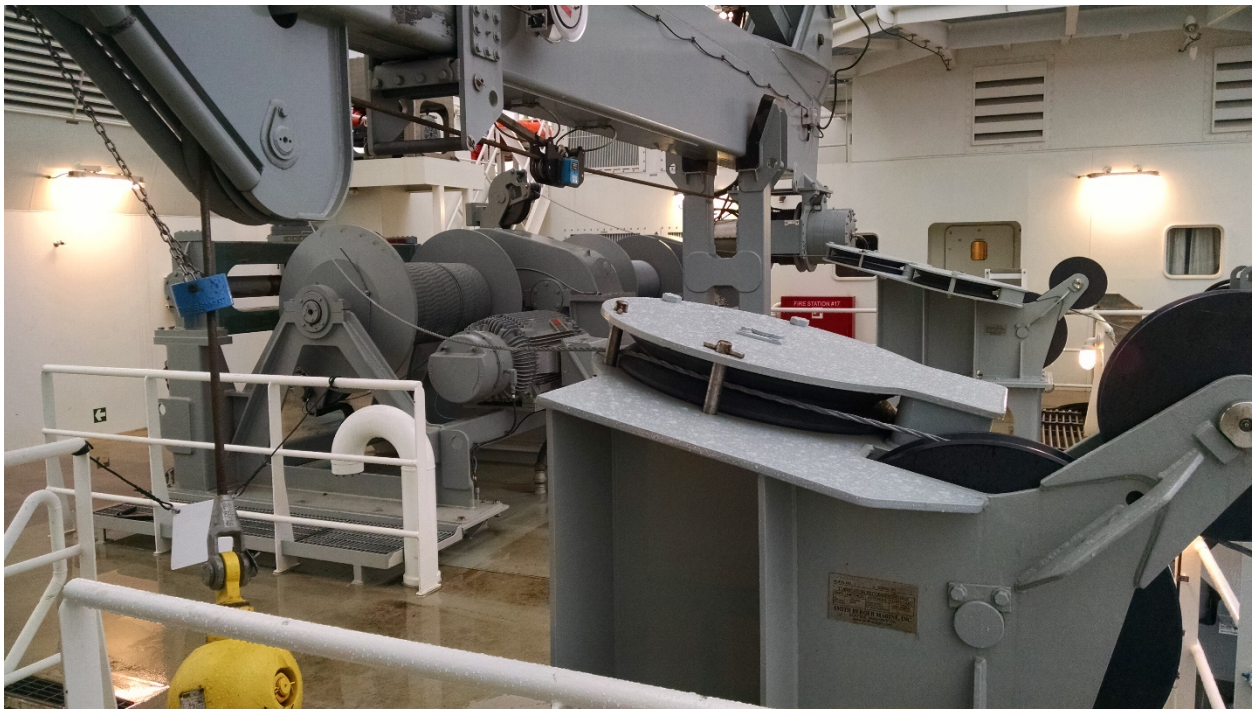
Woody has expressed concern with potential interference of ships main crane and CAST 6 winches. SIO plans to swap forward CTD handling arm with the after overboarding arm. This may exacerbate potential interferences with stowed crane. A possible solution would be to stow the crane athwartships (head of the boom aft of the stack). This might be something to do when CAST 6 winches are in use. Crane stowage as built probably best for normal ops. Have to check this possibility out once we have the ship. There is a possibility that stowing the crane athwartships will improve stern visibility from

wheelhouse. .

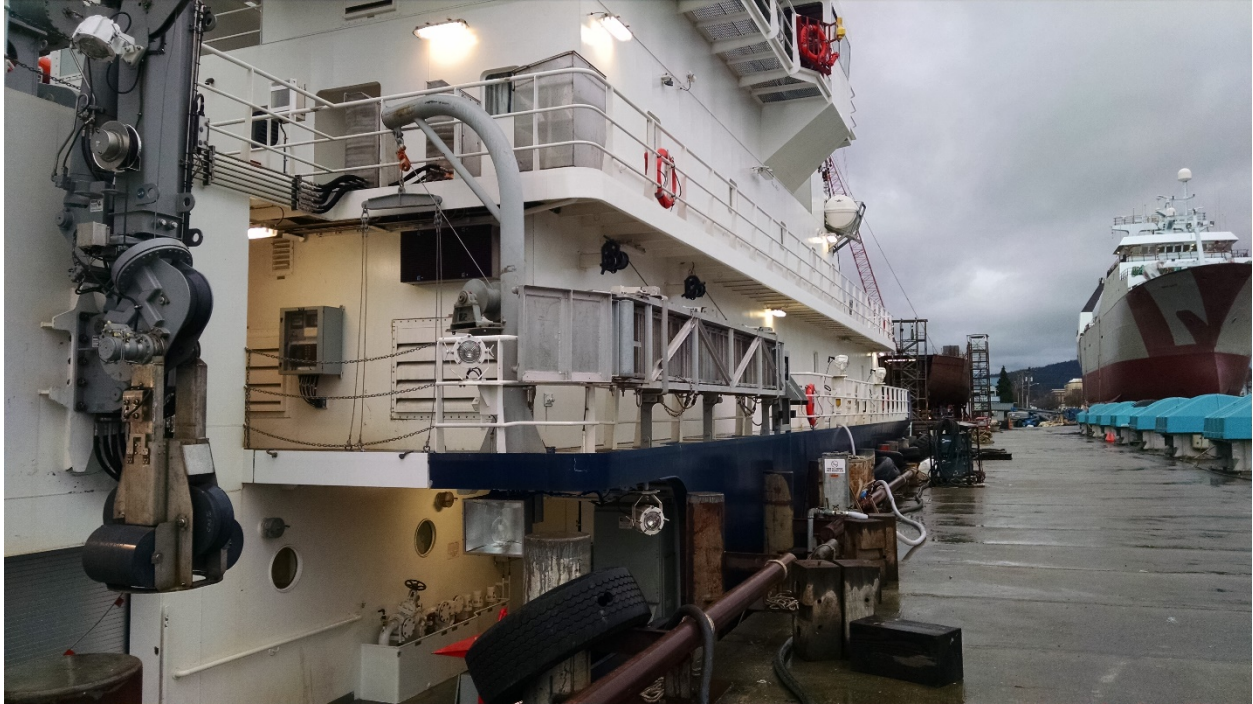
Accommodation Ladder demo didn't go real well for MOC INSURV...Installed davit doesn't reach outboard far enough to allow the gangway to be lowered onto the pier. Utilizing the ships main crane to spot the end of the gangway further outboard is a good workaround. Deck height of the pier may be an

issue in some locations. May have to carry a portable gangway for some ports.

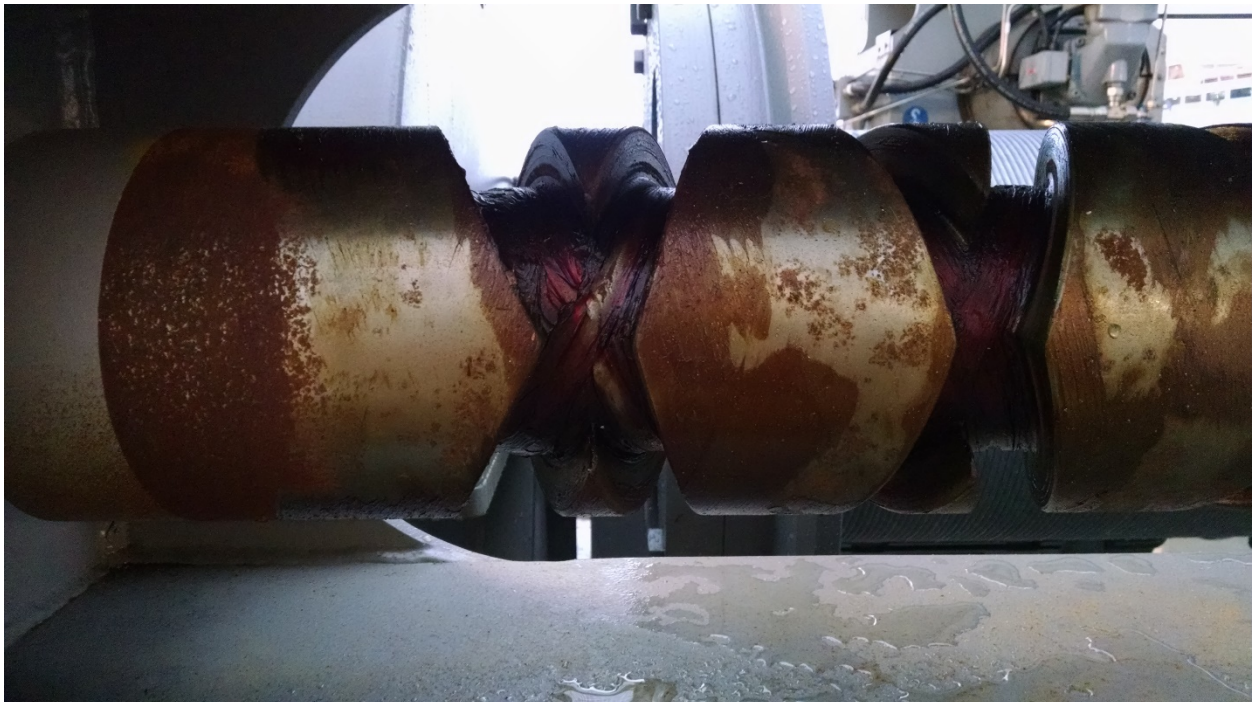
Level wind diamond screw for forward CAST 6 winch showing signs of light rust. Winch was tested some time ago, rust needs to be cleaned up and grease reapplied on both CAST 6 winches.
