SIO Shipyard Representative Bi-Weekly Progress Report

Project: AGOR 28	Contract No.: N00014-12-C-0305	Shipyard: Dakota Creek Industries
Prepared by: Paul D. Bueren Scripps Institution of Oceanography (SIO) 297 Rosecrans St. San Diego, CA 98106	Date: 1 March 2016	Program Officer: Robert (Tim) Schnoor Office of Naval Research 875 Randolph St ONR 321 Arlington, VA 22203-1995
Distribution Statement A: Approved for public release; distribution unlimited.		Report No. A002.095

Weekly Report 29 Feb 2016

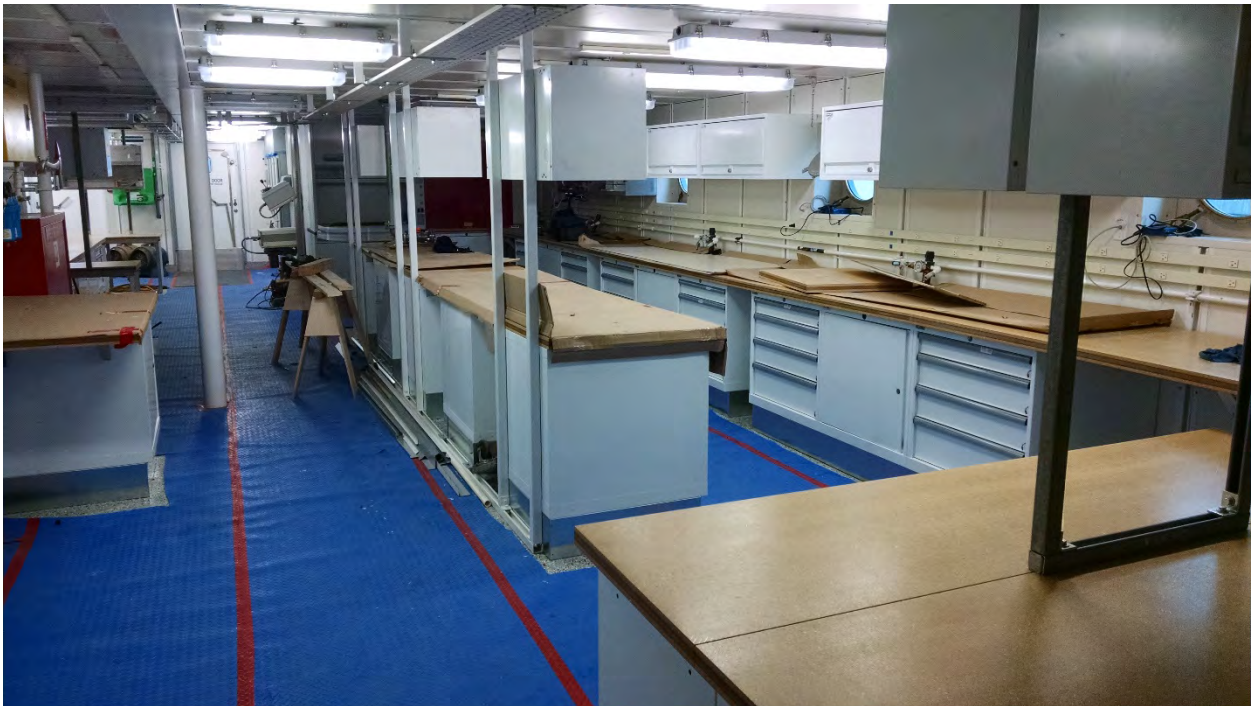
Work continues in Labs, getting closer to finishing

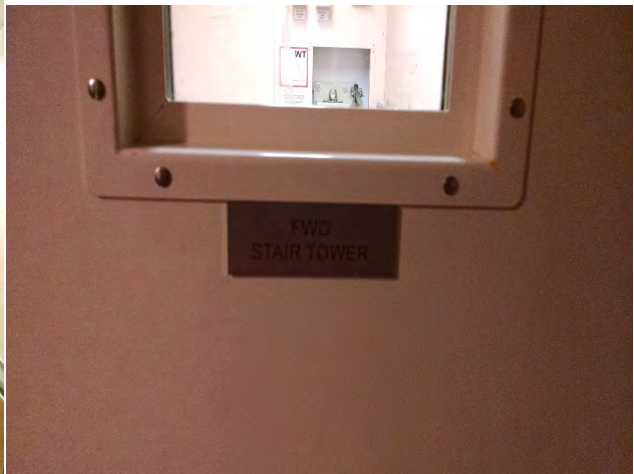
Bad Access door main deck to fwd stair tower sprung. Difficult to operate, will point out to DCI.

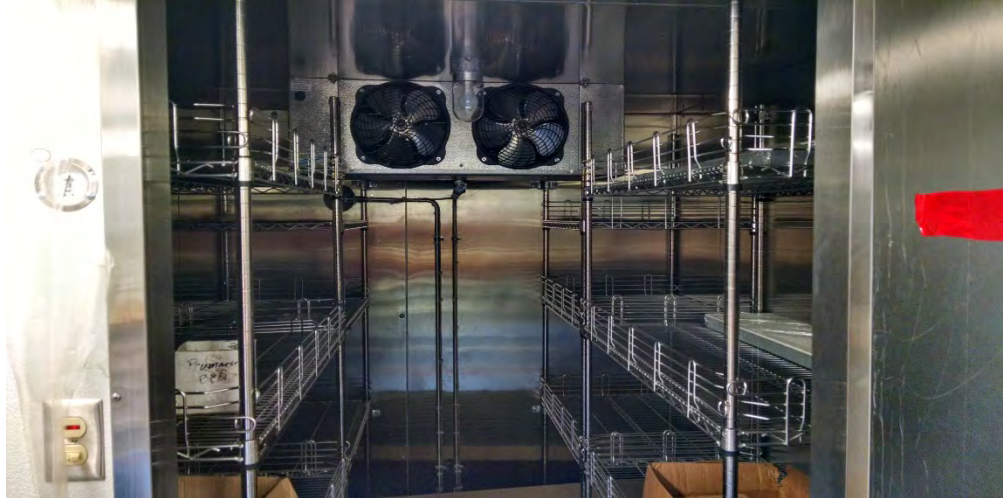
Science Refer crew training instructor from Bronswerk mentioned that the strip heaters on the condensate drains in the science boxes are possibly too large. Boxes are quite warm with refrigeration secured. Will

bring it up to the shipyard.

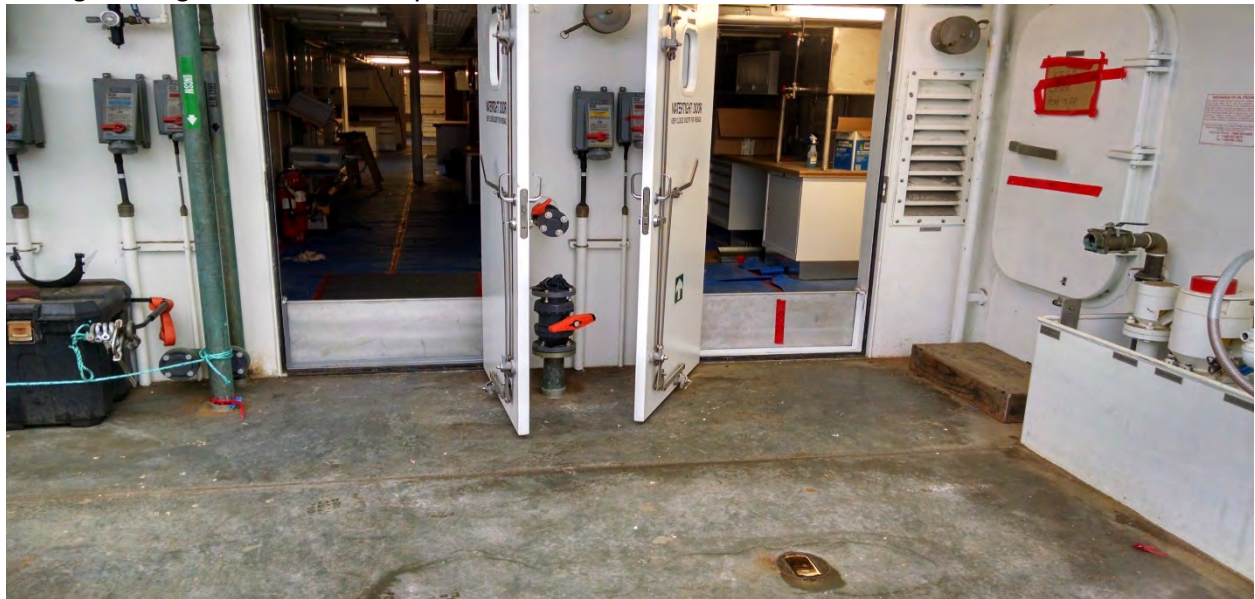
DCI was shown first-hand the need for raised sills on main deck hatches. During Trials last week boarding seas made it into the labs. There was a flurry of activity as the sills were located and installed. No damage but a good lesson for the yard workers.

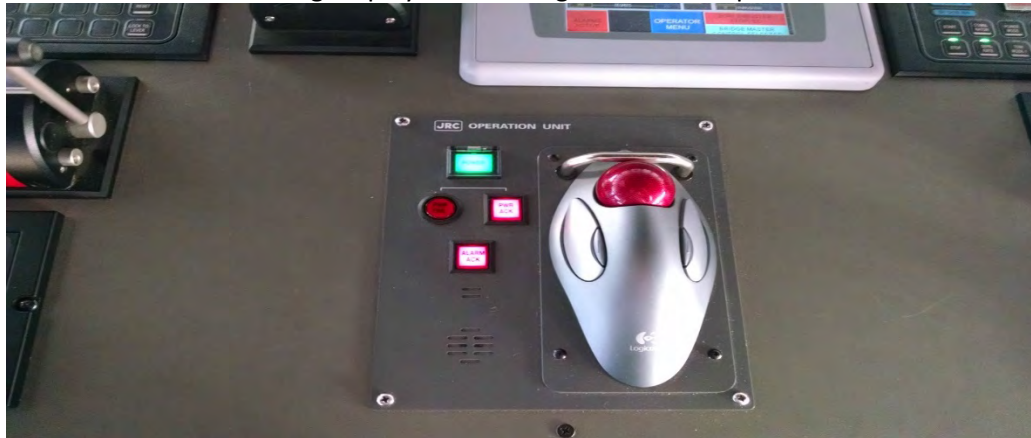
Mouse control for the Conning Display on the bridge console not provided with dimmer.

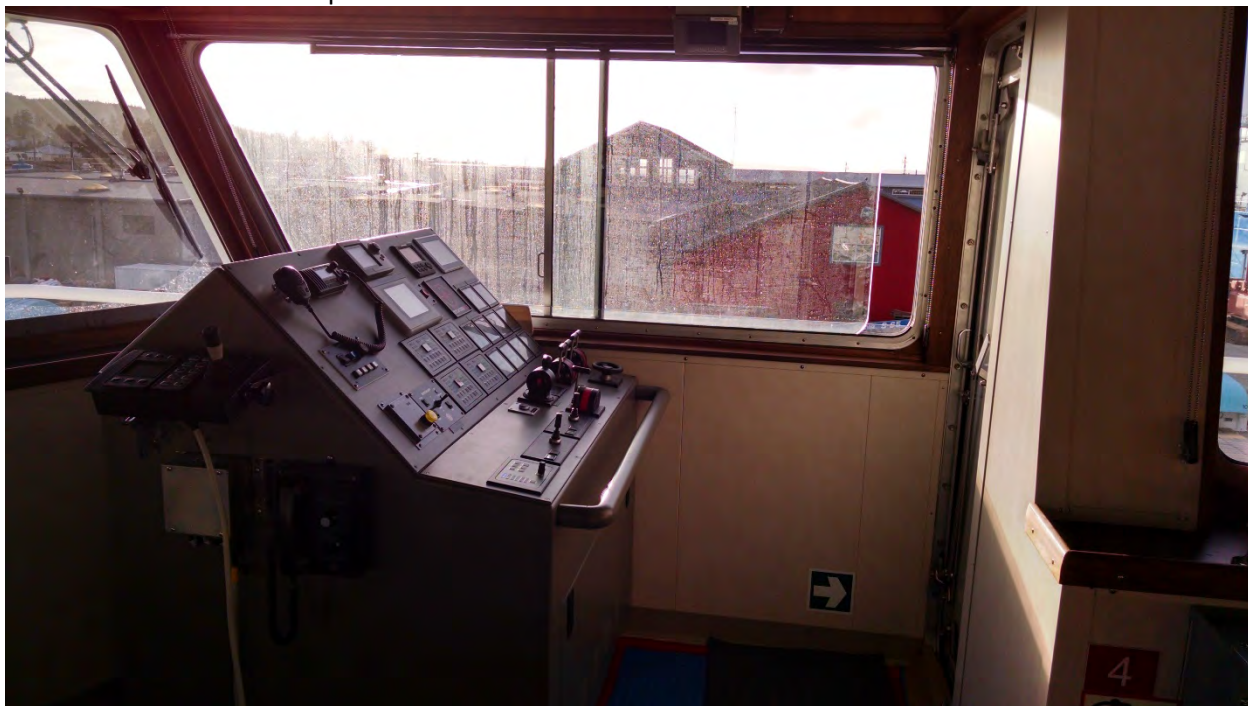
Bridge side windows pretty tough to clean. Not served with the wash down system. After sliding glass covers forward when opened
