| SIO Shipyard Representative Bi-Weekly Progress Report | | |
| <b>Project: AGOR 28</b> | <b>Contract No.: N00014-12-C-0305</b> | <b>Shipyard: Dakota Creek Industries</b> |
| <b>Distribution Statement A:</b> Approved for public release; distribution unlimited. | | <b>Report No. A002.097</b> |

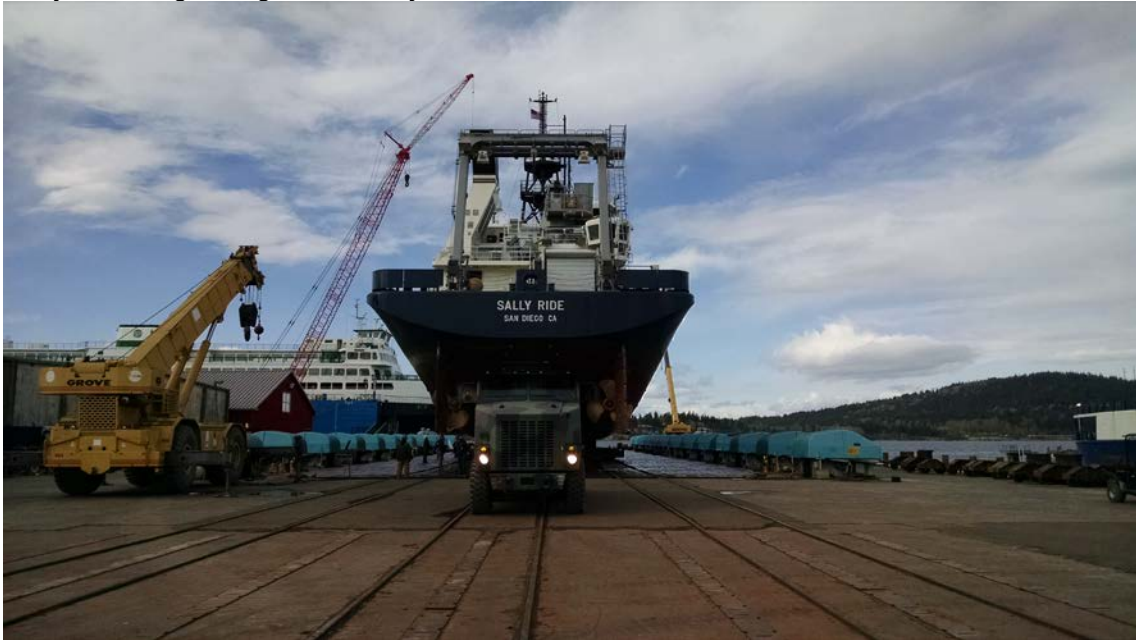
- Phase III Haul-out – Sally Ride was scheduled to be on the synchro-lift on 1 April, put due to a delay in floating a barge on the ways, she was hauled out on the afternoon of the 8<sup>th</sup>.

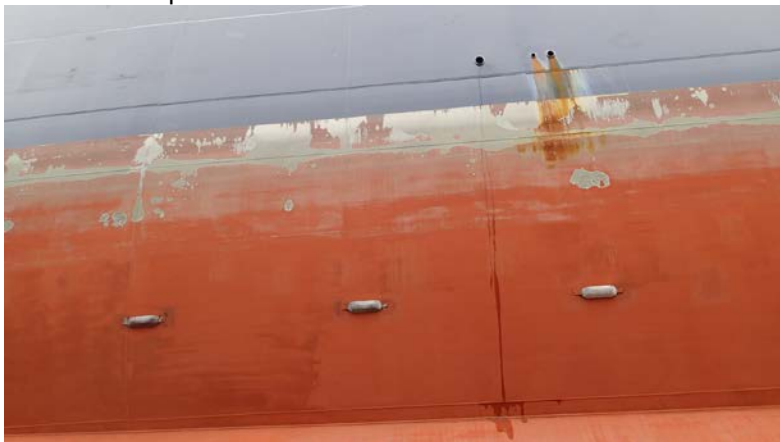
- Underwater Coatings – The International paint rep was on site and walked the ship with DCI's paint foreman. There is 3-foot wide strip of AF failure on the port side and 4 or 5 softball size patches on the starboard side. The yard will fix these per International Paints recommendations. The yard will provide Internationals report to us. In addition, AF will be applied to the tail shafts as requested. The yard will then do a full coat of AF on the hull, including any touch up required for the bilge keel and other mods.

Example of Port Side AF Failure

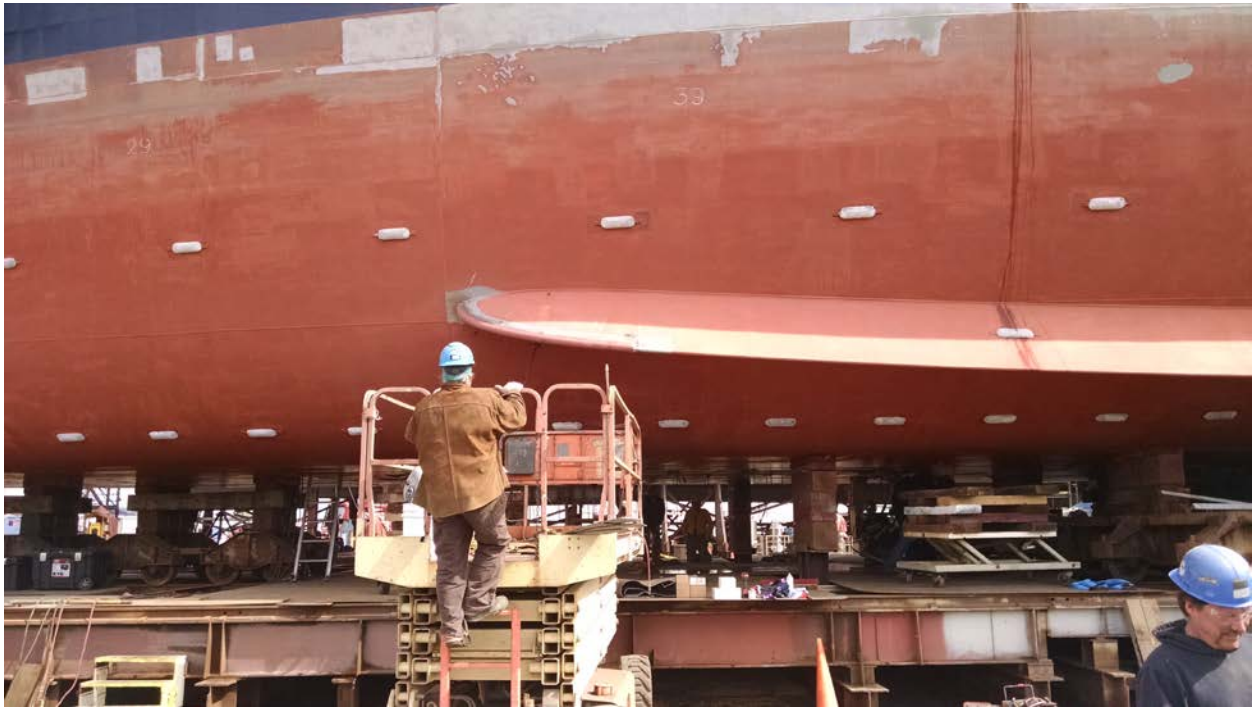
Example of port side AF repair. Painters are sanding and fairing in affected areas at the waterline.

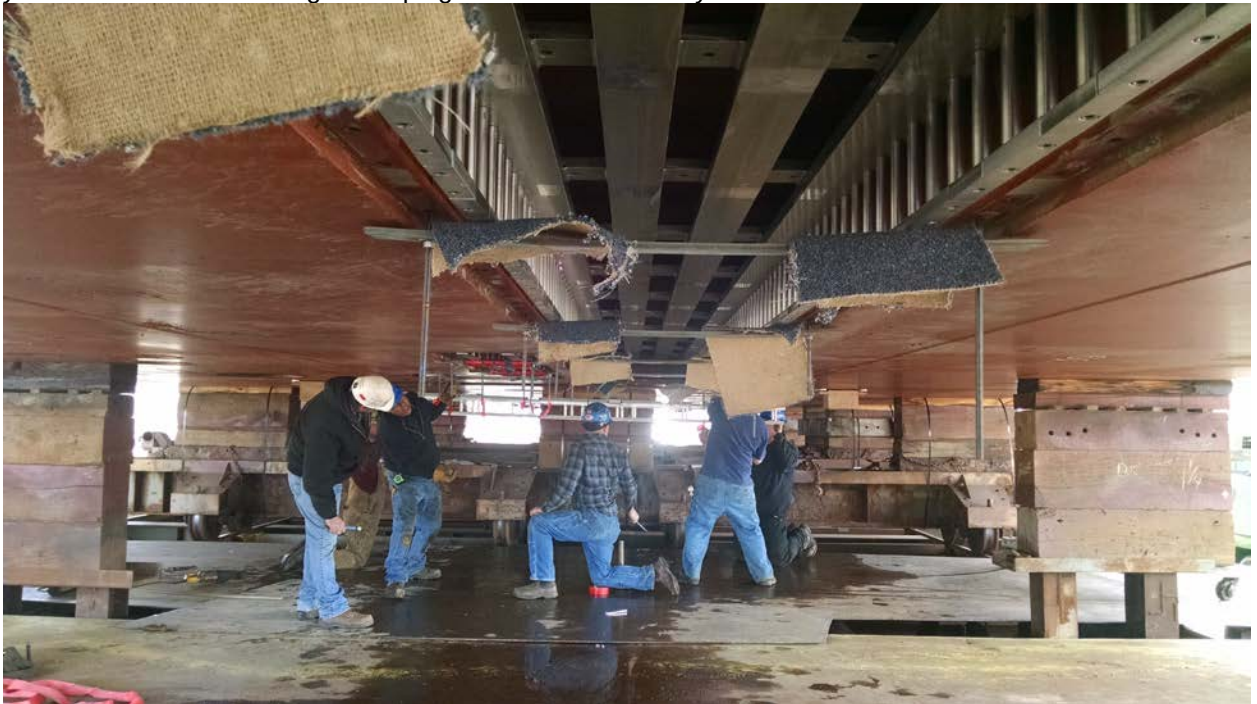
- Bilge Keel Mod – DCI is in the process of fitting and welding the new section to the bilge keels. See above picture.
- EM122 and EM712 Frames – The frames have been surveyed in and clamped into place. The yard will commence drilling and taping the holes on Monday.

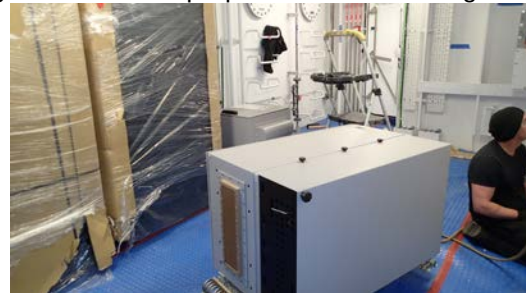
- Transceiver Room – Rack and Kongsberg Equipment have been staged for installation in the transceiver room. Outside machinists are drilling foundations in preparation for mounting.

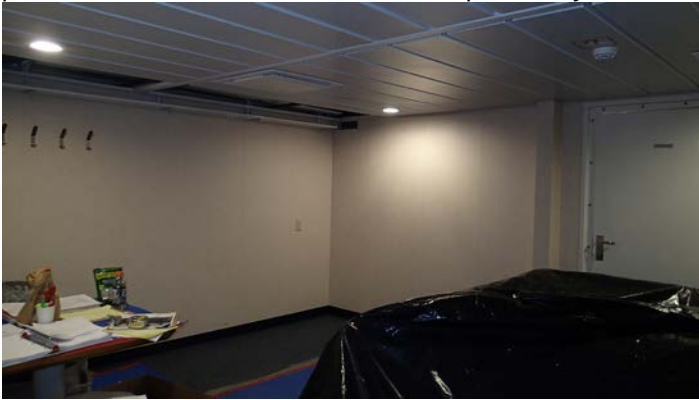
- Cable Transit – An additional cable transit was required to accommodate the large number of cables being run between the transceiver room and computer lab. The yard is taking care to protect the furniture, bulkheads and carpet in way of the cutting and welding.

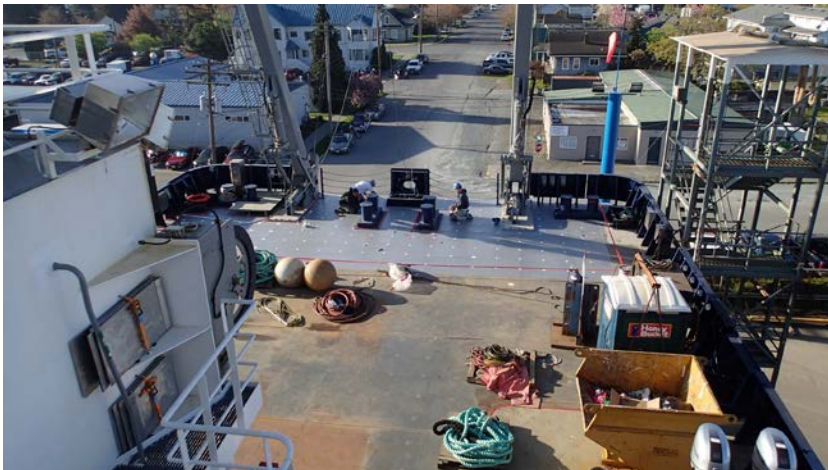
- Topside Paint – Painters are making hay while the sun shines. Where necessary, they are going down to bare metal prior to coating.
