SIO Shipyard Representative Bi-Weekly Progress Report

SIO Shipyard Representative Bi-Weekly Progress Report		
Project: AGOR 28	Contract No.: N00014-12-C-0305	Shipyard: Dakota Creek Industries
Prepared by: Paul D. Bueren Scripps Institution of Oceanography (SIO) 297 Rosecrans St. San Diego, CA 98106	Date: 22 April 2016	Program Officer: Robert (Tim) Schnoor Office of Naval Research 875 Randolph St ONR 321 Arlington, VA 22203-1995
Distribution Statement A: Approved for public release; distribution unlimited.		Report No. A002.098

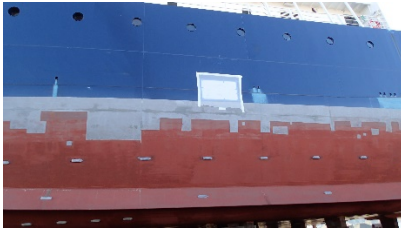
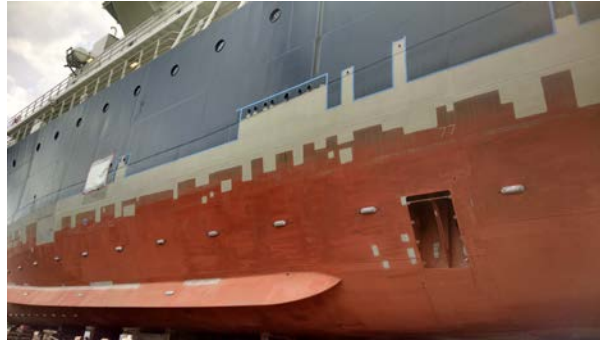
- Underwater Coating – DCI is faring in and applying epoxy primer to areas where AF had failed.

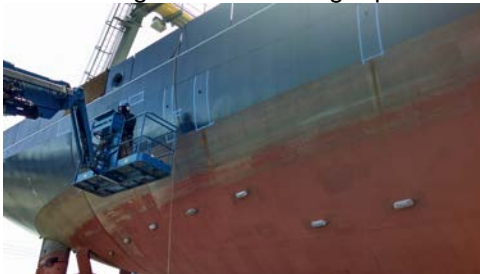
- Hull Coating – DCI is making repairs to the paint system above the water line as needed.

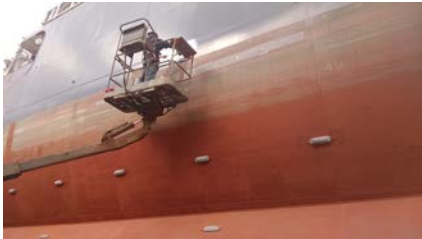
- Plimsoll Lines – ABS verified location and yard punch marked lines.

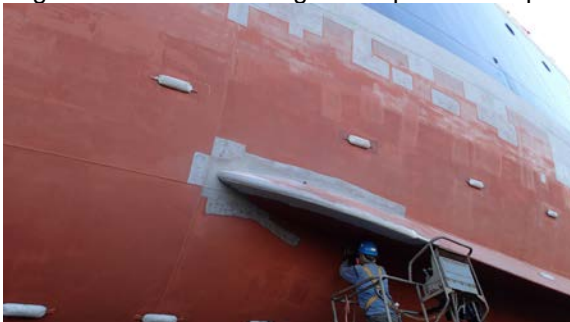
- Bilge Keel Mod – Welding is complete. The painters are applying the fairing compound.

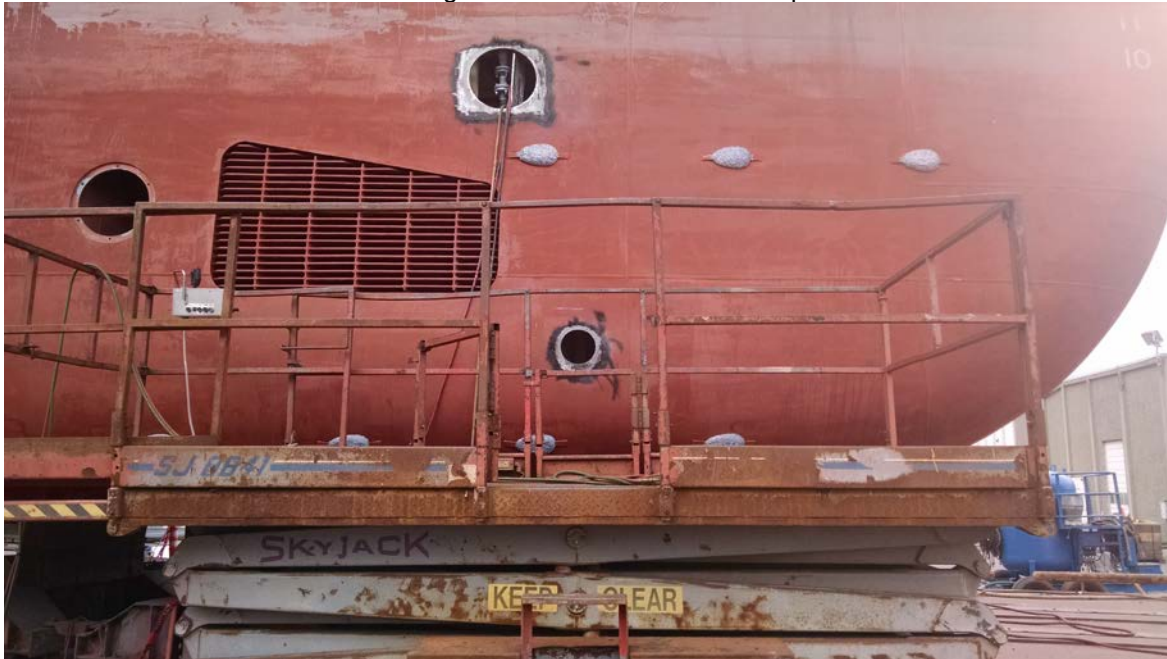
- Uncontaminated Sea Chest – Original sea chest removed and penetration made at new location

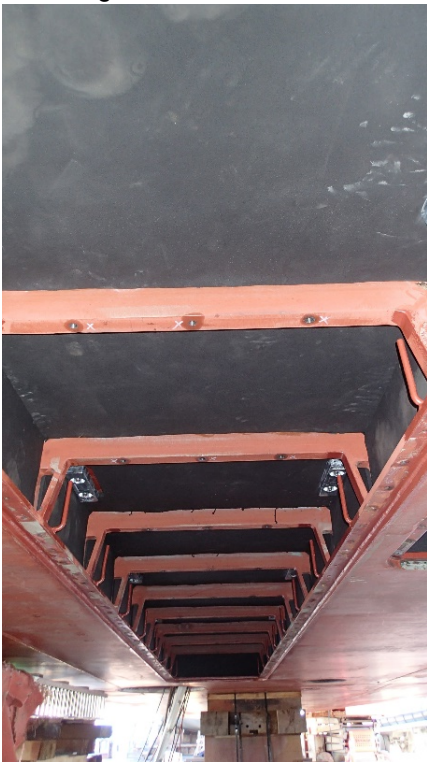
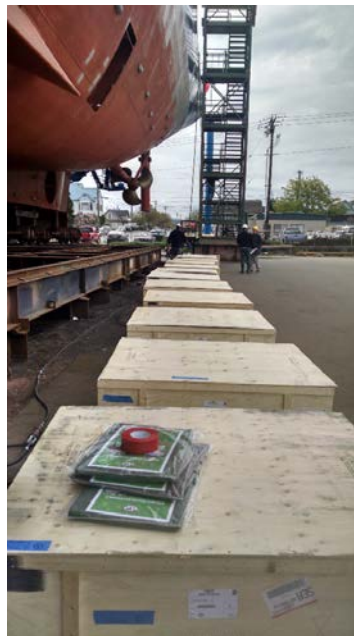
- Anchor Pocket Shims – Shims are being fabricated with installation to begin next week
- EM122 – The frames for the transmit and receive arrays are fully installed and surveyed in. Minimal shimming required. Zincs and sound dampening material were installed prior to mounting the frames. The transducer modules are lined up and ready for installation.

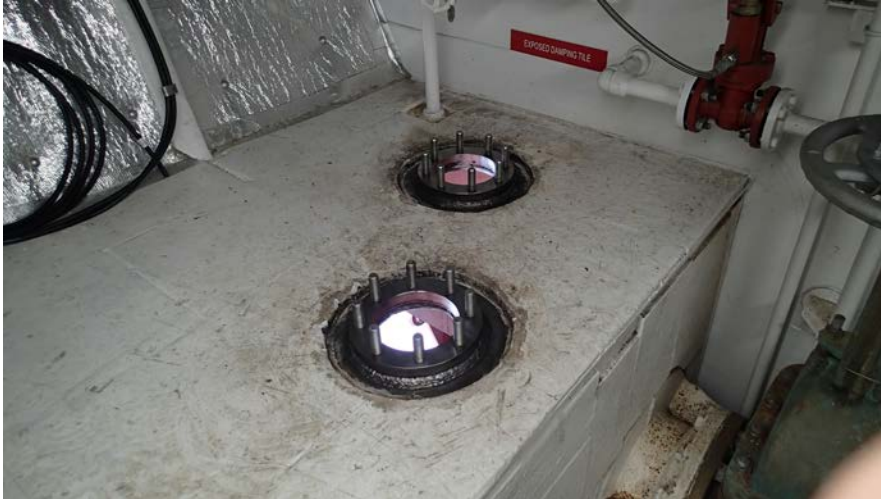
- Sea Chest Anti-Bio Fouling System WP10 – The anode flanges have been fitted and welded to the three sea chests. ABS on site to inspect welds. Cable runs are complete.

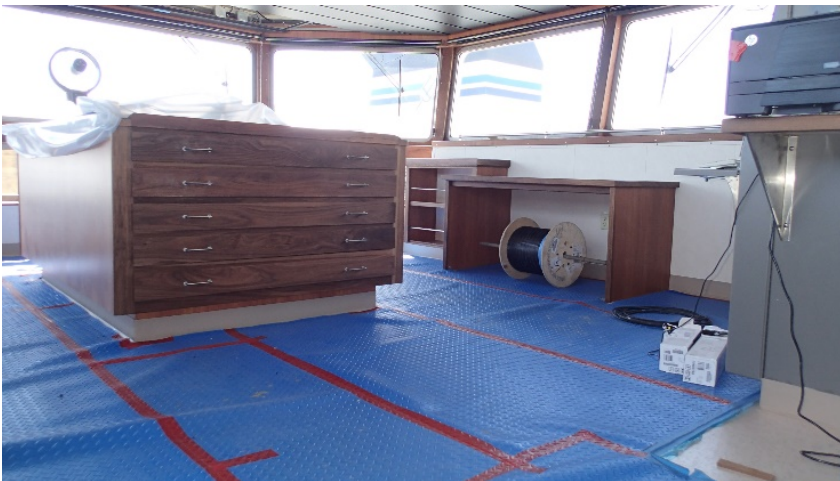
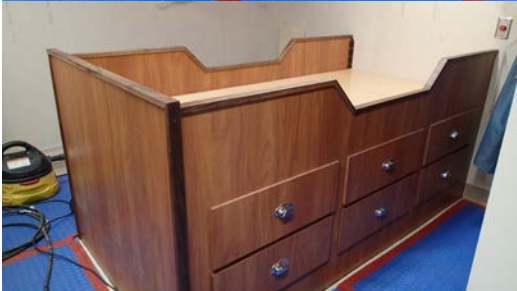
- Fire Pump Sea Chest De-icing Line – Piping run is complete and ABS witnessed pressure test of the sea valve. Yard to pressure test entire run next week.
- Transducer Mods – Work continues apace on the additional transducer foundations and the modifications to the existing foundations. ABS inspected welds and witnessed leak test.
- Furniture Configuration Change – Work completed in the pilothouse and hospital.

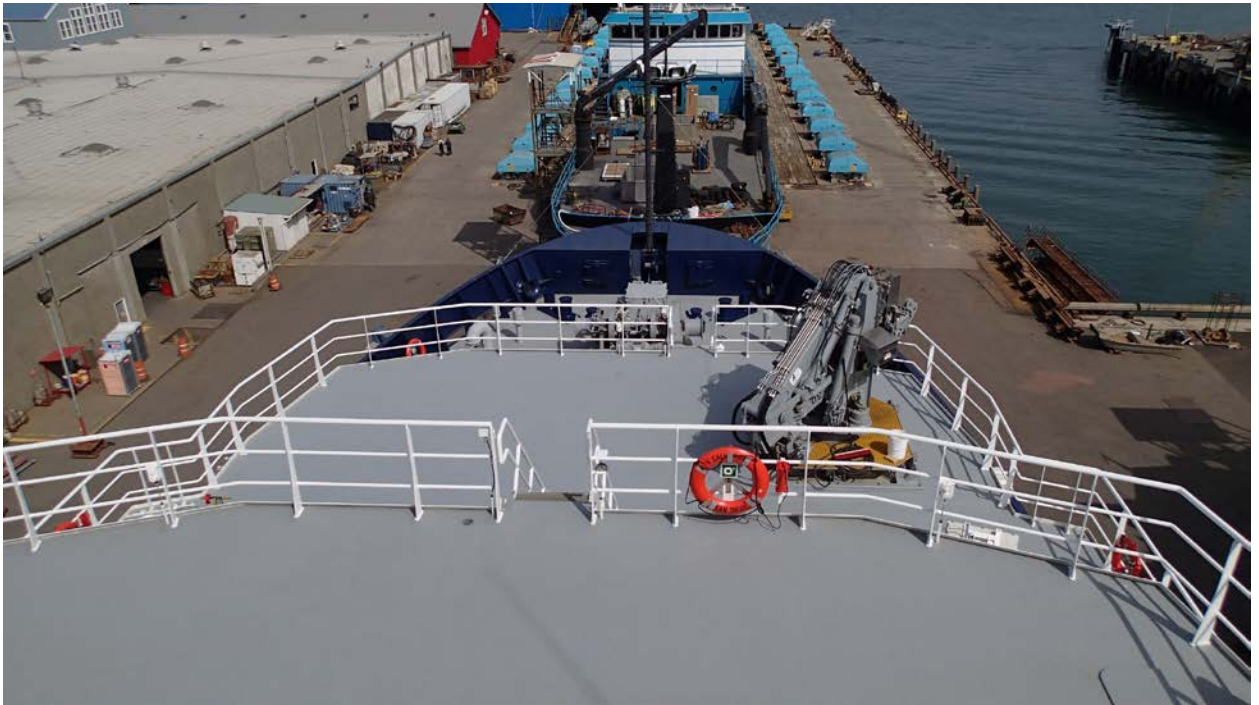
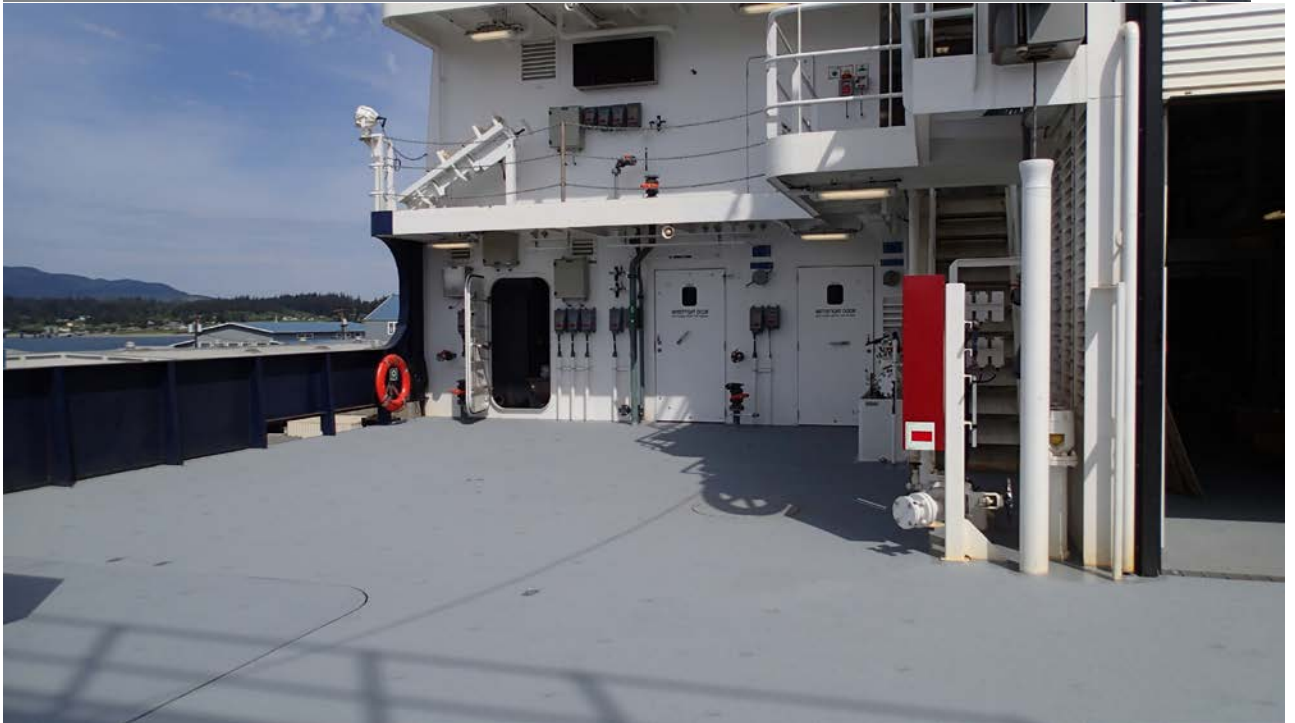
- Topside Paint – Looking good

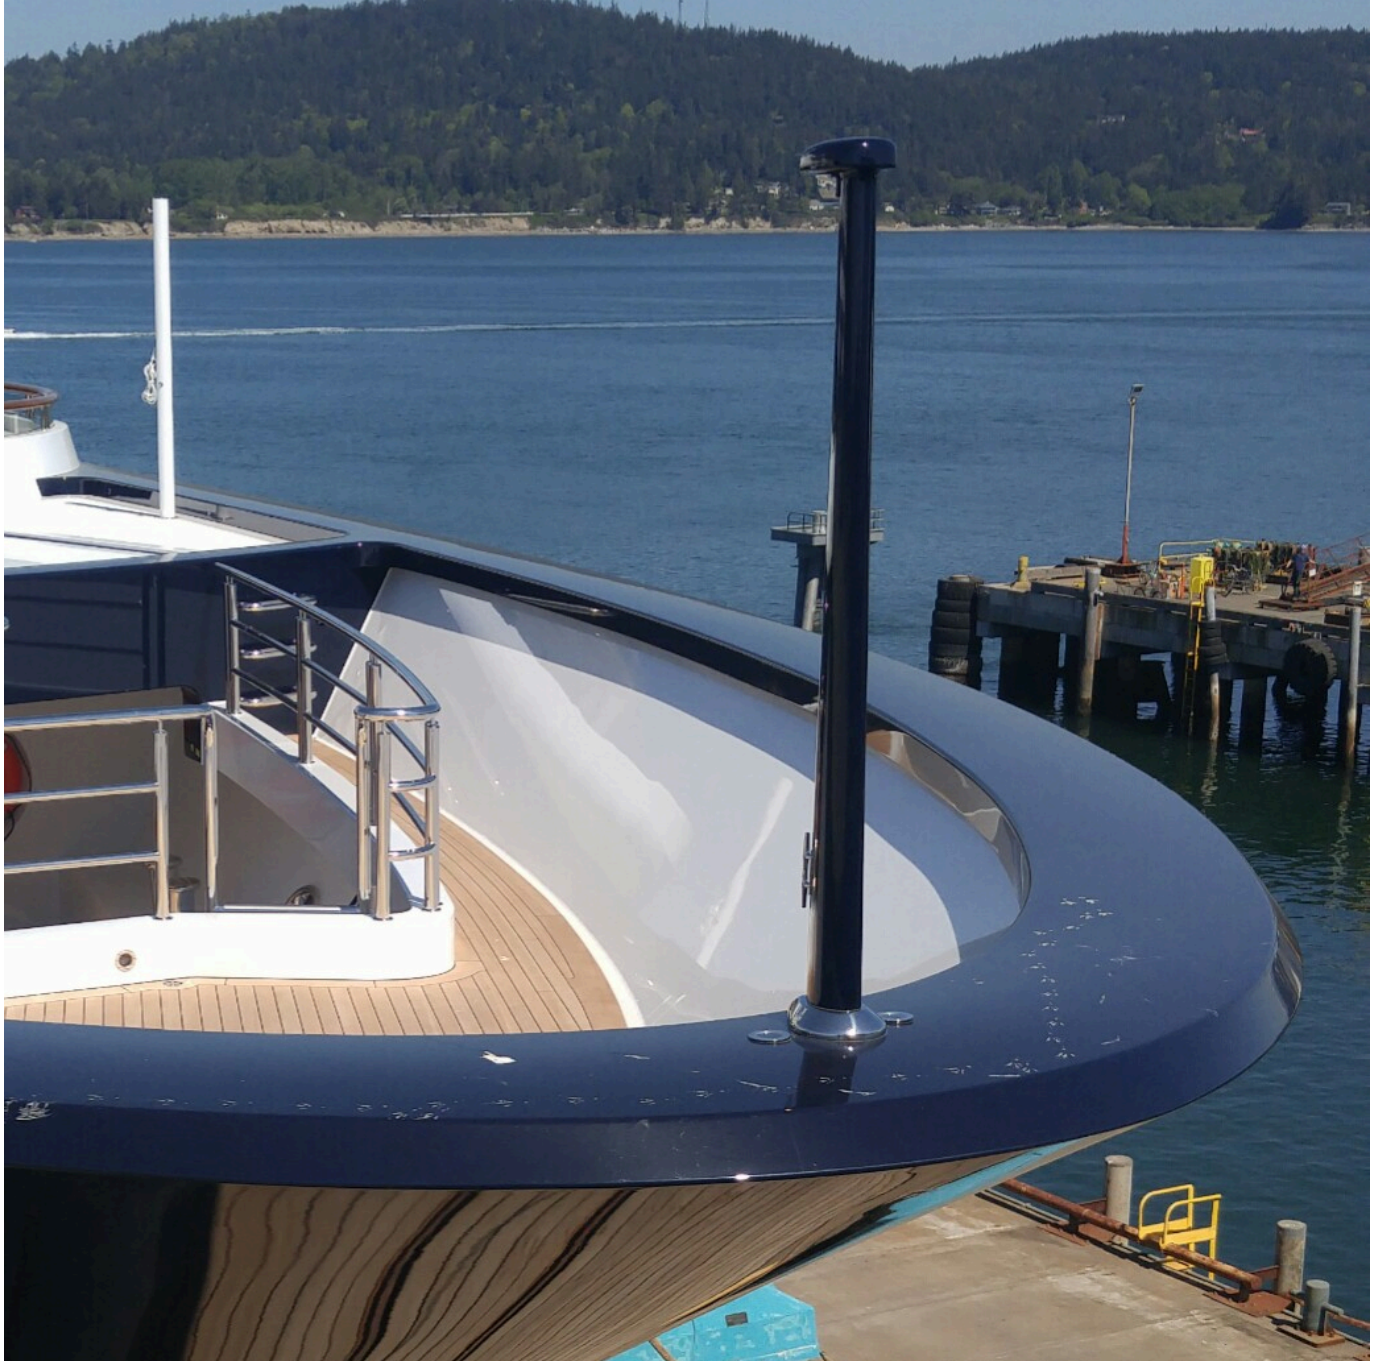
When a bird lands on wet paint and then walks across your \$2 million paint job... The Motor Yacht Albatross parked behind Ride
