AFCEC-CX-TY-TP-2013-0006

**EXPERIMENTAL INVESTIGATION OF
WIDESPREAD DELAMINATION DAMAGE TO
COMPOSITE MATERIALS CAUSED BY
RADIANT HEATING**

Contract No. FA4819-09-C-0030

June 2013

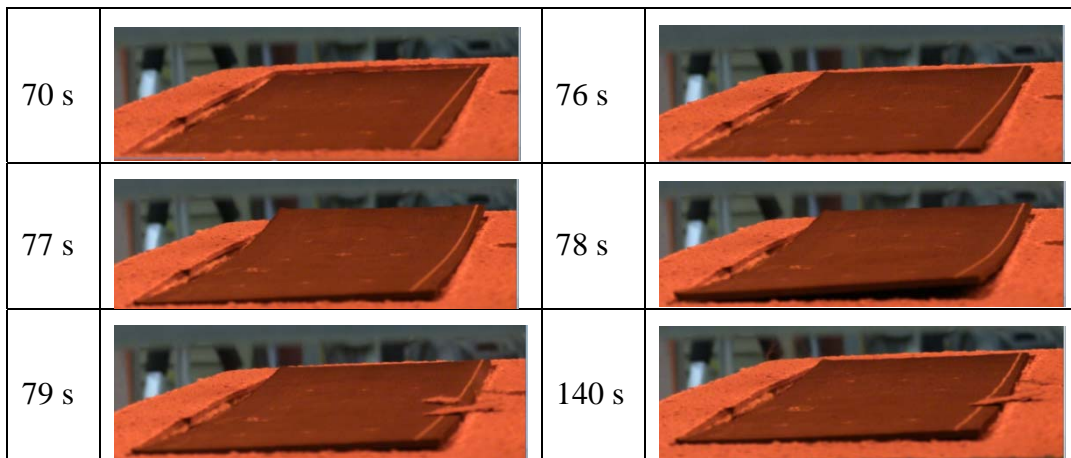
In all materials and heat flux magnitudes tested where there was mechanical degradation measured, it was found that the composite plate experienced sudden damage, prior to any significant charring or mass loss, in the form of delaminations, sometimes throughout the entire thickness. The general sequence observed during testing is shown for plate A9 in Figure 7. In general, there was that no physical response, including little or no smoking, up to the time where surface bubbling formed (localized raised regions of the material), indicating delamination initiation. The plate would then bend upward, many times exhibiting audible cracking. The plate would then dynamically rebound to some degree, indicating further delamination, many times

Figure 7. Plate A9 (1.15 % moisture content) during delamination at 35.2 kW/m^2 .

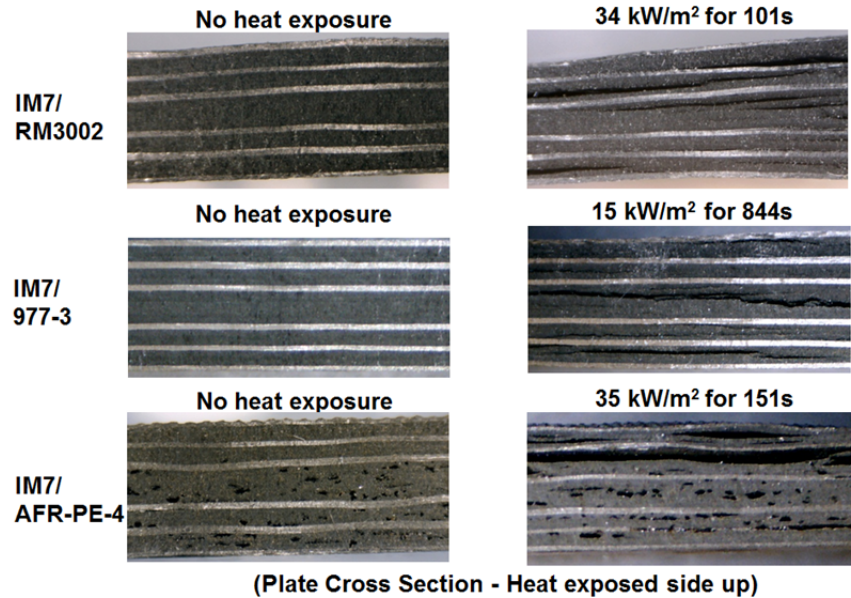
Optical microscopy was performed on all samples cut from the exposed plates. Widespread delaminations were evident throughout the thickness of the plates showing mechanical degradation. Exemplar cracks in each material are shown in Figure 10. There was no apparent pattern to where the delaminations occurred. Large widespread delaminations were seen throughout the thickness in the IM7/RM3002 and IM7/977-3 composites, but only on the plies on the heat exposed side of IM7/AFR-PE-4. Only small delaminations were seen on the unexposed side of this material. It is obvious that delaminations seen by the visual surface bubbling of the plates during testing were caused by the application of heat. However, it is possible that some of the delaminations throughout the thickness were also caused by the mechanical stresses caused by plate bending.

Figure 10. Microscopic images of plate cross-sections before and after radiant heat exposure.
