# **ACES-II Seat Roller Study: Findings of Detrimental Friction under High Windblast or Adverse Flight Conditions**

*Analytical findings of an intrinsic, restraining, high-friction response from the ACES-II Ejection Seat's legacy "seat roller" (a dry metal wheel on a shaft), when subjected to high loads (such as ejections at high speeds or with an aircraft yaw angle). Recommendations are made for improvement.*

12 Aug 2015

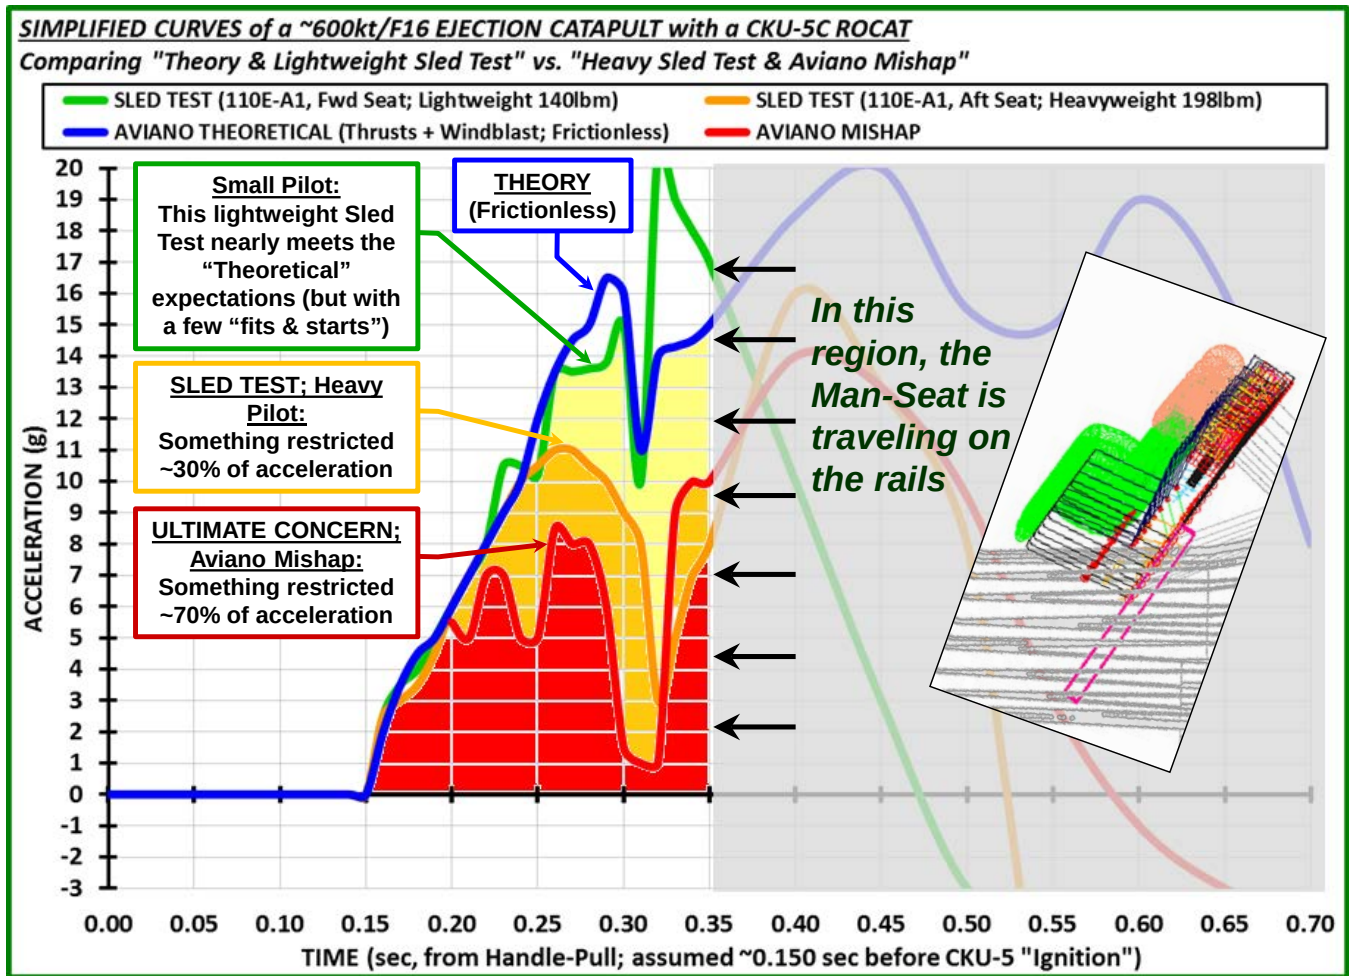
Figure 1 – Summary of "Low-g" Artifact and Its Severity Increase with Loads on Seat Rollers

The certainty of Artifact #1 (low-g period at top of rails) was increased by the expectation that – at these high speeds (~600 knots) – windblast should have been "getting underneath the seat" and increasing the spinal acceleration. Theoretically (Figure 1 - blue line; frictionless rollers), windblast should superimpose on the CKU-5 ROCAT's catapult and sustainer spinal vectors, particularly in the "leaned back" aircraft rail (34-deg, vs. 17-deg) and exposed man-seat (no windscreen) of the F-16 aircraft. Figure 2 confirms this wind-assist via hand calculations. Rough expectations then sum the catapult thrust (~3500 lbf; ~10g) with the windblast "getting under the seat" (~6.7g, as shown in Figure 2) for a sum of 16.7g. Thus, a hand-calculated expectation of a high-speed F-16 ejection would be a spinal acceleration peaking at ~15-20g during catapult phase, and the specific hand calculation (~16.7g) also matches the peak theoretical (frictionless) 6-DOF ADAMS model prediction (Figure 1; blue line).

As shown in Figures 1 and 3 (the red curves; spinal acceleration of the Aviano mishap); instead of finding this 15+g spinal acceleration during the Aviano's catapult phase, the investigation noted a "low g" performance; intermittent spinal acceleration, with a peak of only ~8g (instead of ~15-20g), and with regions down to ~0-1g. For perspective on the seat position (Displacement = Velocity x Time); recall that during a 50msec period (such as from 0.280sec to 0.330sec) – a man-seat traveling at ~40fps would traverse about 2 feet of the rail. So, this ~0-1g "low-g dropout" period was not a "brief transient" (as it may appear on a time-scale), but a long-stroke restraint or loss of thrust, occurring to the seat.

This contrast between the prediction (~15-20g) and observation (0-8g) drew the initial investigative concern – and in general; the finding that windblast caused a *decrease* in the man-seat’s acceleration, rather than an increase, led to the logic of investigating friction (seat roller friction) as a potential cause of the restrained man-seat motion.

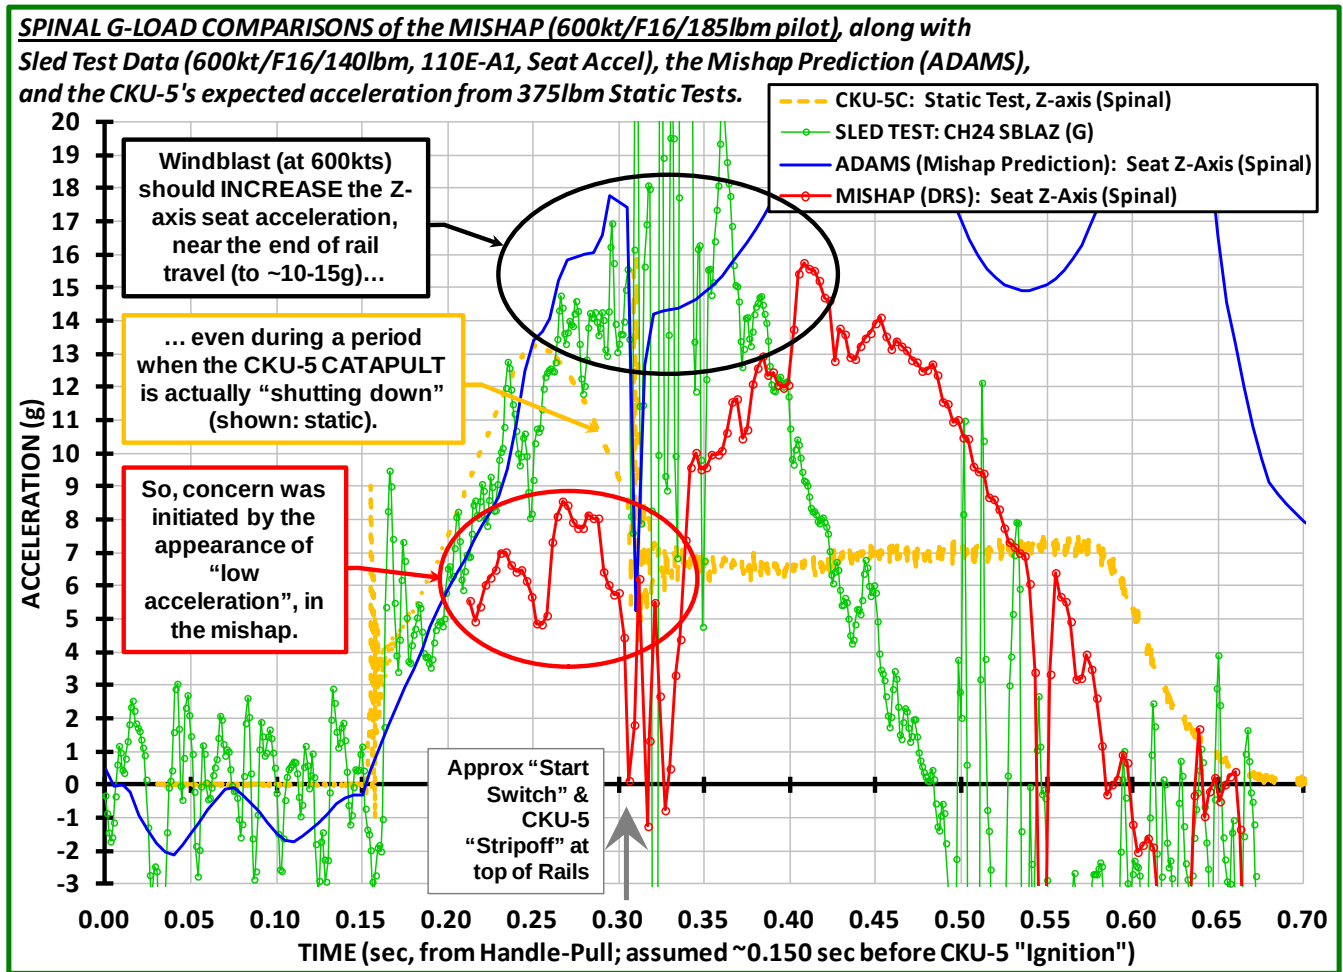
Figure 3 – Prior Graph from Reference-1: Mishap Artifact #1 (Apparent "Low-g" Region)

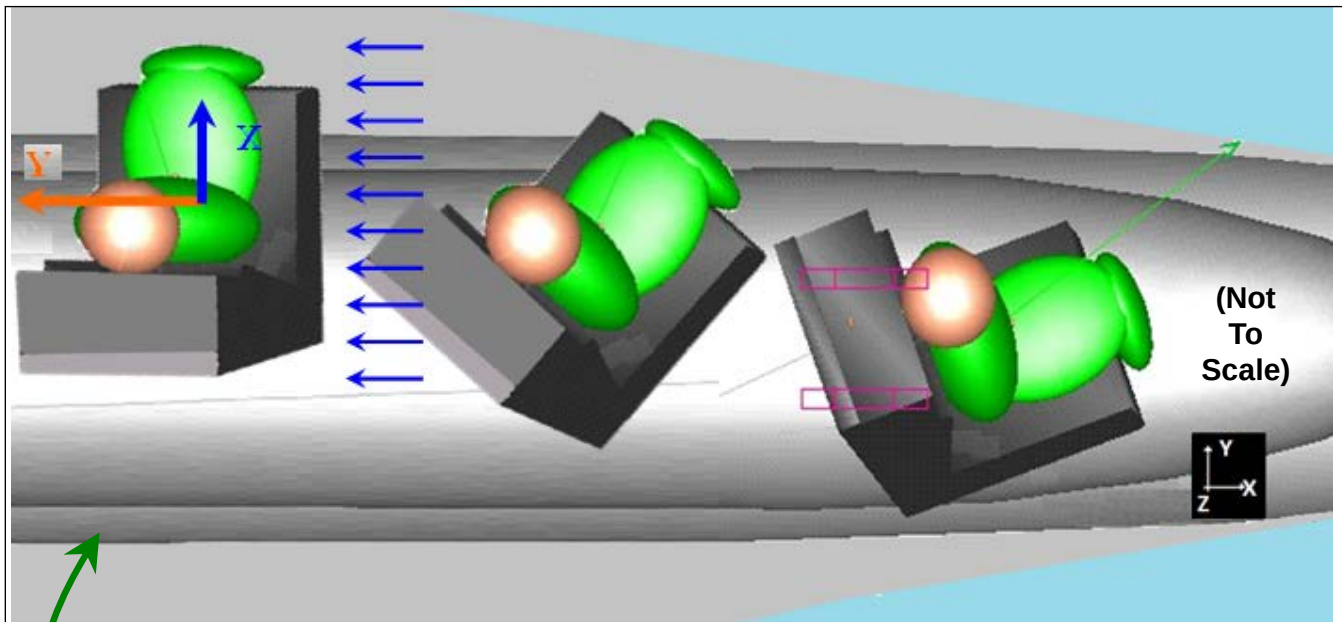
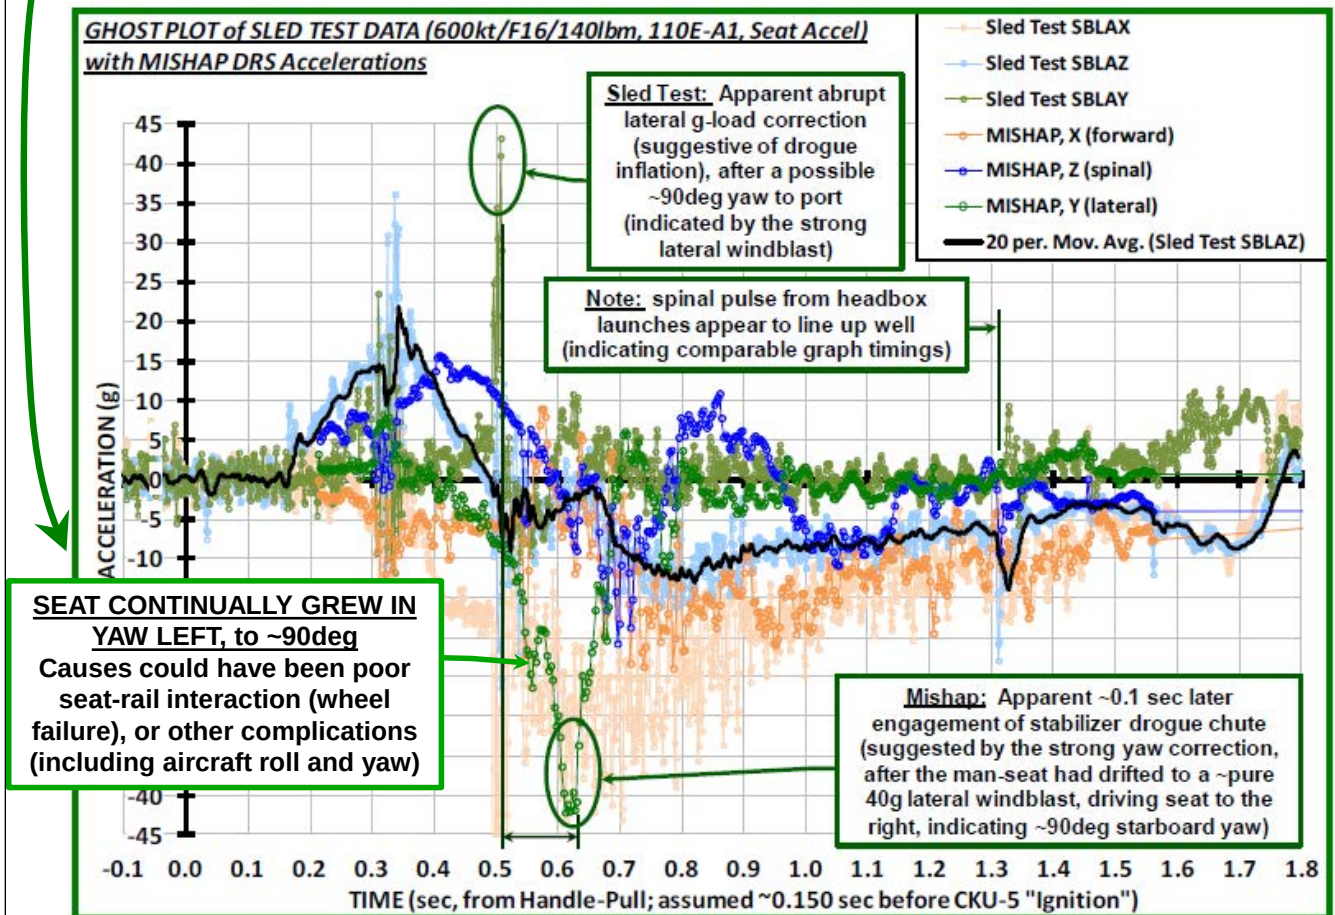
As for "Artifact #2" (the drogue inflation delay, aggravated by the seat having drifted to ~90-deg Yaw) – this seat rotation in yaw may have been caused by the perturbing ambient aircraft yaw and roll, or by a seat roller failure, or – potentially - a combination of both. As shown in Figure 4 (which includes an excerpt from Reference (1)) – the lateral seat acceleration of the Aviano mishap's man-seat (shown as the lowest green dots) grew steadily from the point of man-seat departure from the aircraft's seat rails, ultimately reaching (possibly clipping) at ~43g's – which indicates the man-seat yawed ~90deg against the windblast. The period of this yaw was during free-flight; between seat-rail departure ( $t=0.3$  sec, on the graph) and drogue chute inflation ( $t=0.6$  sec, which appears to be ~0.1 sec later than a comparable sled test). The rate of this yaw is uncertain, but *averages* a strong rate of  $300 \text{ deg/sec} = 90\text{deg}/(0.6\text{s}-0.3\text{s})$ . When the drogue chute inflated, the correction "snapped" the man-seat back to face-forward. While the cause of this progressive man-seat yaw is not known, motion difficulty on the rail (wheel friction and failure) is among the possible drivers (along with aircraft roll and yaw, intrinsic man-seat aero-instability, pilot shift and slump, asymmetric helmet movement, asymmetric limb flail, etc.).

At Yaw=90:  $F_{\text{drag}} = \frac{1}{2} \rho A C_d V^2 = 0.5(0.0019)(4 \times 2 + 2.5)(1.5)(1000\text{fps})^2 = 15000 \text{ lbf}$ ,  
 Or:  $\text{Accel-Y} = F/m = 15000/350\text{lbm} = 43\text{g}$ , which matches mishap g-Y (although ~clipped)

(Previous Report: Figure 18 – Mishap Artifact #2: Apparent ~0.1 sec Delay in Drogue Chute Inflation)

Figure 4 – Recap of Artifact #2; Apparent Man-Seat Yaw of ~90deg plus Drogue Chute Delay

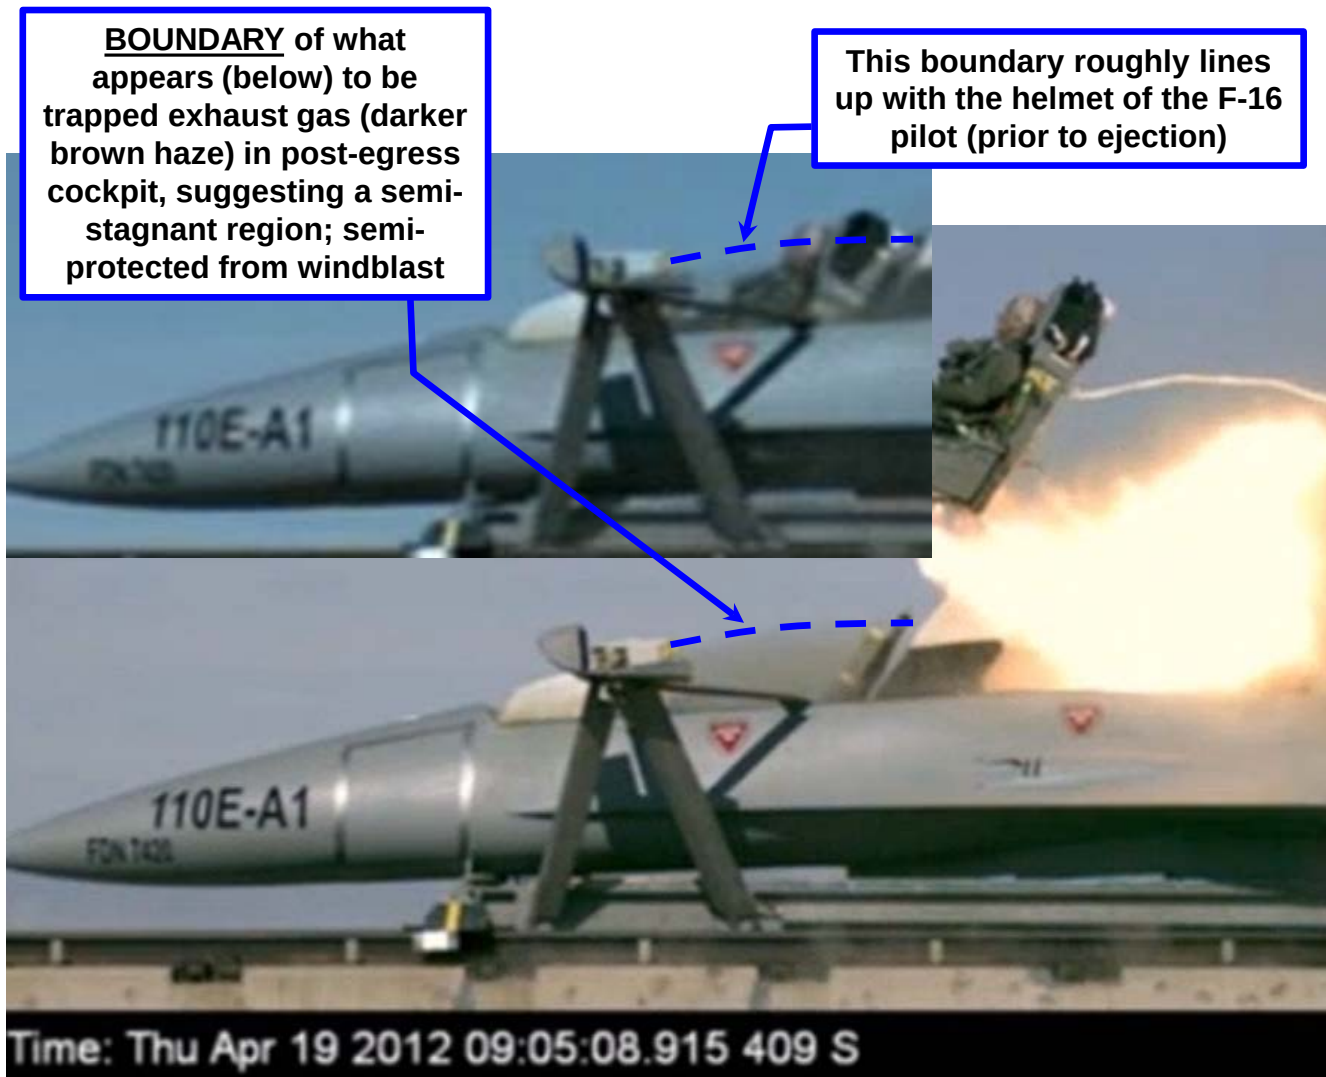
Figure 5 – Sled Test Example of Windblast Emergence (Between Elbow and Head Height)

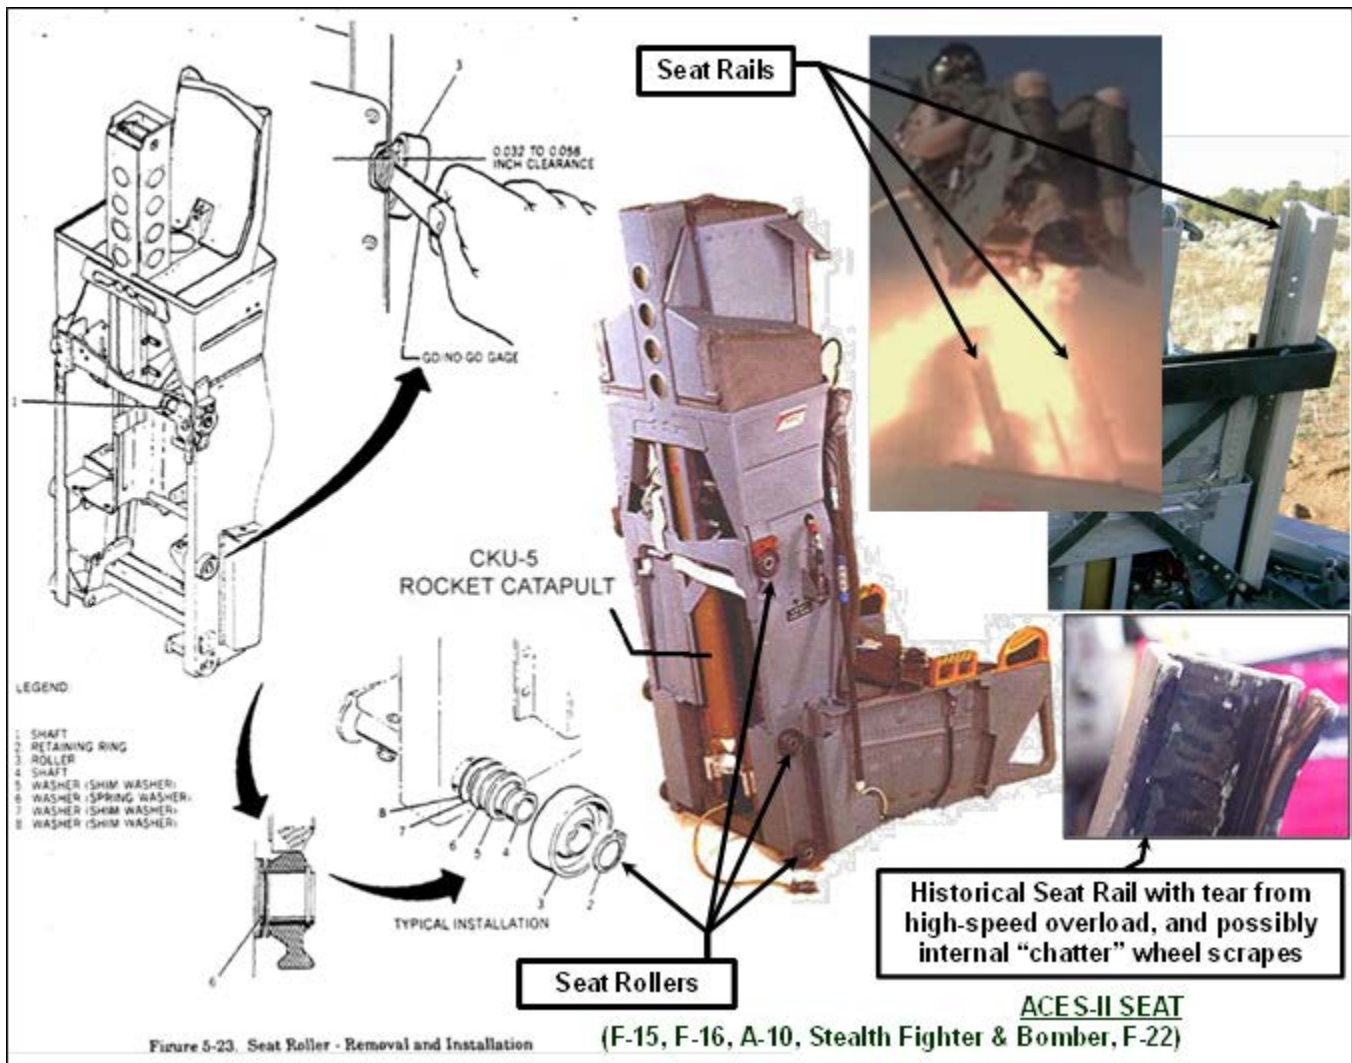
The current configuration of the ACES-II Seat Rollers is shown in Figure 6, from TO 13A5-68-2 (and is essentially the same seat roller design since conception in the late 1970’s – and that roller design itself was inherited from the prior-generation, “ESCAPAC” seat). As indicated, the ACES-II Seat Rollers apparently are hand-assembled steel wheels on dry metal shafts, with only metal spacers for positioning.

Figure 6 – Diagram of Current ACES-II Seat Roller Design, Installation, and Use

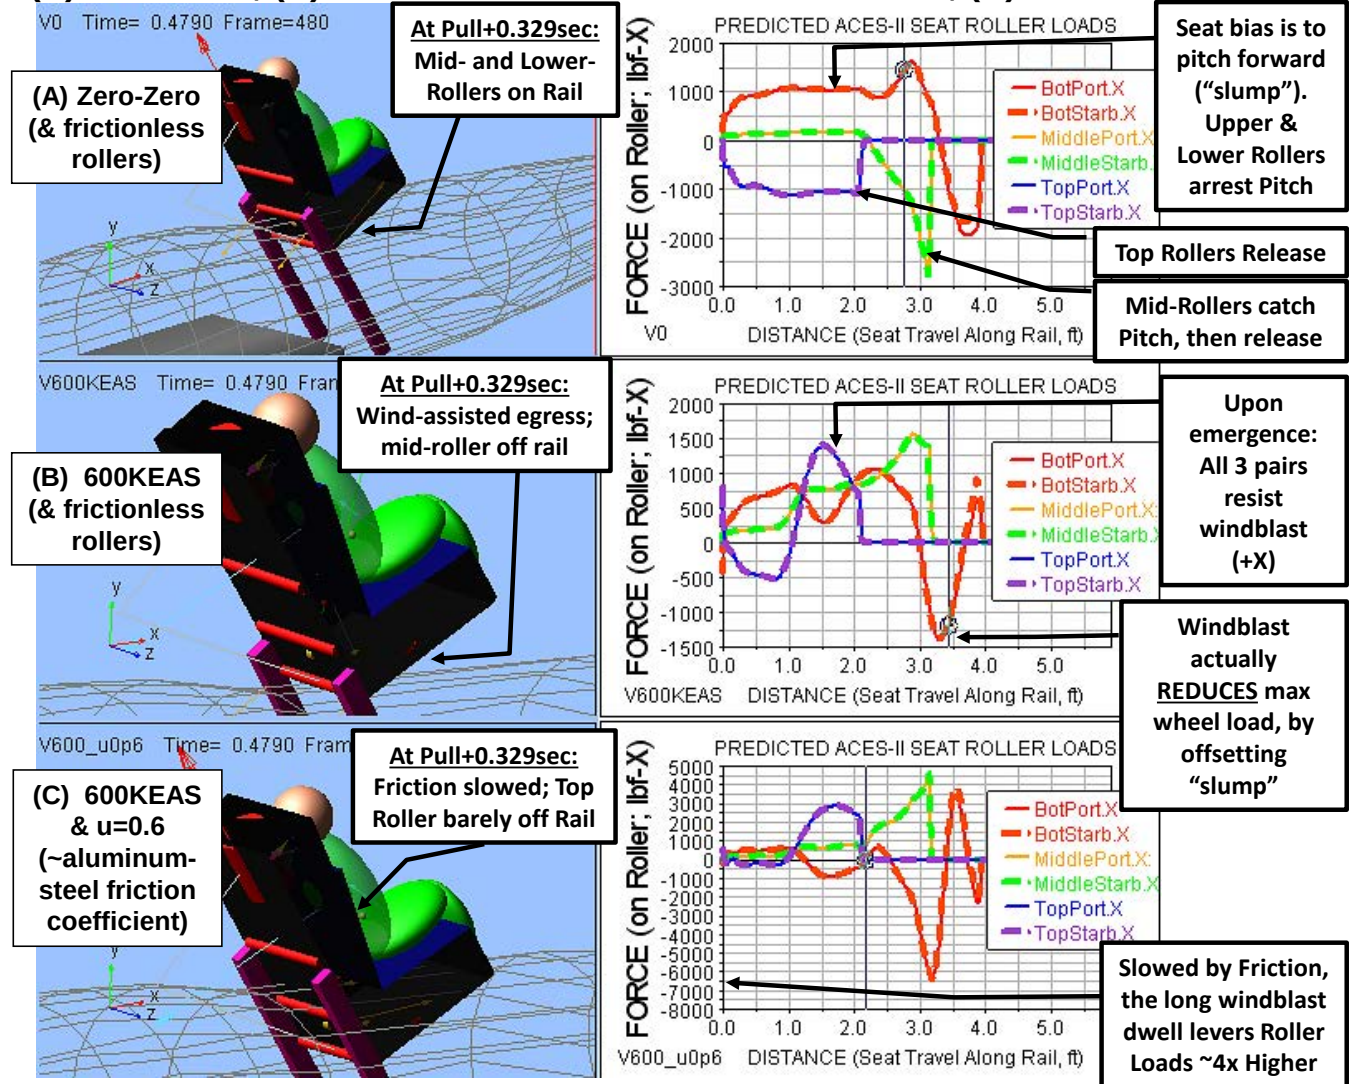
**(A) Zero-Zero, (B) 600KEAS & Frictionless Cam Rollers, (C) 600 KEAS &  $\mu=0.6$**

Figure 9 – ADAMS-Predicted ACES-II Seat Roller Loads (Fx) at Two Friction Coefficients

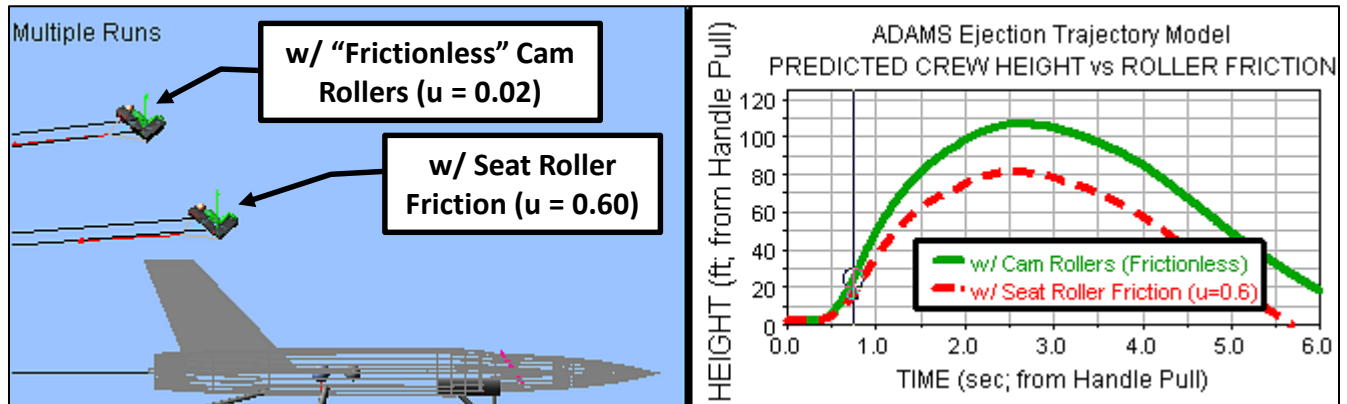
Figure 10 shows the continued flyout of Scenarios B and C (the two 600KEAS friction variants, from Figure 9), illustrating the reduced tail clearance (reduced from yards to feet), lower apogee (reduced from ~110ft to ~80ft), and reduced time of flight (~1.5 seconds less to complete the parachute stabilization, deceleration, and pendulum swing).

Figure 10 – ADAMS-Predicted ACES-II Tail Clearance and Apogee at Two Friction Coefficients

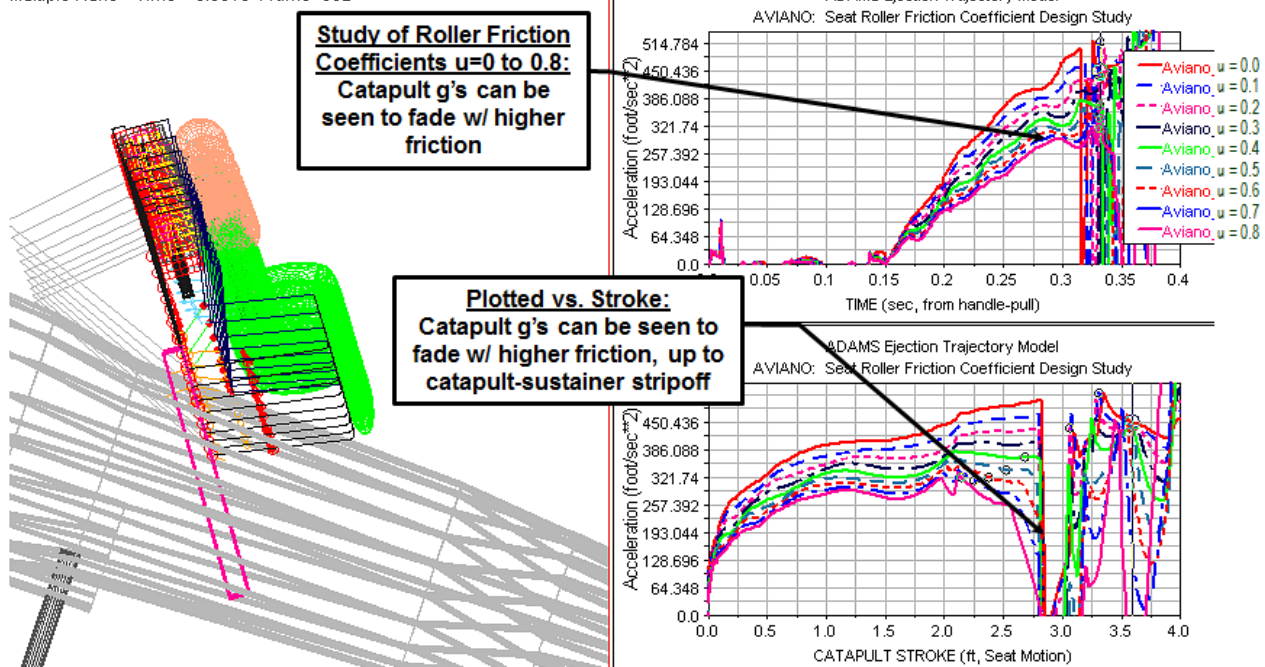
Figure 11 shows ADAMS-predicted man-seat spinal accelerations for the studied range of ACES-II Seat Roller friction ( $\mu = 0$  to  $0.8$ ), plotted against time (upper right quadrant) and seat motion (lower right quadrant), for flight conditions comparable to the Aviano mishap ( $\sim 18$  deg dive through  $\sim 7100$  ft-msl at  $\sim 599$  KEAS). Results confirm majority losses are possible (ultimately up to “near zero” acceleration).

Figure 11 – Results from ADAMS Design Study of Seat Roller/Rail Friction Coefficients

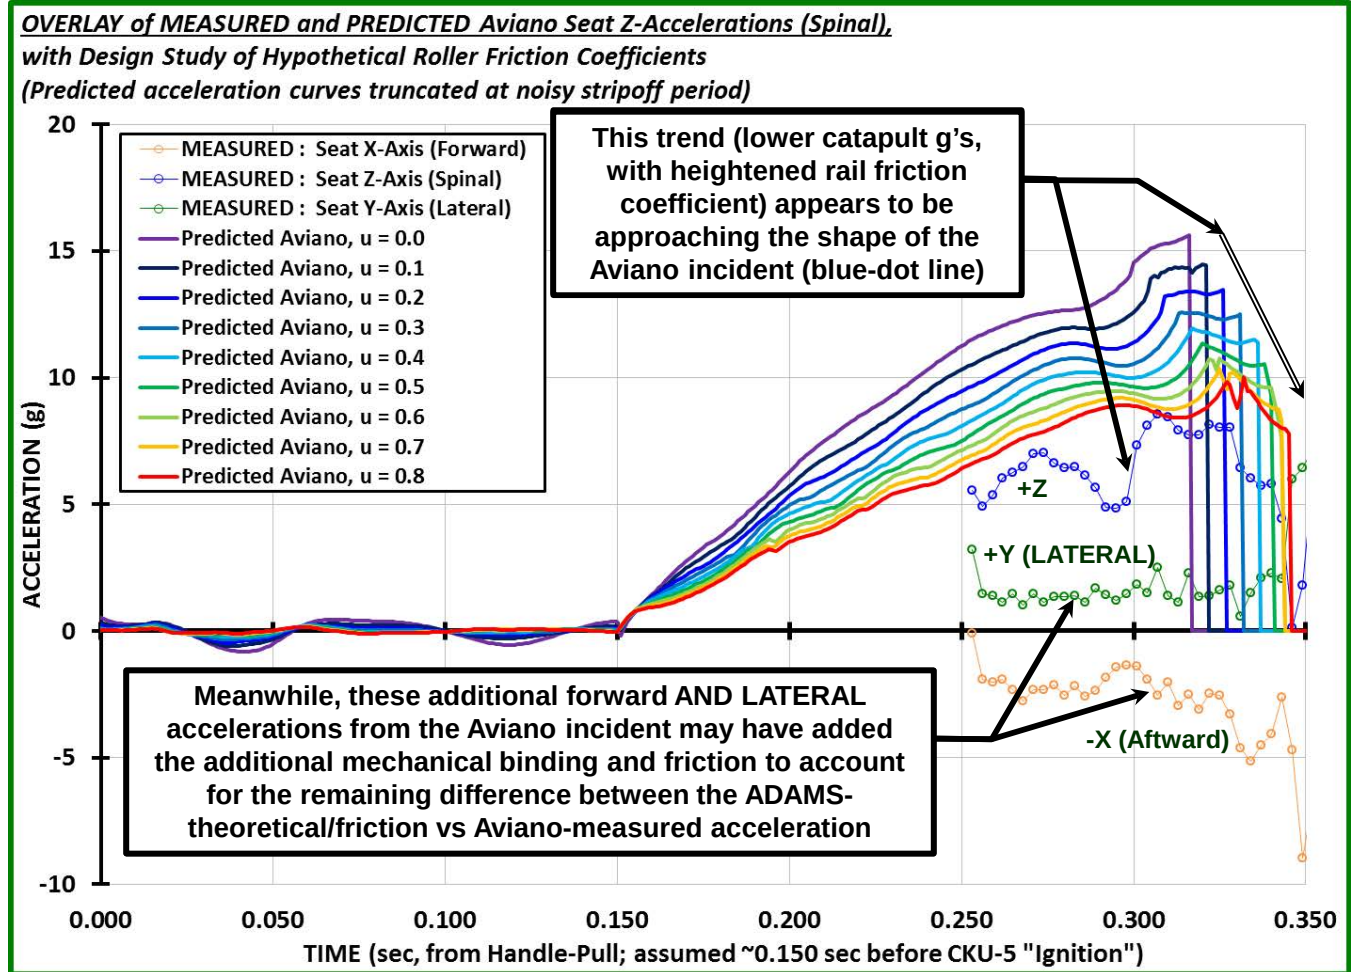
These same results (cropped to only show the CKU-5's catapult phase; excluding the sustainer onset, for clarity), are shown in Figure 12, with the Aviano Mishap seat accelerations overlaid. This overlay reminds that – in the mishap – additional lateral accelerations were simultaneously occurring, so the additional loss in spinal acceleration may be explained by the additional friction from these lateral loads, and further “intermittent drops” in spinal performance (such as at  $t = 0.300$  sec) may have been caused by (X-axis) oscillation; the dynamic rocking of the seat forward and aft; “banging” rollers up the rails.

Figure 12 – Superposition of ADAMS Design Study with Aviano Seat Accelerations

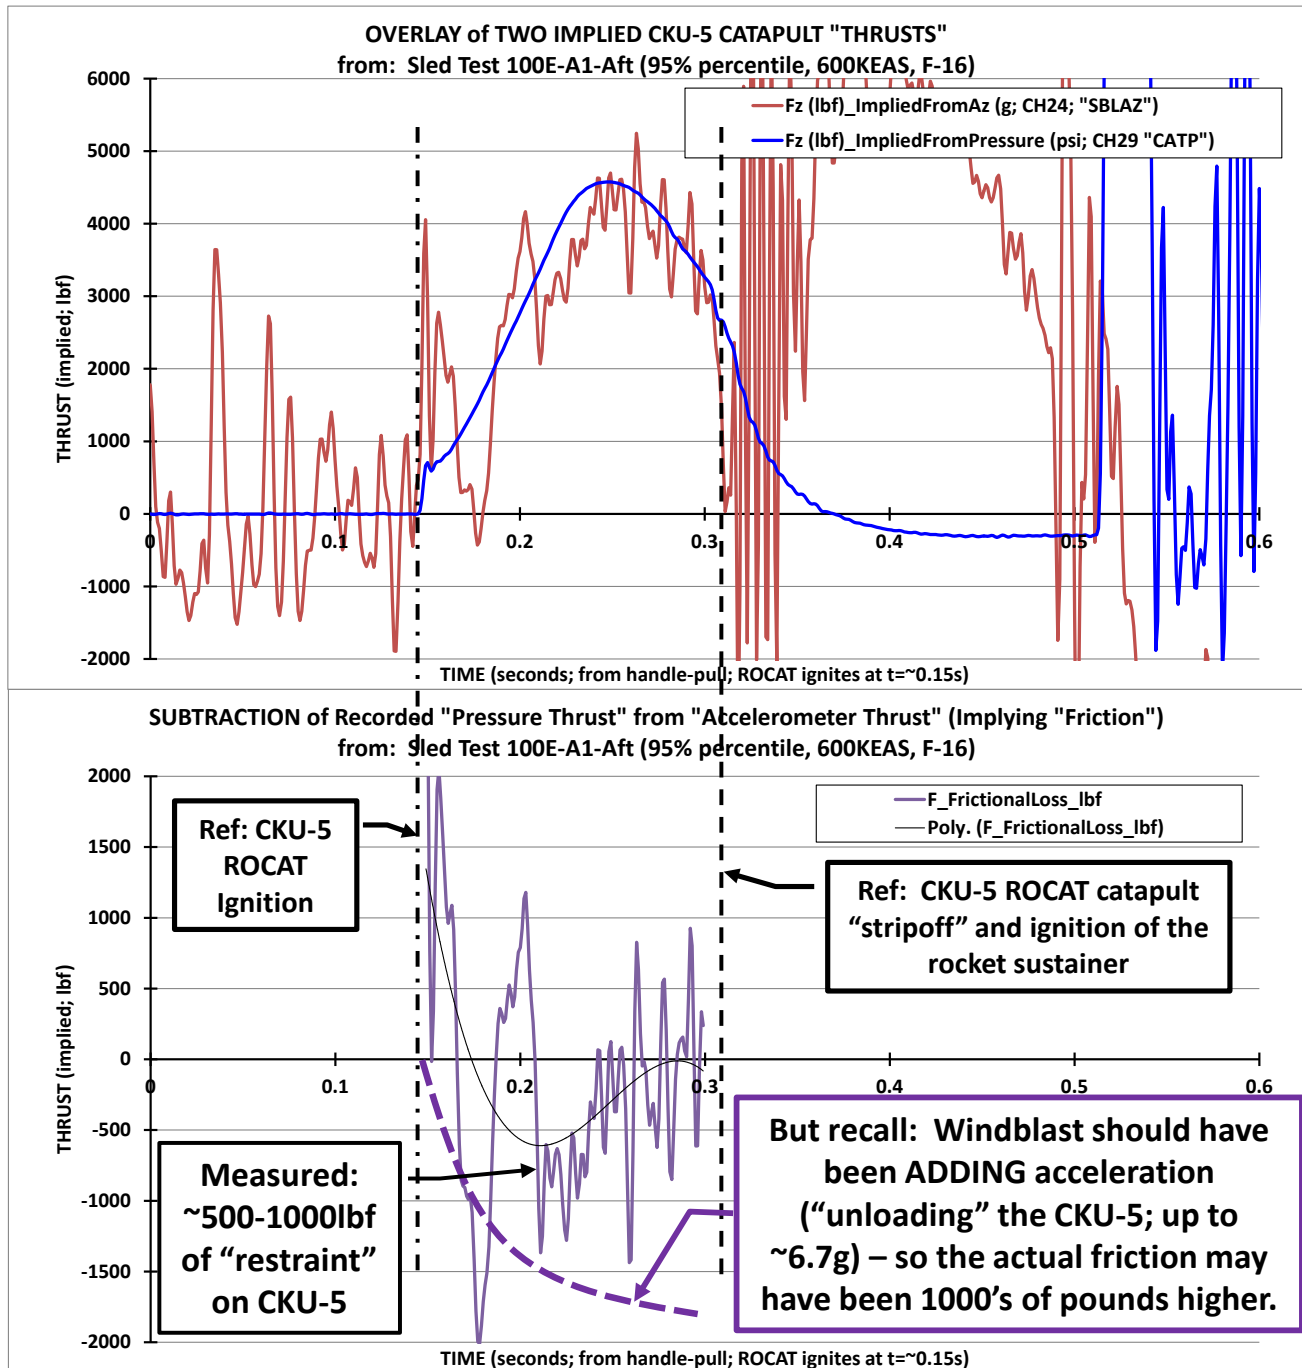
Regardless (i.e. even if neglecting the expected “wind assist”), the seat roller friction is observed to have been at least ~500-1000 lbf. This magnitude of restraint is ~1.5 to 3g of egress loss ( $a=F/m$ , with a ~350lbm man-seat); up to ~30% of the CKU-5’s ~1000-4500 lbf catapult performance. So, even this “small” amount of friction (~500-1,000 lbf) is a significant portion taken from a ~3500 lbf ROCAT, and appears to be of a comparable magnitude to the loss described in Figure 1 (~30%).

Figure 13 – Sled Test Indication of Seat-Rail Friction (at “Straight and Level” Conditions)

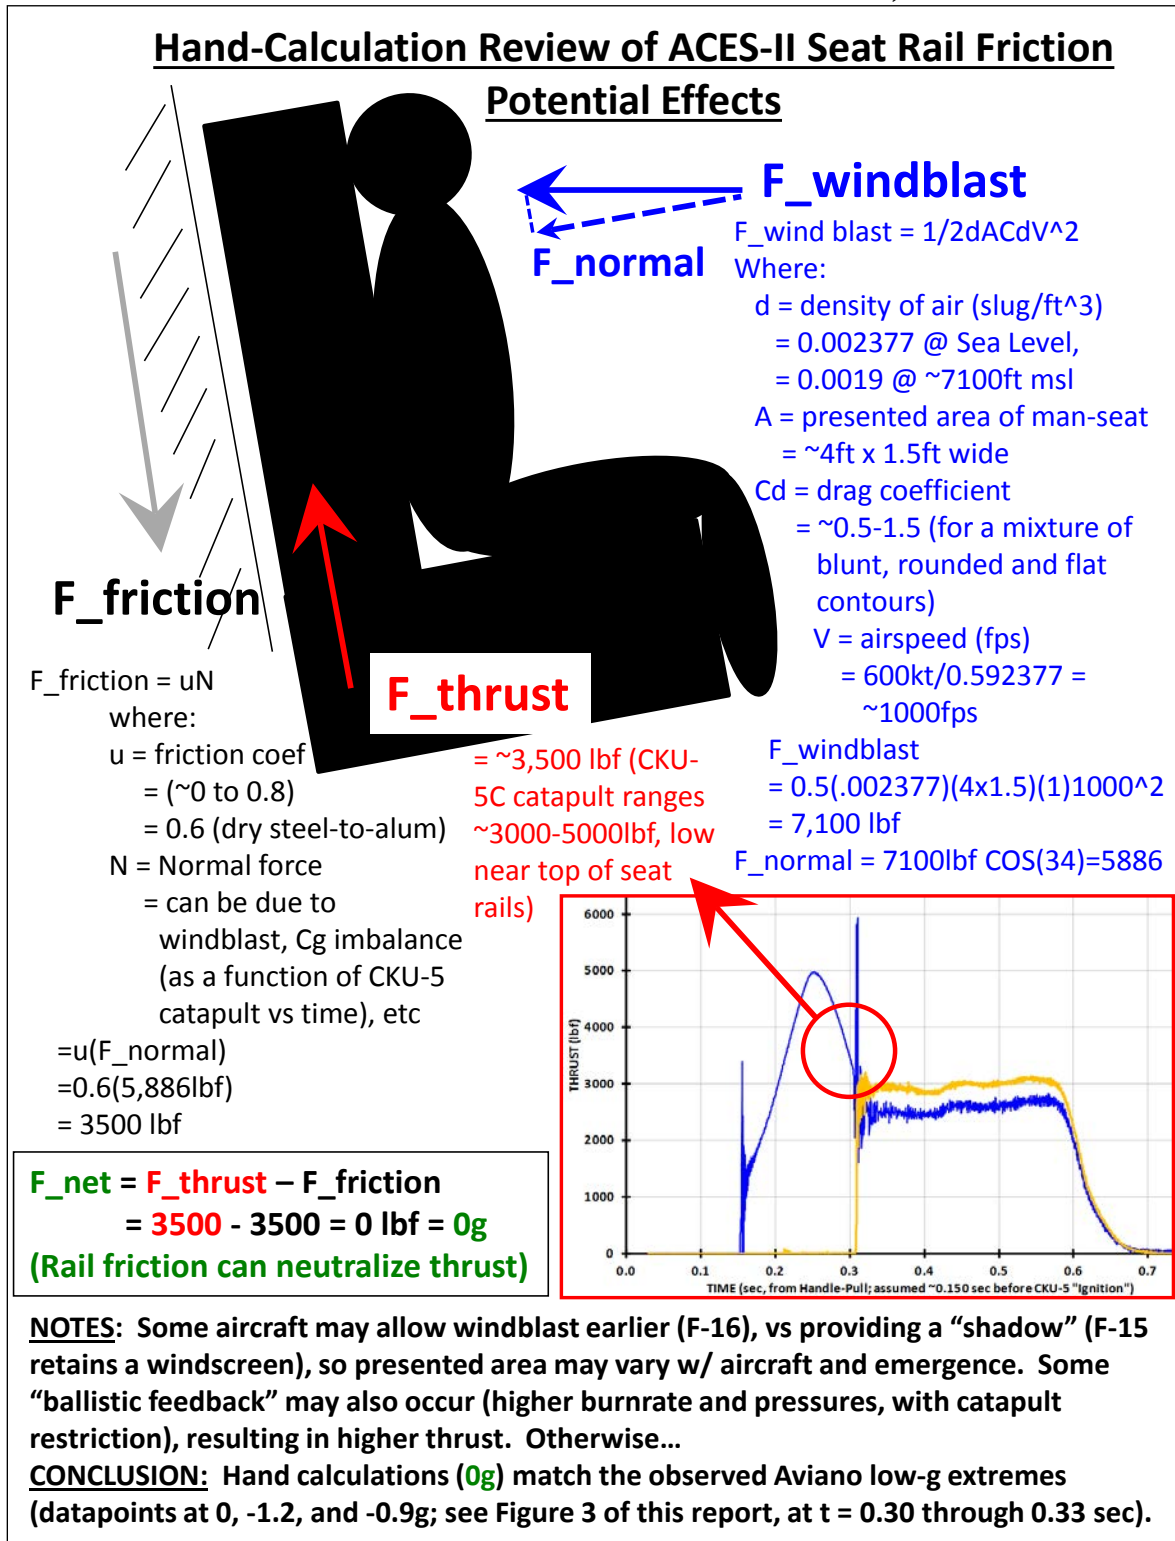
As shown in Figure 14, hand-calculations indicate a similar magnitude of response (that seat roller friction can match – or overcome – the nominal thrust of a CKU-5 ROCAT).

Figure 14 – Hand Calculation Supporting Conclusion of Causal ACES-II Seat Roller Friction

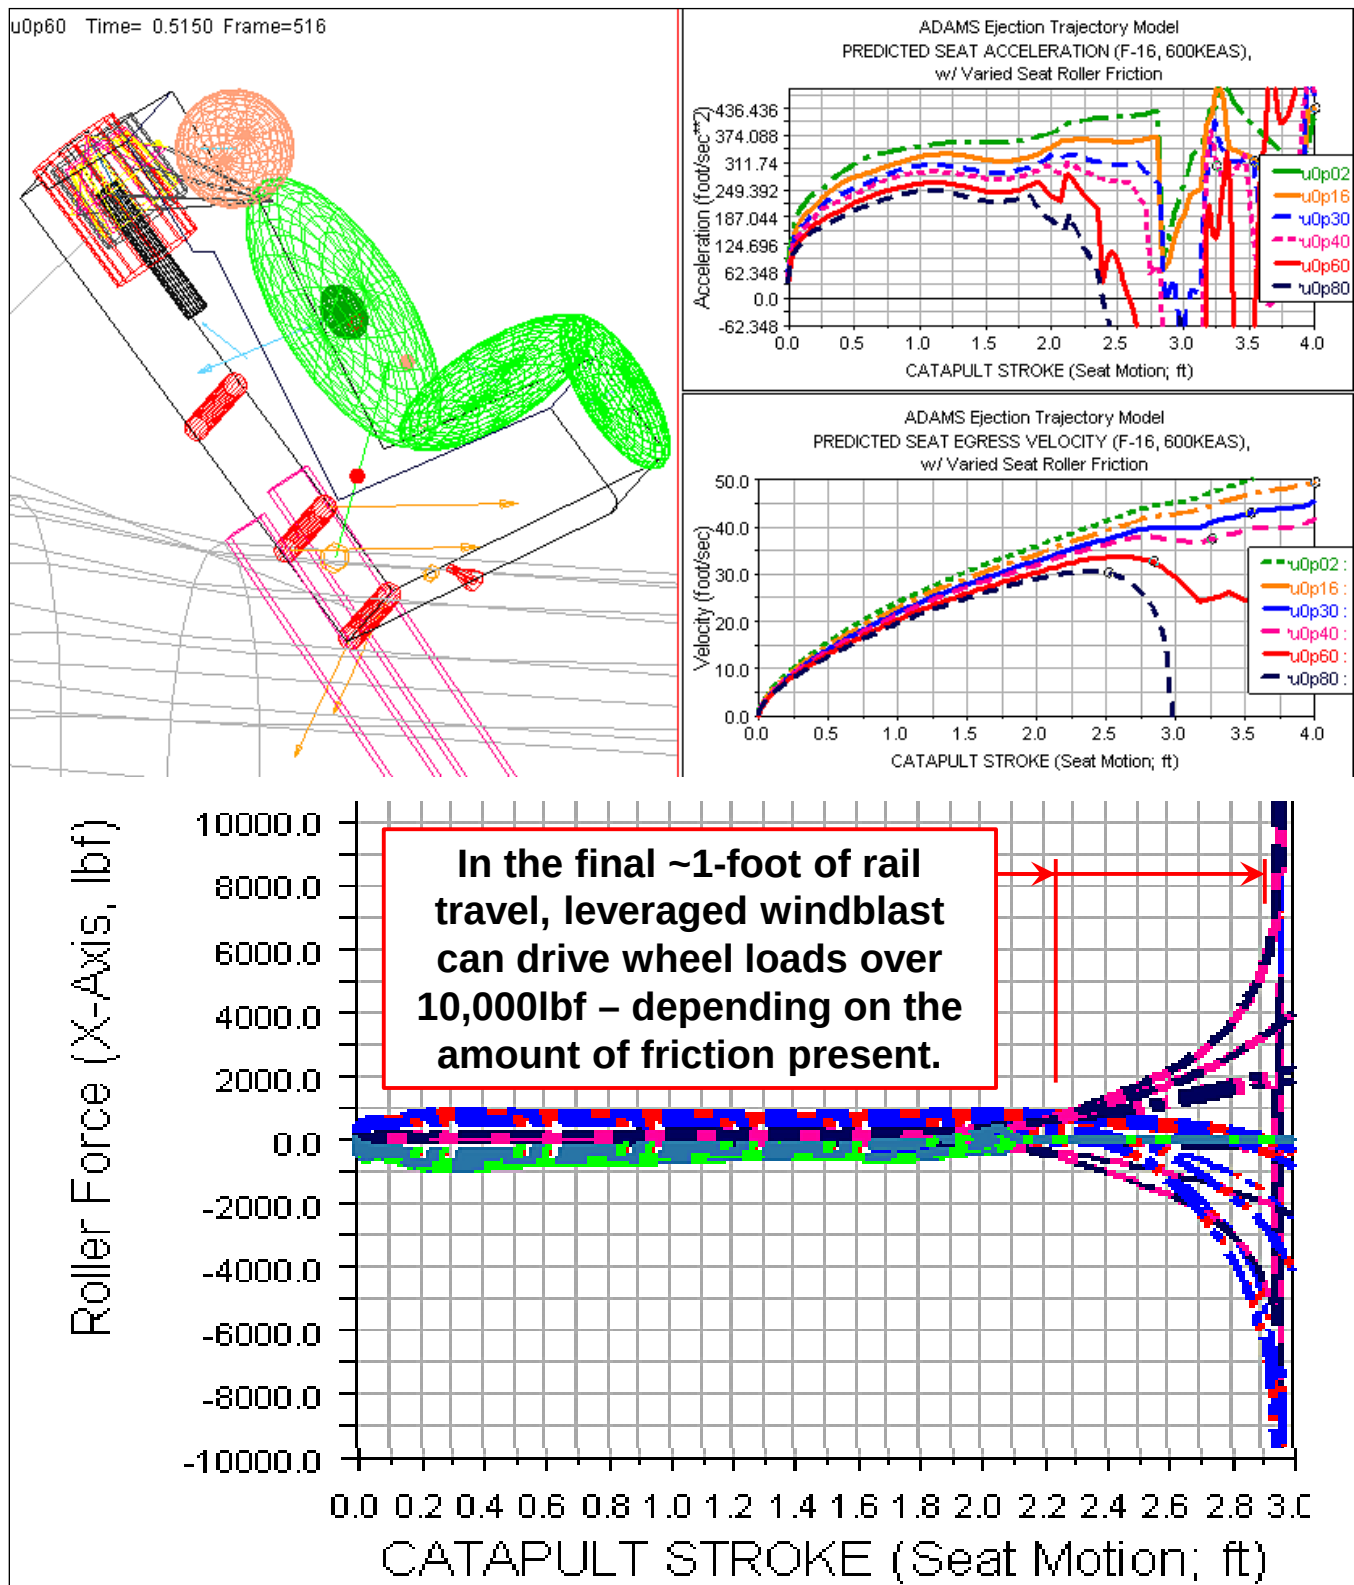
- 3) **SLOWER MOTION CAUSES HIGHER FORCES.** If the dwell time of the man-seat at the top of the rails is brief (i.e. a lightweight pilot “shooting up the rails” at the highest speeds), then there may be insufficient time for the windblast to fully “rock back” the seat to cause back-loading of the seat rail and rollers. Conversely, if the dwell time of the seat at the top of the rails is large - sufficient to fully “rock back” the seat against the rails (enough to cause full deflection; i.e. semi-static reaction loads), then the windblast is able to fully transfer mechanically into the seat rails and rollers. In this case, due to the leverage advantage of having only two pairs of rollers engaged while the man-seat emerges, the middle rollers could arguably approach a sharing of ~14,000 lbf between the two wheels (~7,000 lbf per wheel), due to resisting both the windblast (translational) and the leveraged reaction (bending moment) with the bottom rollers. Meanwhile, the lower rollers are rocked FORWARD, and share ~7,000 lbf (~3,500 lbf per wheel), from this same bending moment. Prior to this (i.e. before onset of windblast, or without wind loads; a “zero-zero” ejection), the bias of a man-seat during catapult is to “rock forward” (rather than aerodynamically “rock backward”), as virtually all of the man-seat mass is in front of the ROCAT’s catapult line-of-thrust, rails, and rollers. Therefore, the “dwell time” in windblast at the top of the rails is primary to the seat roller loads, as a short dwell time will not allow aerodynamic loads to be transferred to the seat rollers (zero-wind max wheel load: ~1500 lbf per wheel), while a long dwell time will allow the full aerodynamic and leveraged forces to apply on the rollers (i.e. max load, with thrust and dynamic collisions, could be on the order of ~10,000 lbf per wheel).

Figure 15 – Results from ADAMS Design Study: Friction Can Drive Roller Loads Above 10,000lbf

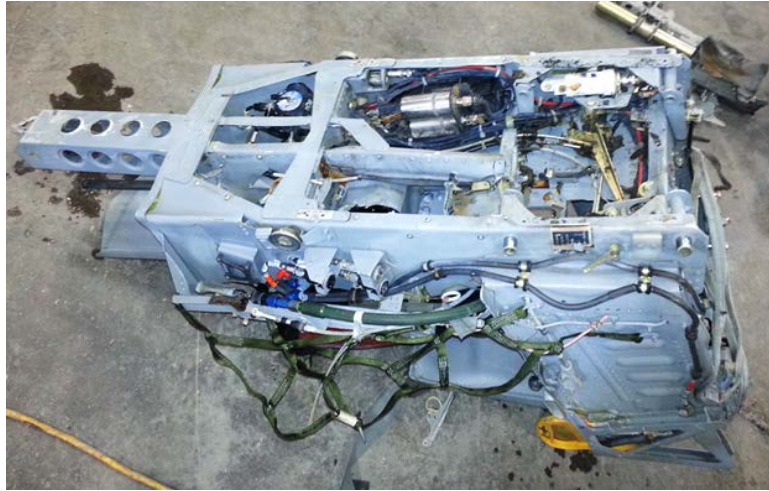
- 1) B-1 Ejection, Montana, 19 August 2013: The second seat (of four) to eject from this aircraft – which was in an uncontrolled roll, and 400 knots – was observed via DRS to have suffered a negative-g acceleration (complete loss of catapult acceleration) during ascent up the rails... and lost all 4 of the lower wheels.
