Acquisition Directorate

Report No. CG-D-02-16

Initial Burn Pan (JMTF) Testing Results

March 2016

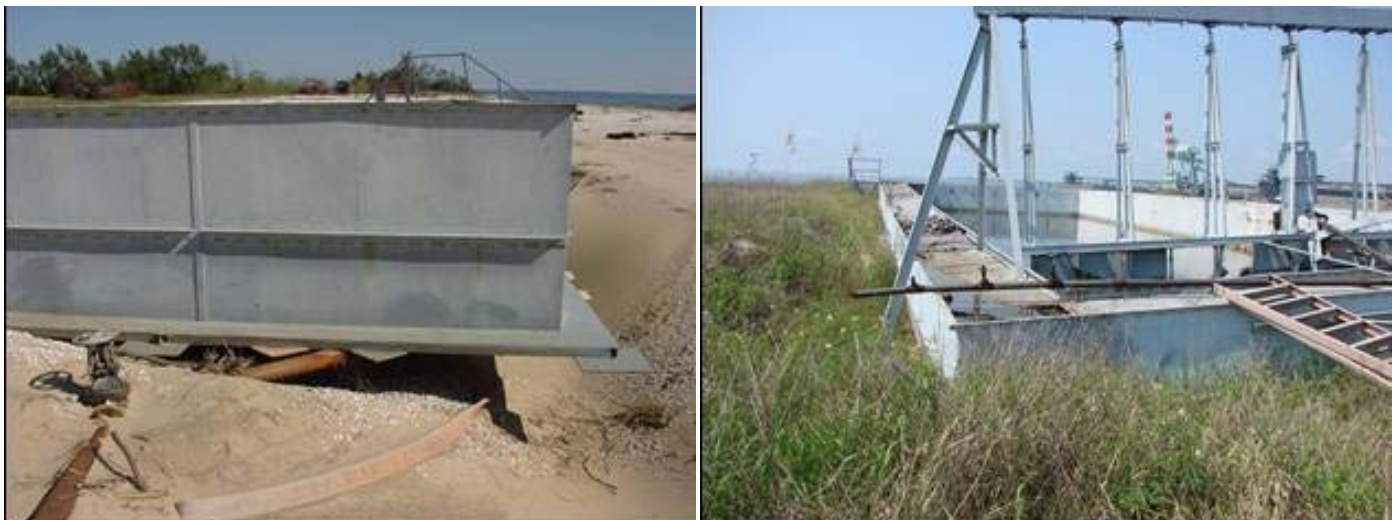
The burn pan was fabricated out of steel and installed in 1998 on Little Sand Island (Figure 2). The outer burn pan is approximately 33.0 m (108 ft) long, 11.6 m (38 ft) wide and 1.5 m (5 ft) deep. The 1.02 m (4 ft) wide trough separates the inner burn wall from the outer wall. The inner burn pan is approximately 30.5 m (100 ft) long, 9.2 m (30 ft) wide and 1.5 m (5 ft) deep. About 4.9 m (16 ft) of the north end of the burn pan is occupied by the wave generator which features a wave paddle suspended by a support structure 4.9 m (16 feet) above the tank floor (seen to the left in Figure 1 and to the right in Figure 2). The top of the trough is covered with deck grating and serves as a walkway around the top of the burn pan (Bitting 1999). Testing in Figure 2 shows a boom constrained from horizontal movement by several stanchions anchored to the bottom of the tank. It was instrumented with temperature and heat flux gauges. The last full test was in 1999. Figure 3 shows damage to the tank from hurricanes that flooded the island in 2005.

Figure 3. Burn pan showing sand removed from base and disconnected pipes (left) and other damage (right).

The ISB burn pan on LSI was re-leveled and repainted; and the surrounding ground cleared to prepare for this test. As mentioned above, the burn pan consists of a pan-in-a-pan design where the inner pan is the actual fire pan and the outer trough is filled with water to provide cooling of the fire pan walls. Figure 4 shows the interior of the refurbished burn pan. There are a number of piping interfaces that were originally installed on the burn pan to provide access for the various subsystems on LSI, such as fuel input and water draining. Since these subsystems were also destroyed by Katrina, the interfaces were sealed off during this test program. However, two new spool pieces were added during this refurbishment on the east side of the burn pan to provide access for the fuel pipe and instrumentation.

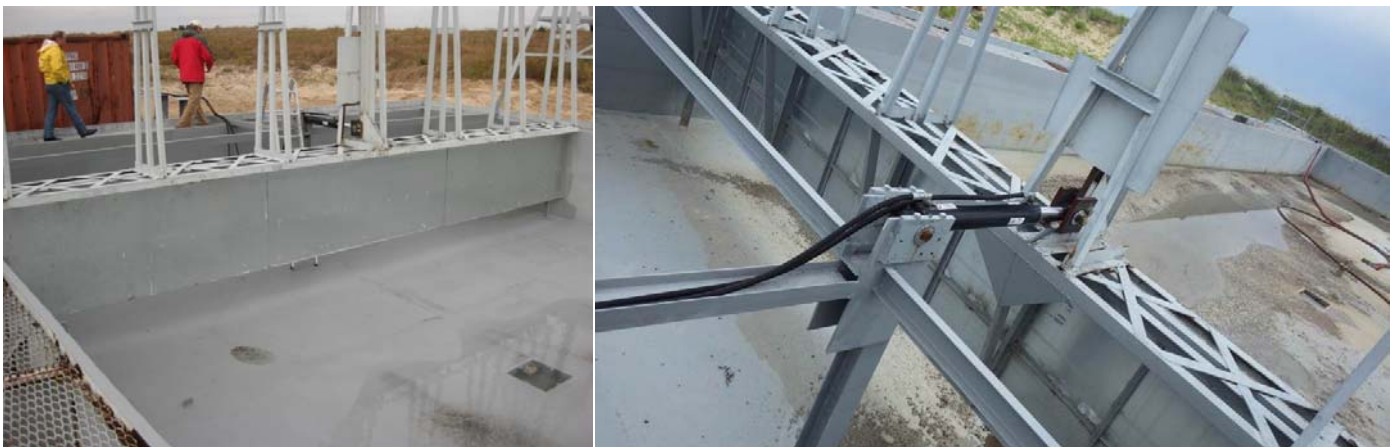
The hydraulic motor and reservoir were destroyed by Katrina and still need to be replaced. The paddle assembly and the hydraulic cylinder are shown in Figure 5. The original intent was to refurbish the wave generator and purchase a new hydraulic supply system for use during the demonstration. However, due to cost constraints, the hydraulic supply system was not purchased and thus the wave generator was not used during this test series.

Figure 5. Views of wave generator.

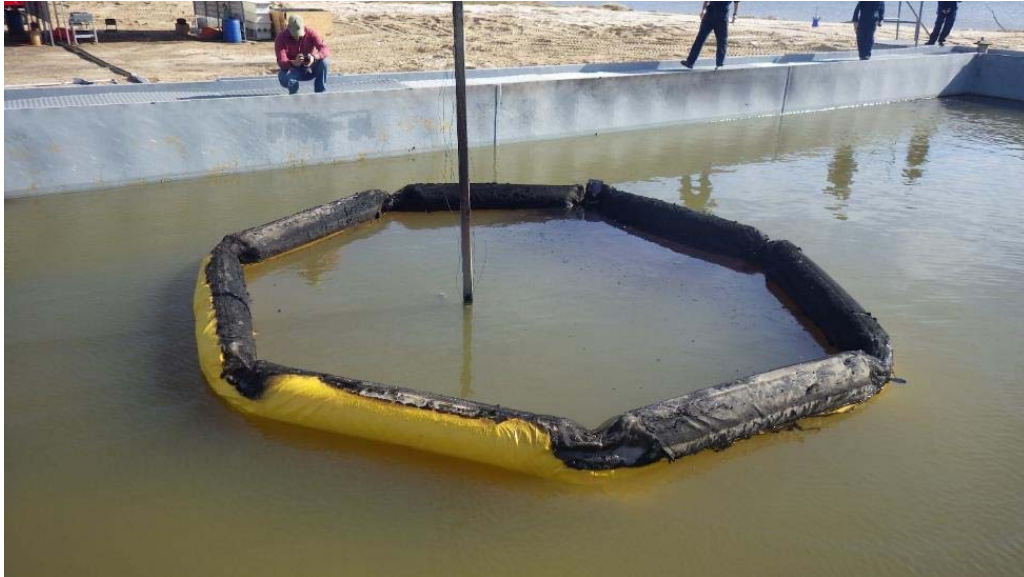
A post-test inspection of the boom revealed that all of the yellow vinyl cover on the south end of the boom had been consumed by the fire leaving only the material below the waterline intact. The north end of the boom experienced less damage with most of the yellow vinyl freeboard on the north side still fairly intact. A photograph showing the boom after the test is provided as Figure 15.

Figure 15. Test 1 - Post-test boom condition.
