Corrosion Control of Central Vehicle Wash Facility Pump Components Using Alternative Alloy Coatings

Final Report on Project F09-AR14

Michael K. McInerney and Robert B. Mason, Jr.

July 2016

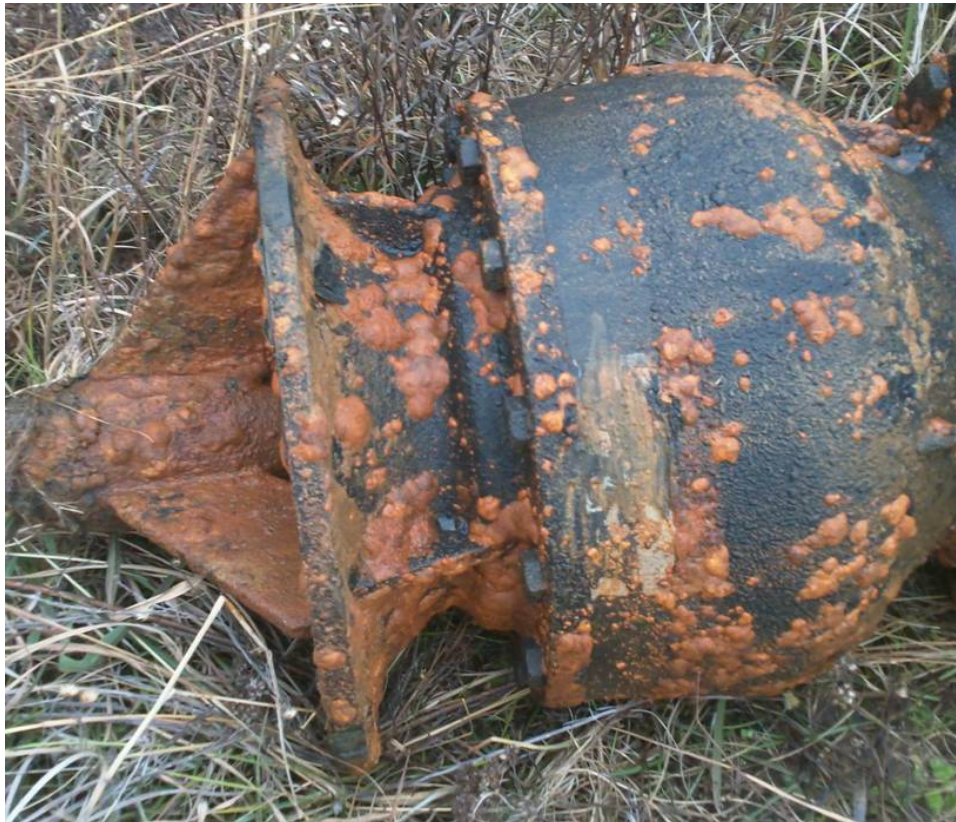
Figure 14. Condition of first state of old Unit 2 pump.

The Unit 2 pump was evaluated first since it was the first to be disconnected and removed. All of the outer pump surfaces were found to be severely corroded. However, the steel was not perforated at any point, indicating that the corrosion was general rather than localized. The condition of the first stage of Unit 2 pump is shown in Figure 14.

Since more than 50% of the outer surfaces of the pump were corroded, all surfaces were given a rating of “0” for both protection and appearance in accordance with ASTM B537. Even the basket at the bottom of the first stage was severely corroded.

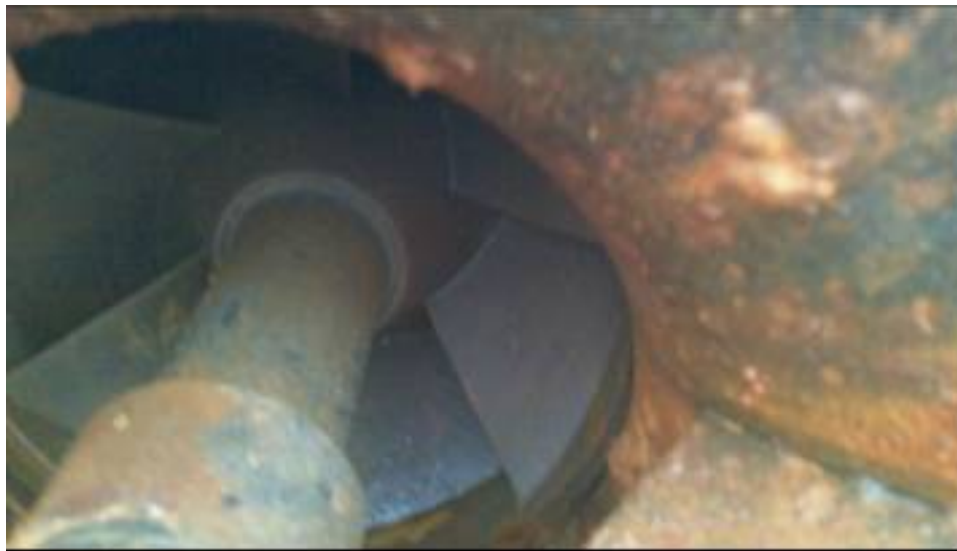
Figure 15. Old Unit 2 pump first-stage impeller.

Despite the corroded appearance of the outer surfaces, the impellers from this pump were found to have minimal corrosion or erosion. Only very minor wear was observed. The condition of the first-stage impeller from this pump is presented in Figure 15.

The condition of the impeller corresponds to a rating of 9 in accordance with ASTM D2809.

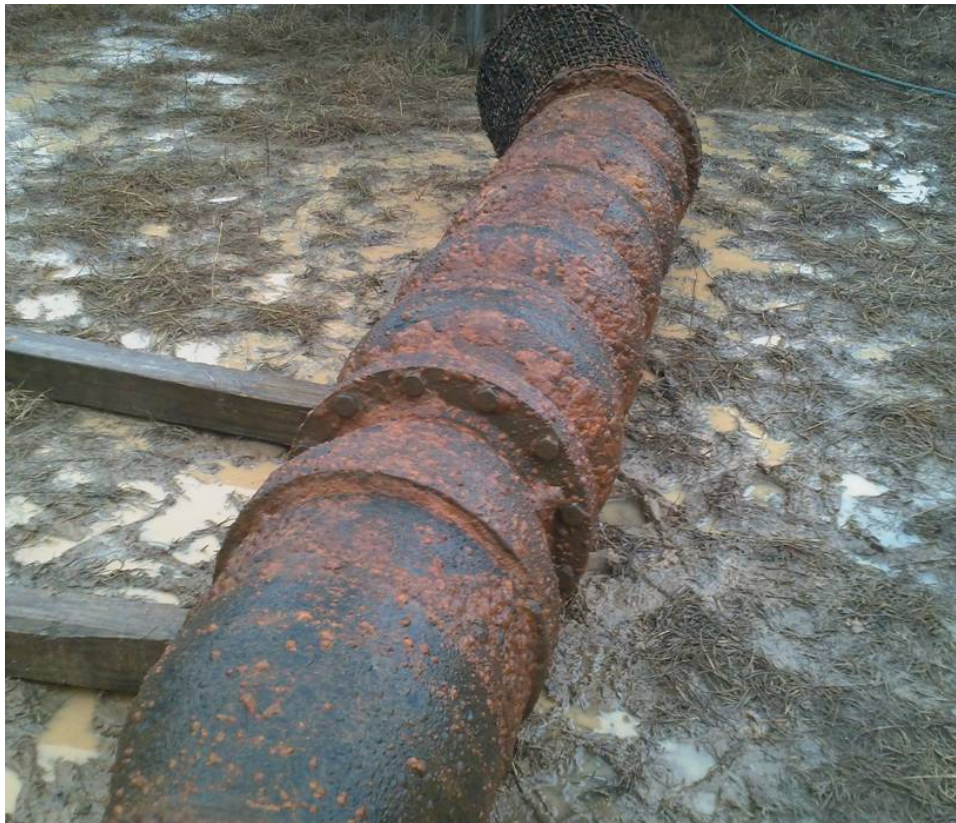
Figure 16. Condition of old Unit 1 pump bowls.

The Unit 1 pump was also found to be severely corroded when removed from the sump. Once again, no perforation of the outer surfaces was observed. The exterior condition of the bowls from the Unit 1 pump is shown in Figure 16.

Since more than 50% of the outer surfaces of the pump were corroded, all surfaces were given a rating of “0” for both protection and appearance in accordance with ASTM B537.

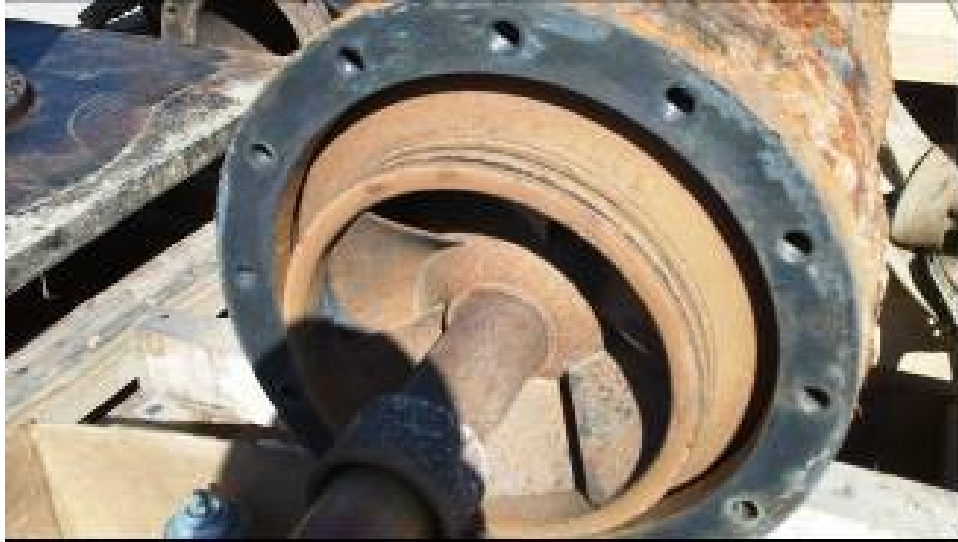
Figure 17. Old Unit 1 first-stage impeller.

The impeller from this pump displayed some evidence of erosion. The condition of the first- and fifth-stage impellers from the old Unit 1 pump is presented in Figure 17 and Figure 18.

The condition of the first-stage impeller corresponds to a rating of 4 in accordance with ASTM D2809.

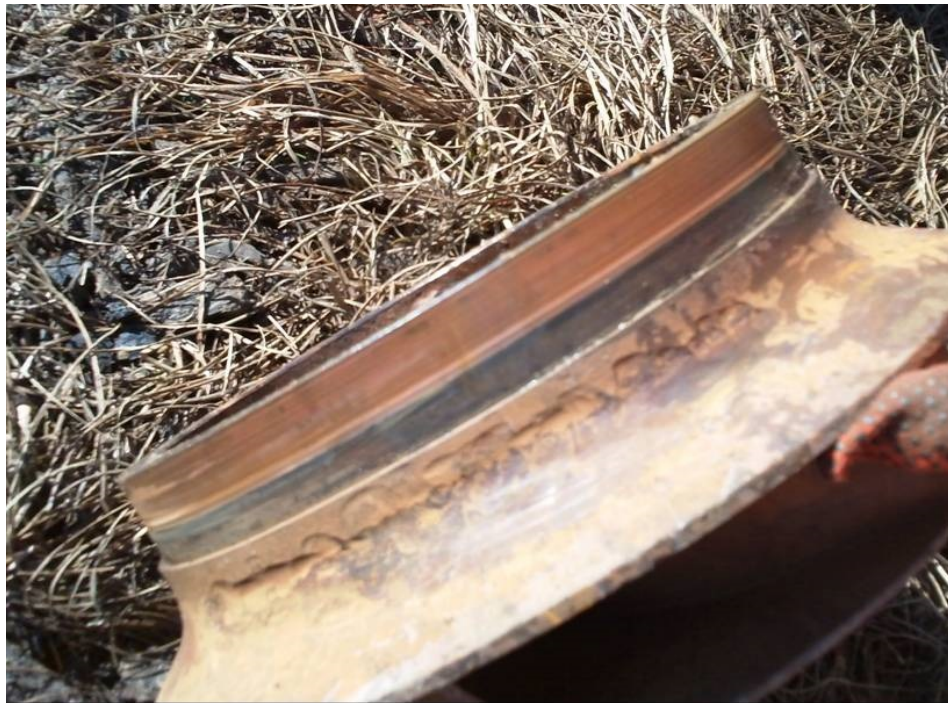
Figure 18. Old Unit 1 fifth-stage impeller.

The old Unit 1 pump was cut to expose the fifth-stage (top) impeller, which showed some signs of erosion and wear. The impeller was removed, and

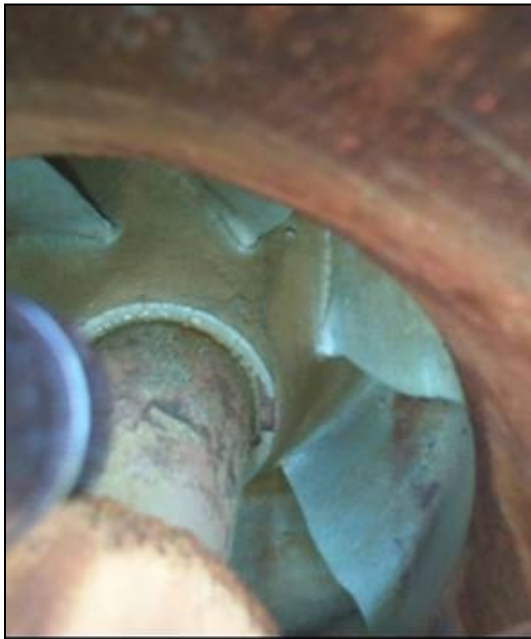
The Unit 1 pump was then disassembled. The first-stage impeller had only minimal corrosion and erosion damage, as shown in Figure 24.

Figure 24. Condition of Unit 1 first-stage impeller, after 15 months of exposure.

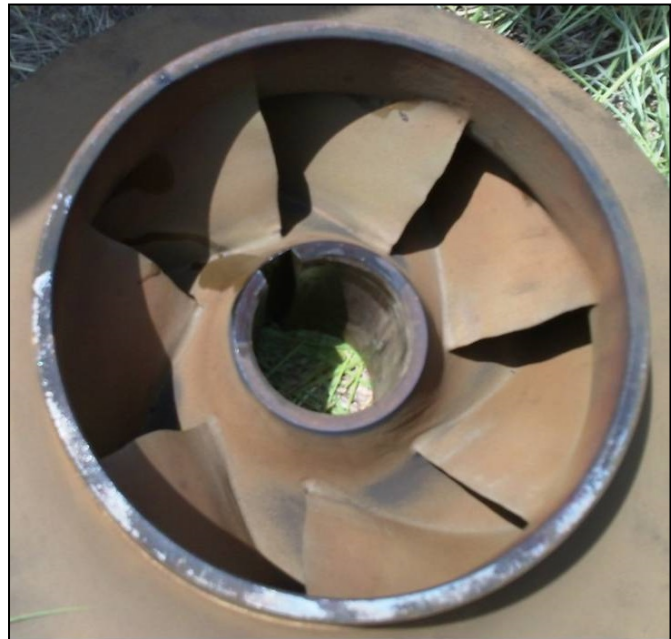
Upon removing the first-stage impeller from the pump bowl, some minor surface corrosion was evident. This corrosion was minimal, and it was easily wiped off. Minor erosion of the fins at the leading edges was noted, as shown in Figure 25.

Figure 25. Condition of Unit 1 first-stage impeller after 15 months of exposure.

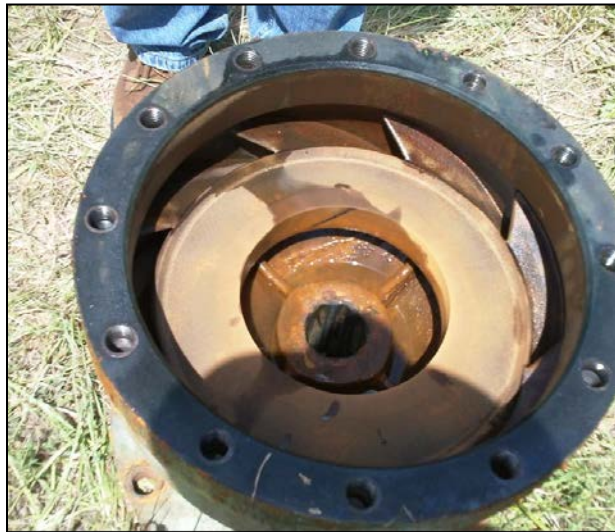
Nearly all of the pump bowl sections had some minor surface corrosion inside, but no wear or erosion damage. The second-stage bowl for Unit 1, after being removed from the pump assembly, is shown in Figure 26.

Figure 26. Condition of Unit 1 second stage pump bowl, after 15 months of exposure.

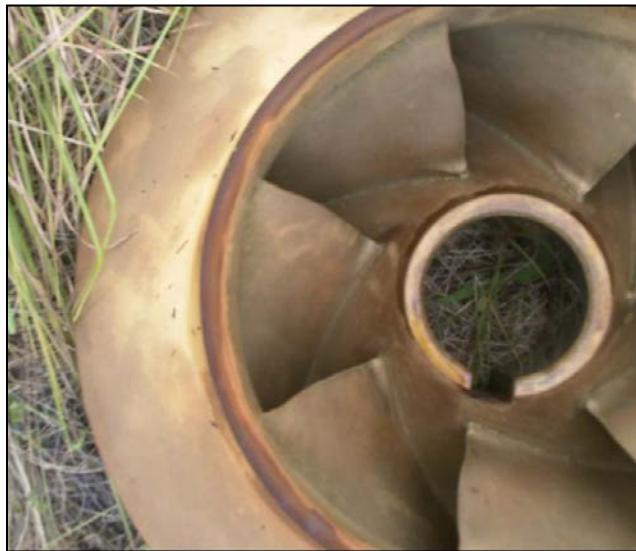
The Unit 2 pump was disassembled and inspected. Like the Unit 1 pump components, the Unit 2 pump components had minor surface corrosion. The corrosion was minimal and easily wiped off. The third-stage impeller exhibited minor uniform corrosion. Upon removing this impeller, very minor wear on the leading edges was noted, as shown in Figure 28.

Figure 28. Condition of Unit 2 third-stage impeller after 15 months of exposure, showing minor wear on leading edges.

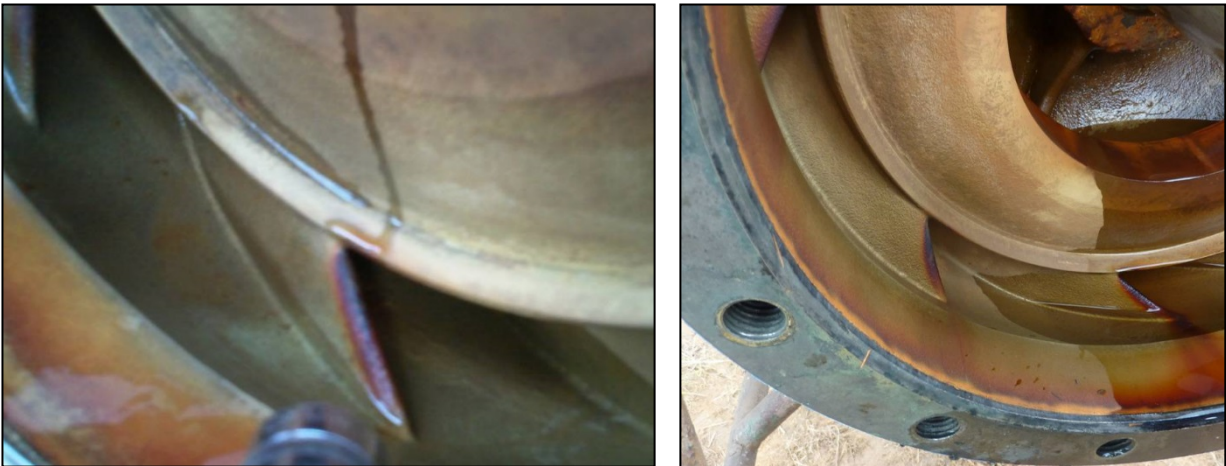
The condition of the Unit 2 pump components (EN coated) was slightly different from the condition of Unit 1 pump components (Stellite coated). In Unit 2, the edges of all bowl vanes showed dark staining, as seen in Figure 29.

Figure 29. Condition of Unit 2 first-stage bowl (left) and second-stage bowl (right) after 15 months of exposure, showing dark stains on vanes.

One hypothesis is that these areas might be surfaces where the thermal spray process did not fully coat the steel. Thermal spray application is inherently a line-of-sight process, and can be difficult to apply uniformly or completely to uneven or partially concealed surfaces. This hypothesis is circumstantially supported by comparison with the EN coating process, which involves full immersion in chemicals and coats all surfaces evenly; no similar dark spots were observed on Unit 1 pump components.

Another possible explanation for the dark spots is iron deposits, caused by sediment that slowly dripped down the submerged pump. It was noted that iron and other sedimentary material were present on all pump components.
