## **Demonstration and Validation of a Lightweight Composite Bridge Deck Technology as an Alternative to Reinforced Concrete**

Final Report on Project F09-AR16

August 2016

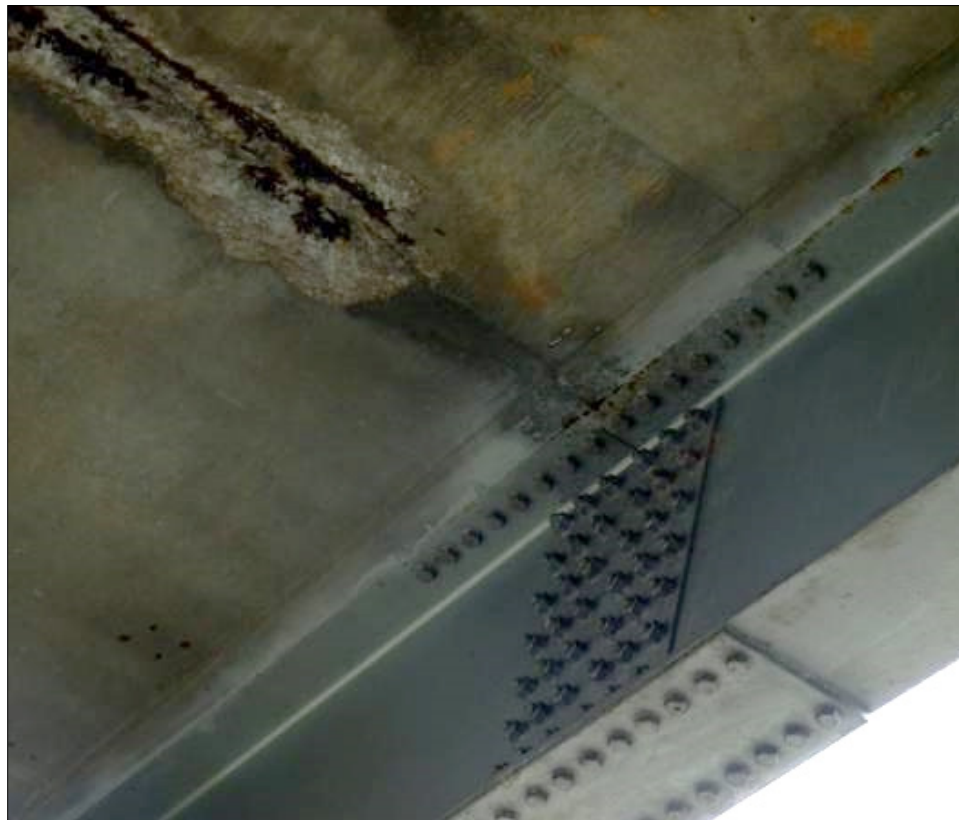
rebar due to cracking and other problems allow salts to attack the steel and cause concrete spalling (Figure 1). The loss of concrete exposes more steel, further accelerating corrosion until the bridge becomes unsafe, and costly repairs are needed. When a deteriorated deck is repaired with an overlay or is rehabilitated using the same materials, the degradation cycle may be slowed but not halted.

Figure 1. Spalling on underside of original Bridge 18 deck.

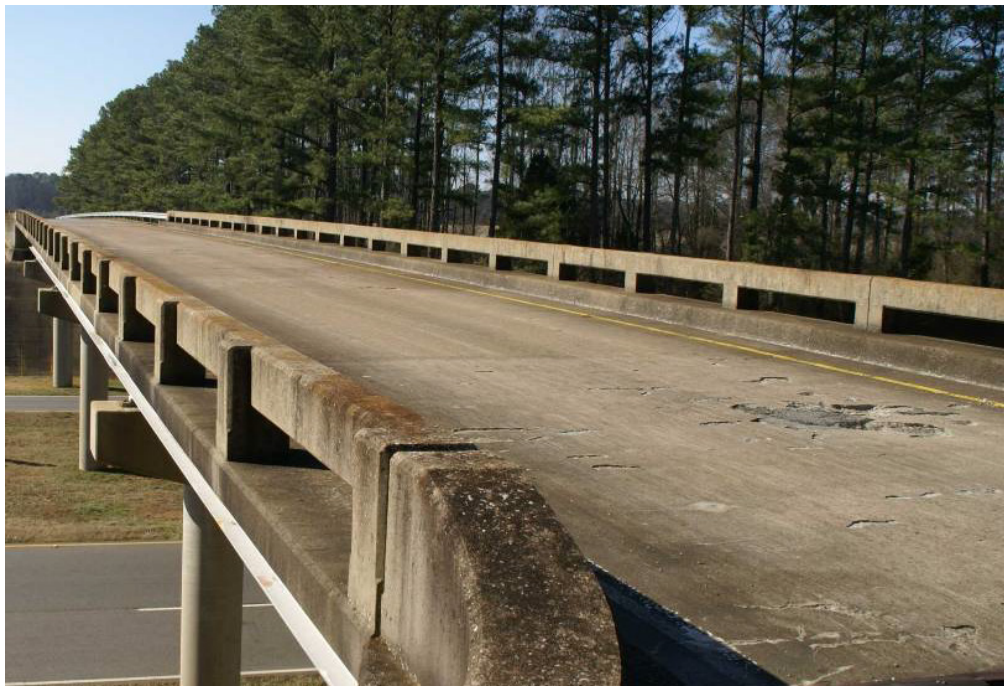
Figure 2. Original Morris Road bridge deck (Bridge 18), showing concrete spalling at right.

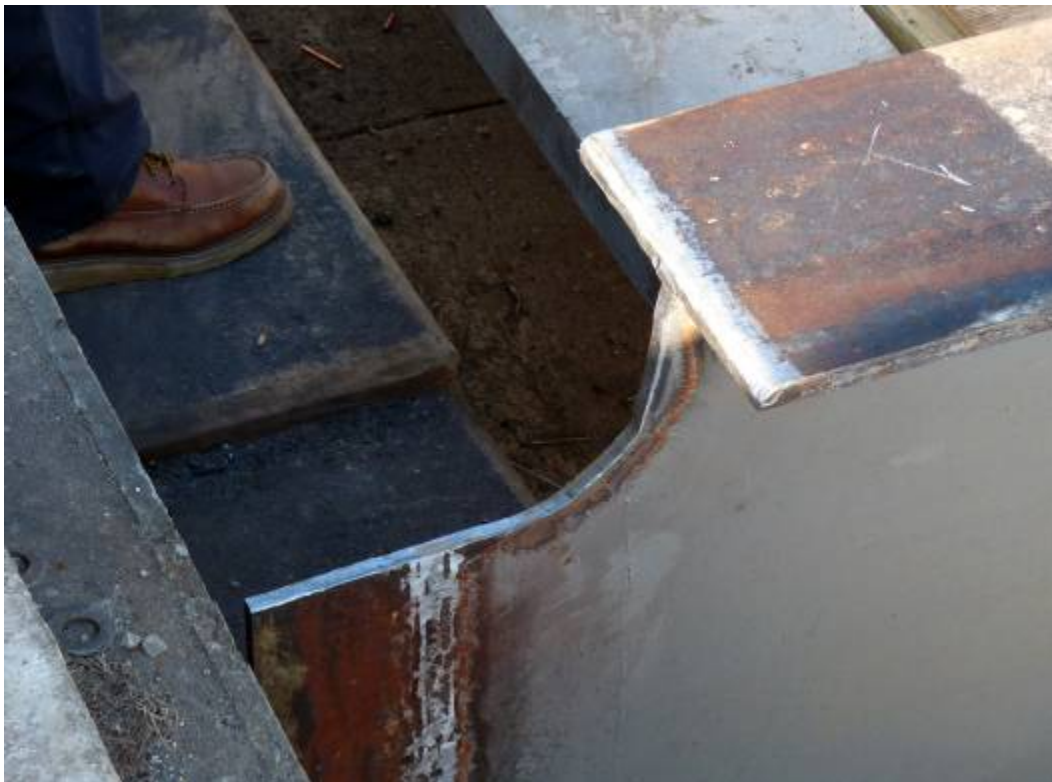
Next the girders were cleaned, inspected and rehabilitated. The inspection revealed that the upper corners of the girder ends needed to be replaced due to extensive corrosion. Figure 10 through Figure 12 show an end of a girder with the section removed, the extent of corrosion damage, and the repaired girder. Also the southeastern-most girder section was replaced in its entirety due to corrosion and impact damage. All girder refurbishment was performed by Redstone Arsenal DPW and was not part of the CPC project.

Figure 10. Girder with corroded section removed.

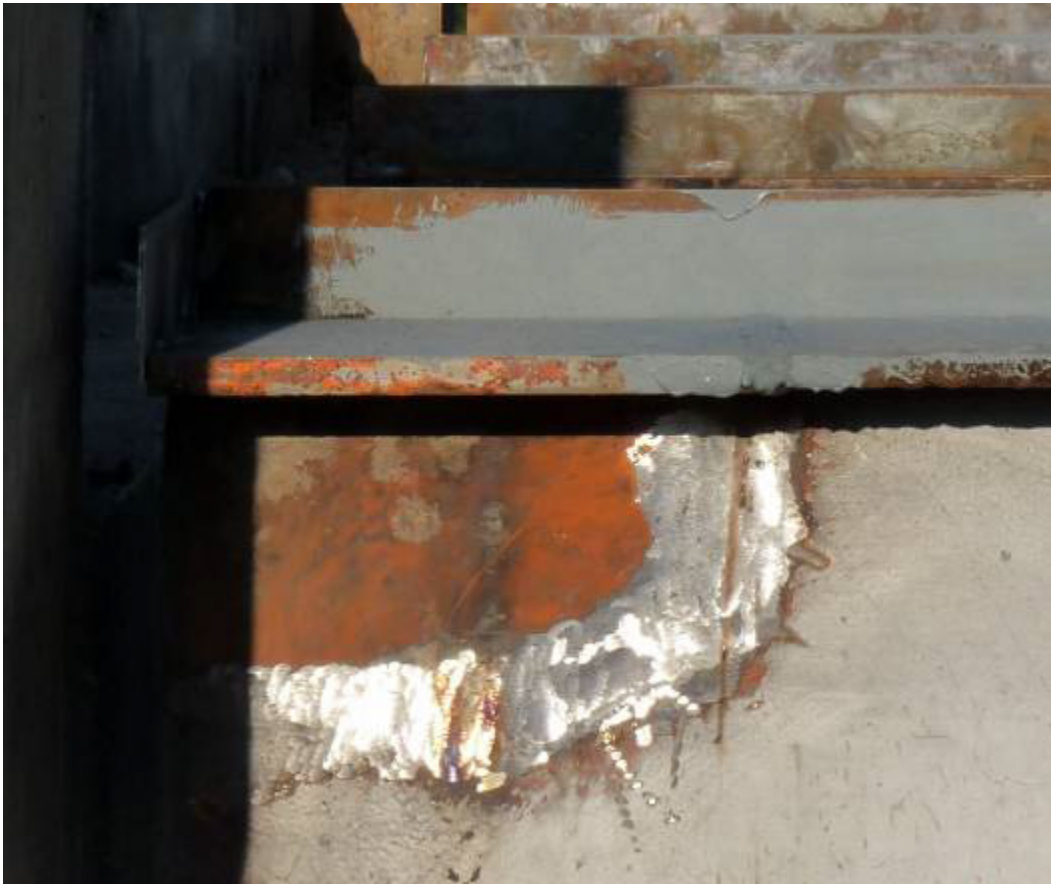
Figure 12. Repaired section of girder shown in Figure 10.

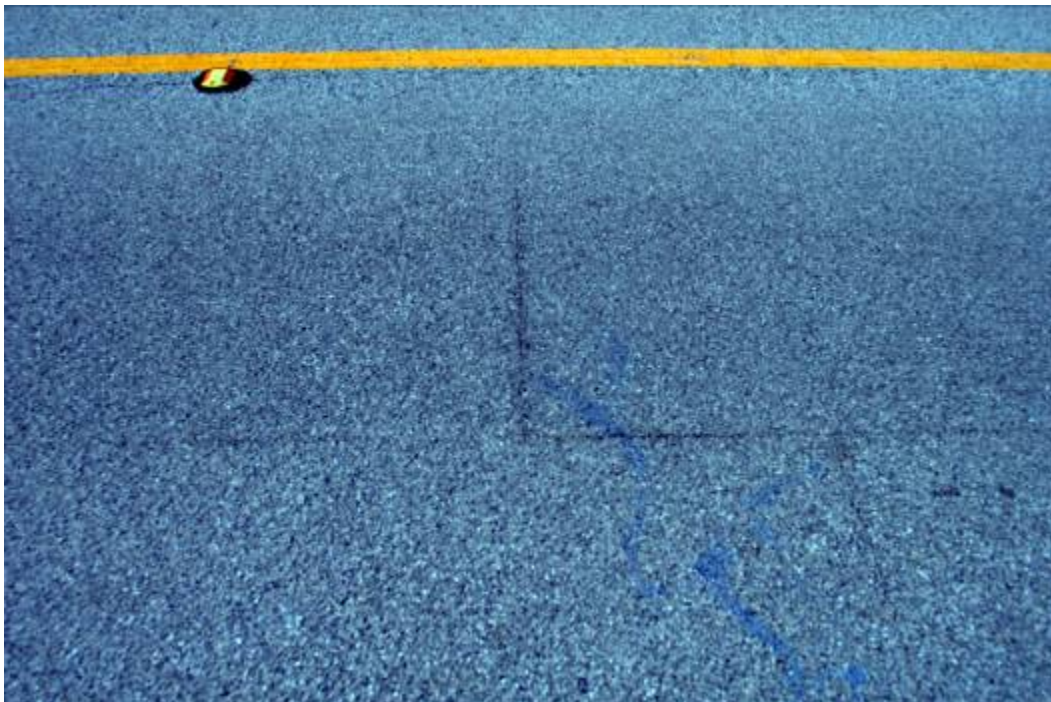
The first problem was that cracks had developed in the wear surface. It quickly became apparent that they were reflective cracks, as their location coincided with the joints between the composite cover sheets over the bridge deck. An example of this cracking is shown in Figure 54, which has been visually enhanced to highlight the cracks.

Figure 54. Wear surface cracks (contrast enhanced).

After these initial repairs to the raised sheets and adjacent wear surfaces were finished, the reflective cracks were repaired. The cracks were cut open to provide a surface to adhere to the sealant. First, a straight cut was made to provide a guide for the second step (Figure 76), which was cutting a v-groove (Figure 77). The completed v-groove is visible in Figure 78. Once the v-groove was cut, the cracks were cleaned of dust and debris using compressed air. Next, a primer (Tremco Vulkem 171) was applied (Figure 79). This material was used at the suggestion of the sealant manufacturer because adhesion testing was not going to be practical for this particular repair, and the GFRP composite-sealant bond is not as common as bonds to other materials. Once the primer cured, the sealant (Tremco THC-901) was applied. The sealant was mixed in accordance with manufacturer's instructions, including the inclusion of a coloring agent to match the wear surface coloring. The sealant was applied with a bulk sealant gun (Figure 80). Before the sealant set, a scraper was used to remove excess material (Figure 81) and to ensure contact between the sealant bead and the top of the wear surface on each side of the joint (Figure 82). The completed repair is shown in Figure 83, and the procedure for the wear surface repair is documented in Appendix B, section B1.

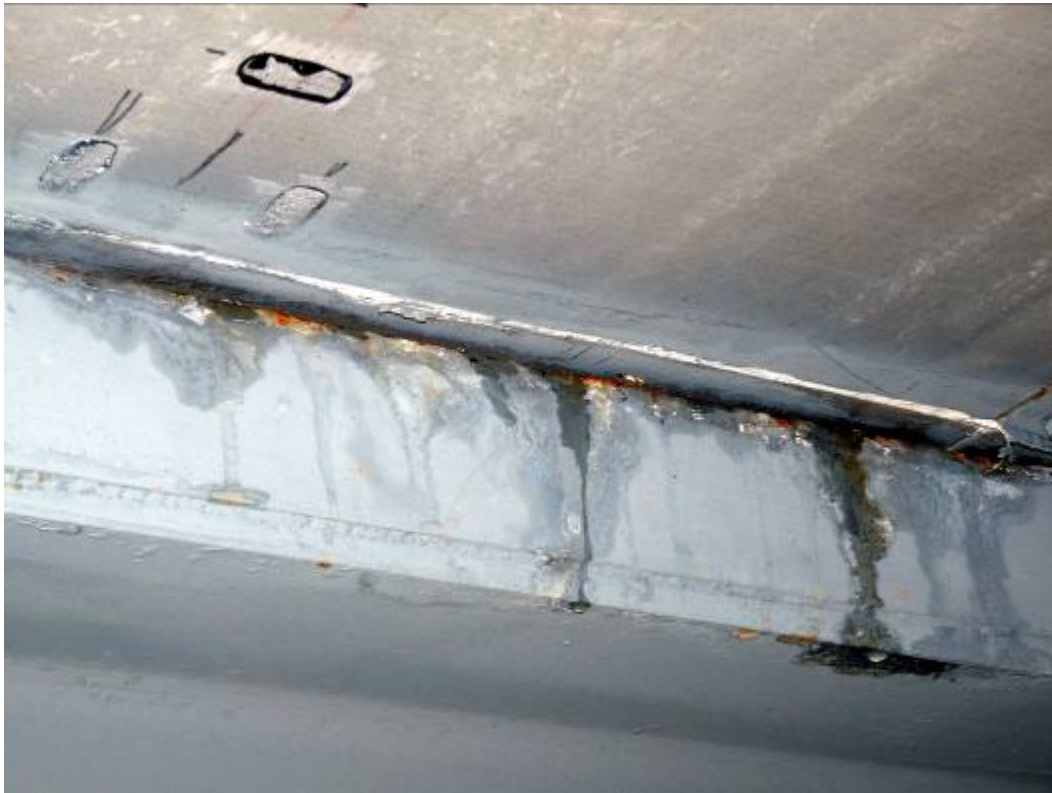
The third reported problem was that moisture was clearly migrating inside the deck panels and collecting on the steel girders. At several locations, water was visibly collecting on the grout forms and girders, then dripping onto the bridge abutment or the road surface. This phenomenon is also visible in Figure 55.

Figure 55. Deck gap over steel and signs of unwanted drainage (contrast enhanced).

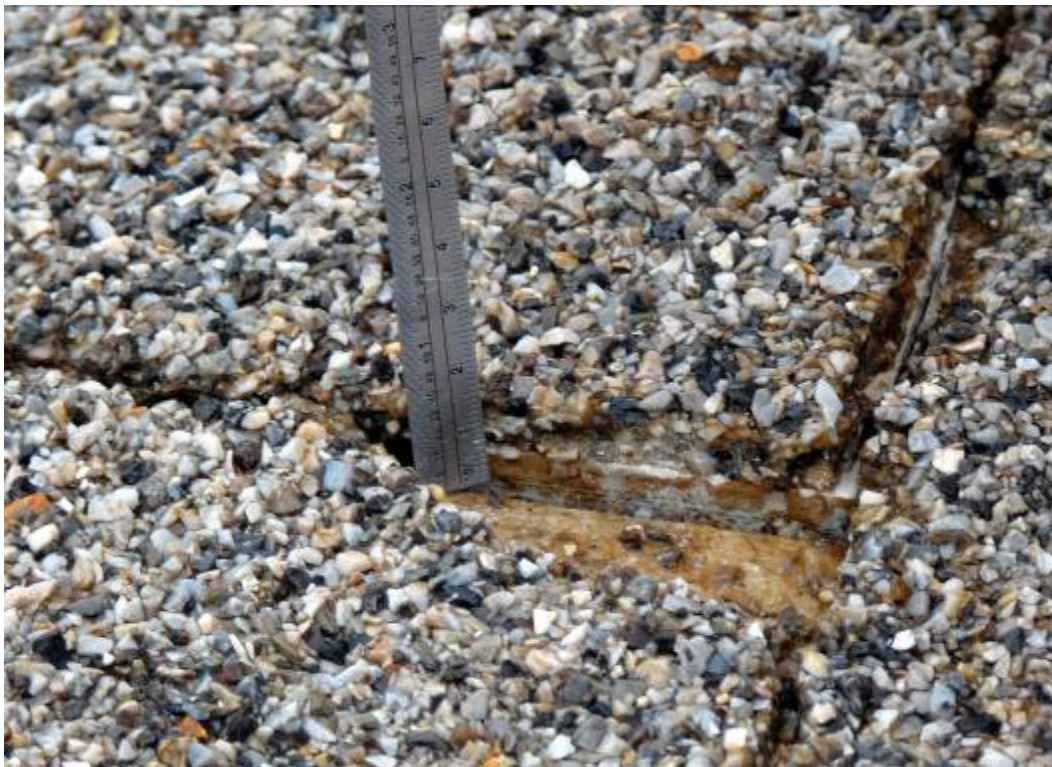
During an inspection in December 2010, MEC noticed two additional issues with the wear surface and deck. First, two of the GFRP composite top sheets had become loose and were no longer flush with the adjacent sheets. Second, the wear surface adjacent to one of the sheets had failed, and the sheet was visible and unprotected. Both problems are shown in Figure 56. The edge of the composite sheet adjacent to the scale is clearly visible in the figure, as is the top surface of the adjacent sheet.

Figure 56. Raised GFRP composite sheet and damaged wear surface.

Repairs to the wear surface and voids began 16 May 2011. First, dirt and other foreign materials were removed from the cracks adjacent to the raised flat composite sheets supporting the wear surface. The wear surface material was then removed to expose the closest fasteners (Figure 69). The exposed fasteners were removed to check whether the threads had damaged the composite material (Figure 70). Although not visible in Figure 70, in all cases the screws had in fact been overtightened, shearing the composite material and contributing to the panel raising. Replacement fasteners were installed adjacent to the original ones, and fasteners were added to help prevent any future panel lifting (Figure 71, Figure 72, and Figure 73). In all instances, replacing the fasteners returned the composite sheets to sit flush with the adjacent ones. Figure 73 shows two locations where extra screws were added before wear surface repair. The same area after the first application of polymer concrete is shown in Figure 74. The completed repair, before full cure, is shown in Figure 75.

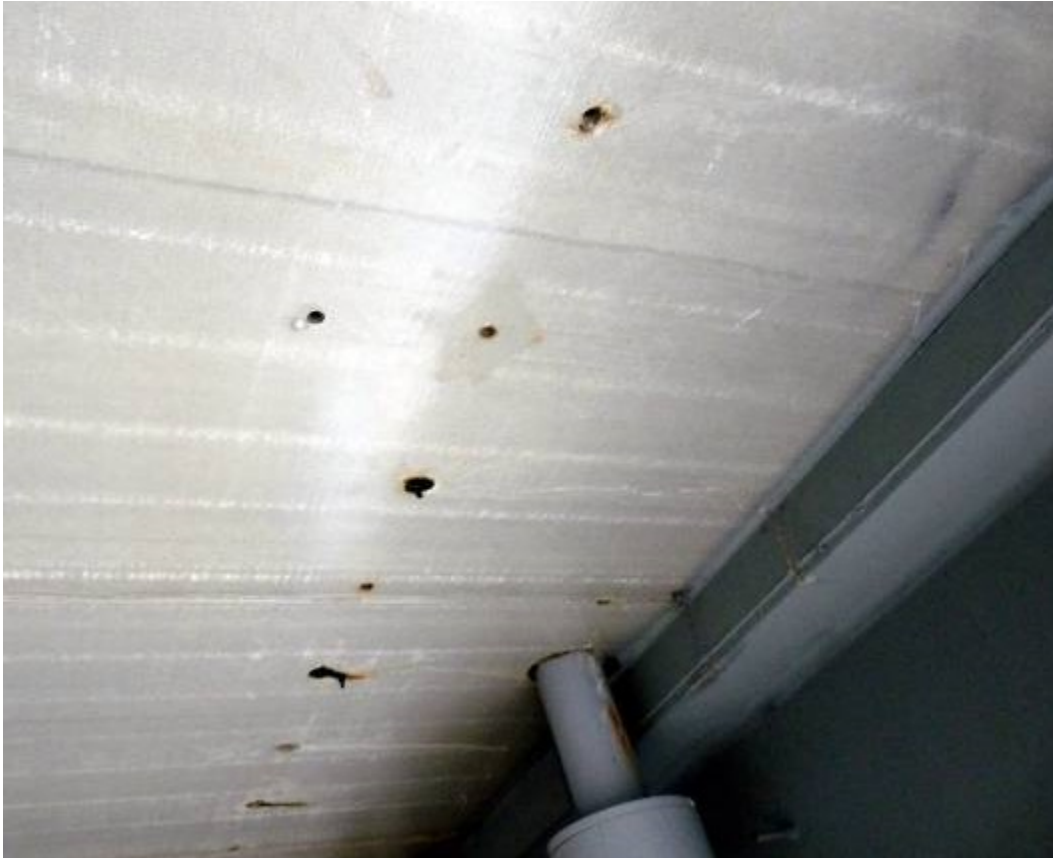
drainage through the half channels was interrupted by the grout pockets that had been created to encase the shear studs. As a consequence, any water that infiltrated the bridge deck “upstream” of these pockets was trapped by design. In addition, several weep holes had become plugged by concrete that escaped the barrier rail form facing the deck interior.

Figure 63. Additional weep hole drilled next to concrete-obstructed hole.

Because of the imminent onset of the winter freeze/thaw cycle in Huntsville, AL, immediate corrective action was undertaken to drill additional weep holes in the bottom of the deck. Overall, approximately 296 additional 0.5 in. diameter weep holes were drilled into the deck. Of those, approximately 90% drained in excess of 2 gallons of retained water (Figure 62). Finally, in locations where concrete was obstructing existing weep holes, MEC drilled replacement holes at higher elevations at 6 in. intervals until an unobstructed weep hole could be established (Figure 63).

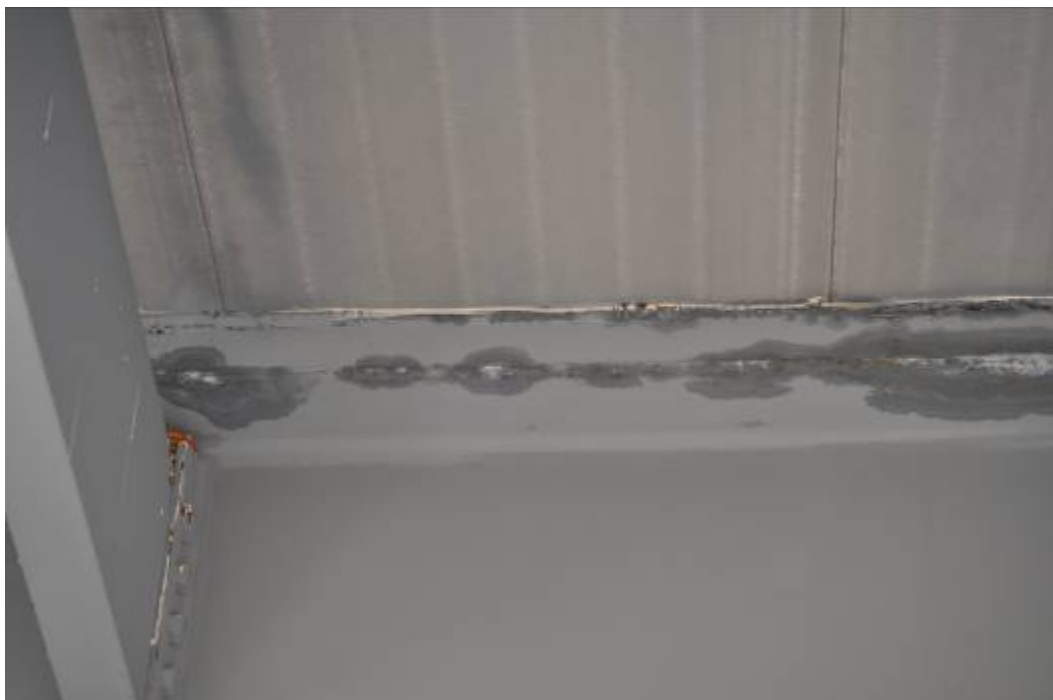
In addition to finding retained water, the inspection confirmed the reflective cracking in the wear surface and the presence of voids in the grout haunch. The inspection also found that a significant amount of water was migrating through the grout haunch, particularly near voids, causing water to accumulate on girders and create corrosive conditions (Figure 64).

Figure 64. Moisture infiltrated through grout onto girder.

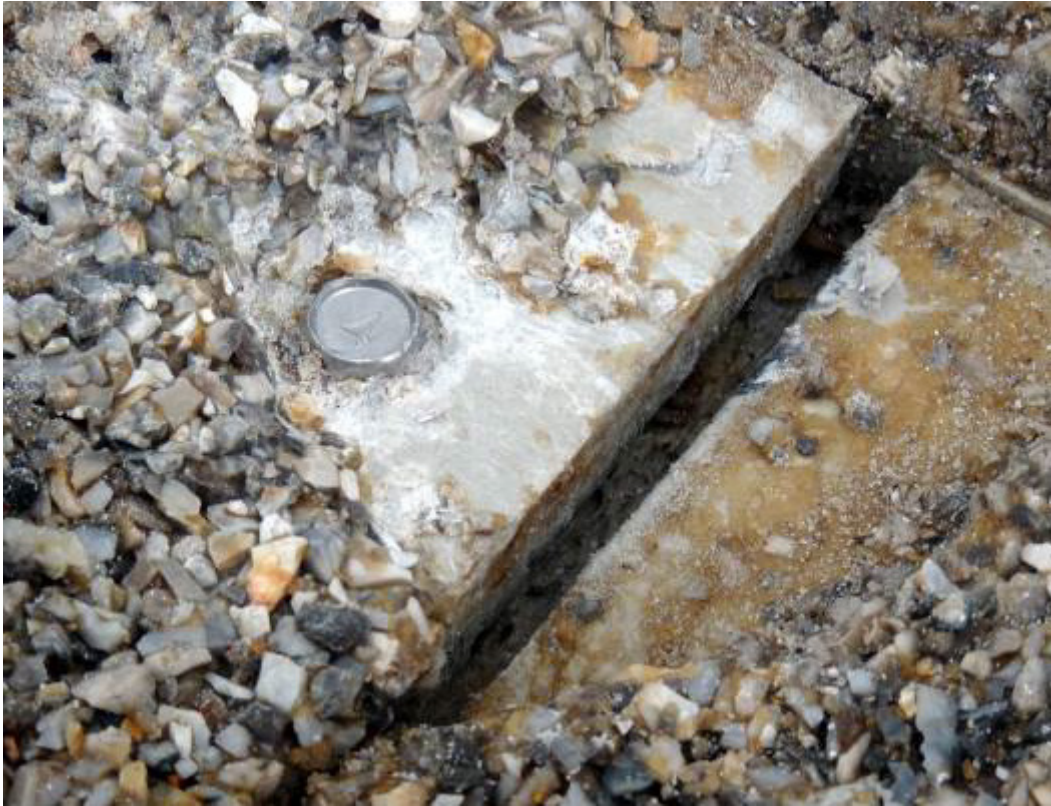
Figure 69. Wear surface hole and gap between GFRP composite sheets.

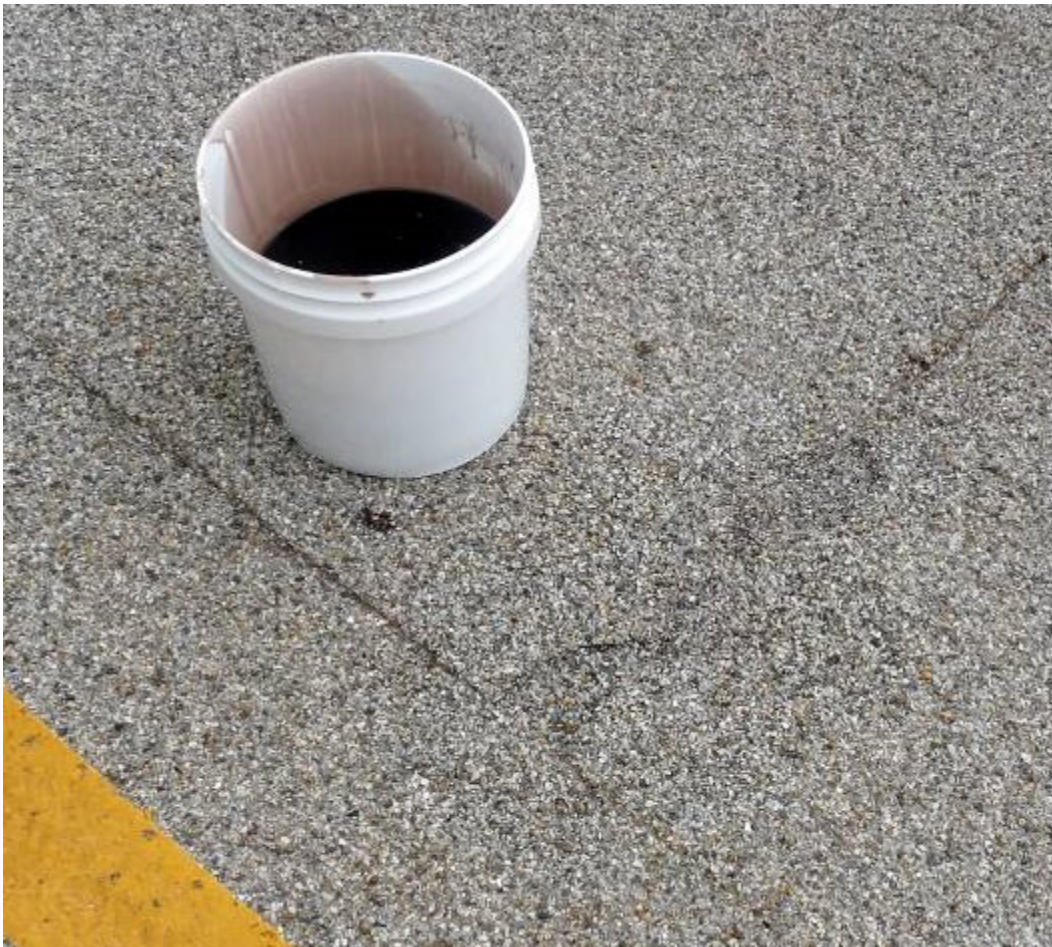
Figure 74. Patched areas of wear surface.

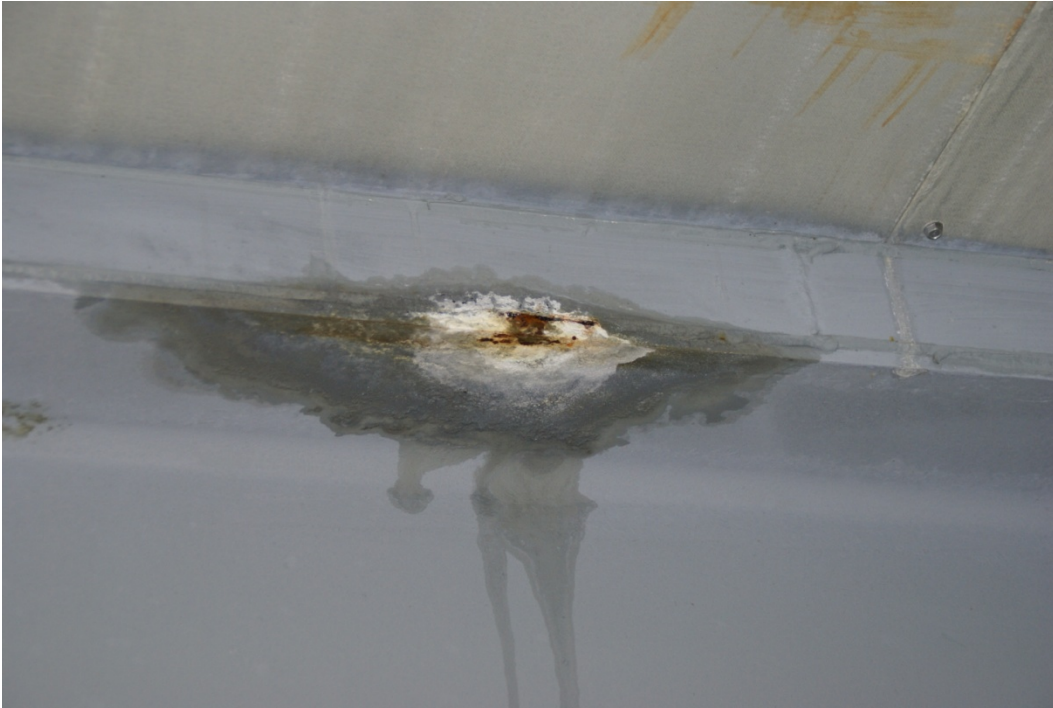
Figure 101. Corrosion on top flange where steel strip attached to form grout haunch.

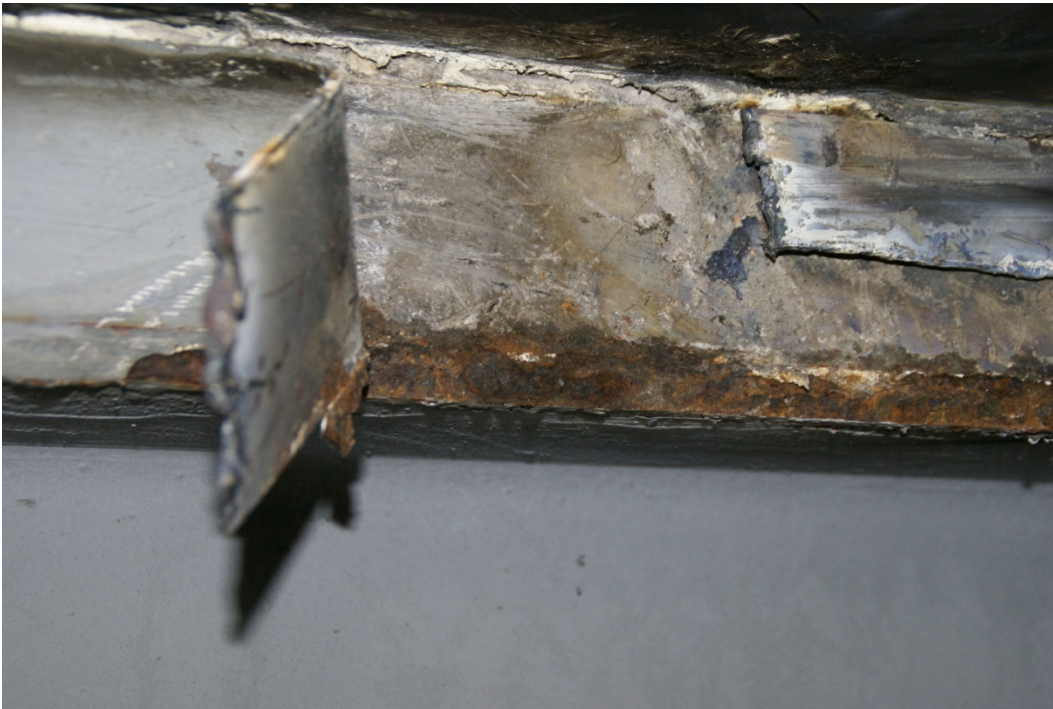
Figure 102. Exposed area after the steel strip peeled back.

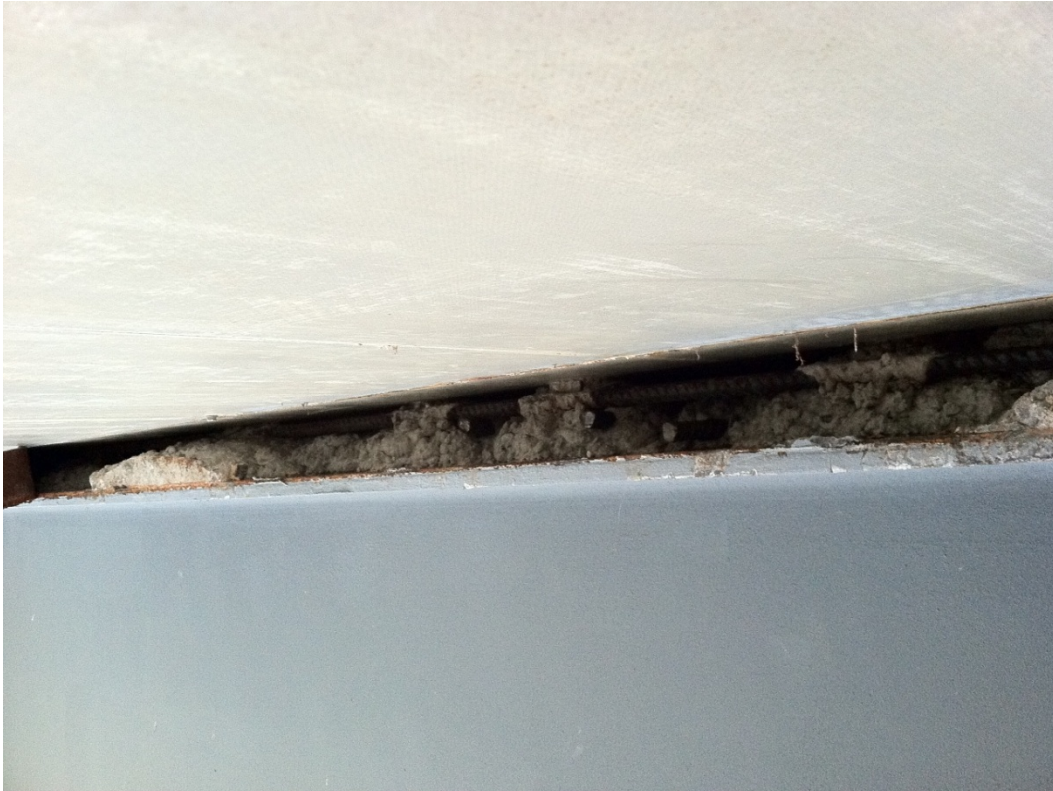
Figure 103. Extensive missing grout revealed after steel strips removed.

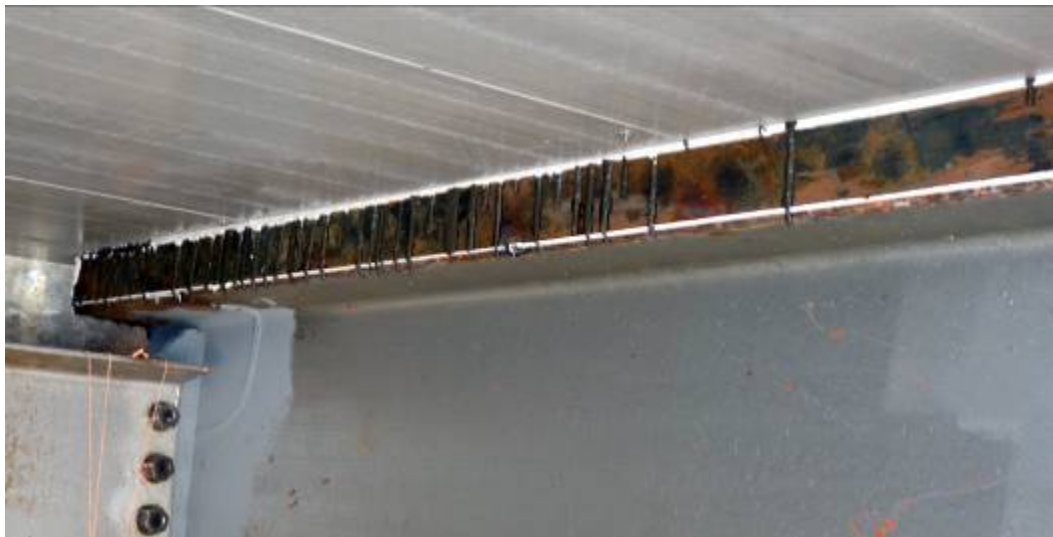
Figure 104. Grout leaking through caulk.

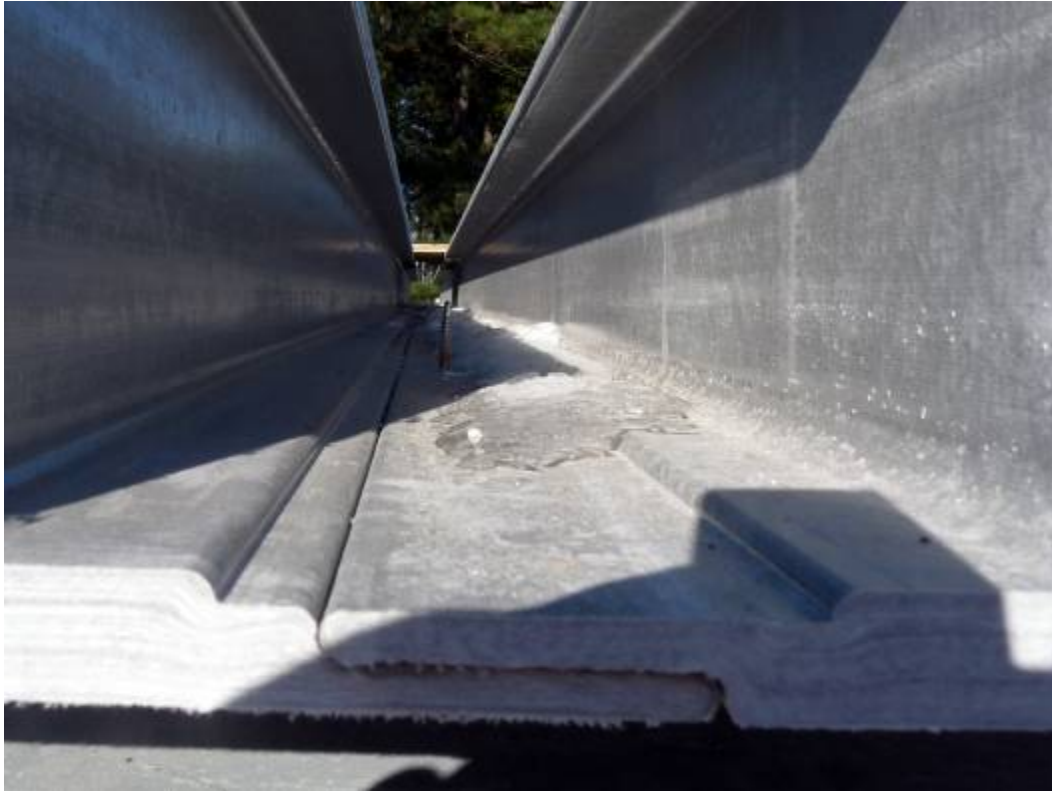
Figure 105. Lap joint showing inverted fastener.
