**AFRL-RQ-WP-TM-2016-0155**

# **OPERATION OF A T63 TURBINE ENGINE USING F24 CONTAMINATED SKYDROL 5 HYDRAULIC FLUID**

**SEPTEMBER 2016**

**Interim Report**

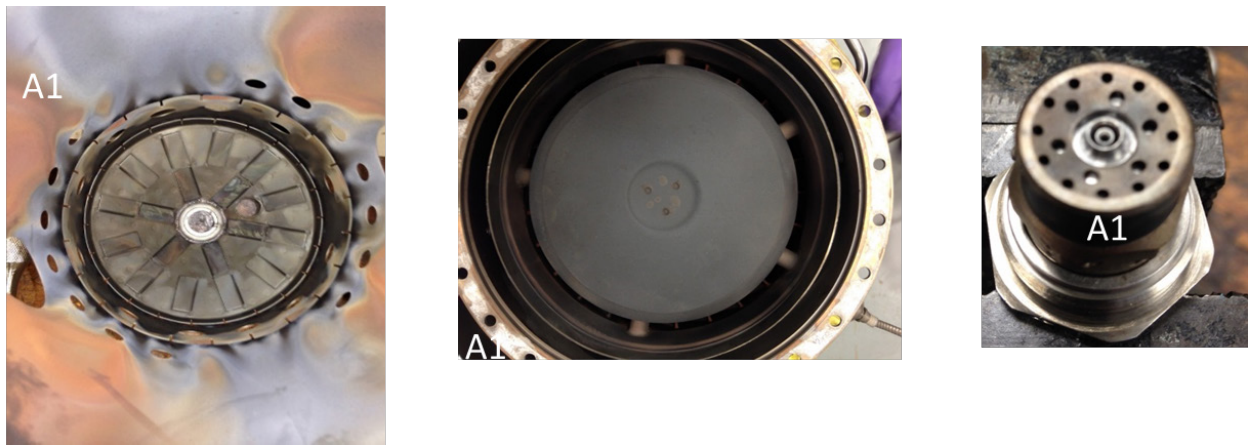
Figure 2. Combustor Liner, First Stage Heat Shield and Fuel Nozzle Prior to Operation of T63 Engine

The engine was reassembled with a plastic media blasted clean combustor liner, first stage heat shield, and ultrasonically cleaned fuel nozzle depicted in Figure 2. The inspection included photo documentation of the first stage nozzle and #1 turbine condition from the rear of the engine with the combustion liner removed shown in Figure 3. Additional inspections of the second stage nozzle, #2 turbine, and third stage nozzle were carried out by removing combustor thermocouple and using a borescope depicted in Figures 4 and 5. The #4 turbine and fourth stage nozzle were accessed through the exhaust ports of the engine with the borescope Figures 4 and 5. SEM results indicated the first stage nozzle was comprised of 49.2% (wt.) cobalt.

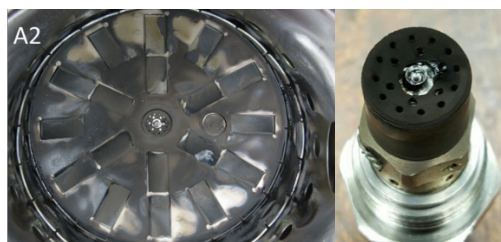
Figure 6. Combustor Liner and Fuel Nozzle after 5 Hours of Operation Using a 5% Skydrol/F-24 Fuel

The engine was removed from the EERF and transferred to the build room for post operation disassembly and inspection. The combustion liner and fuel nozzle were removed and photographed in Figure 6. The first stage heat shield indicated no visible change after operating on the 5% Skydrol/F-24 fuel.

Carbon deposits were apparent on the inner air baffles at the 1 and 4 o'clock position on either side of the ignitor. These type of deposits are not unusual and have been documented on occasions when operating on F-24 fuel during additive testing. SEM results indicated the deposits consist of predominately carbon see Figure 7. The combustor liner was uncharacteristically coated with carbon soot black streaking down the sides of the liner. The fuel nozzle also exhibited an unusual carbon like build up in the 3 o'clock position which coincided with position of the ignitor used for starting the engine.

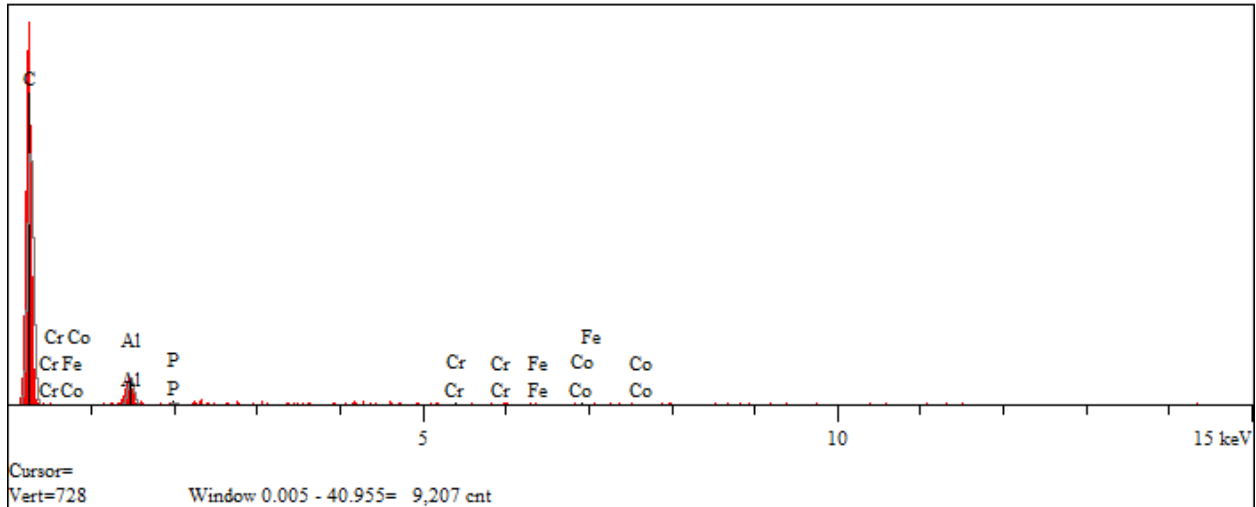
Figure 7. Carbon Deposit SEM Results

Elt.	Line	Intensity (c/s)	Conc	Units	Error 2-sig	MDL 3-sig	
C	Ka	43.30	96.473	wt.%	2.996	0.940	
Al	Ka	5.07	3.252	wt.%	0.394	0.410	
P	Ka	0.49	0.275	wt.%	0.273	0.400	
			100.000	wt.%			Total

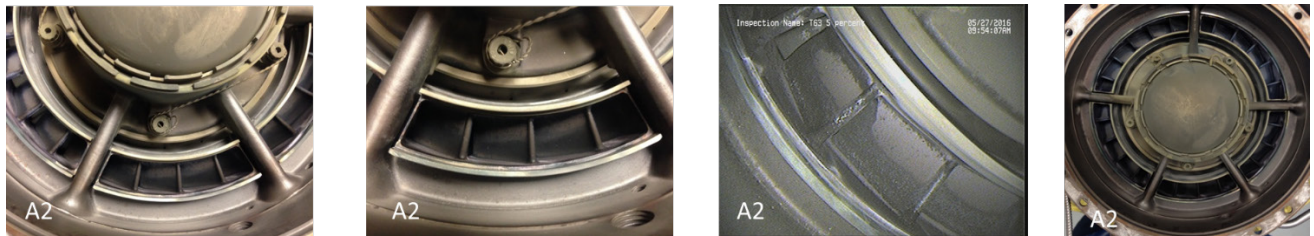
Figure 9. First Stage Nozzle Condition after Engine Operation on 5% Skydrol Contaminated Fuel

Additional inspection included the same areas of the turbine section examined prior to operation on the 5% Skydrol/F-24 fuel mixture. The first stage nozzle condition is presented in Figure 9 exhibiting a purplish shade on the surface of the nozzle. No cracks were discovered in the first stage nozzle during the inspection.

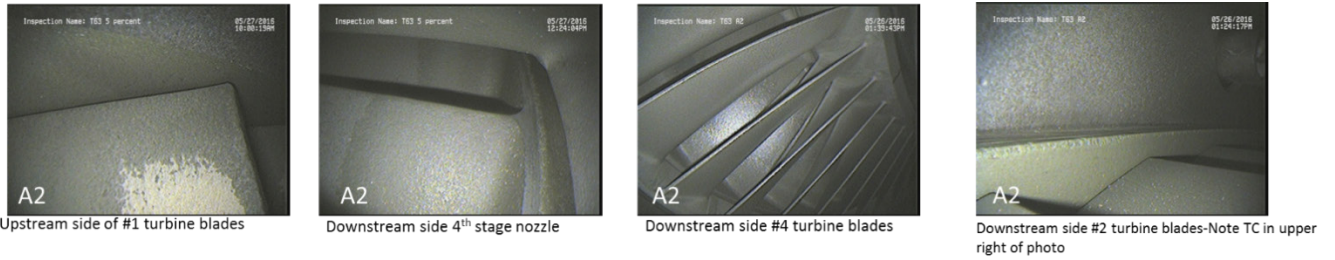
Figure 10. Turbine Section Component Borescope Photos after 5 Hours Operation Using 5% Skydrol/F-24

The turbine assembly inspection continued with the removal of the T5 thermocouple located in between the #2 turbine and the third stage nozzle (see Figure 1). The T5 temperature is used for combustion temperature measurement to meter fuel flow. This temperature is critical so as not to overheat the combustion section beyond the operation limits of the alloys used in the turbine section components. The condition of the #1 turbine, the fourth stage nozzle, #4 turbine, and #2 turbine are represented in Figure 9. Slight purplish discoloration is present on the surfaces. The turbine and nozzles indicate no major loss of blade/nozzle material. The condition of the #3 turbine and nozzle are revealed in Figure 10 and exhibit similar conditions as described for Figure 9.

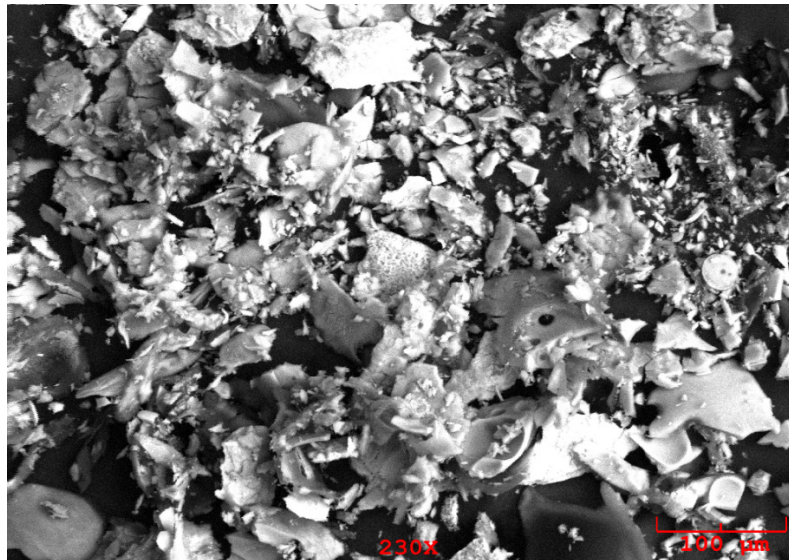
Figure 12. Soot Deposition Sample of 5% Skydrol/F-24 Scraped From Combustor Liner

Elt.	Line	Intensity (c/s)	Conc	Units	Error 2-sig	MDL 3-sig	
Al	Ka	0.71	1.250	wt.%	0.954	1.387	
P	Ka	41.42	51.517	wt.%	1.764	1.134	
Cr	Ka	3.26	4.312	wt.%	0.835	1.049	
Fe	Ka	13.41	22.280	wt.%	1.502	1.348	
Co	Ka	3.16	6.040	wt.%	1.165	1.449	
Ni	Ka	6.61	14.602	wt.%	1.509	1.521	
			100.000	wt.%			Total

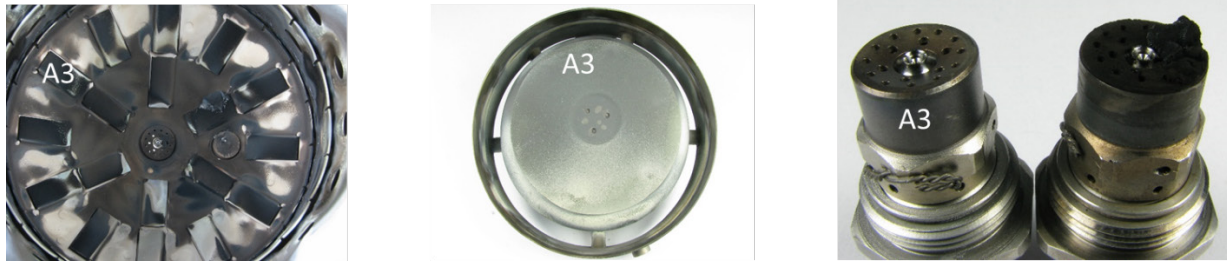
Figure 15. Combustion Liner, First Stage Heat Shield, and Fuel Nozzle after 25 Hours of Operation Using a 1% Skydrol 5 with F-24 for Fuel

The engine was removed from the EERF and transferred to the build room for post operation inspection. The combustion liner, first stage heat shield and fuel nozzle were removed and photographed. The results are revealed in Figure 15. The combustor liner results provided a carbon deposit as seen with previous operation in the 2 o'clock position on the air baffle directly above the ignitor. The first stage heat shield yielded a distinct color with a greenish hue and the fuel nozzle displayed a much larger carbon like deposit as seen operating with the 5% Skydrol 5 fuel in the same 3 o'clock position.

*(Note: The fuel nozzle on the left depicts a clean nozzle for contrast to the 25 hour contaminated fuel nozzle on the right.)*

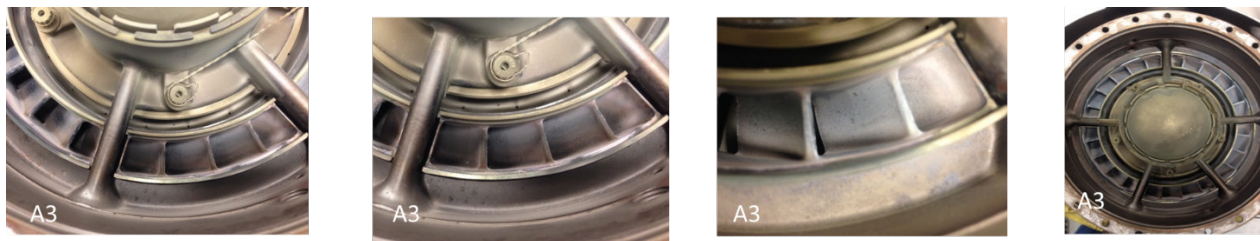
Figure 16. First Stage Nozzle after Operating on 1% Skydrol 5 with F-24 for Fuel for 25 hours

The inspection continued with the examination of the first stage nozzle condition after the removal of the combustor liner and first stage heat shield. The condition of the first stage nozzle can be observed in Figure 11. The first stage nozzle did not exhibit any cracks and the number eight bearing cover remained a shade of green as seen earlier when operated on the 5% Skydrol concentration fuel. Upon closer examination of the first stage nozzle a color change was observed resulting in a pinkish purple hue coating the nozzle surface with washed out white patches. The washed out areas were also observed as seen in Figure 17 when inspecting the turbine section surfaces with a borescope through the thermocouple mounting port and behind the first stage nozzle on the #1 turbine. These surface color changes continued through the rest of the turbine section inspection observed in Figure 18
