INSPECTOR GENERAL

SEPTEMBER 30, 2016

Military Housing Inspection - Camp Buehring, Kuwait

SUBJECT: Military Housing Inspection - Camp Buehring, Kuwait (Report No. DODIG-2016-139)

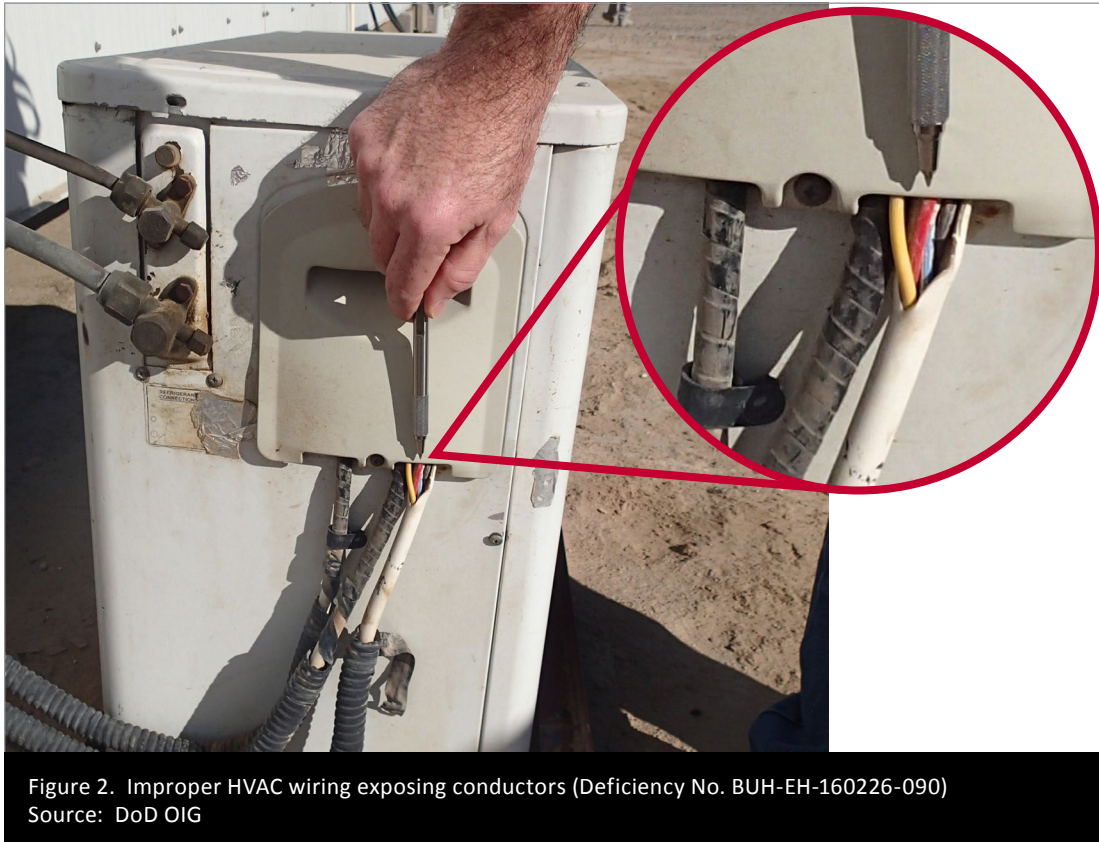
We found that electrical equipment installation and maintenance at Camp Buehring had not been performed in a manner consistent with the National Electrical Code (NEC). We identified 34 instances of improper attachment of electrical wires to heating ventilation and air conditioning (HVAC) units and outdoor lighting fixtures. These wires are required to have sheathing or flexible conduit secured

inside the HVAC unit or electrical box. The improper attachment of these wires exposes live conductors to the elements and increases potential for damage to insulation (Figure 2). This increases the risk of electrical shock or electrocution.

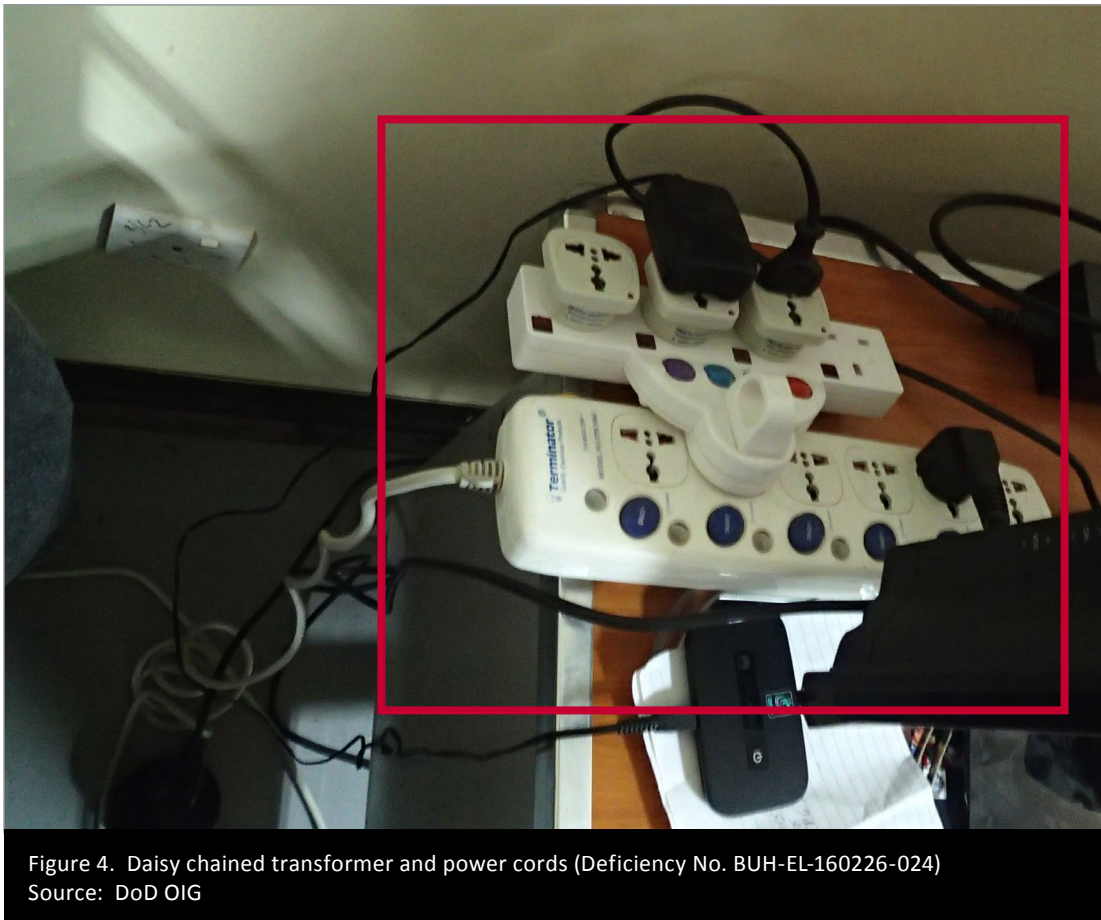
Tenants engaged in unsafe practices with electrical cords and electrical devices. We found 13 examples where tenants in housing and administrative areas daisy chained power cords and transformers (Figure 4). Daisy chaining electrical power strips together can result in overloaded and overheated power cables increasing the risk of fire. Tenants used transformers that were not approved by a recognized safety laboratory, such as UL or Conformité Européenne. Tenants connected American-style power cords approved for 125 volts to British-style 220-volt receptacles, making it easy to exceed the approved power rating of an extension cord or appliance. Also, heat-generating appliances, such as coffee makers and microwave ovens, were often found in sleeping quarters. The use of unapproved electrical devices or devices not used in accordance with their approved design are at a higher risk for malfunction resulting in shock, fire, or electrocution.

Figure 4. Daisy chained transformer and power cords (Deficiency No. BUH-EL-160226-024)
Source: DoD OIG

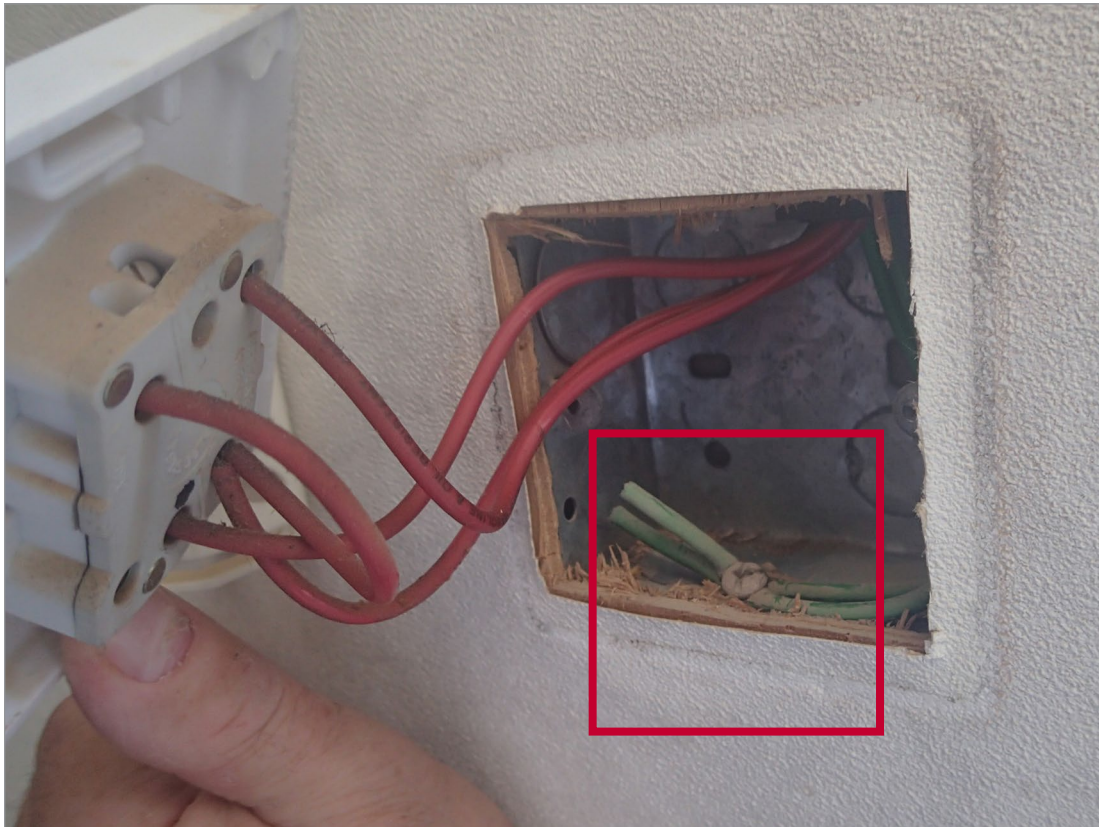
For grounding and bonding deficiencies, we found eight light switches and outlet receptacles in the trailers without proper equipment grounding. Also, light switches in the trailer park-style housing were improperly grounded due to a manufacturing defect. Instead of the wires being properly wrapped around the screw, or an appropriate wire termination lug applied, the ground wires were simply connected to the metal box by a sheet metal screw driven through the insulated ground wire conductors (Figure 5). This unapproved method fails to guarantee a secure ground and can leave a receptacle without proper equipment grounding, thereby increasing the risk of shock or fire.

Figure 5. Improperly grounded light switch (Deficiency No. BUH-EL-160226-056)
Source: DoD OIG

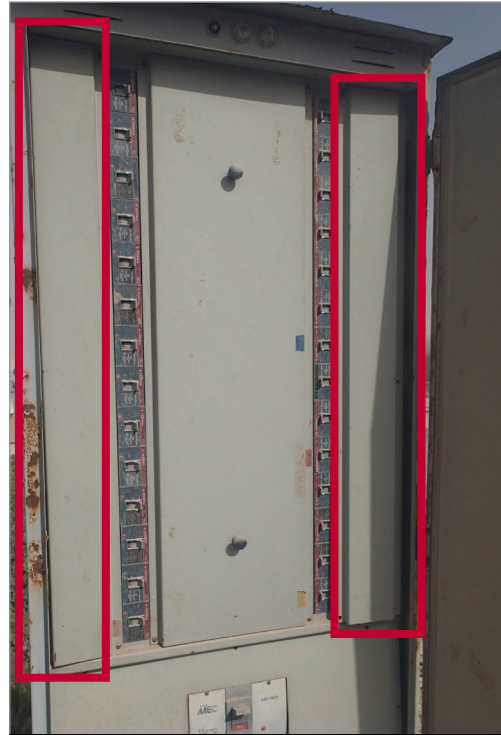
For equipment accessibility and labeling, we found blocked access to electrical panels and 11 instances where electrical panels were not properly labeled identifying the facility to which it supplied power. These panels were also missing proper labeling describing the function of their individual circuits (Figure 6). This lack of information presents a shock or electrocution hazard in an emergency situation where a circuit may need to be de-energized.

Figure 6. Unlabeled electrical distribution panel (Deficiency No. BUH-EL-160226-054)
Source: DoD OIG

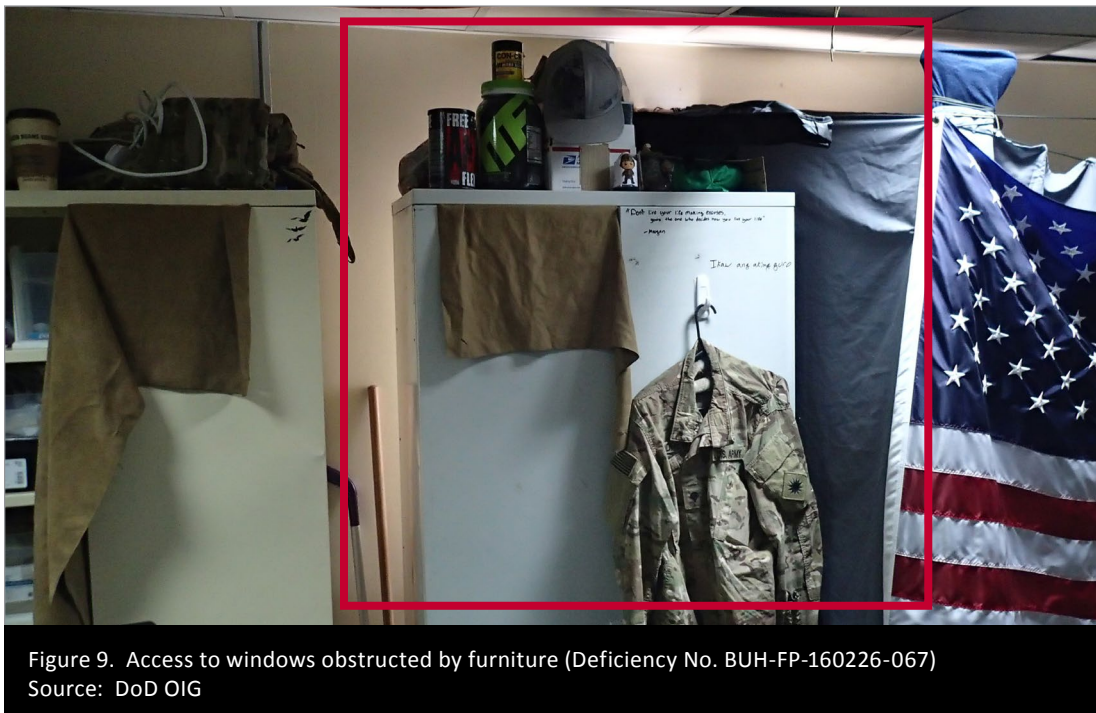
We found 15 windows in 11 barracks sleeping areas with fixed (bolted) bars across each window. We also found eight windows blocked by furniture (Figure 9). The required secondary means of escape is rendered unusable when windows are blocked by non-removable bars or furniture. If a fire blocks the primary means of egress (for example, the door to the corridor) and the window is blocked occupants can become trapped, posing a significant risk to life.

Figure 9. Access to windows obstructed by furniture (Deficiency No. BUH-FP-160226-067)
Source: DoD OIG

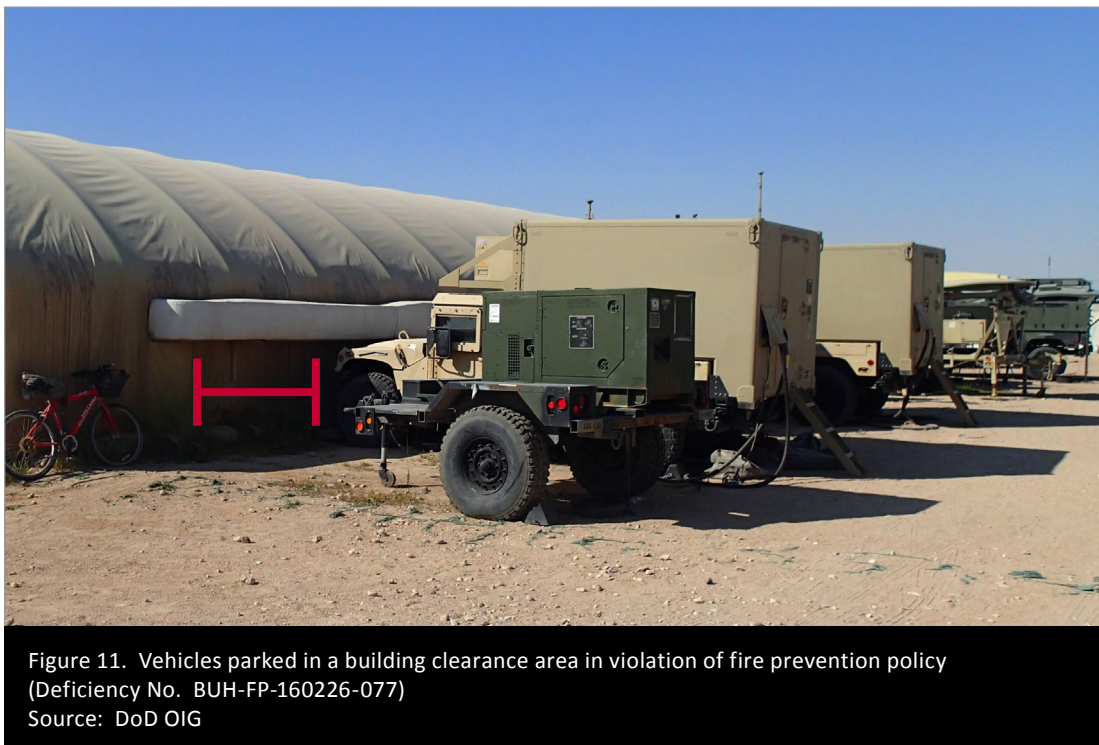
For fire prevention, we found that required clearance areas around buildings were obstructed by vehicles, storage, and vegetation. According to the UFC fire protection regulation, 30 feet of clearance is required between the building and the parking zone. We found vehicles parked within building separation zones (Figure 11). We also found inadequate separation between tent structures, and between housing and non-housing structures. Storage of combustibile materials, or parking of vehicles too close to structures presents a risk of exposure to fire should the materials or vehicles ignite. They also obstruct firefighting equipment and personnel, and can delay or prevent the firefighter's response in the event of fire. These conditions increase unsafe and hazardous conditions.

Figure 11. Vehicles parked in a building clearance area in violation of fire prevention policy (Deficiency No. BUH-FP-160226-077)
Source: DoD OIG
