## **Demonstration and Validation of Reactive Vitreous Coatings to Prevent Corrosion of Steel Fixtures Attached to Masonry Walls**

Final Report on Project F10-AR12

Under Project F10-AR12, "Use of Reactive Vitreous Coatings on Steel Fixtures for  
Masonry Wall to Prevent Corrosion at Fort Stewart, GA"

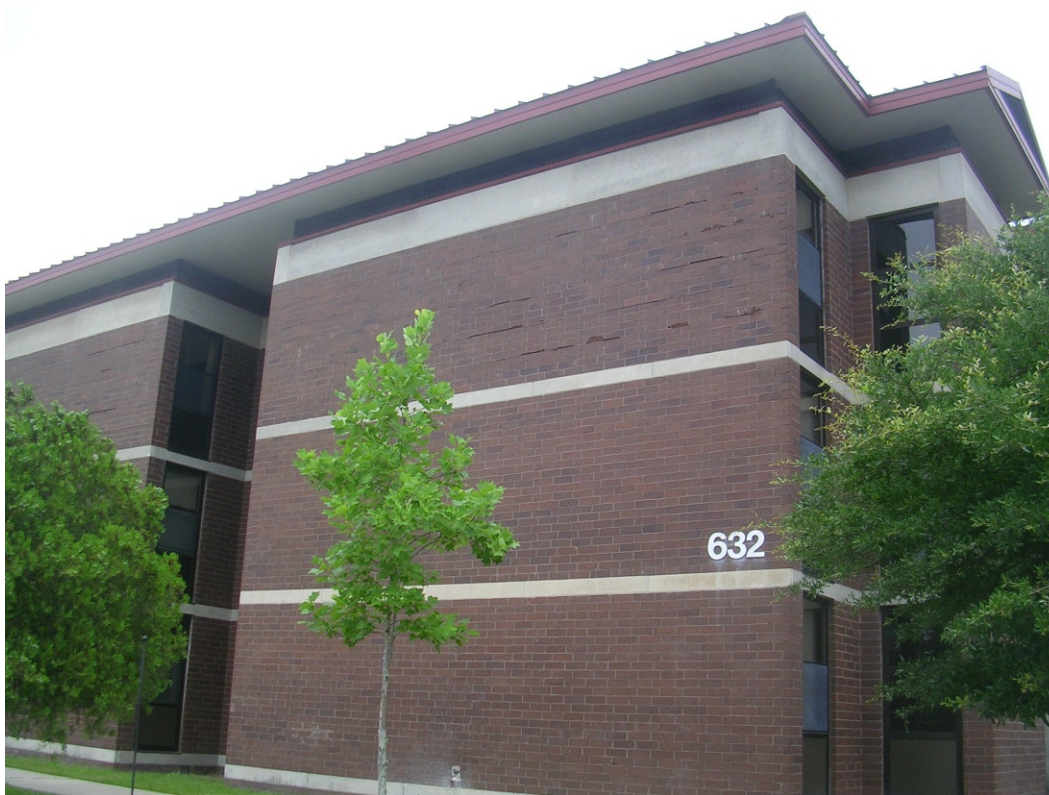
This demonstration involved selecting two buildings that totaled approximately 6,200 sq ft of masonry requiring replacement. The subject buildings had multiple panels of masonry work that displayed visible evidence of failure in the form of fractured/crumbling brick, corroded reinforcing wire, and displaced mortar joints as shown in Figure 1 and Figure 2.

Figure 1. Exterior view of Building 632 brick veneer construction.

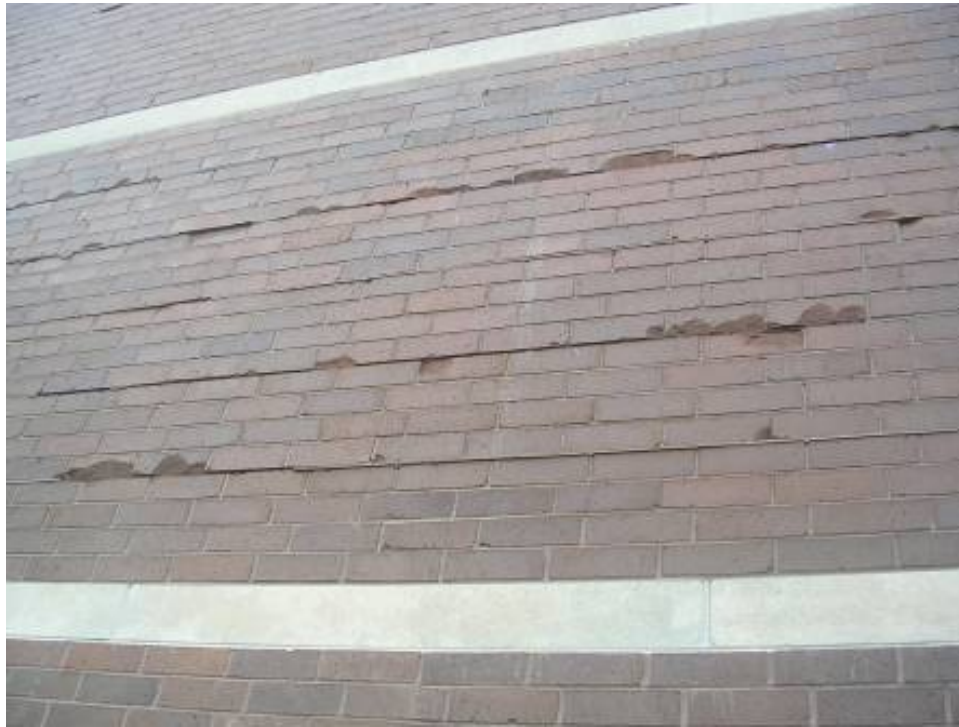
Figure 2. Failed masonry joints, showing spalled bricks.

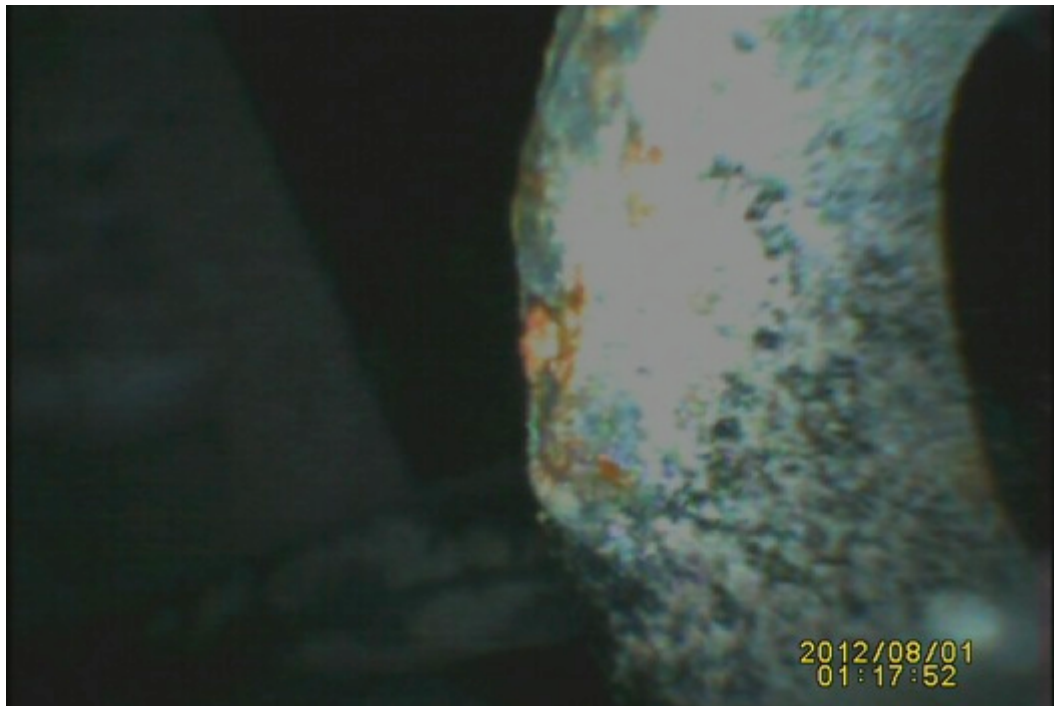
Borescope inspections were completed every 3 months for a period of 18 months after installation. Figure 20 – Figure 27 are images from the final inspection completed in August 2012, and they include eye and pintle components that show the most evidence of corrosion from each inspection location. Individual reports from each inspection are listed in Appendix C. Corrosion was primarily found on the rounded edges of the eye components. The rounded edges are the most susceptible coating imperfections, which was the cause for the corrosion found on items tested. The pintles showed little to no corrosion in all locations. It was also observed that the components experiencing the most corrosion were in locations with the least exposure to sunlight, suggesting that prolonged moisture retention in the masonry may have been a factor.

Figure 20. Borescope inspection of a vitreous coated wall tie after 18 months of exposure in Building 635 location 2-2.

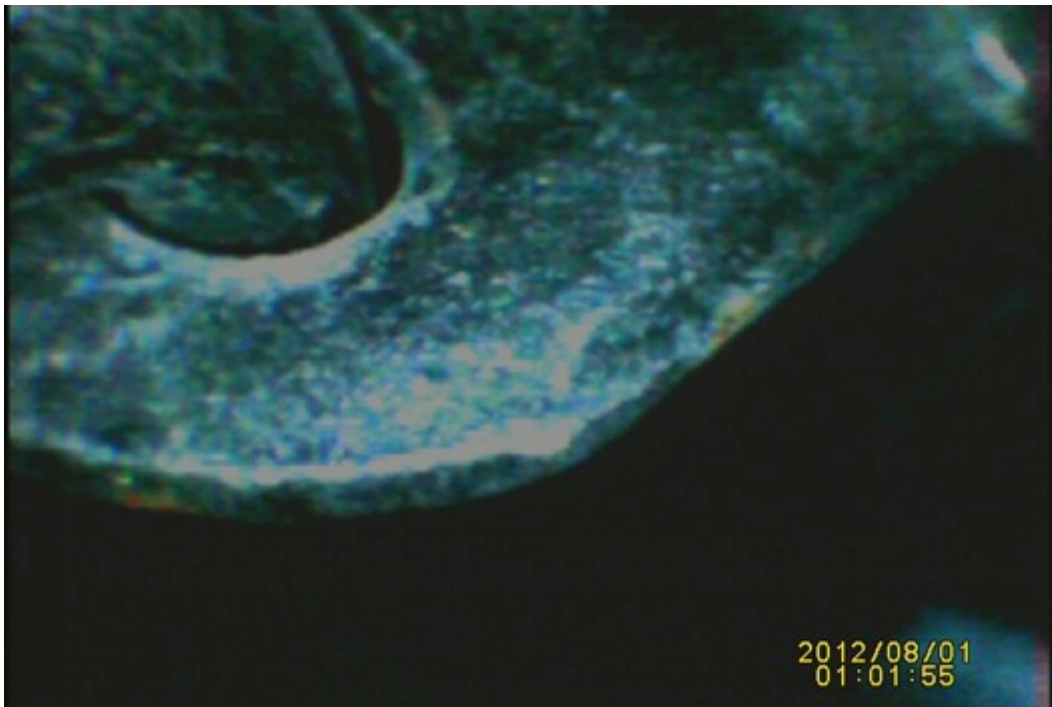
Figure 23. Borescope inspection of a vitreous coated wall tie after 18 months of exposure in Building 635 location 4-1.

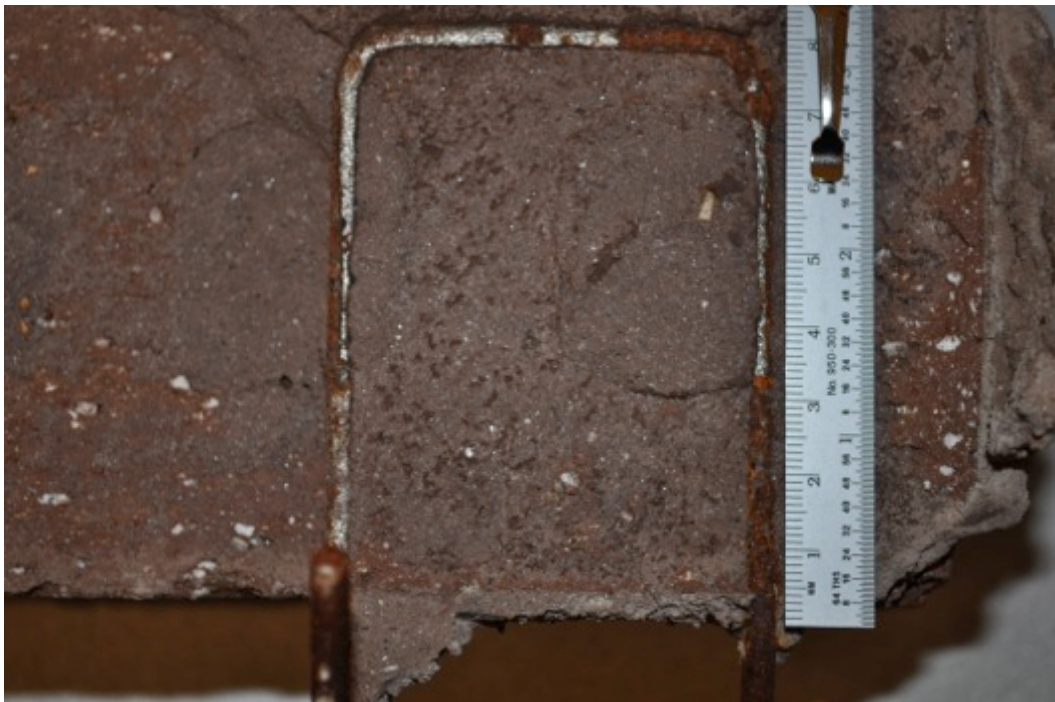
Visual inspections of the brick coupon were completed every 3 months for a period of 18 months after installation. Figure 28 – Figure 37 are images from the final inspection completed in August 2012. Individual reports from each inspection are listed in Appendix C. The brick coupons were broken apart and the mortar was removed from the pintles. The surface area of the standard steel and galvanized pindle that was outside the mortar was 100% covered in rust within 9 months of exposure. The vitreous coated pindle only showed signs of corrosion at the tip of the pindle as shown in Figure 30. The geometry of the tip of the pindle is subject to inadequate coating during application and is the cause of the corrosion. Within 18 months, rust was beginning to form throughout the width of the brick coupon on the standard and galvanized coupons. The vitreous coated coupons did not show any visual signs of corrosion in the interior of the brick coupons.

Figure 28. Destructive inspection of prism interior with galvanized pintle after 18 months of exposure at Fort Stewart.

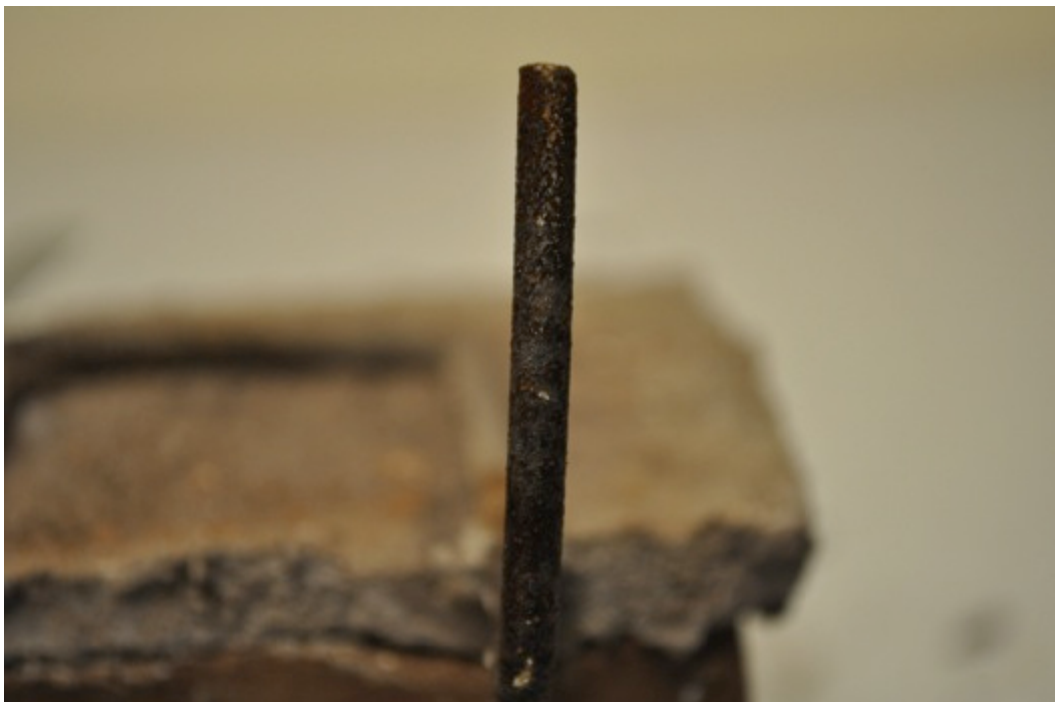
Figure 29. Inspection of the exterior part of the galvanized pintle after 18 months of exposure at Fort Stewart, GA.

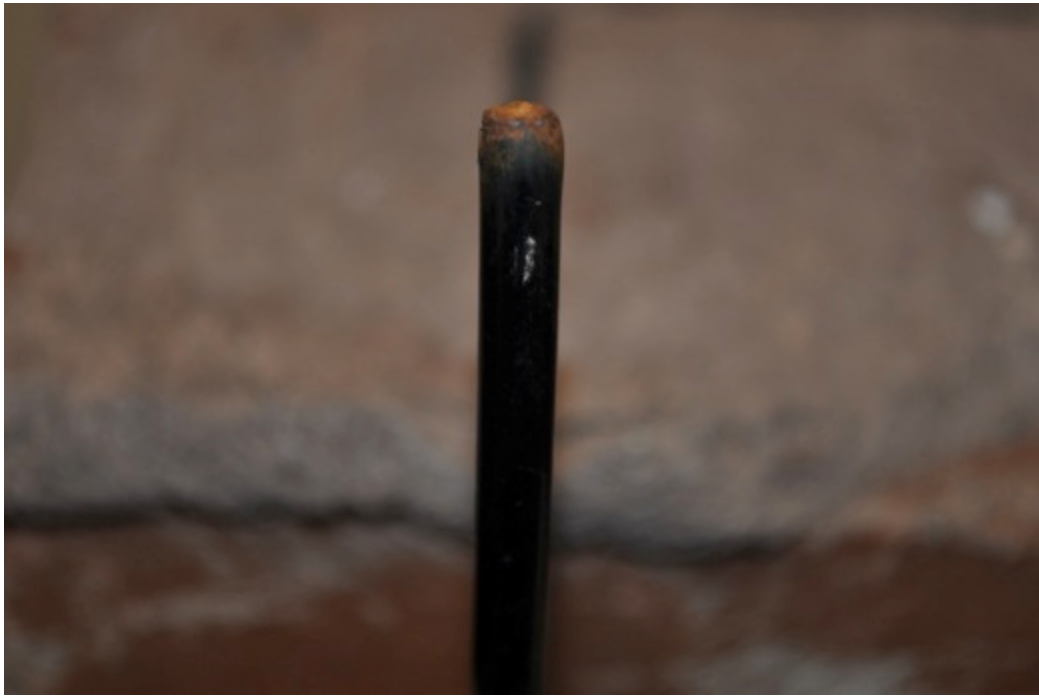
Figure 30. Inspection of the exterior tip of the galvanized pintle after 18 months of exposure at Fort Stewart, GA.

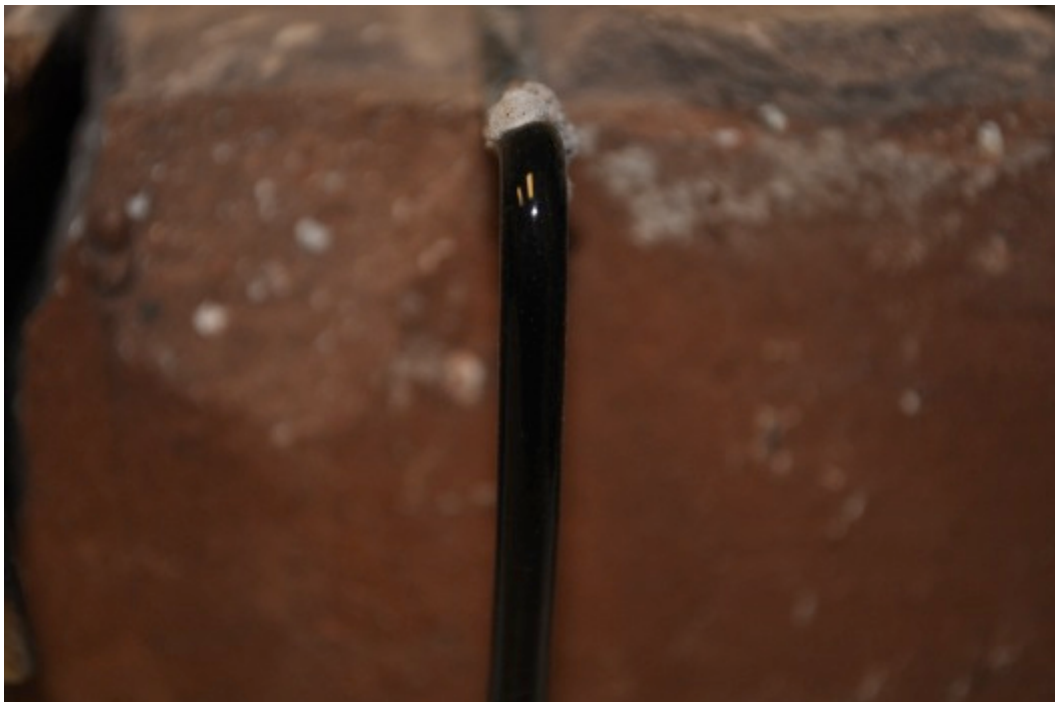
Figure 31. Inspection of the exterior part of the vitreous coated pintle after 18 months of exposure at Fort Stewart, GA.

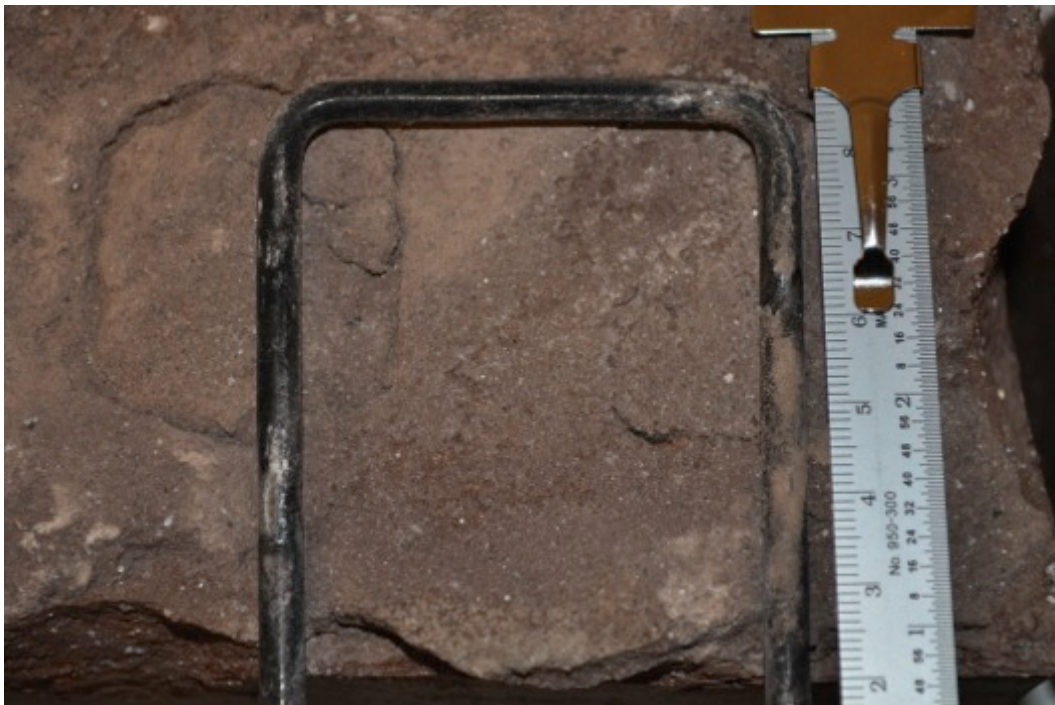
Figure 32. Destructive inspection of the interior of a vitreous coated pintle after 18 months of exposure at Fort Stewart, GA.

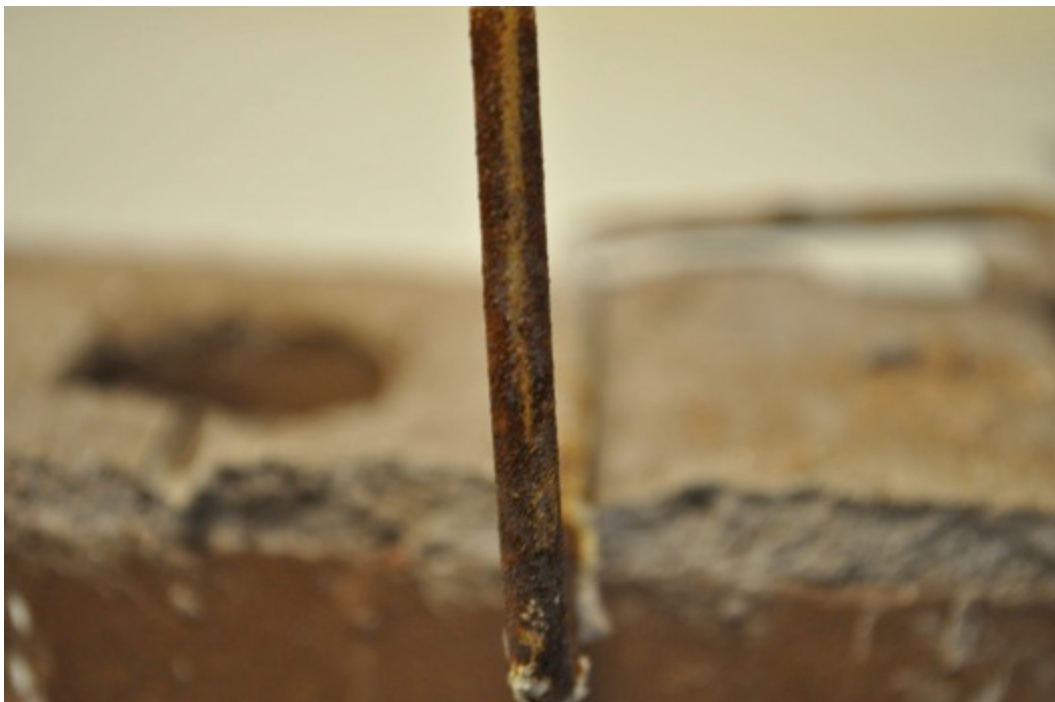
Figure 33. Inspection of the exterior part of the standard steel pintle after 18 months of exposure at Duck, NC.

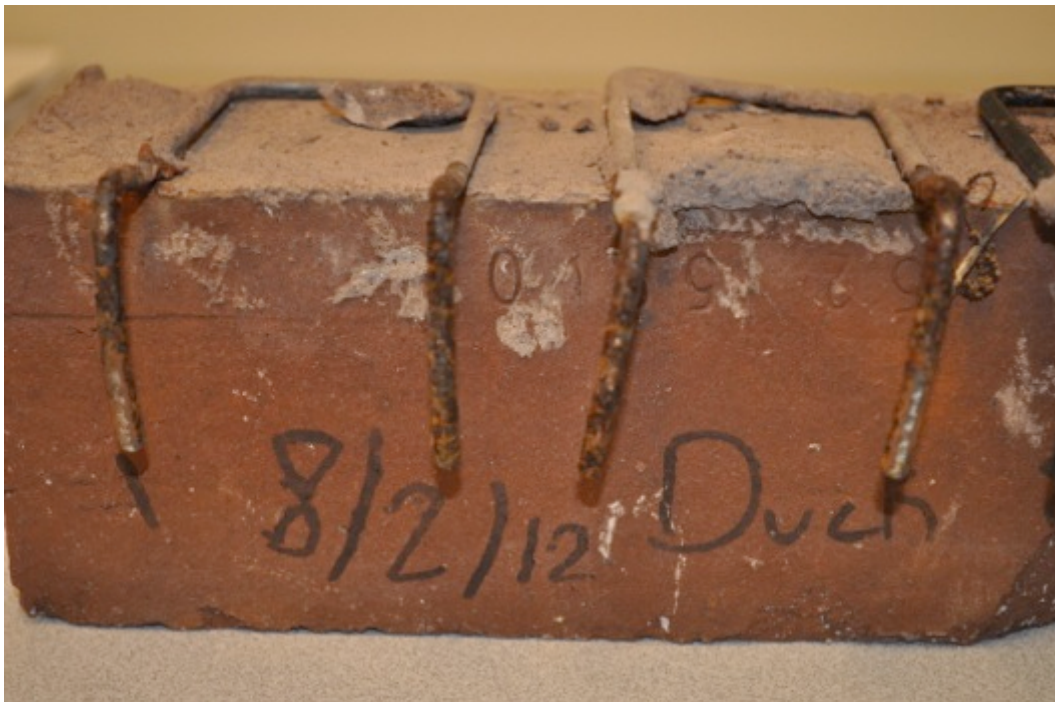
Figure 34. Inspection of the exterior part of the standard steel (left) and galvanized (right) pintle after 18 months of exposure at Duck, NC.

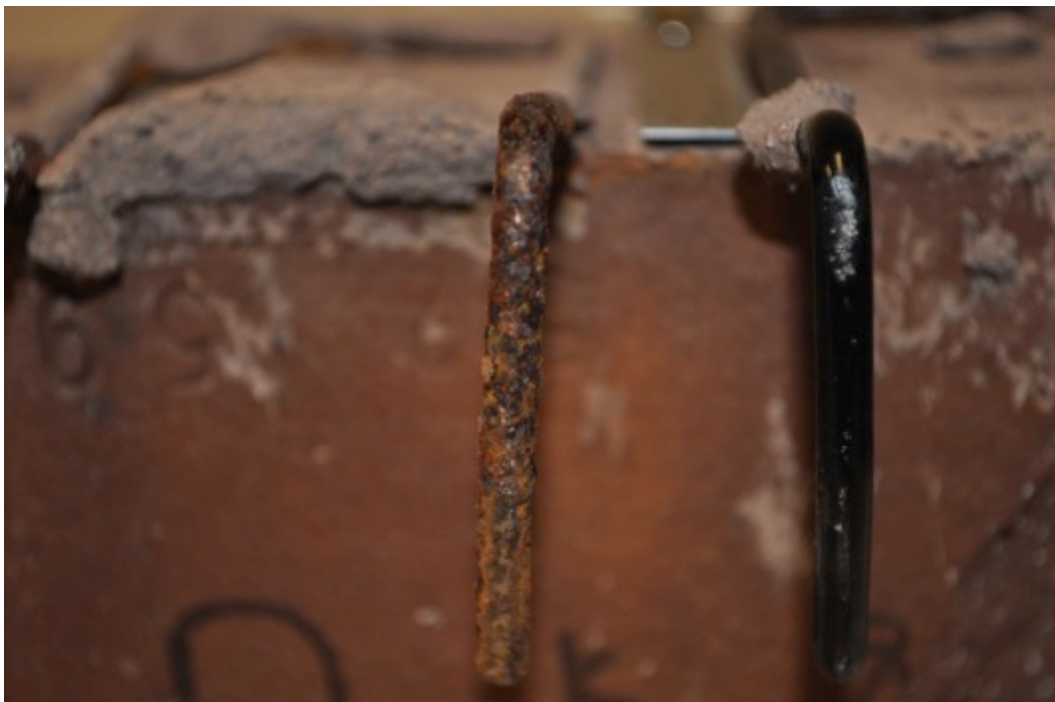
Figure 35. Inspection of the exterior part of the galvanized (left) and vitreous coated (right) pintle after 18 months of exposure at Duck, NC.

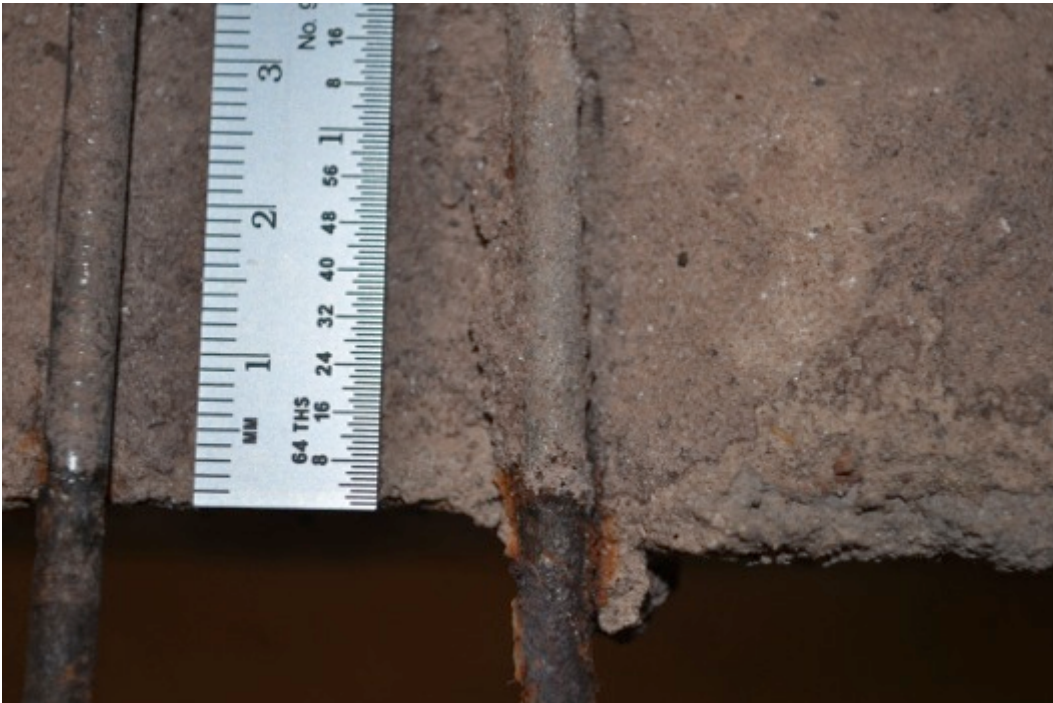
Figure 36. Destructive inspection of the interior of a standard steel (left) and galvanized (right) pintle after 18 months of exposure at Duck, NC.

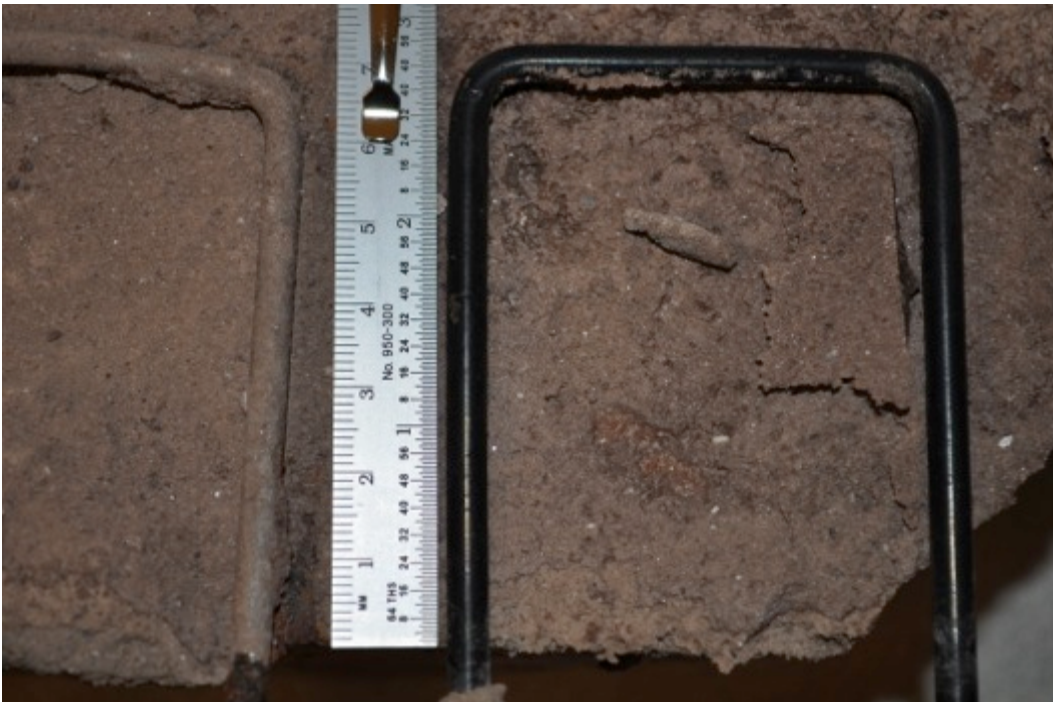
Figure 37. Destructive inspection of the interior of a galvanized (left) and vitreous coated (right) pintle after 18 months of exposure at Duck, NC.

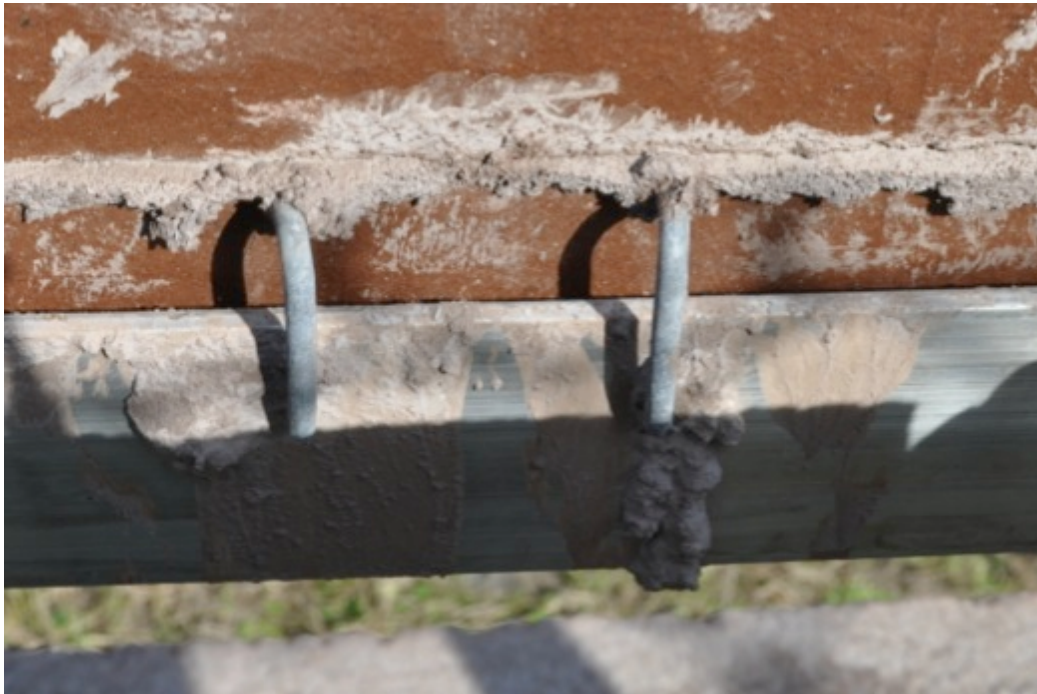
Destructive inspection of some of the 20 comparison coupons (i.e., those containing one bare steel, one galvanized steel, and one enamel-coated steel tie assembly) revealed galvanized pintles that were corroding faster than individual galvanized ones in specimens earmarked for ASTM E754 testing, such as the one shown in Figure 38.

Figure 38. Solo galvanized pintle in an ASTM E754 brick coupon at Fort Stewart, GA.

It was determined that the presence of the uncoated steel pintle inside the same coupon as the galvanized one created a corrosion cell when moisture was present in the mortar to serve as an electrolyte and conductor. The

zinc coating of the galvanized pintle had begun to sacrifice itself to protect exposed steel in both pintles. Corrosion-cell current was confirmed by connecting a multimeter to both materials. Because the vitreous enamel coating is an insulating material, no current should have been able to move between the galvanized pintle and the coated one as observed. To verify that corrosion current was affecting the coated hardware, a tip was cut off and voltage measurement was taken between the exposed substrate and the standard steel pintle; the recorded voltage was similar to the current between the bare steel and galvanized specimens, suggesting the presence of a break in the vitreous coating undetected through visual inspection.

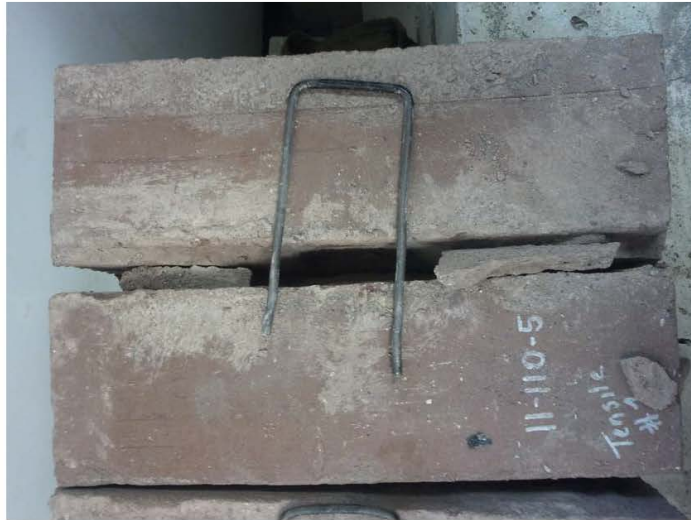
Photo 2 – Mortar Joint Shear

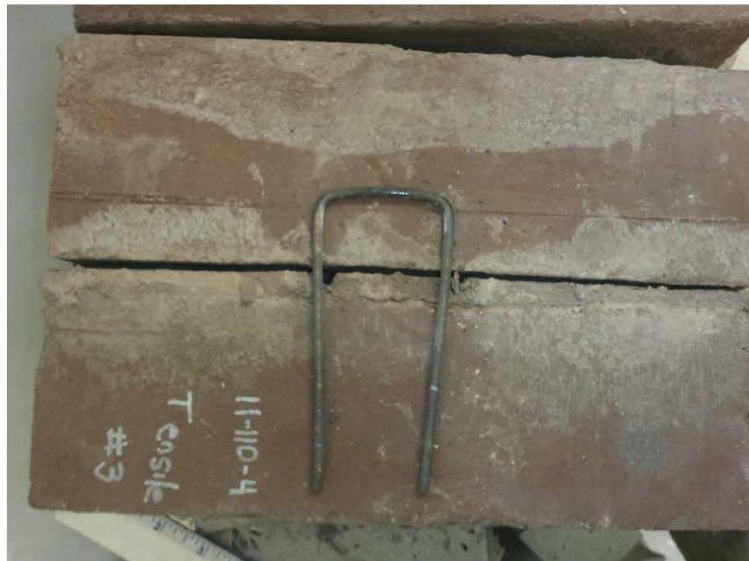
Photo 3 – Mortar Bond Failure on One Side

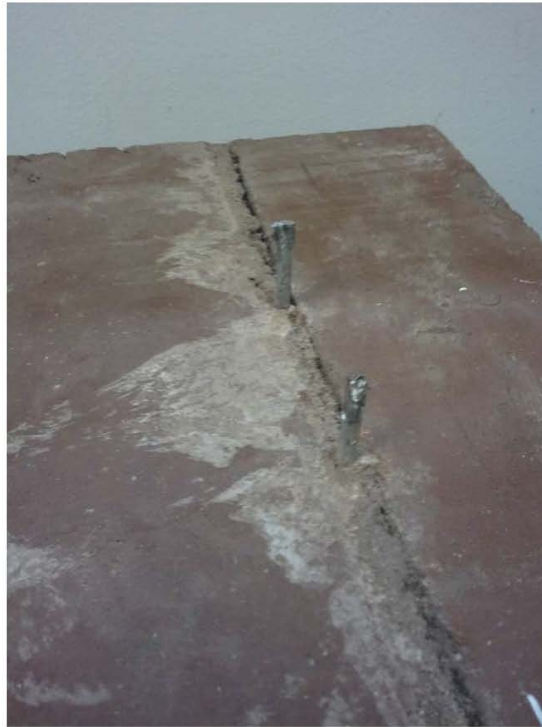
**Photo 4 – Metal Tensile Failure**
