Petrographic Analysis of Portland Cement Concrete Cores from Pease Air National Guard Base, New Hampshire

E. Rae Reed-Gore, Kyle L. Klaus, and Robert D. Moser

November 2016

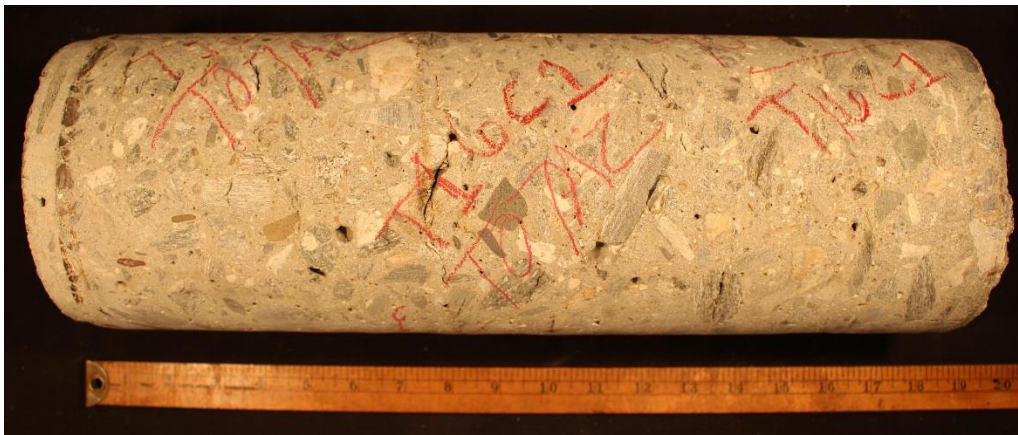
The as-received core from location T07A2 is shown in Figures 1 and 2. The core was 16.25 inches (41.3 cm) long and approximately 6 inches (15.24 cm) in diameter. The surface of the sample had 2 fine cracks measuring 0.08 mm and 0.15 mm. Initial observation of the sample noted cracking throughout the sample. There were 2 vertical cracks, one measured 3.9 inches (9.9 cm) from the surface and was 0.25 mm wide. The second was located at 14.5 inches (36.83 cm) depth in the core and was 1.5 inches (3.81 cm) long and 0.25 mm wide. Horizontal cracks were evaluated at 3.5 in (8.9 cm), 4.0 in (10.2 cm), 7.0 in (17.8 cm), 8.0 in (20.3 cm), 10.25 in (26.0 cm), and 11.5 in (29.2 cm). They ranged in width from 0.2 mm to 1.75 mm. Cracking in coarse aggregates, where the crack extends through the cement fraction, was observed throughout the core. Cracks, entrained air voids and entrapped air voids were infilled by a white deposit. Carbonation staining was observed within the top 2 mm of the sample. The aggregates were angular to sub-round (granitic to gneissic in composition) (Figure 3).

Figure 1. 160159-11 (T07A2), the as received core sample.

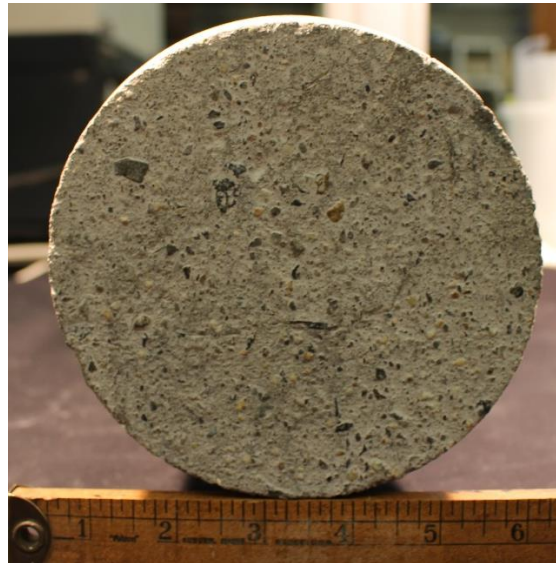
Figure 2. To view of the as-received sample (T07A2). The surface of the sample had 2 fine cracks measuring 0.08 mm and 0.15 mm.

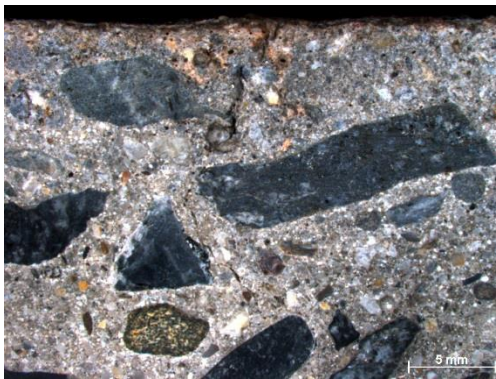
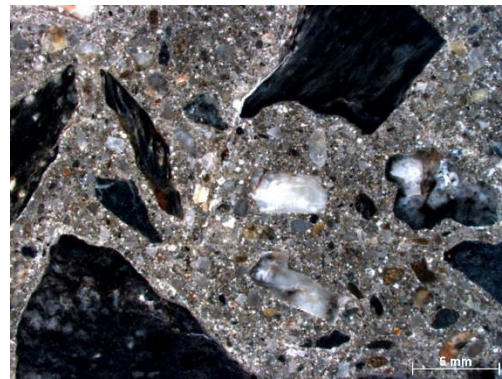
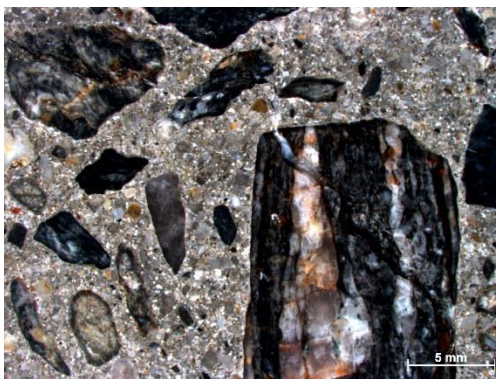
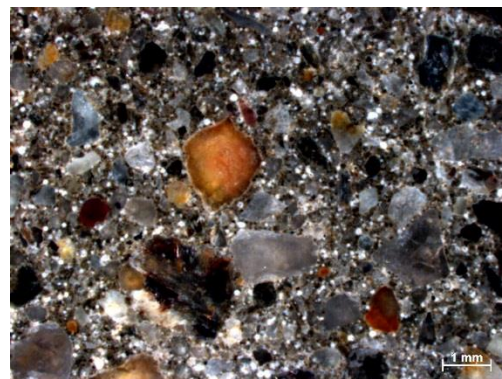
Figure 3. Low and high magnification photomicrographs of 160159-11 – T07A2, (a) very little carbonation staining at the surface, (b) infilling of voids and crack at coarse aggregate boundary, (c) crack in coarse aggregate into the paste, (d) view of cement and fine aggregate, with infilling of voids.

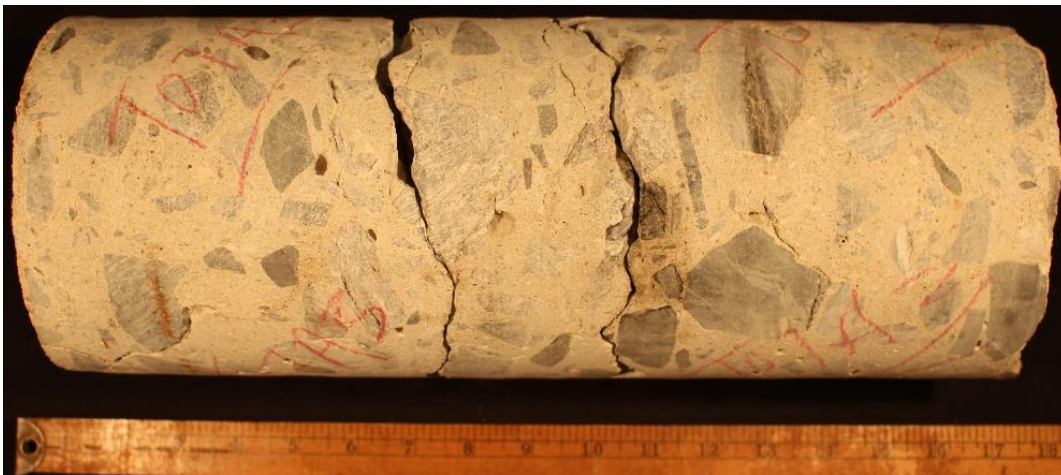
The as-received core from location T07A3 is shown in Figures 4 and 5. The core was 14.2 inches (36.1 cm) long and approximately 6 inches (15.24 cm) in diameter. The surface of the sample had cracks measuring 0.5 mm to 7.0 mm. Initial observation of the sample noted cracking throughout the sample. There were 4 vertical cracks, one measured 2.5 inches (6.35 cm) and another, 4.5 inches (11.4 cm) from the surface and were 1.75 mm and 1.55 mm wide respectively. The other 2 were located at 8.8 inches (22.4 cm) depth in the core and were 6.0 inches (15.24 cm) long and were 2.0 to 2.5 mm wide. Horizontal cracks were evaluated at 5.4 in (13.7 cm), 6.0 in (15.24 cm), 7.2 in (18.3 cm), and 7.8 in (19.8 cm). The horizontal cracks at 5.4 in (13.7 cm) and 7.8 in (19.8 cm) were complete delamination cracks. Others ranged in width from 0.6 mm to 1.5 mm. The cracking in coarse aggregates, where the crack extends through the cement fraction, was observed throughout the core. Cracks, entrained air voids and entrapped air voids were infilled by a white deposit. Carbonation staining was observed within the top 2 mm of the sample and down surface cracks. The aggregates were angular to sub-round (granitic to gneissic in composition) (Figure 6).

Figure 4. 160159-12 (T07A3), the as received core sample.

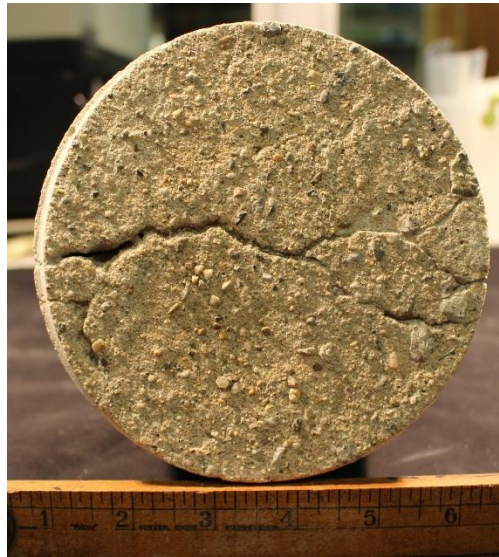
Figure 5. To view of the as-received sample (T07A3). The surface of the sample had cracks measuring 0.5 mm to 7.0 mm.

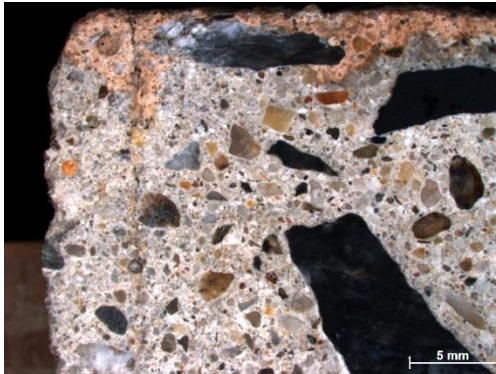
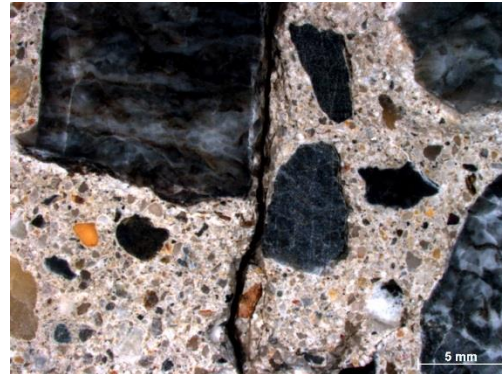
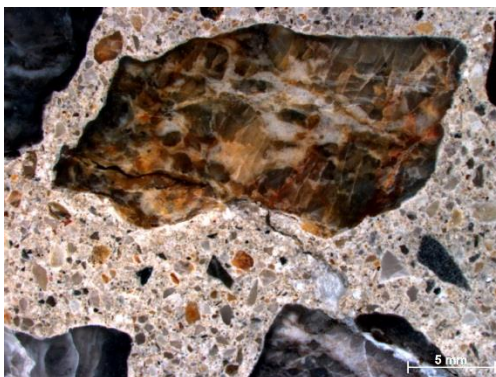
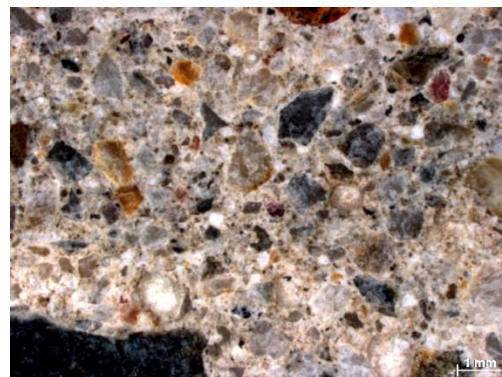
Figure 6. Low and high magnification photomicrographs of 160159-12 – T07A3, (a) carbonation staining at the surface and down crack, (b) crack along coarse aggregate, (c) highly fractured coarse aggregate with what appears to be gel infilling crack and voids, (d) view of cement and fine aggregate, with infilling of voids.

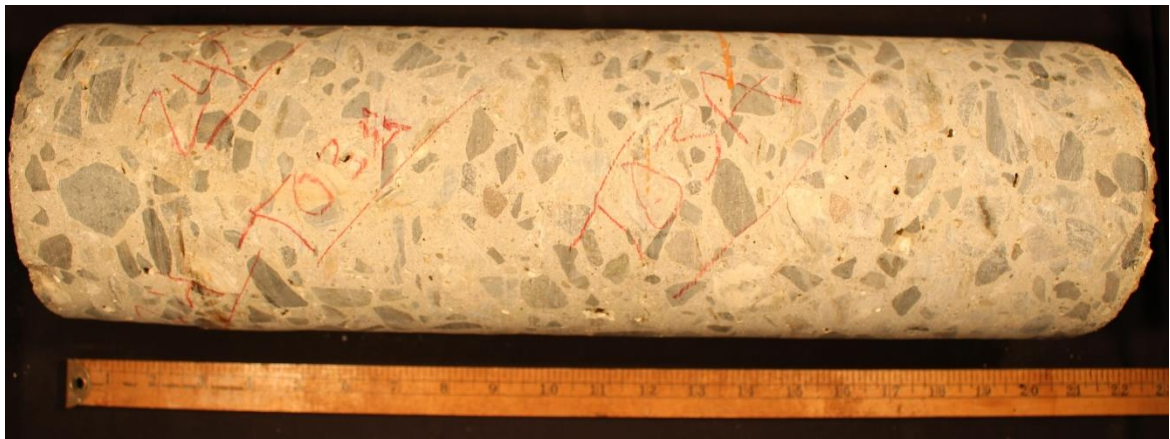
The as-received core from location T03A is shown in Figures 7 and 8. The core was 15.5 inches (39.4 cm) long and approximately 6 inches (15.24 cm) in diameter. The surface of the sample had 6 fine cracks measuring less than 0.08 mm. Initial observation of the sample noted cracking the top 1.0 to 1.5 inches (2.54-3.81 cm) of the sample. There were 2 vertical cracks, one measured 1.0 inches (2.54 cm) from the surface and was 2.0 mm wide. The second was located at 1.5 inches (3.81 cm) from the surface and was 0.2 mm wide. Cracking in coarse aggregates, where the crack extends through the cement fraction, was observed throughout the core. Cracks entrained air voids and entrapped air voids were infilled by a white deposit. Entrapped air voids ranged in size from 1.0 mm to 19 mm. Carbonation staining was observed within the top 2 mm of the sample. The aggregates were angular to sub-round (granitic to gneissic in composition) (Figure 9).

Figure 7. 160159-13 (T03A), the as received core sample.

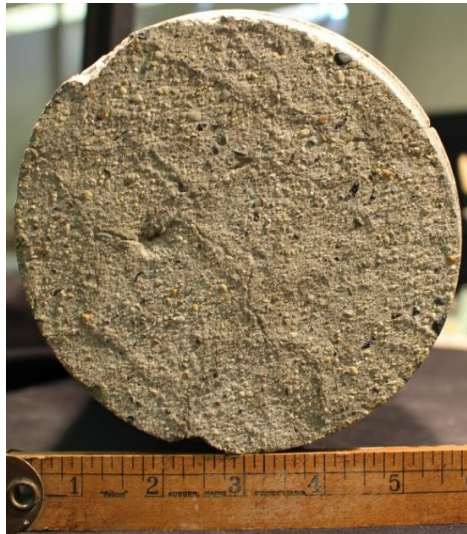
Figure 8. To view of the as-received sample (T03A). The surface of the sample had 6 fine cracks measuring less than 0.08 mm.

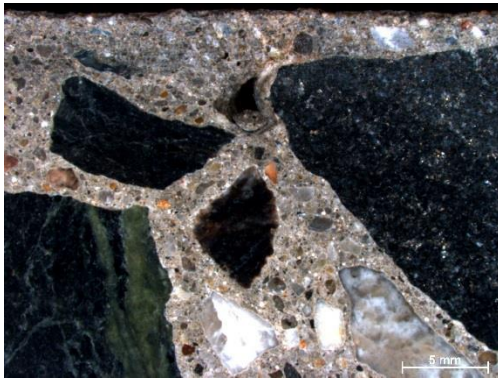
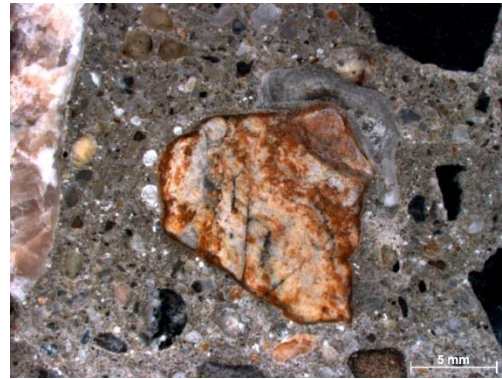
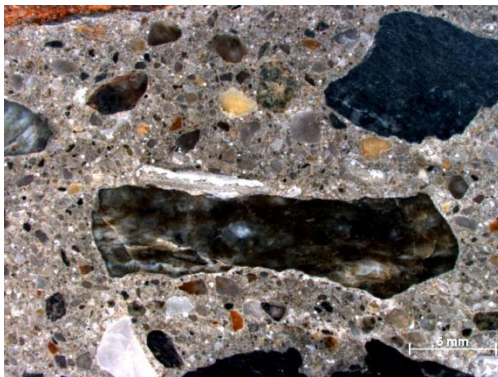
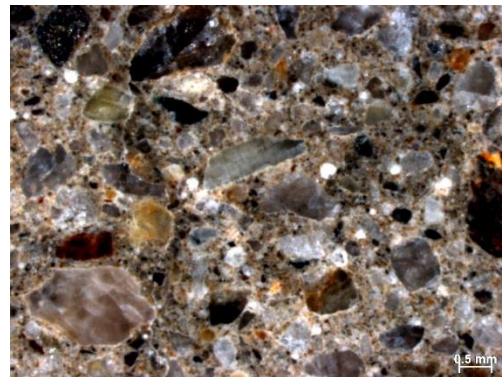
Figure 9. Low and high magnification photomicrographs of 160159-13 – T03A, (a) very little carbonation staining at the surface, (b) iron staining within around coarse aggregate, (c) highly fractured coarse aggregate with what appears to be ASR gel infilling voids and around deboned surface, (d) view of cement and fine aggregate, with infilling of voids and iron staining.
