# High Frequency Shock During Random Vibration Testing

# Overview

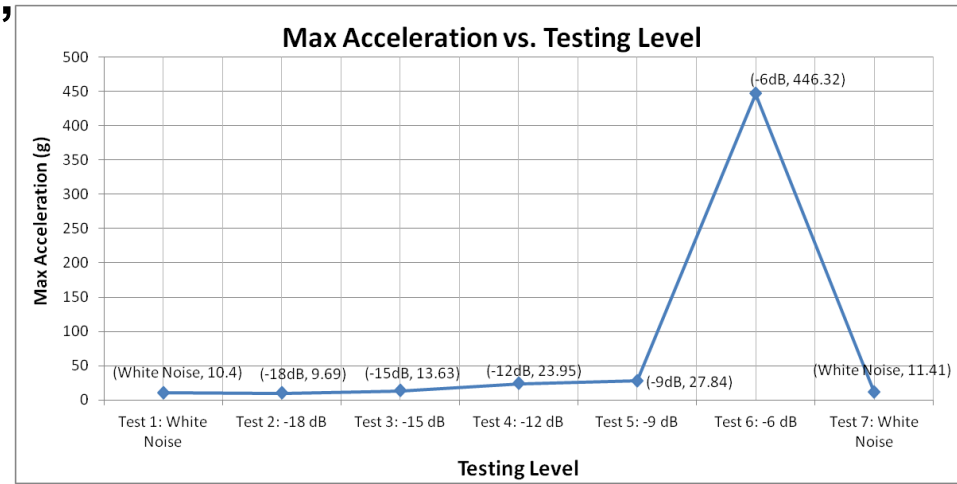
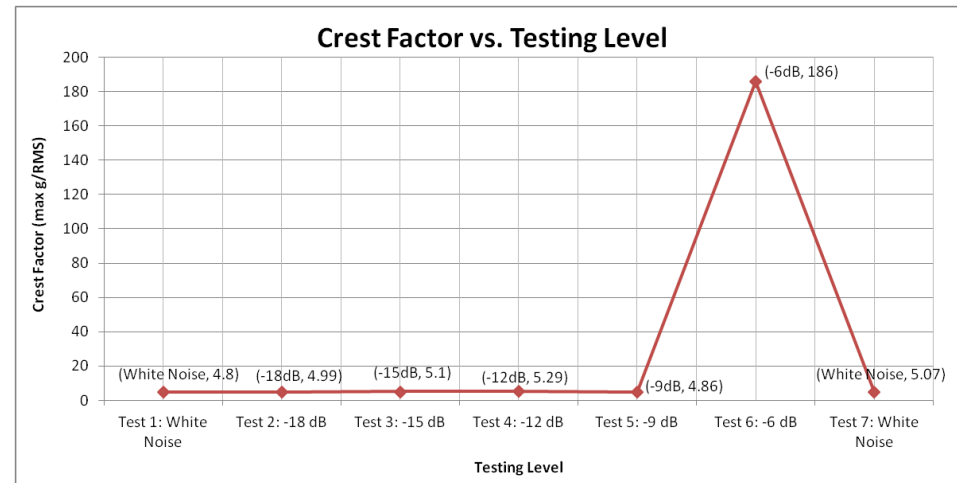
# Y-axis Testing Results

- Testing aborted at -6dB: “peening” sound heard acoustically
- Analysis of data shows a max 446.32g shock event at 13kHz originating from flexure (off-axis)
  - Corresponding natural frequency shift during -6 dB test

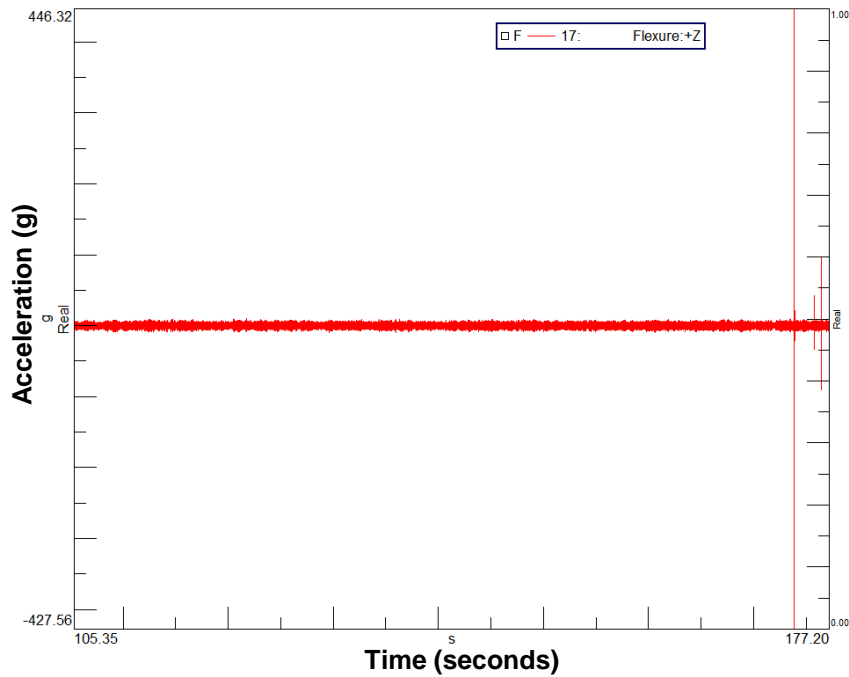
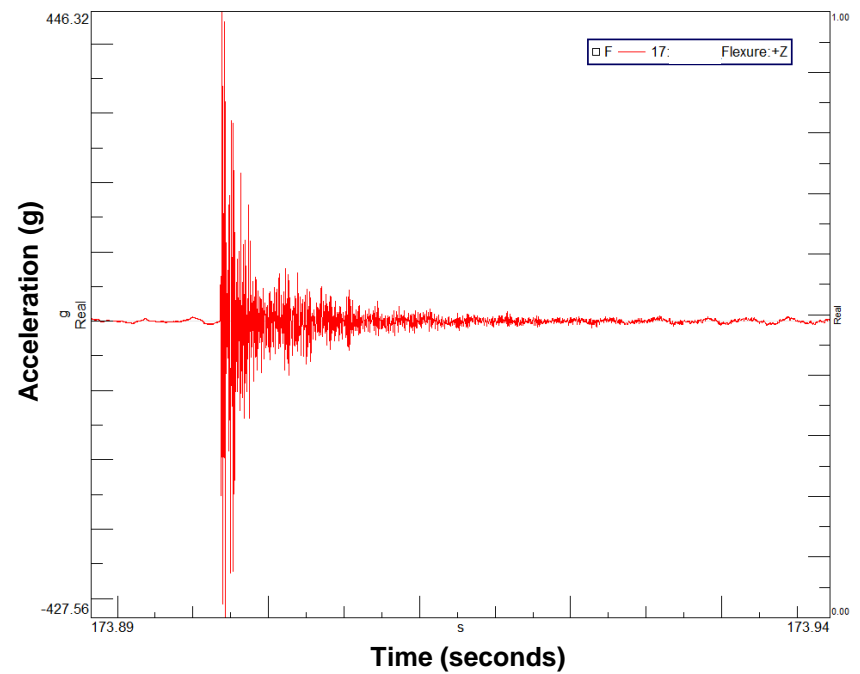
# Shock Event

- -6dB Random Input
- Shock origination: Bottom Flexure

- **System already in final configuration**
- **Not realistic to replace flexures, but needed to fix rotational stiffness**
- **Reduced shock down to acceptable levels by stiffening flexures using Constrained Damping Layer**

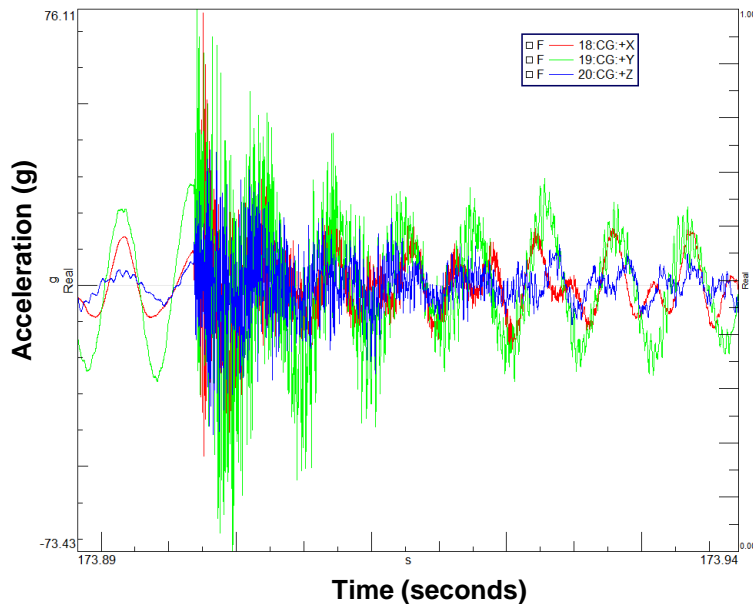
CG Accelerometer

- Ydir Input -6dB Random
- Response at CG accelerometer and Front Face accelerometer

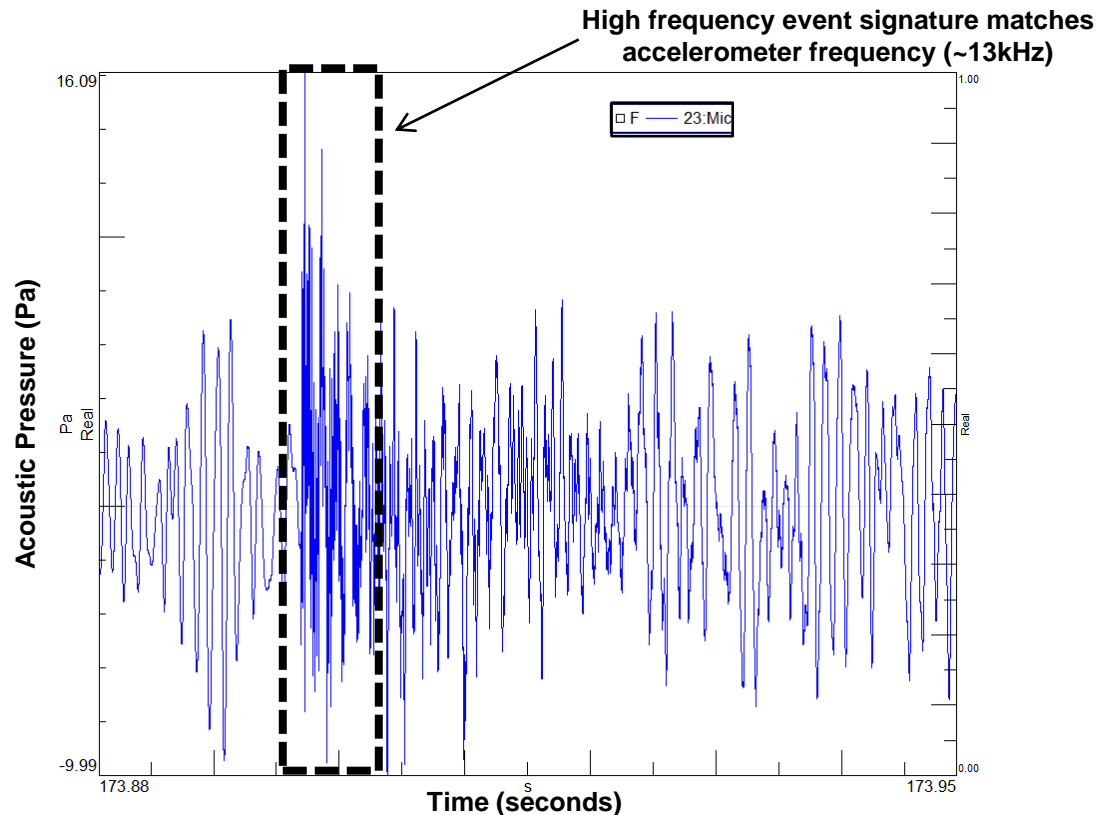
- Input -6dB Random
- Response on microphone normal to bottom flexure (channel 21)

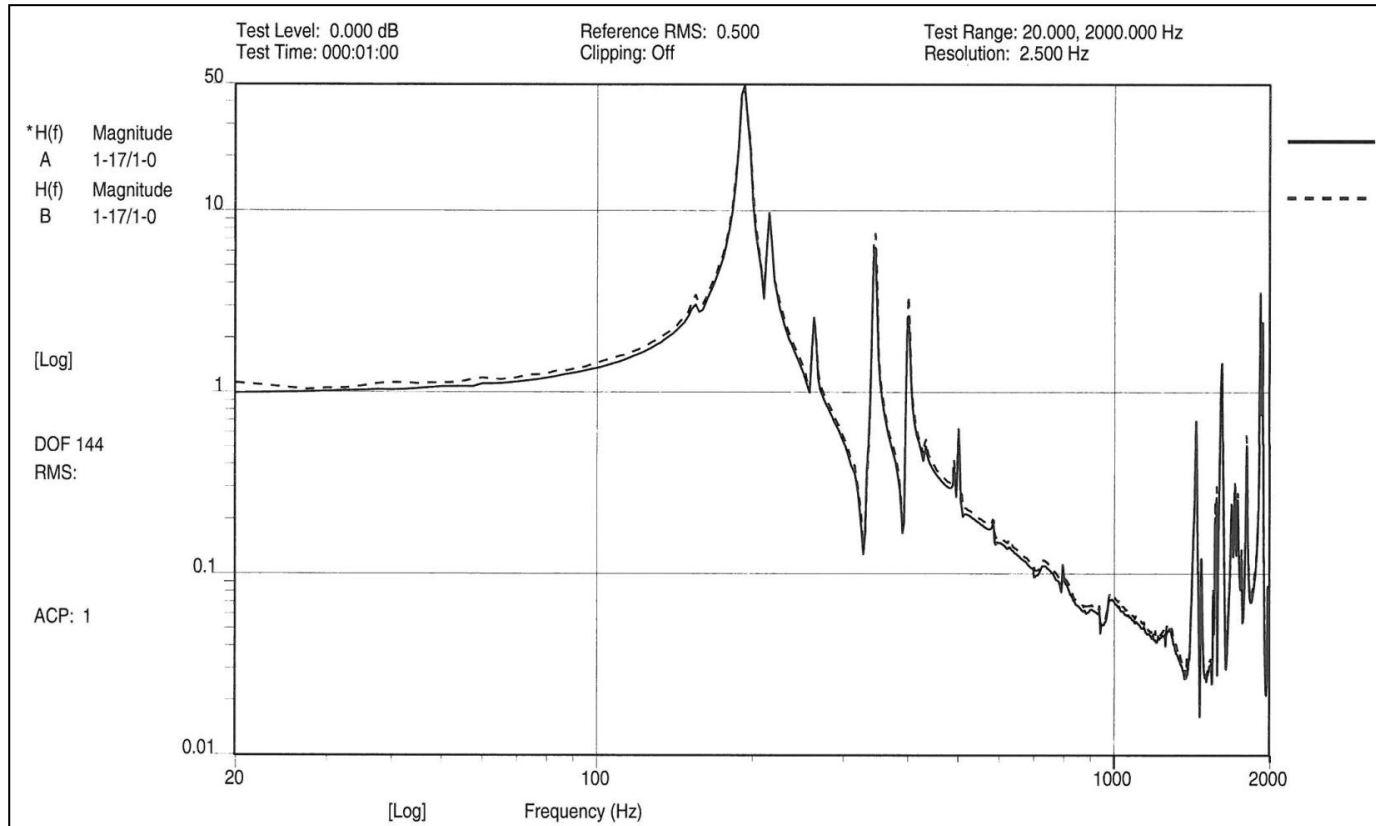
Resonant frequencies and damping are unchanged after the shock event during vibration at -6dB
