## **Investigation of Hydrophobic Concrete Additive for Seawall Replacement at Pililaau Army Recreation Center, Hawaii**

Final Report on Project F09-AR05A

May 2017

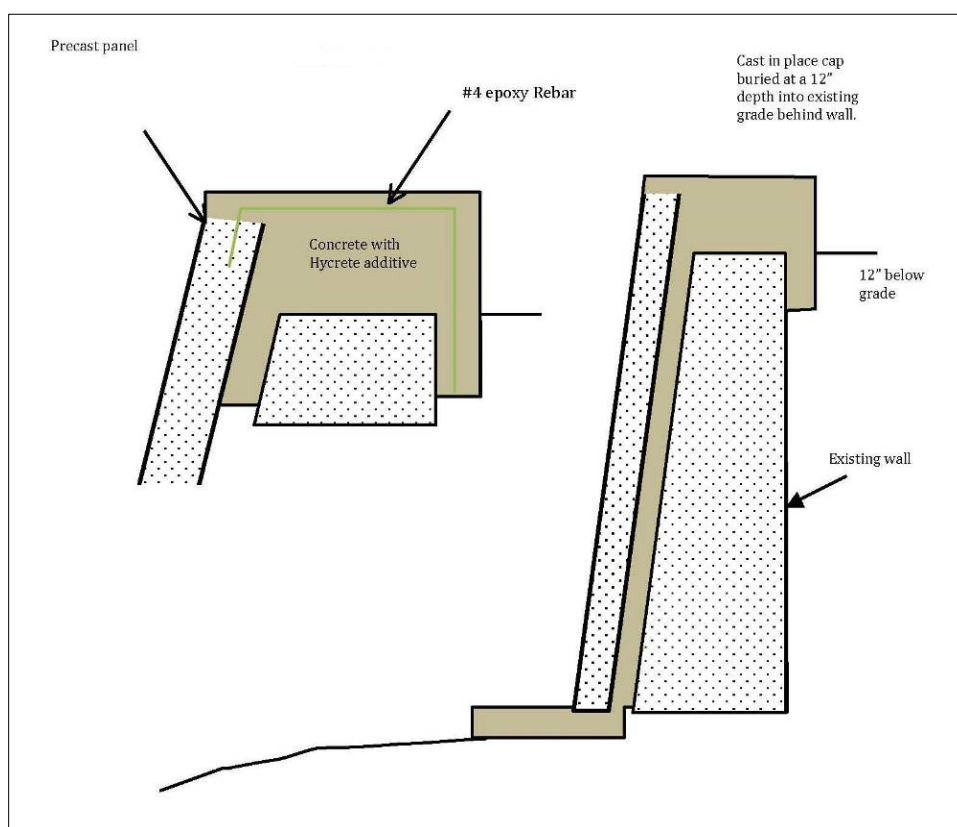
Figure 3. Repair concept.

The design selected and approved by ERDC-CERL and the garrison's DPW was a concrete veneer structure to repair an existing section of seawall. The veneer was designed to include precast panels with the front molded to resemble the rock pattern of the adjacent wall. The panels would be secured to the existing seawall and placed on a concrete footer at the base of the seawall. Treated concrete then would be poured between the precast panels and the seawall and over the top of the existing seawall to create a reinforced concrete cap (Figure 3).

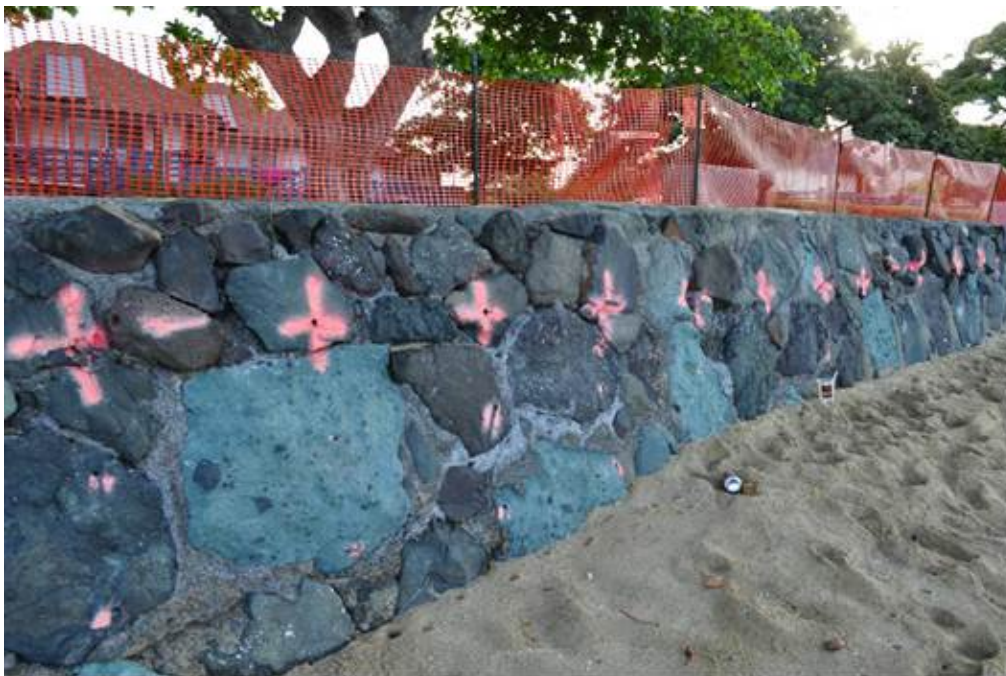
Figure 4. Holes bored in the existing seawall, to be fitted with rebar and epoxy.

Initially, the work began by drilling the seawall (Figure 4) to facilitate using epoxy to secure rebar that would be interlaced with rebar that would project from the back of the panels and become the face of the seawall. To support this work, a cofferdam was constructed using “super sack” bags to provide a temporary barrier between the seawall and the ocean. The bags were lined up approximately 20 feet from the seawall. However, the cofferdam was unable to withstand the surf from a large storm of more than 2 days, and it had to be removed. Initially the project team had determined that the work would require no permit, but after the cofferdam collapsed, local officials advised the team that, in fact, a permit was required. During the request for the temporary permit, all work on the seawall was suspended.
