CONTRACT NUMBER: FA8532-17-C-0008 (CDRL A002)

Evaluation of the Aircraft Ground Equipment (AGE) at Pacific Air Force (PACAF) Locations

Prepared by:
Battelle
505 King Avenue
Columbus, Ohio 43201

Date: 16 January 2018

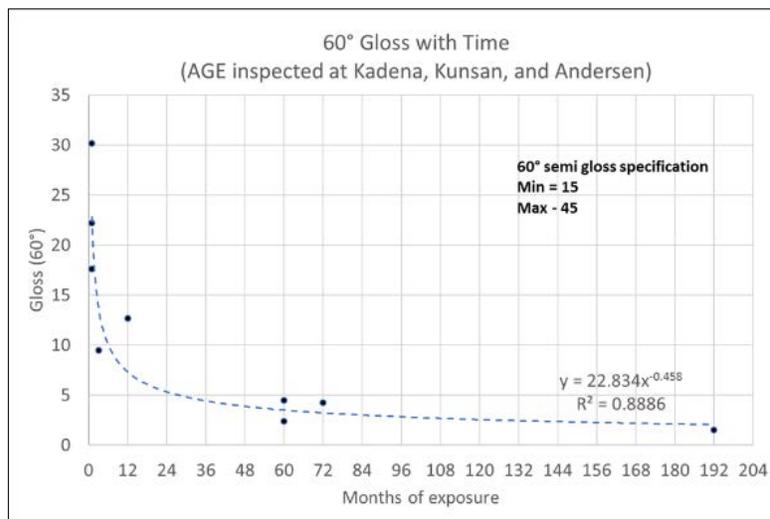
Figure ES- 1. Overview of UV Degradation

Coatings Degradation from Exposure to UV light. Color, gloss, and coatings thickness measurements were taken from the AGE inspected at the three PACAF locations. Results as seen in Figure ES- 1 show significant loss of gloss across the

inspected AGE as quickly as 3 months after being painted. Gloss readings on the MIL-PRF-85285 coating were below the minimum gloss specification of 15 units for semi-gloss in the 60° angle of incidence. Readings for color showed significant change over time from UV exposure. The two parameters indicate high levels of UV degradation of the polyurethane backbone, which in turn reduces the binding between the PU and the pigments. This can cause chalking and roughening of the coating surface which reduces the gloss of the coating. The inspection of AGE at each PACAF locations and the respective readings to determine level of coatings degradation from exposure to UV and, the general modes of corrosion are discussed in details in section 3.0 and evaluation of the PACAF AGE results are discussed in sections 4.1 - 4.3 of this report.

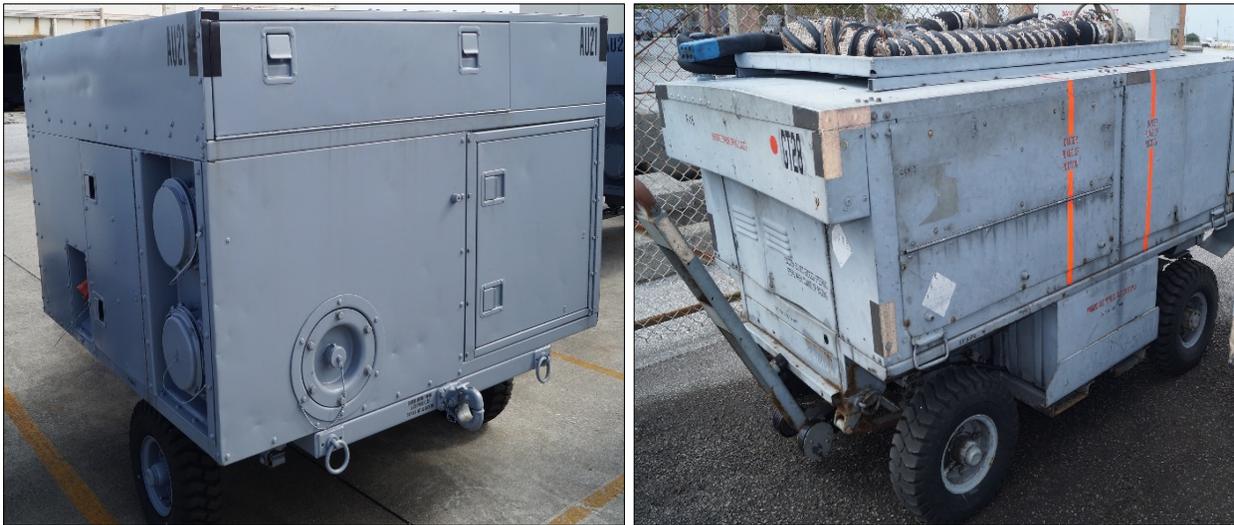
Figure 4. Photos of AGE in Kadena to show the loss of gloss over time

Significant loss of gloss can be seen between these two assets evaluated at Kadena. The AU-21 aircart was painted 1 month prior to this photo, while the GT28 generator was painted 60 months

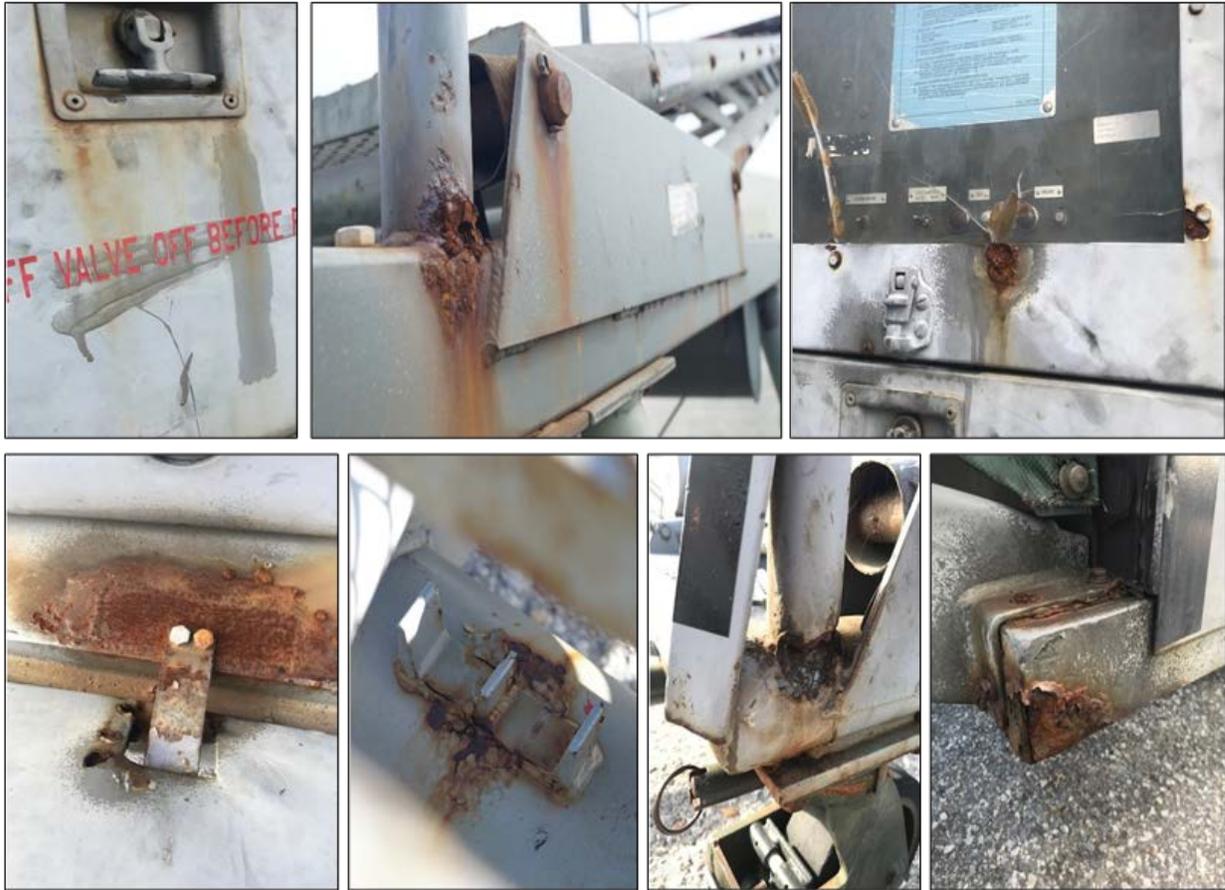
Figure 5. Corrosion observed on Inspected AGE at Kadena

Many of the corrosion products found on the AGE equipment at Kadena AB were in areas of bolts, leaf springs, under carriage, welds, and crevices between dissimilar metals. These are areas where moisture can collect and in the case of dissimilar metals an electrochemical process can occur in which one metal corrodes preferentially when it is in electrical contact with another, in the presence of an electrolyte. In the areas of welds, the problem arises from the fact that weld metal compositions (which are normally optimized for mechanical properties) tend to be slightly anodic to the parent steel. Therefore, the weld metal corrodes at a higher rate than the parent.

Photos of corrosion products found on AGE at Kadena AB. These are most likely the result of galvanic, crevice or preferential weld corrosion

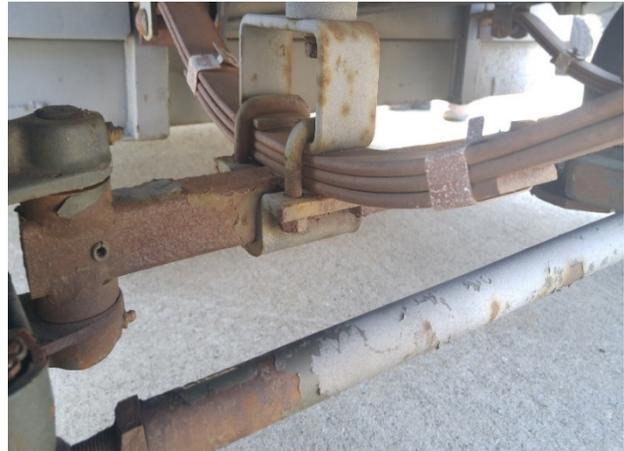
Figure 8. AGE Inspection Findings at Kunsan AB

Example of probable crevice corrosion or corrosion due to compromised coating seen on the undercarriage of AGE at Kunsan AB

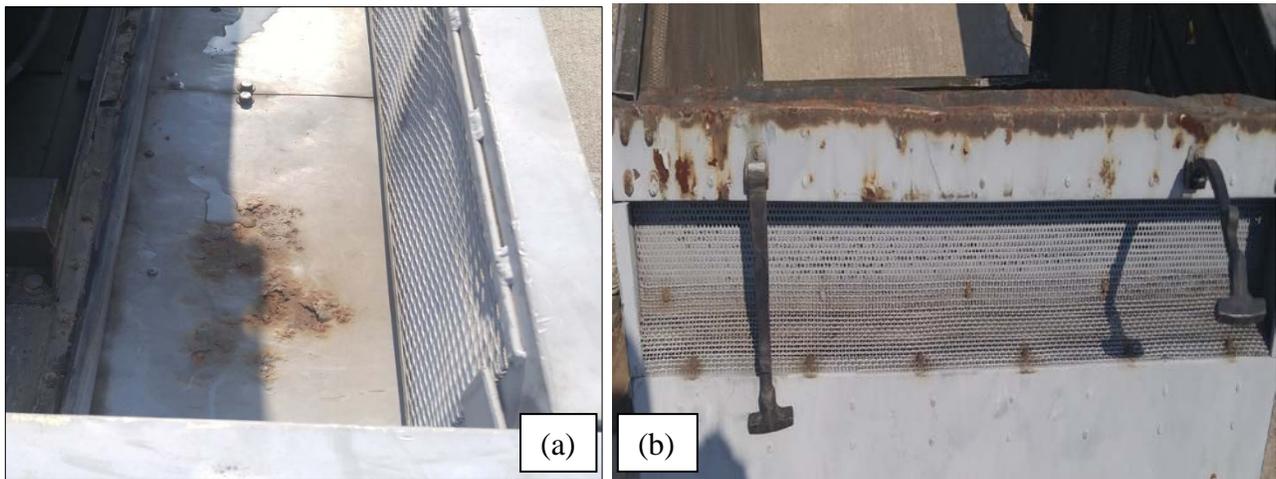
Figure 9. Additional AGE Inspections at Kunsan

(a) Example of Possible example of MIC from hydraulic oil. (b) Edge effects seen on the fairing of a Dash 95 TC 21 at Kunsan AB. Corrosion peeking through paint at corners is likely a result of edge effects and the coating naturally being thinner there, so it is the first spot to form pores and thus lead to corrosion

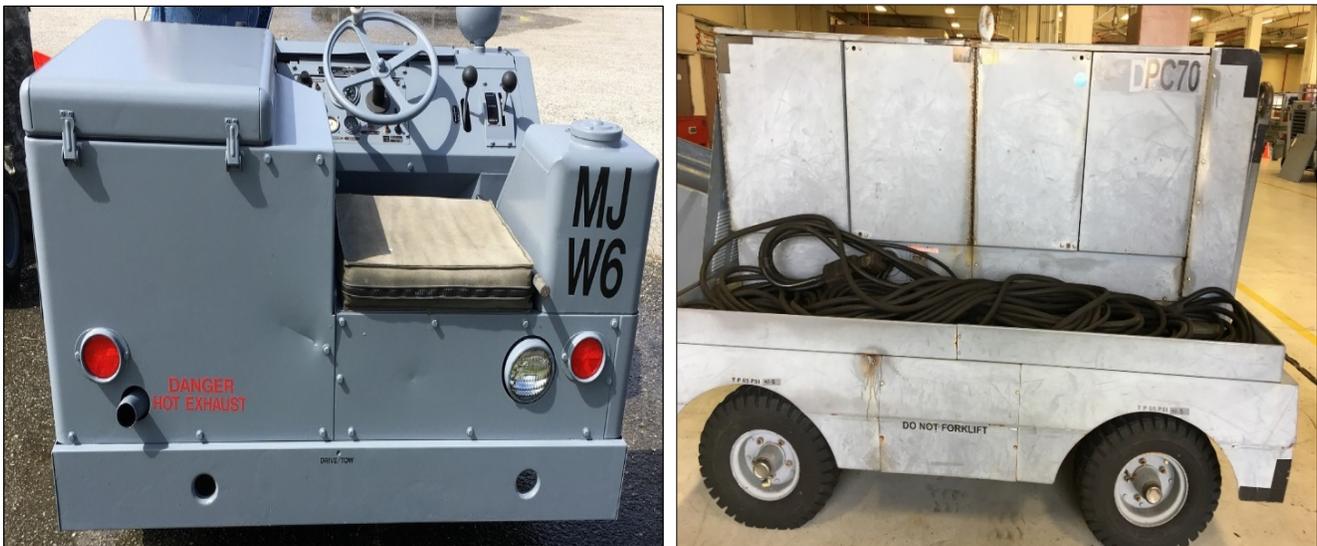
Figure 12. UV degradation of coatings at Andersen AFB resulting in loss of gloss

Figure 12 shows the striking difference in color and gloss from UV degradation on the bomb lift painted a month ago and the Dash 86 generators painted five year ago and Figure 13 shows corrosion damage on the inspected AGE at Andersen AFB.

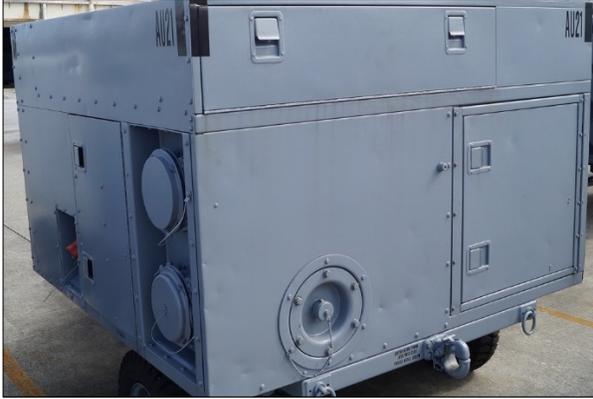
AU21 Kadena 1 month Gloss = 30.13

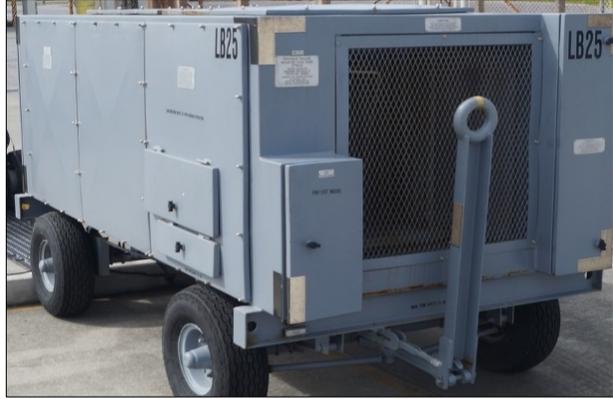
LB25 Kadena 3 months Gloss = 9.47

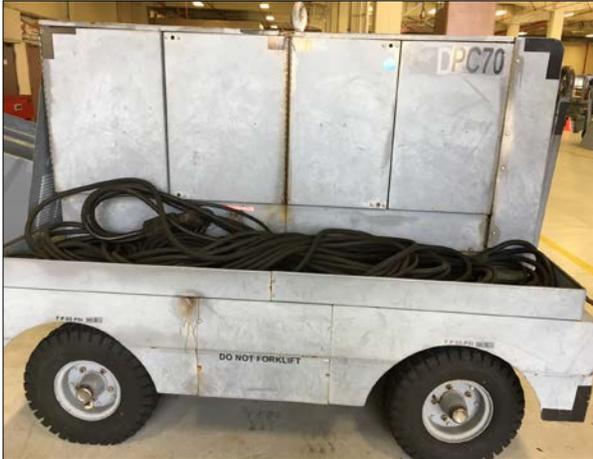
PC70 Andersen 60 months Gloss = 4.47

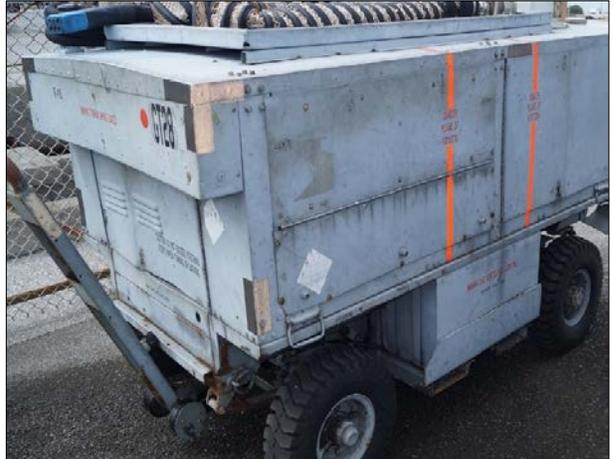
GT28 Kadena 60 months Gloss = 2.37

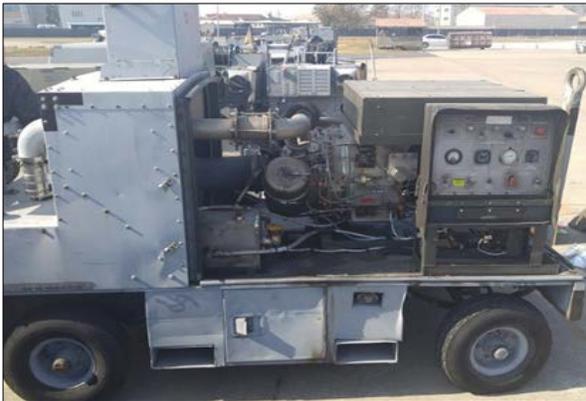
TC21 Kunsan 192 months Gloss = 1.53

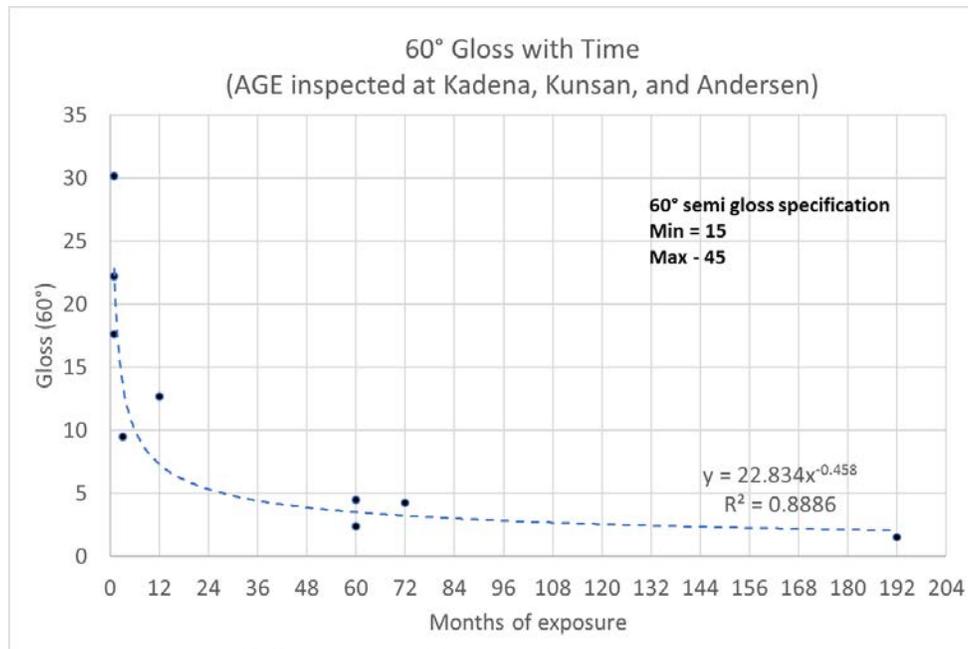
Figure 15. Plot of 60° gloss readings vs. time

Assets in which the maturity of the coating could be verified through records were plotted for the 60° gloss readings versus time. This plot included three assets from each of the three PACAF locations. In Figure 16 below we see a dramatic drop in gloss, falling below the minimum specification as soon as three months.
