## **Demonstration of an In Situ Pipe-Lining Technology for a Fire Suppression Deluge System at Fort Drum, NY**

Final Report on Project F07-AR17

May 2018

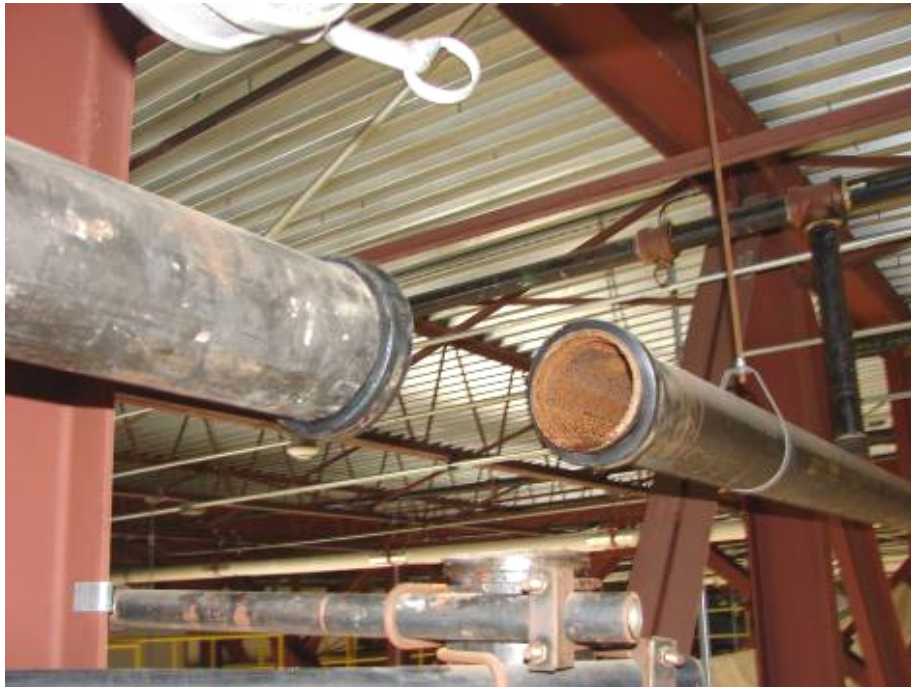
Figure 2. Deluge system with tee removed.

All plumbing within both the AFFF distribution system and the deluge system consisted of black iron pipe (Figure 2), with a combination of threaded fittings and couplers.

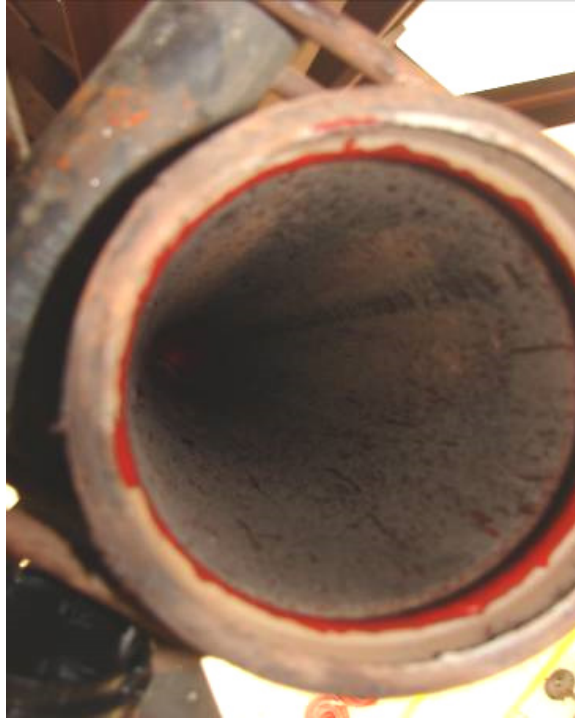
Figure 5. Interior of the deluge system's main pipe after sand blasting.

As part of the barrier-coating process, the metallic surface must be clean and free of any corrosion, oil, water, or debris (Figure 5). To achieve this clean surface, an abrading agent (grit) was introduced into the air stream

and into the piping. As the grit moved through the plumbing via the forced air, the grit removed scale and corrosion from the interior of pipe walls.

Per the epoxy lining manufacturer's specifications, a minimum surface-roughness profile of 2 mil was required for proper adhesion and bonding of the epoxy to the pipe. To ensure that the specified profile minimum was met, an impression tape called Press-O-Film<sup>4</sup> was used. Once the impression was taken of the pipe's interior surface, the profile was measured with a micrometer.

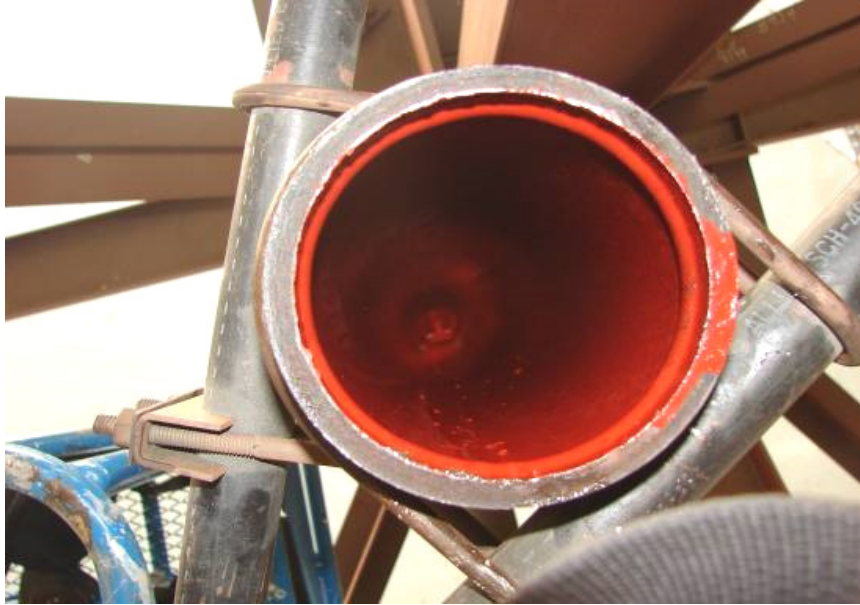
Figure 6. Inside the deluge system's main pipe after epoxy lining.

had reached the exit air connection and had thinned to specified thickness. To gage the thickness of the epoxy coating, wet film thickness cards were used. An epoxy-lined pipe is shown in Figure 6.

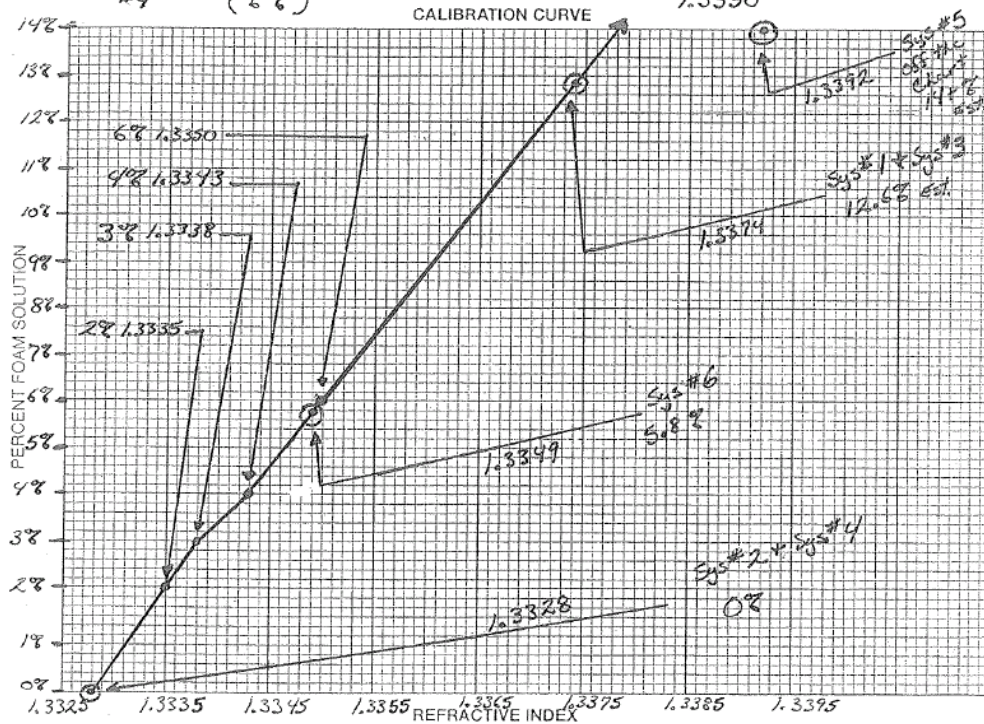
Upon completing the scope of work and testing the samples of mixed AFFF and water, Davis-Ulmer found that each riser had minor to significant failures in the proportioning of water to AFFF. Appendix C shows the Davis-Ulmer report with calculations and conclusions. As noted in that report, most of the ratios of AFFF to water were too high, and two of the systems were reported to have no AFFF solution in the mixture.

SYSTEM DISCHARGE SAMPLE	REFRACTIVE INDEX	PERCENT FOAM SOLUTION
System #1	1.3374	12.6% Est
System #2	1.3328	0%
System #3	1.3374	12.6% Est
System #4	1.3328	0%
System #5	1.3392	14% Est
System #6	1.3349	5.8%
