Guided Wave Testing of Trunnion Rods at West Point Dam, Georgia

by Jason D. Ray, Richard W. Haskins, and James A. Evans

PURPOSE: This Coastal and Hydraulics Engineering Technical Note (CHETN) describes trunnion rod crack detection testing using the portable guided wave test system on a sample of the trunnion rods located at West Point Dam, Georgia, in January 2016. It is also intended to be used as a guide for test efforts at other sites.

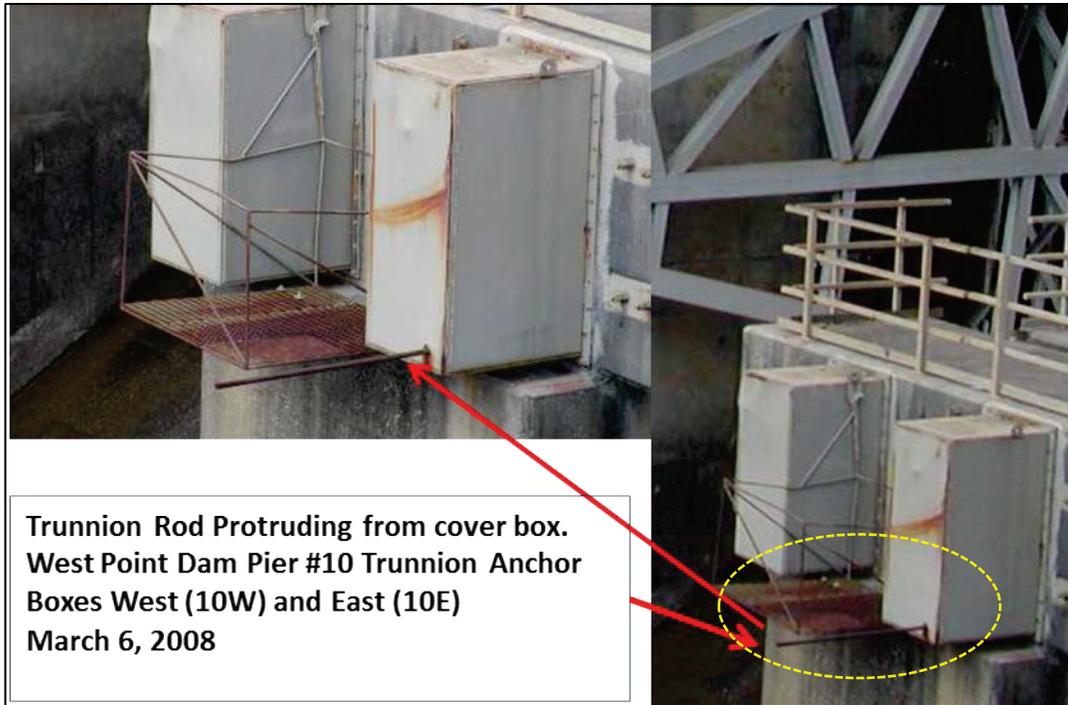
Trunnion rods are now failing at dam sites. Several of these broken rods project through the trunnion anchor cover boxes, as highlighted in Figure 2. The appearance of the cracks in the rods examined indicates that the trunnion rods had been cracked for some time prior to breaking. Stress corrosion cracking may have caused the final loss of the trunnion rod shown in Figure 3. As of 2012, 10 USACE dams contained broken trunnion rods (Table 1).

Figure 2. Trunnion rod protruding from the protective case after breaking.

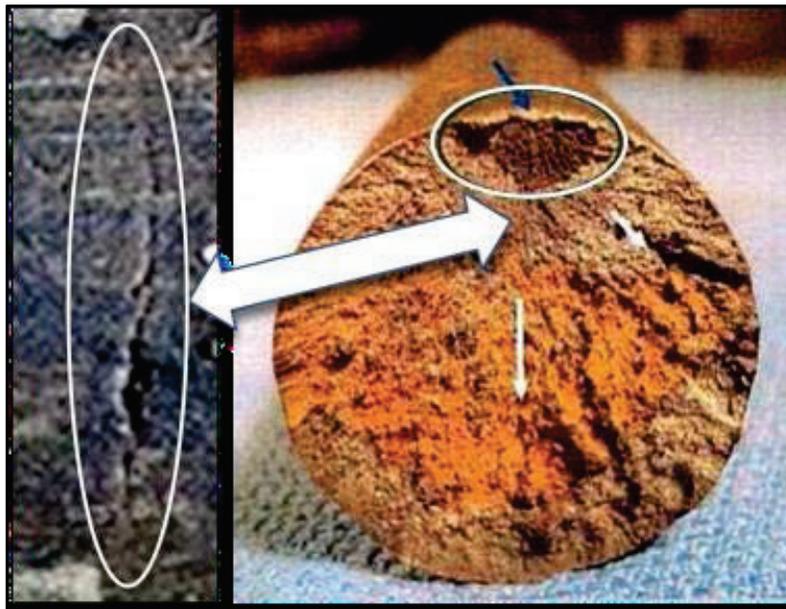
Figure 3. Emerging trunnion rod surface crack (left) and rod completely broken (right).

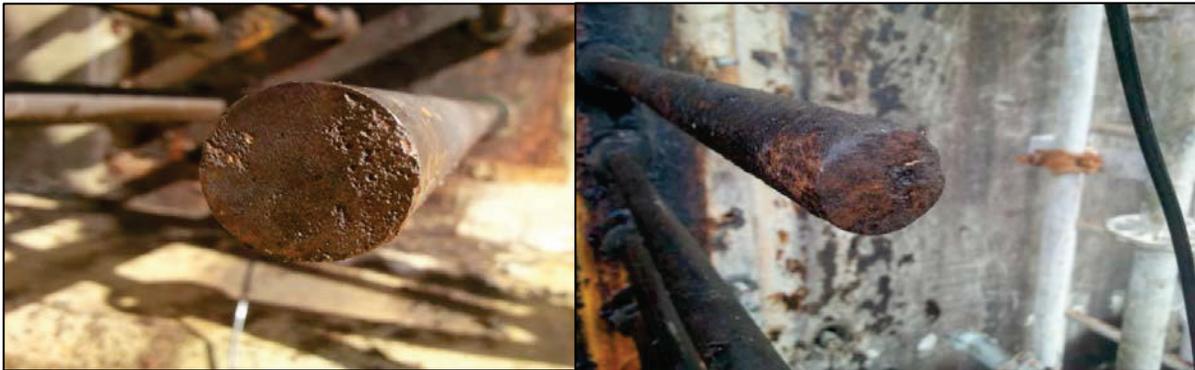
TEST PLAN: Safety concerns at this dam dictated that no grinding or unnecessary contact with the rods would be allowed. It was known before testing that the rod ends were, for the most part, in good shape and would not require any work to prepare the surfaces. A few rods exhibited surface anomalies (Figure 4). Other rods were very flat and were quite responsive to the test (Figure 5).

Figure 4. Pitted rod and surface corrosion on rod.

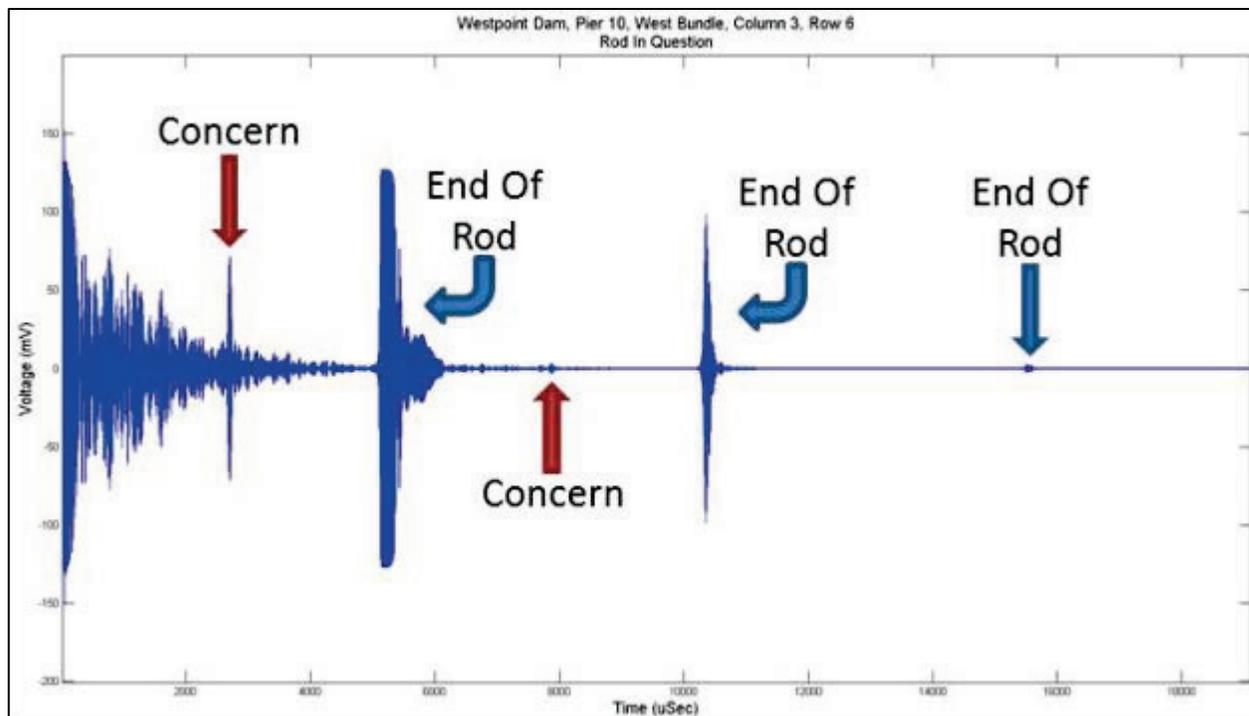
A non-typical response from a rod is shown in Figure 11. Note the return midway between the exciting pulse and the end of rod reflection.

Figure 11. Pier 10, west bundle, column 3, row 6 display, showing areas for concern.

Figure 11 is an annotated display of the data set from a trunnion rod on Pier 10 that displays a possible crack. Although several things could cause the unusual return in these data, the history of this particular pier makes it reasonable to suspect a crack in the rod. Additional analysis of the data set is being conducted to increase the assurance that a defect is present.

CONCLUSION: The purpose of this CHETN is twofold: (1) to describe the testing done at West Point Lock and Dam and (2) to provide an overview of the procedure used to test rods at any dam site. Of the rods that were tested at the West Point dam, one displayed a probable defect. This defect is believed to be a crack in the rod.
