## **Rock Demolition and Hazardous Debris Removal for Ecosystem Restoration on the Elwha River**

Charles W. Ertle, M. Jason Roth, John S. Judson, and  
George H. Vankirk

May 2019

Final report

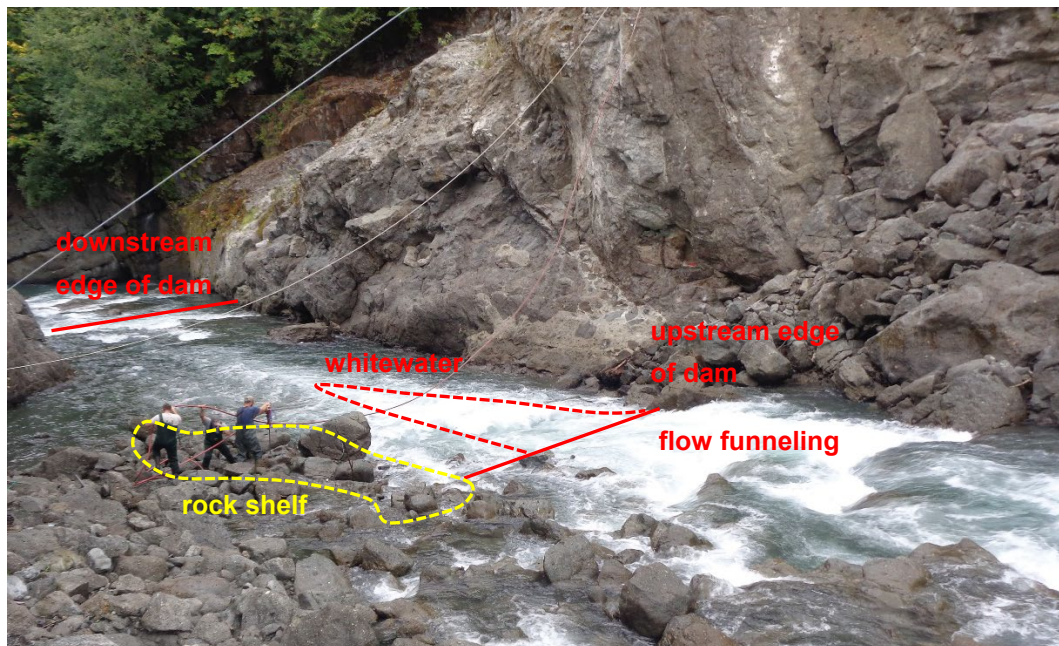
Approximately 80-90 percent of the river channel was safely accessible for the underwater cutting operations. However, flow conditions and a trench that was discovered by the divers created an area near mid-channel that could not be safely accessed. Just upstream of the dam site, several boulders created a restriction that funneled the majority of flow towards the middle of the channel. This created a whitewater jet with significantly higher water velocity, as shown in Figure 17 through Figure 19. Divers were able to work to the left and right of the whitewater area, but velocity and loss of water clarity made cutting in the whitewater area impossible.

Figure 17. Whitewater area at ELD site.

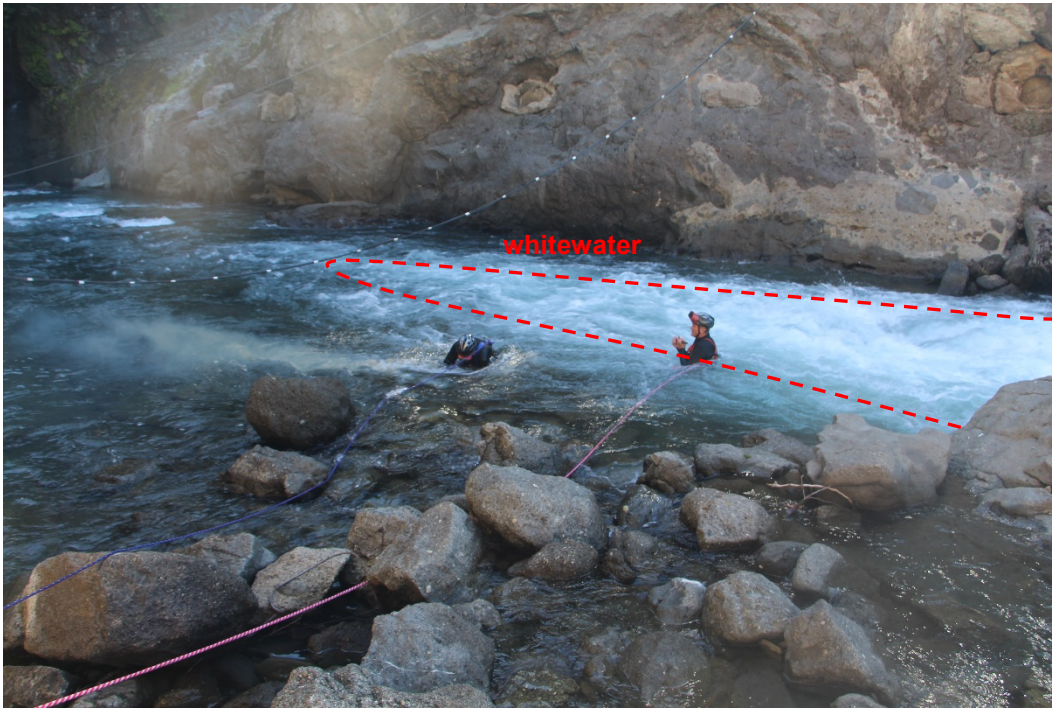
Figure 18. Whitewater area at ELD site, close-up view.

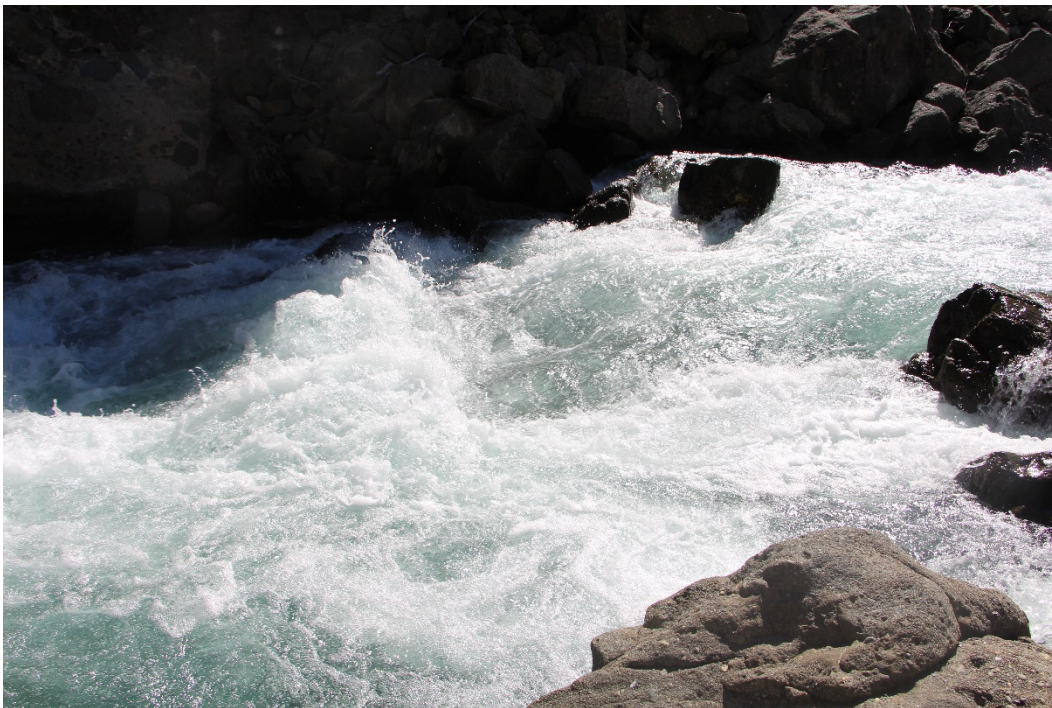
Figure 19. Flow funneling at upstream edge of dam.

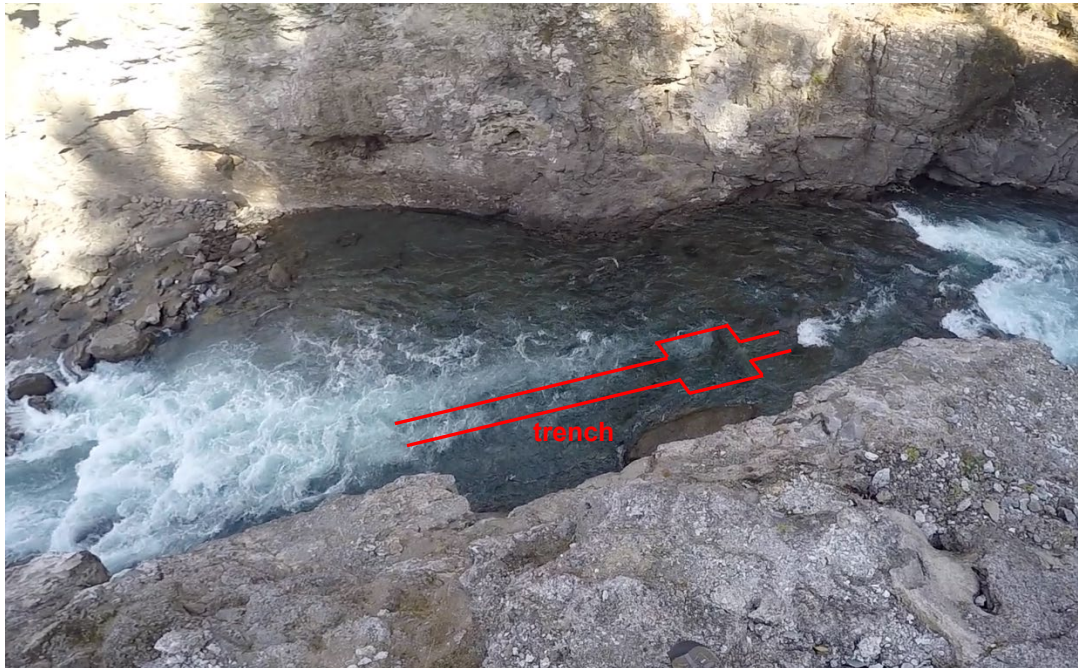
Further complicating the midchannel access was the divers discovering a trench in the concrete foundation that ran underneath the whitewater area. The trench appeared to be manmade and was formed into the concrete. It was approximately 2 ft to 3 ft wide and ran parallel with the riverbanks, i.e., it ran with the direction of water flow. The trench extended into the whitewater area in the upstream direction, so the divers could not see the upstream end of it. Towards the downstream edge of the foundation, the trench widened into a box-type depression that also appeared to be manmade. Rebars were protruding from the edges of the box and were cut by the divers. The divers also observed additional rebar in the box and below the top surface of the concrete foundation. That rebar could not be safely reached, but it was not considered a significant issue, since it was depressed below the foundation surface. A picture of the trench area is shown in Figure 20.

Figure 20. Approximate location of trench in ELD foundation.

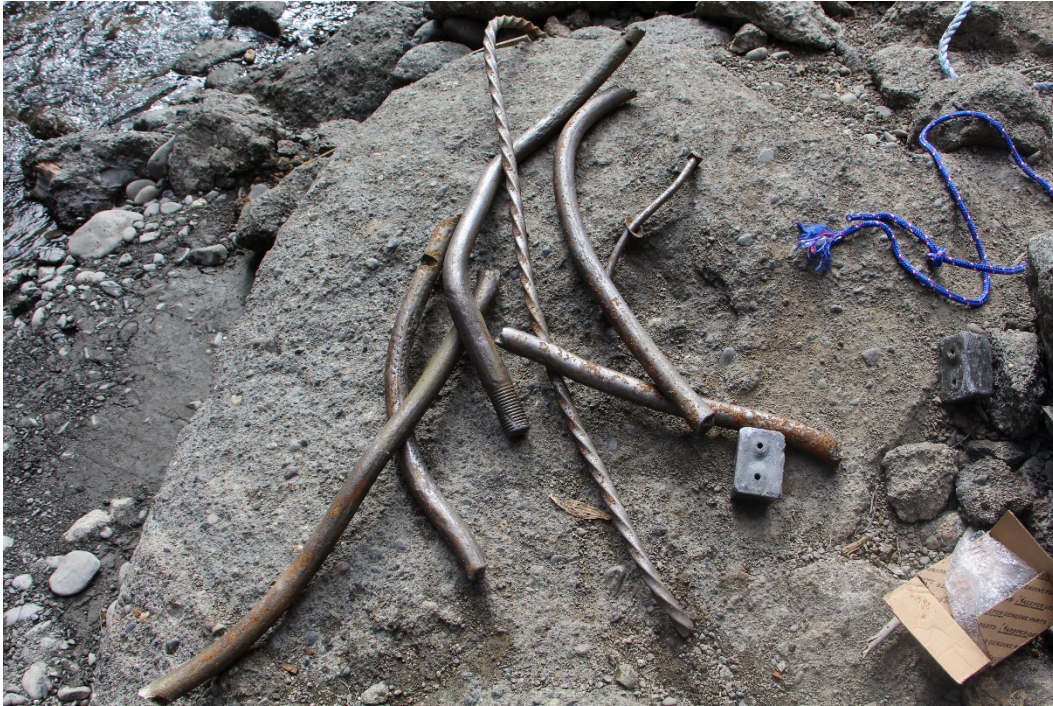
A total of 104 pieces of metal debris ranging from 6 in. to 161 in. in length were removed from the accessible areas. The metal debris consisted of twisted rebar, round stock, flat bar, square stock, and concrete anchors; typical debris is shown in Figure 21. A picture of all of the debris removed from the river is shown in Figure 22. The debris was collected in 9 main locations along the river channel with large concentrated areas of debris (5 or more pieces of debris) found in locations 2, 4, 5, 6, and 9 (see Figure 23). Figure 23 shows a panoramic view of the dam site with the inaccessible area shaded in red and the numbered areas where metal debris was identified and removed outlined in yellow. Table 1 lists all of the debris removed by type, length, diameter, and location.

Figure 21. Typical metal debris from ELD site.

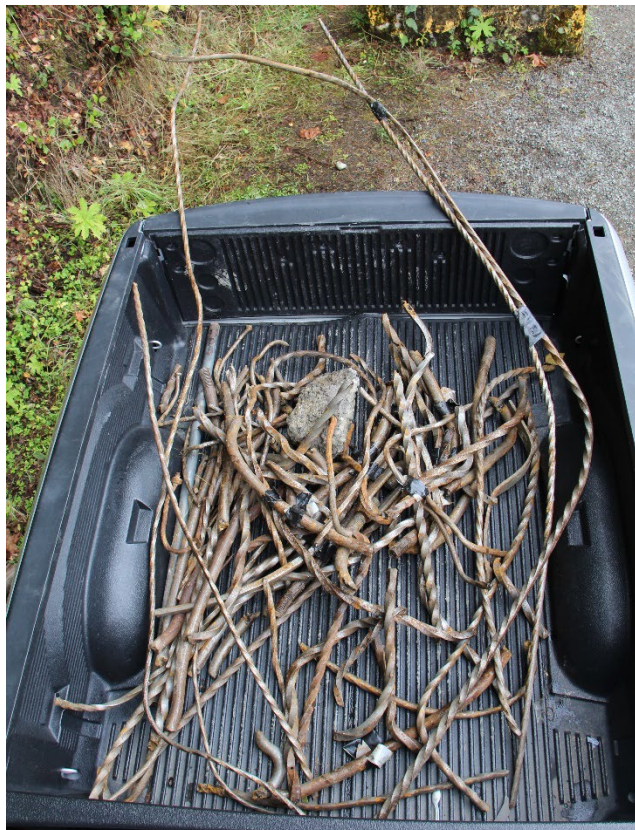
Figure 22. Metal debris removed from ELD site.

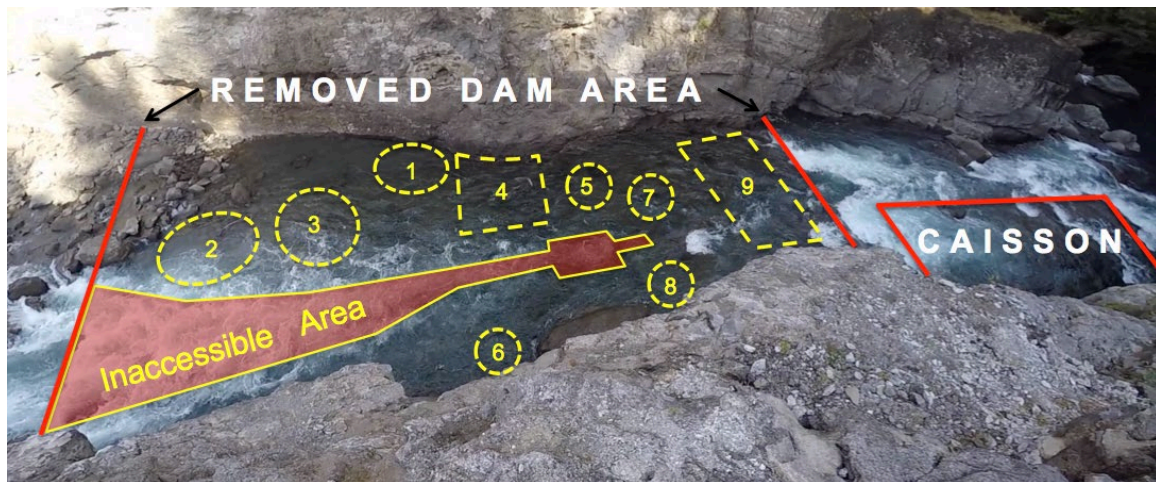
Figure 23. Panoramic view of ELD site with hazardous debris locations.

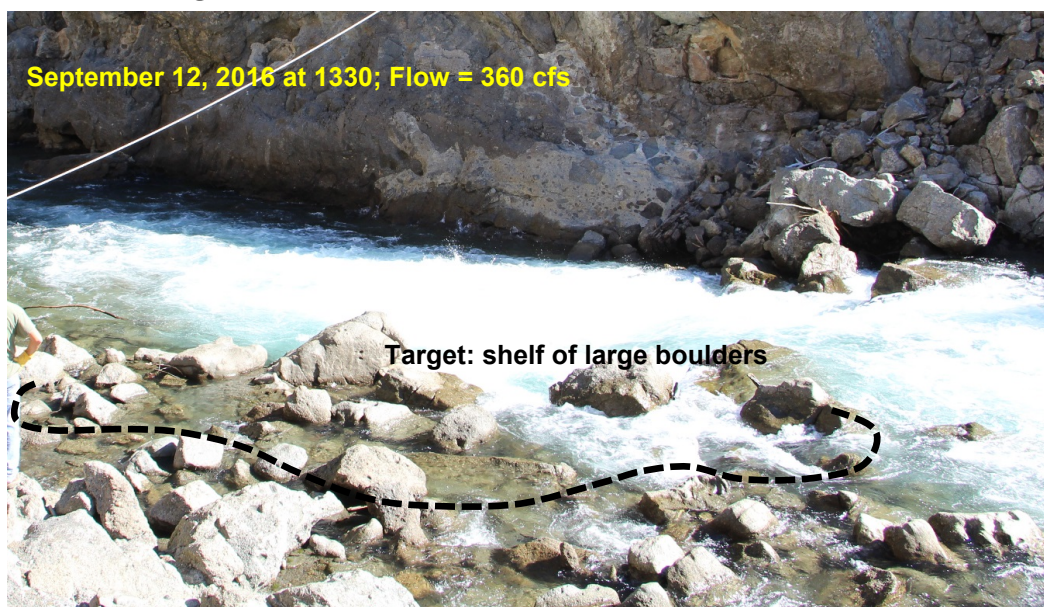
river-left bank (see Figure 17). The shelf caused flows to concentrate towards the right half of the channel and form a jetting area and a large hydraulic jump. As discussed in Section 3.1, this area could not be accessed by the dive team for rebar removal. Therefore, the expectation for demolition along this shelf was to reduce the flow restriction and increase boater access towards the river-left bank, which was more accessible for rebar clearing. The two large boulders downstream of the caisson were positioned side by side and constricted approximately half of the river's flow path. This created a hydraulic jump in the vicinity of the boulders and also created a location to catch smaller boulders from upstream. According to NPS-ONP, removal of these two boulders would reduce the velocity gradient and the potential for more significant blockage in the future as rocks wash downstream through the dam site.

Figure 26. Rock shelf upstream of ELD site, pre-demolition.

Eight large boulders were demolished at the upstream shelf in two detonations on the afternoon of September 16. The total charge weight for the first shot was 3 lb; the second shot was also 3 lb. Flow rate at the time of demolition was 375 cfs. The charges were successfully detonated and fractured all of the target boulders to the water line. A picture of the rock shelf prior to demolition at a river flow rate of 360 cfs is shown in Figure 26. A picture of the rock shelf after demolition at a flow rate of 375 cfs is shown in Figure 27. It is expected that the high winter and spring flows will clear the demolition debris, which was characterized by 2-ft to 3-ft sized rubble.

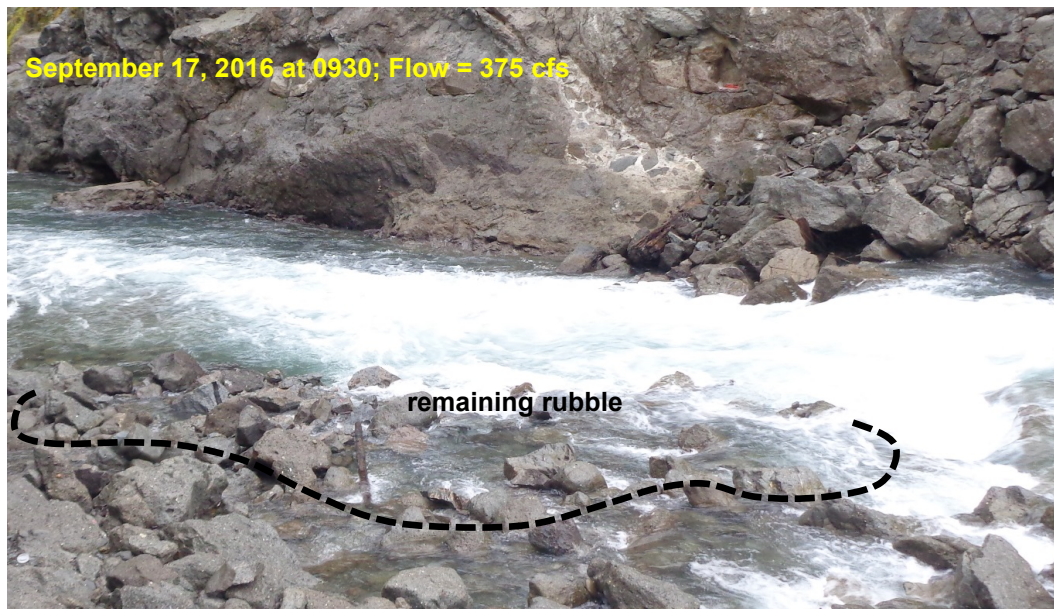
Figure 27. Rock shelf upstream of ELD site, post-demolition.

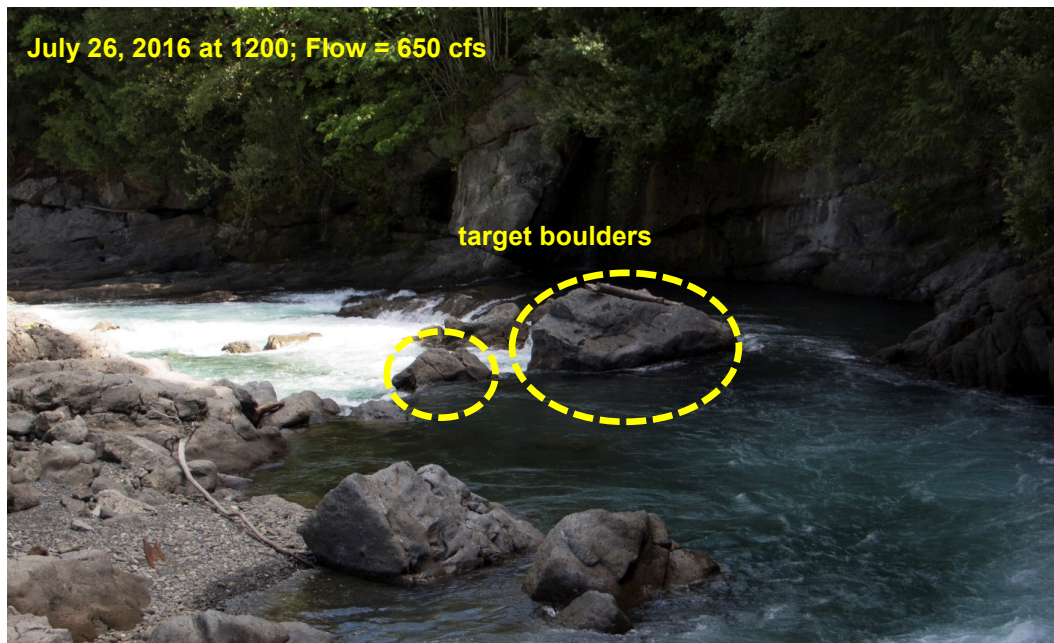
Figure 28. Boulders downstream of ELD caisson, pre-demolition.

The two large boulders downstream of the caisson were demolished in a single detonation on September 18. The total charge weight was 18 lb. Flow rate at the time of detonation was 350 cfs. The charges were successfully detonated and fractured both of the target boulders to the water line. A picture of the boulders prior to demolition at a river flow rate of 650 cfs is shown in Figure 28. A picture of the boulders after demolition at a river flow rate of 320 cfs is shown in Figure 29. A close-up view of the boulders from river-right bank after demolition is shown in Figure 30. As seen, the boulders were generally reduced to 2-ft to 4-ft rubble, which is expected to be moved downstream during winter and spring flows. The detonation process recorded on high-speed video is shown in Figure 31.

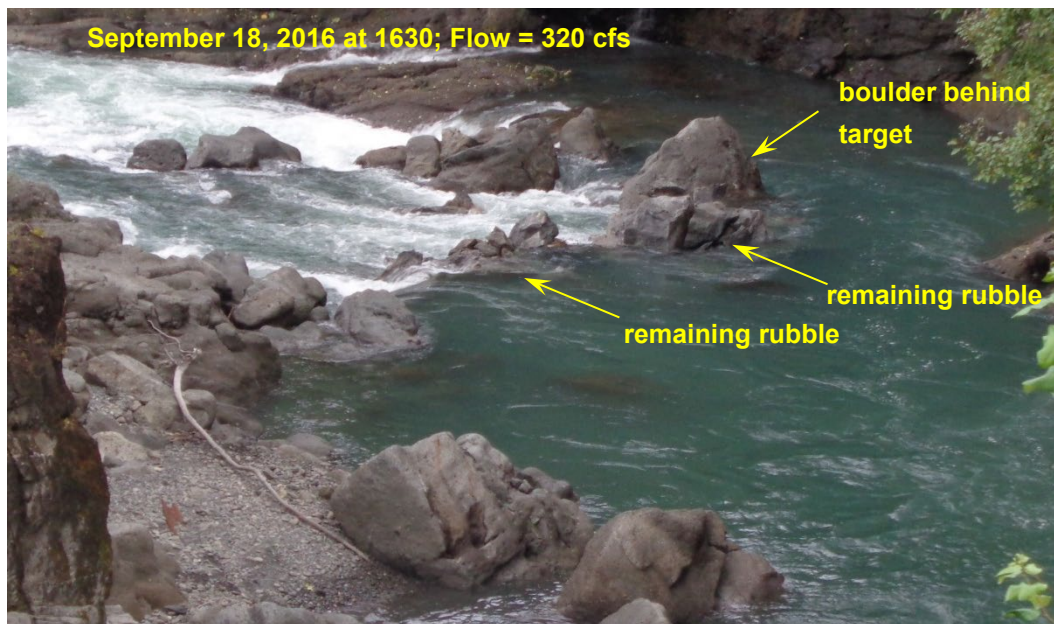
Figure 29. Boulders downstream of ELD caisson, post-demolition.

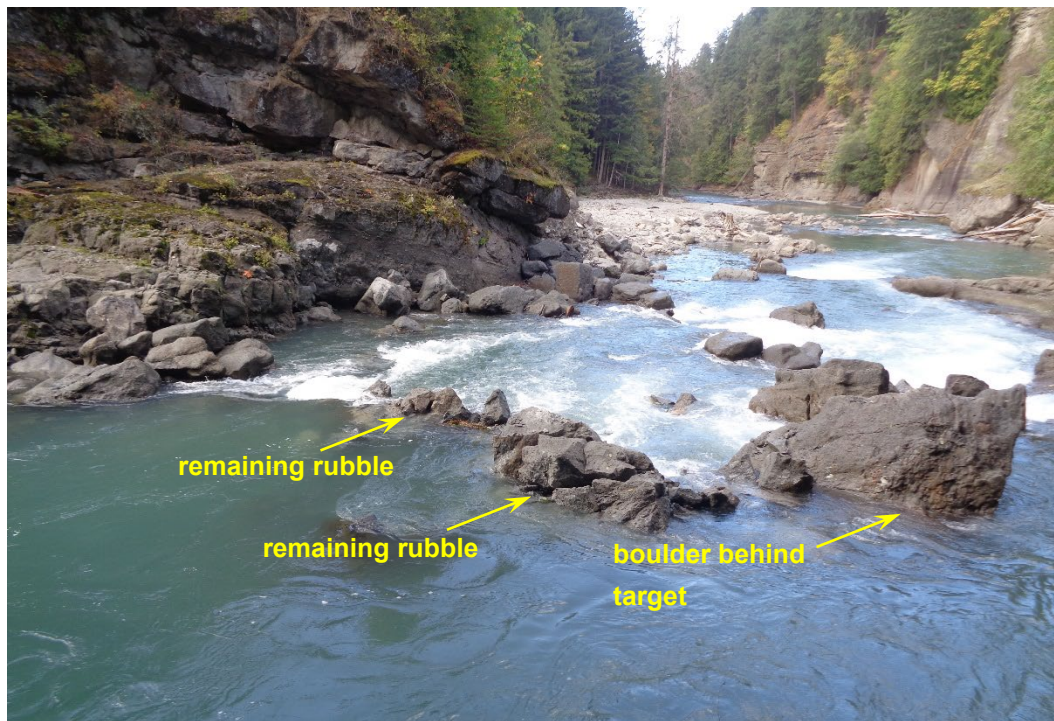
Figure 30. Post-demolition conditions at boulders downstream of ELD caisson.

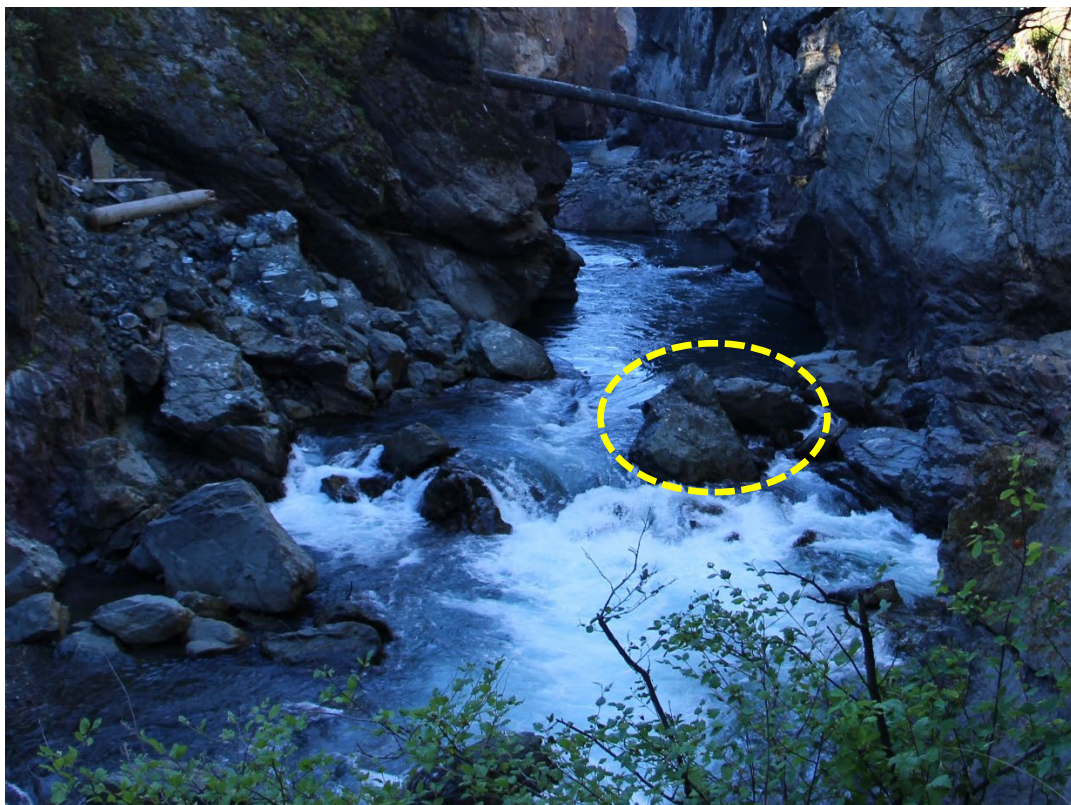
Although a large portion of the channel obstructions were addressed during construction and the follow-on blasting, several large boulders remained that created potential hindrance to fish passage. Channel conditions in July 2016 are shown in Figure 36. Boulders at the river-left bank that are seen in the 2015 photo (Figure 35) are circled in yellow.

Figure 36. Channel downstream of GLI in July 2016.

To address the river constriction and hydraulic jumps caused by the remaining boulders, NPS-ONP requested that several large boulders at river-left and -right banks be demolished as part of this project. Rock formation at the Glines Canyon site differed from the Elwha geology. At GLI, the rock was reported to be Crescent Basalt that is heavily folded and faulted. The Crescent formation was reported to be weak, but during drilling operations, it was observed to be stronger than the rock at ELD.

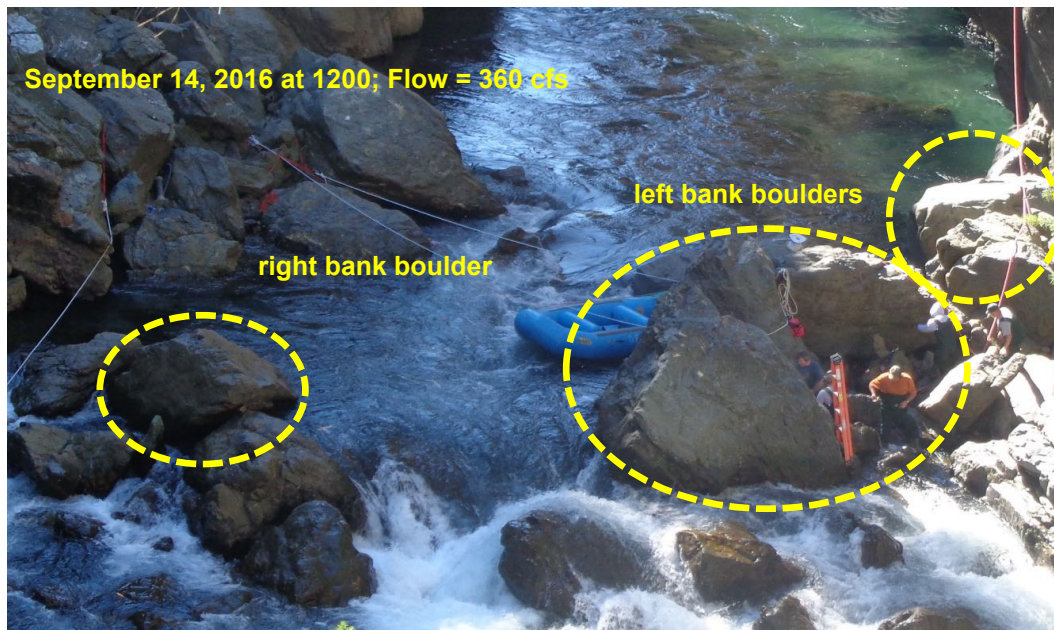
Demolition at the GLI site focused on seven boulders located near the July 2015 blasting area. Six of the boulders were located at the river-left bank, and one was located at river-right. These boulders obstructed approximately half of the channel flow path, which resulted in a large hydraulic

Figure 37. Boulders at GLI prior to demolition.

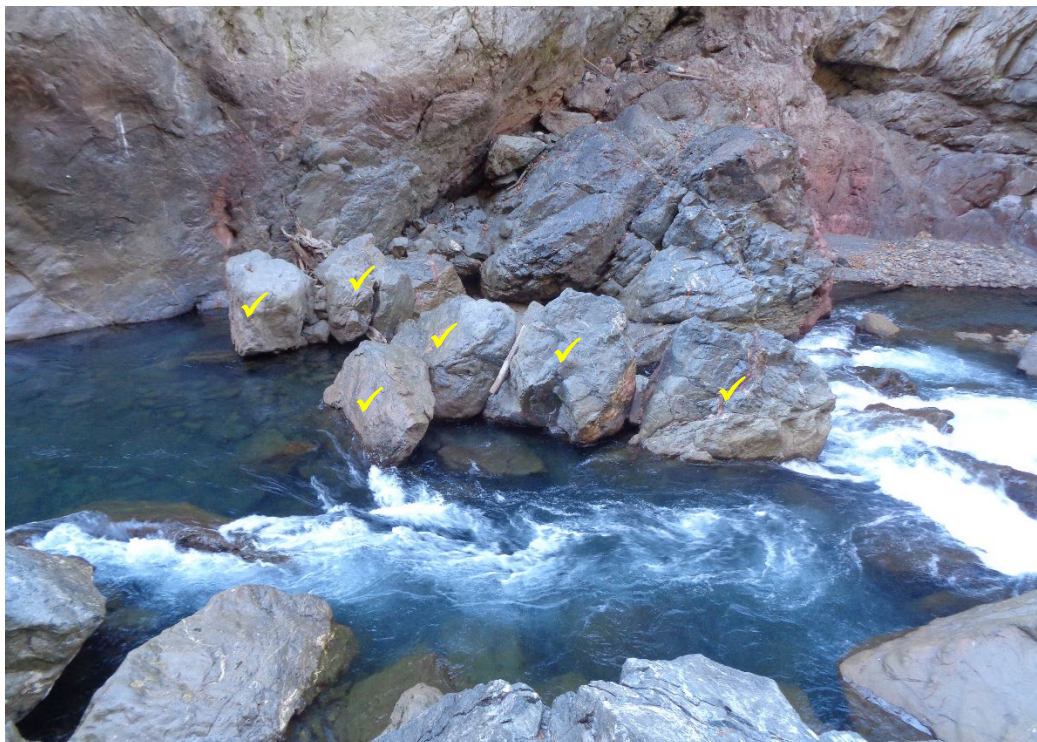
Figure 38. GLI left bank boulders prior to demolition.

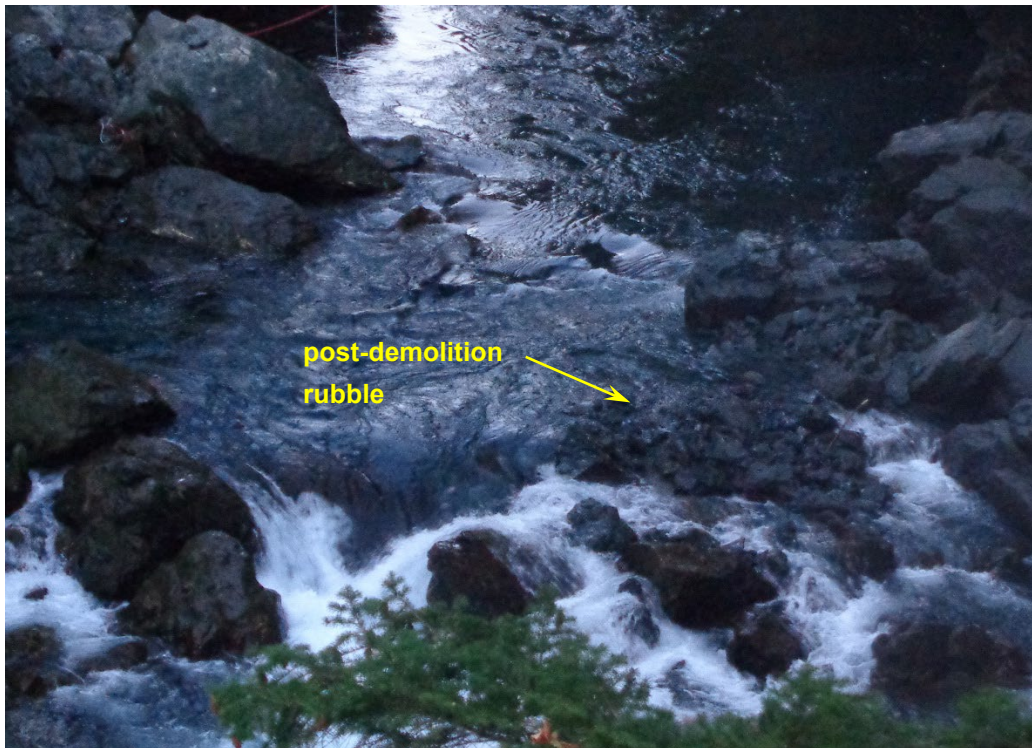
Figure 39. GLI left bank boulders after first two detonations.

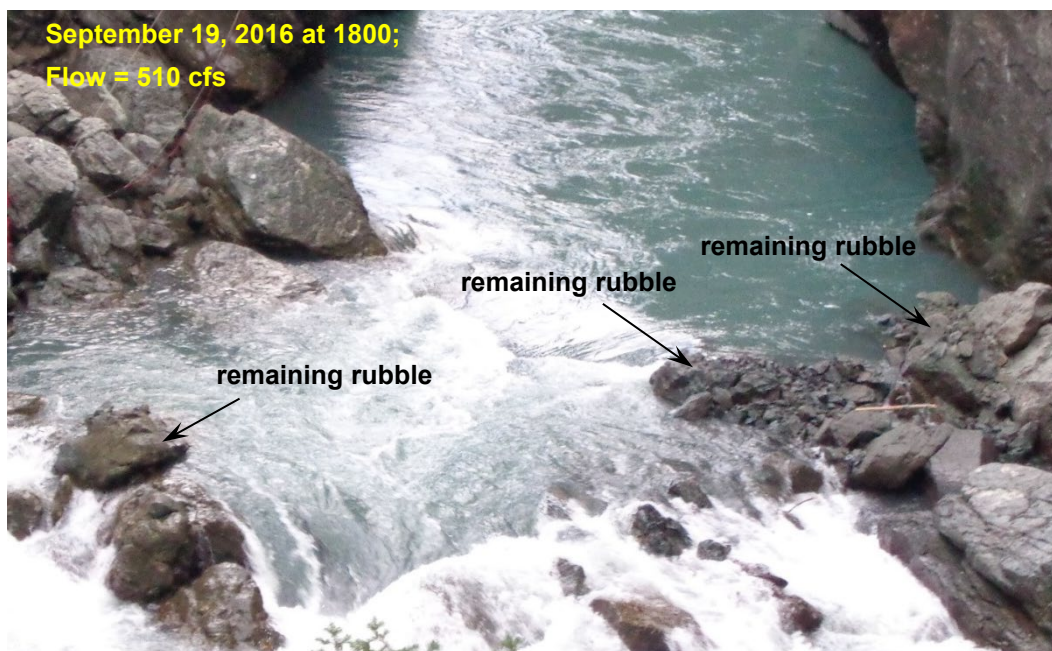
Figure 40. GLI after completion of demolition.

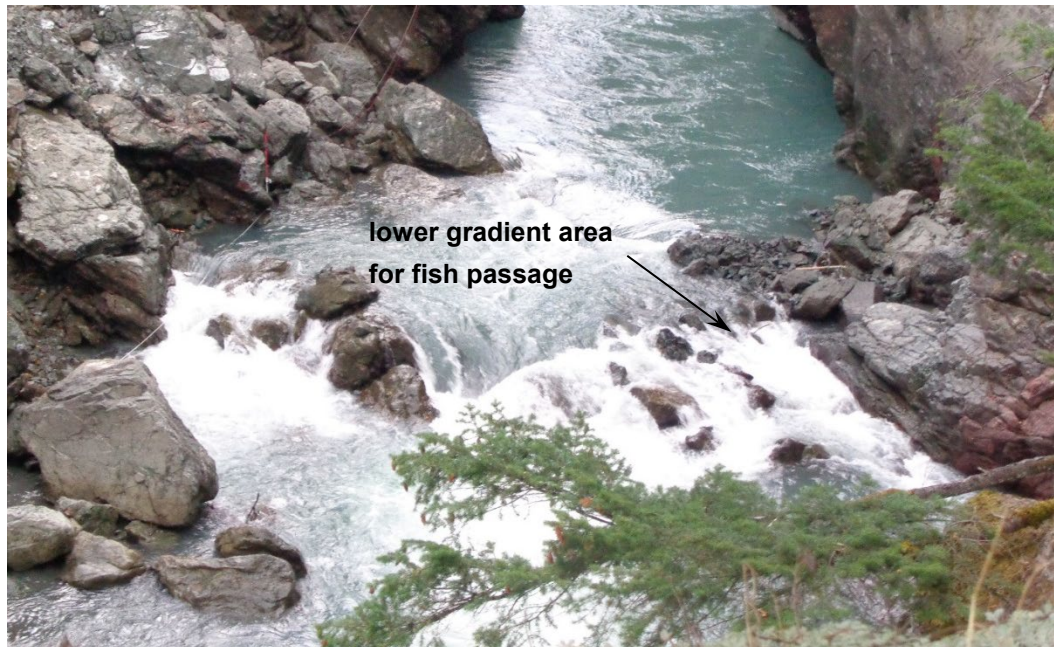
Figure 41. Improved fish passage conditions at GLI following demolition.

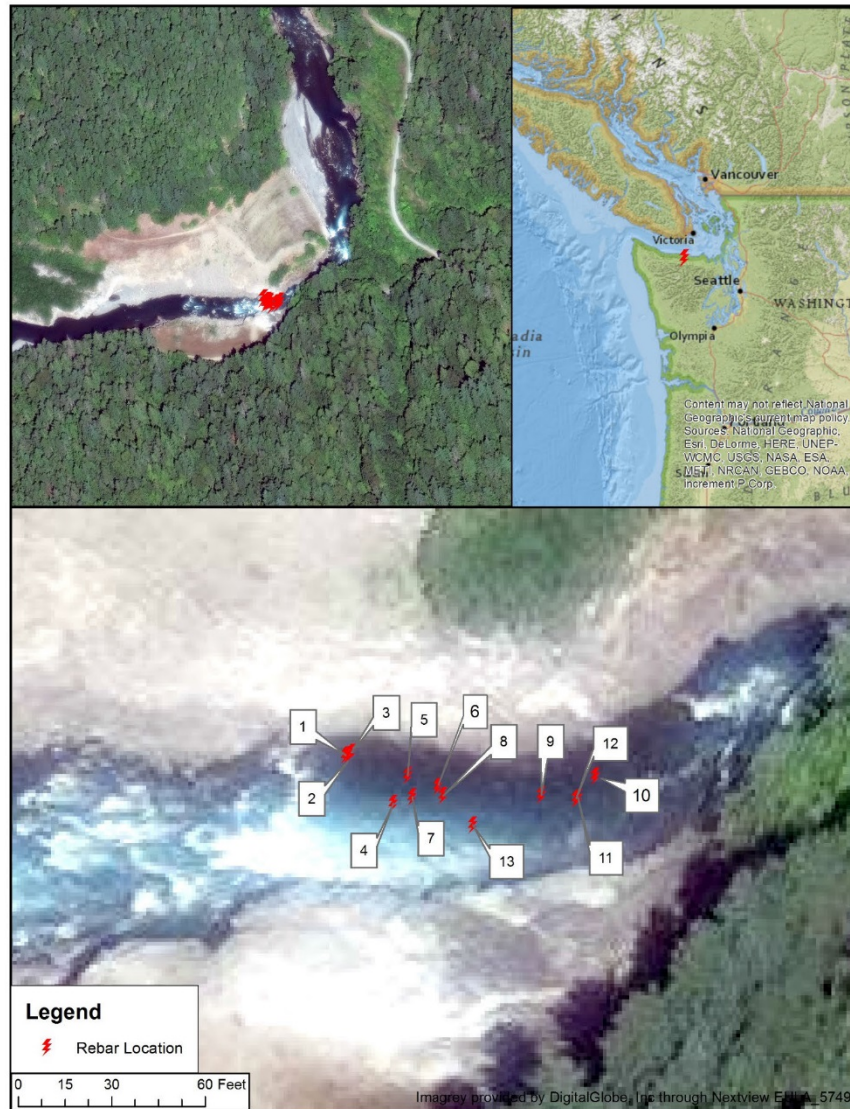
Approximately 25 pieces of debris were identified during the underwater survey, which were located in 11 spots along the river channel. Several of the locations had groups of rebar protruding from the dam foundation, as indicated by the number of pieces identified versus the number of locations. The surveyed debris locations are shown in Figure 3; debris identified during a 2015 snorkel survey by NPS are circled in red and yellow in Figure 2. At most all of the locations, the debris consisted of single pieces of twisted rebar; the rebar was generally between 1-ft and 3-ft-long. From a piece collected at the river's edge, the rebar is approximately 1-in. in diameter. Pictures of the rebar taken by the underwater camera are given in Appendix 1 to this report.

Figure 3. Surveyed metal debris locations at ELD site (survey limited to left portion of channel).

Based on results of this survey and the nature of the metal debris, it is recommended that removal be performed with an exothermic cutting torch system such as the Broco BR-22 underwater cutting torch. This torch is specifically designed for underwater cutting, and uses an oxygen feed and electrical current to create an exothermic cutting tip that is maintained under the water. The size of rebar identified in the survey is within the cutting capacity of the torch system. Explosive methods were also considered and could be used for the debris removal; underwater linear cutting charges produced by Accurate Energetic Systems were identified as an explosive technology that could be used in this project. However, the cutting torch approach is expected to have lower logistical requirements compared to explosive methods, i.e., alleviate explosive transport, handling, placement, etc., so that the torch is recommended as the first choice approach.

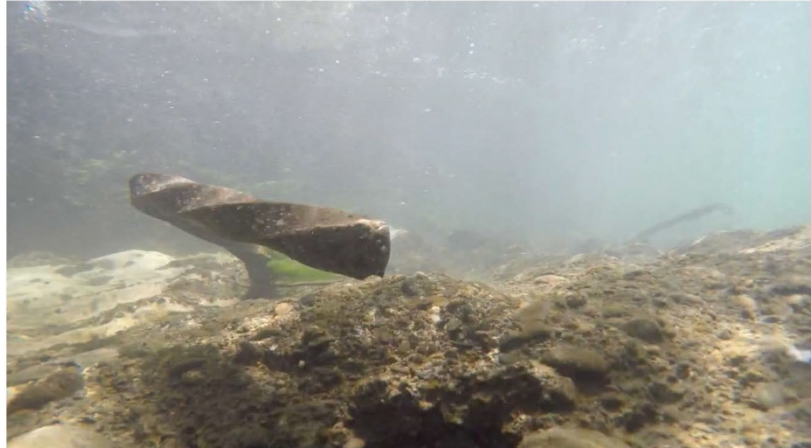
Figure 10. Metal debris, location 1.

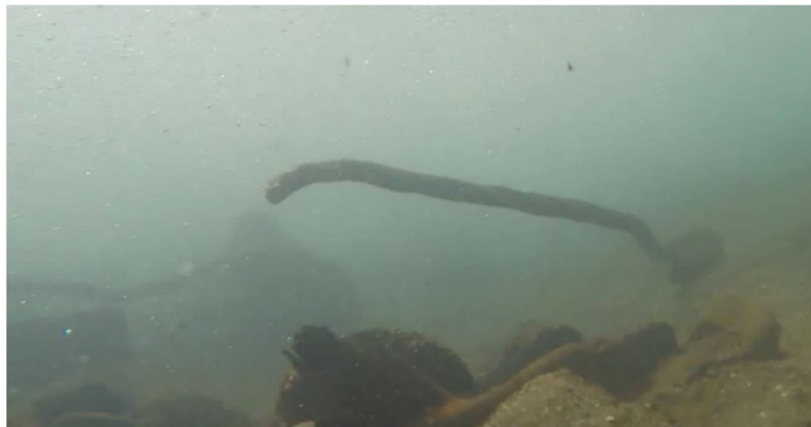
Figure 11. Metal debris, location 2.

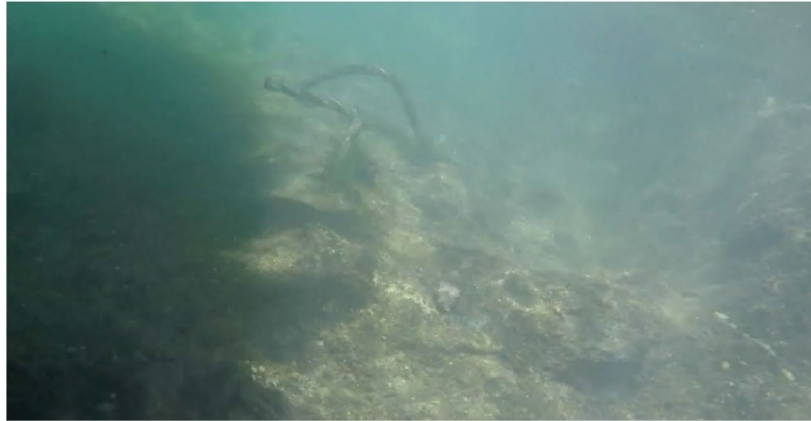
Figure 12. Metal debris, location 3.

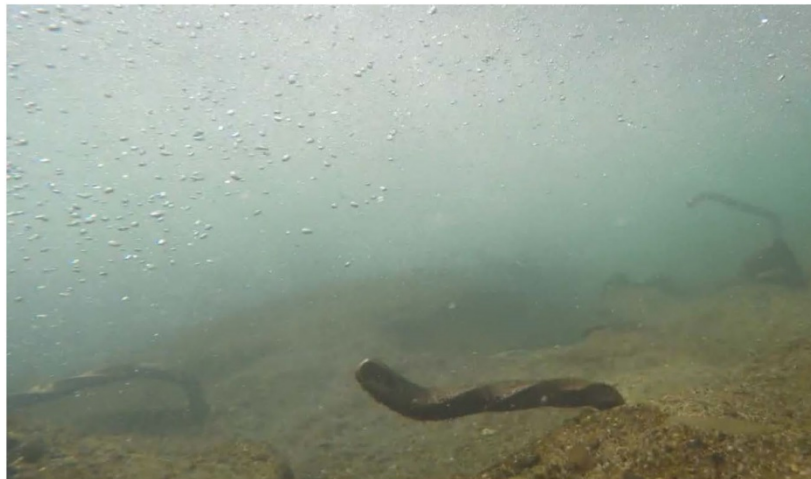
Figure 13. Metal debris, location 4.

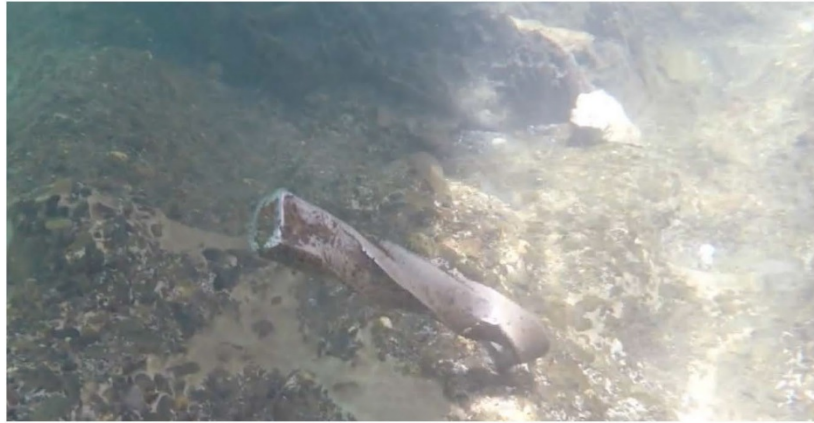
Figure 14. Metal debris, location 5.

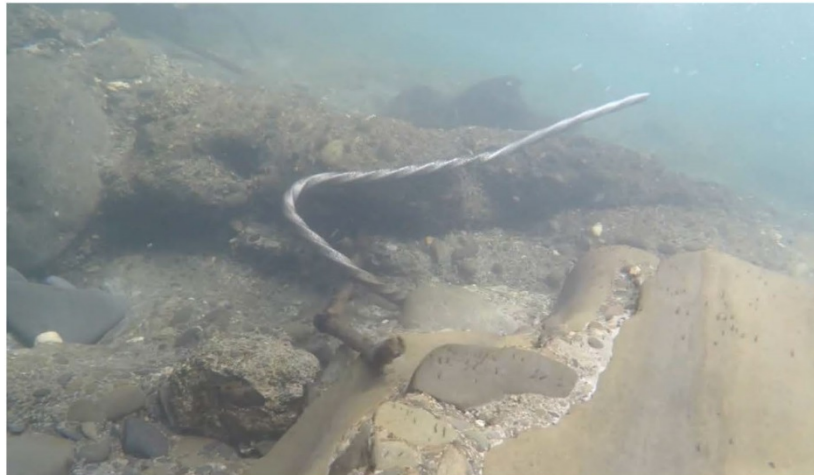
Figure 15. Metal debris, location 6.

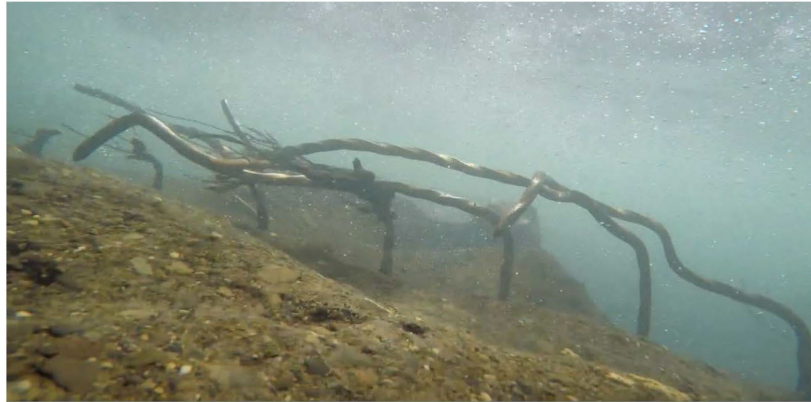
Figure 16. Metal debris, location 8.

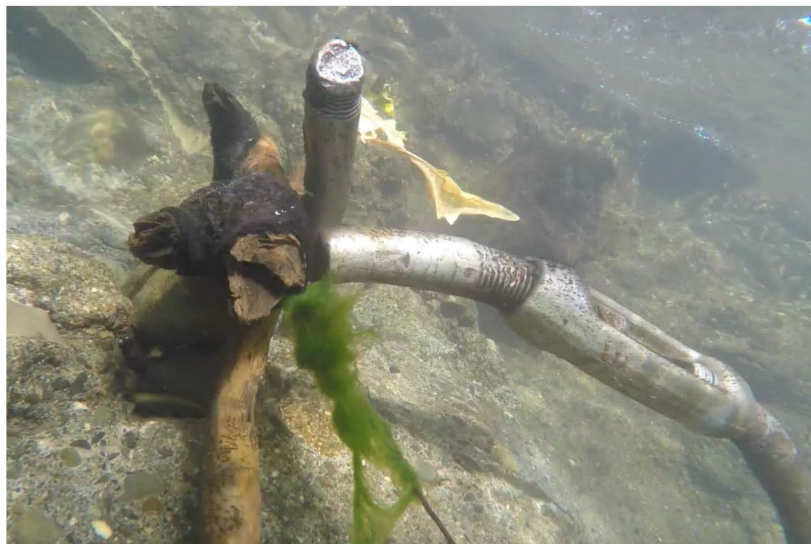
Figure 17. Metal debris, location 9

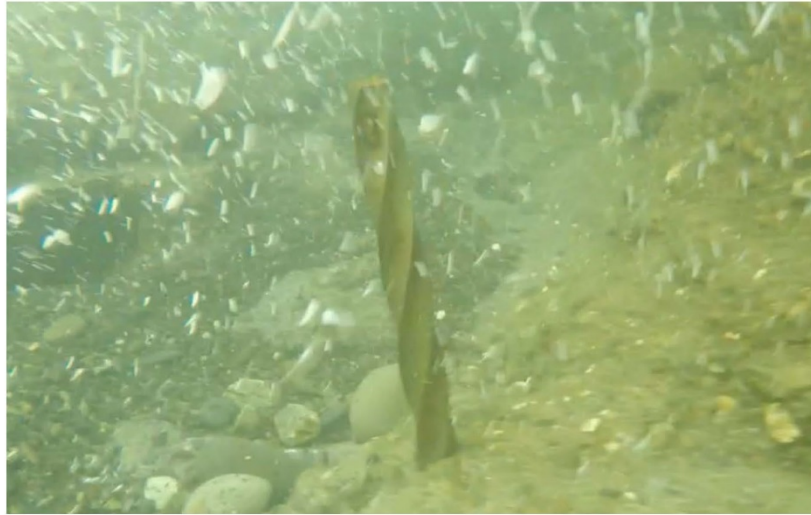
Figure 18. Metal debris, location 11
