# SITE SPECIFIC REPORT SSR-2410-SHR

## IMPACT LOAD TESTS, STRUCTURAL ANALYSES AND LOAD LIMITATIONS OF THE MARGINAL WHARF

TRIDENT REFIT FACILITY NAVAL SUBMARINE BASE BANGOR, WASHINGTON

September 1998

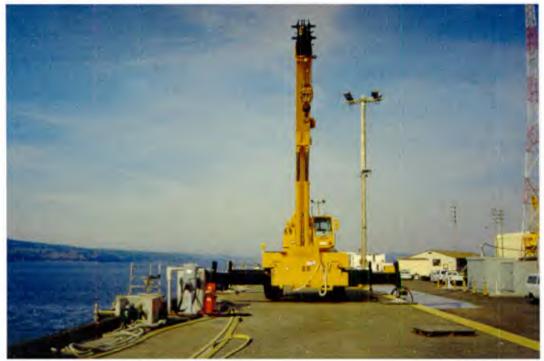
Operators of mobile cranes on the south platform place outriggers on, or near, the outside pile Lines, A and E, of the platform (Figure 7). These piles, as well as the 12-inch by 12-inch post supporting the deck above the pile caps must be maintained in excellent condition. Outriggers are placed on wood panel cribbing. While these wood panels will prevent the deck surface from being scarred by the outrigger floats, they are not sufficiently stiff to enhance distribution of the outrigger loads. To spread the outrigger load further than the floats, heavy timber or, preferably, metal cribbing should be employed. The disadvantage of proper cribbing is its heavy weight, which usually requires a forklift for positioning.

Figure 7. Truck crane on the south platform of the Marginal Wharf.

Damaged piles 42A and 64A are critically located for supporting outriggers along Line A on the outboard edge of the south platform (see Figure 7). The past two inspection reports have noted the damage and recommended replacement of the piles.

NFESC recommends that the two damaged piles along the outboard edge of the south platform be rehabilitated by encasing the damaged section in composite shells filled with nonshrink grout or mortar. It is necessary to return these piles to their original strength because maximum loaded outrigger floats are placed along pile Line A. We also recommend a crane pathway be developed over the main deck to the loading platforms. Carbon composite reinforcement can be added to the top of the deck slab over the rail girders and to the bottom of the approach slab and other slabs of the main deck that are necessary to create a path to the platforms. Main deck load capacity can be increased approximately 20 percent by addition of reinforcing over the rail girders to allow travel of all cranes except Grove RT880.

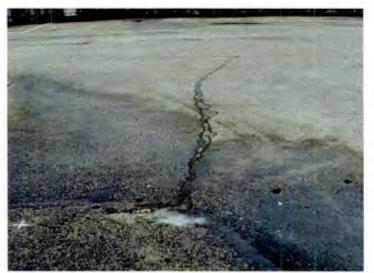
In addition to the two broken piles there are two structural conditions that could restrict the load carrying capacity of the pier deck at some time in the future. One is the presence of large cracks that have occurred because of the absence of expansion joints in the original construction (Figure 8) or structural modifications to the original deck. Large transverse crack systems occur at Bents 31, between Bents 68 and 69, and between Bents 110 and 111. Attempts to patch and seal these cracks have failed because they are working cracks and continue to widen and grow. We suspect the reinforcing bars at these cracks are badly corroded which may result in a loss of section strength. Similarly, structural modifications to the approach and the platforms have resulted in construction joints that did not integrate with the original deck slab. The "new" construction boundaries have resulted in open cracks. Exposed reinforcing bars are visible on the approach.

Figure 8. Crack emanating from approach addition (in the foreground) between bents 68 and 69.

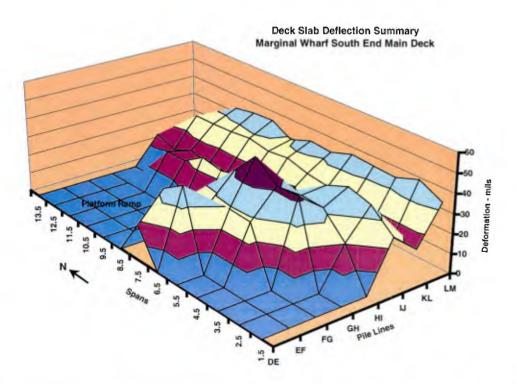
The deck areas at the bases of the ramps also demonstrate softening and cracking due to repeated overloading (Figures 29 and 37).

Figure 29. ILM maximum deflection response summary. Deck slab of south end south pier main deck.

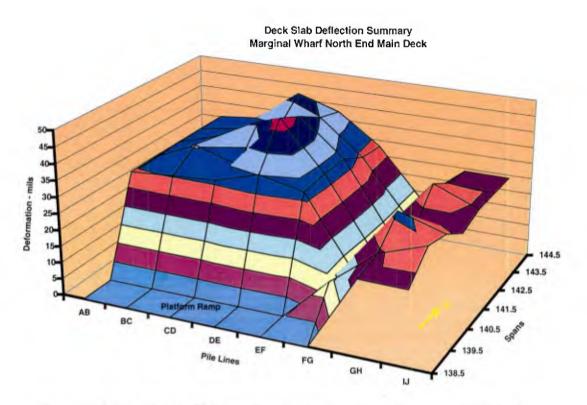
Figure 37. ILM maximum deflection response summary. Deck slabs of wharf north end.

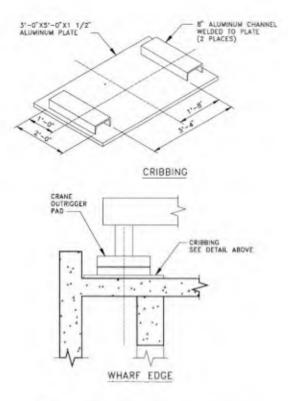
Figure 50. Aluminum cribbing.

We recommend aluminum cribbing replace the wood cribbing now in use. An example aluminum cribbing plate is shown in Figure 50. Steel cribbing proposed by Johnson Controls in August 1992 is also satisfactory. Cribbing should be considered for all outrigger loads in excess of 100 kips.

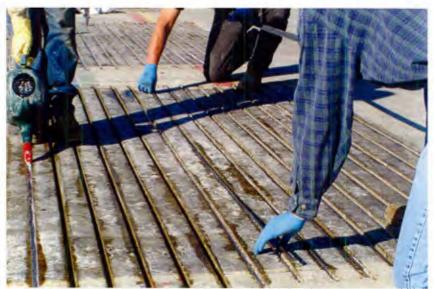
Figure 51. Embedding carbon reinforcing rods in pier deck.

Embedding high strength carbon/epoxy rods into slots filled with epoxy in the top surface of the deck above the rail girders is a relatively easy technique to increase the load capacity of the main deck slab (Figure 51). The traditional alternative approach is to remove more than three inches of concrete from the deck surface, splice in place necessary steel reinforcement, and replace the concrete with shrink resistant grout. High strength carbon rods possess necessary stiffness, strength, and durability to perform better than steel and they are compatible with concrete and epoxy adhesives. The process of cutting slots in the concrete surface and embedding carbon rods in slots is fast and the area can be returned to service within 24 hours after the rods are placed. The required area of high strength carbon rod reinforcing over the rail beams can be satisfied by ¼-inch diameter rods at 6-inches on center (Figure 52). The rods do not require deformations like conventional steel rebar because the rods are embedded in epoxy. NFESC has measured more than 1,200-psi bond strength using the rods embedded in epoxy. A high strength, ¼-inch diameter, carbon composite rod would have a 10-kip ultimate tensile strength and a service limit of 5 kips.

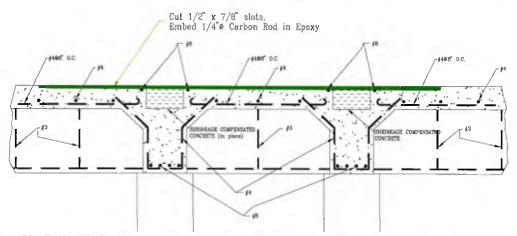
Figure 52. Embedded carbon composite rod to upgrade main deck strength adjacent to rail beams.

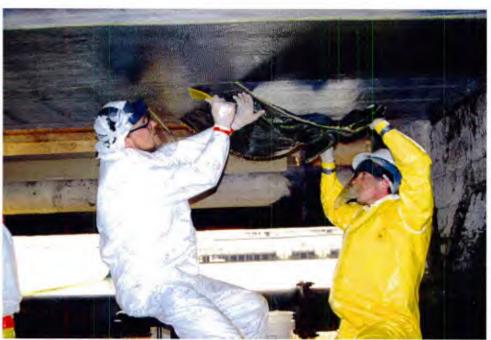
Figure 53. Applying uniaxial carbon fiber sheet to underside of pier deck.

A maximum of five carbon fiber plies can be allowed in the orthogonal directions to obtain the required reinforcement area. The first layer is applied after coating the fiber sheet or the concrete surface with epoxy saturate. Successive plies are added between layers of epoxy saturate. Epoxy saturate is hand rolled and brushed into the tow sheet in order to completely wet the carbon fibers (Figure 53). Excess saturate and bubbles are worked out of each layer by squeegee and roller. Holes are not allowed to be cut in the composite when obstructions such as drains, pipe hangers or other hardware are encountered. Instead, tow sheets are to be split along uniaxial fibers to bypass the obstruction when it is not located between strips. Lap splices are allowed if necessary. Laps must be at least 8 inches (20 cm) or more in length. Successive layers of carbon sheets are not to be spliced at the same location. The finished laminate thickness is expected to be 0.2 inches (4 mm) or less.

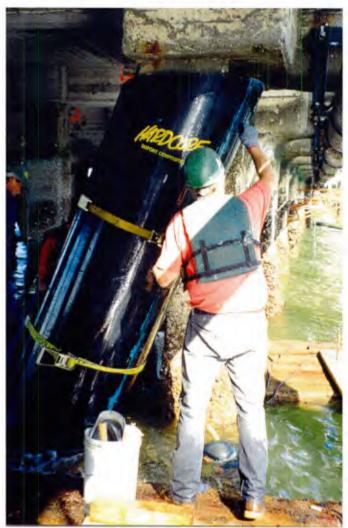
Figure 54. Placing cylindrical composite shell around rectangular concrete pile.

Composite shell encasement is an attractive alternative to replacement if the steel reinforcement retains at least 80 percent of its cross sectional area. This technique employs single and two piece preformed fiberglass reinforced vinylester shells to encase the damaged areas of the piles with shrink resistant epoxy grout or concrete injected or pumped between the shell and the existing pile (Figure 54). The grout will restore the concrete cross section and the shell will increase the confinement strength of the concrete. NFESC has employed shells with a circumferential (confinement) strength of 4 kips/inch at a maximum strain of 0.2 percent and a longitudinal strength of 1 kip/inch.

The diameter of the laminate shell must be at least 28.5 inches so that it will encase the 18-inch square pile and leave space for the grout. The shells should be long enough to extend from the pilecaps down beyond the damaged area. Laps and connections must be able to develop the full, circumferential, shell strength and stiffness. Piles must be cleaned of all marine fouling and loose concrete. The concrete cover of existing steel reinforcing does not need to be removed unless the steel is corroded, then the steel must be exposed and cleaned. The shells should be configured to allow placement within 1 inch of the pile cap.
