NAVAL FACILITIES ENGINEERING SERVICE CENTER
Port Hueneme, California 93043-4370

SP-2054-SHR

REVIEW OF AIRFIELD PAVEMENT CONSTRUCTION FALLON NAVAL AIR STATION

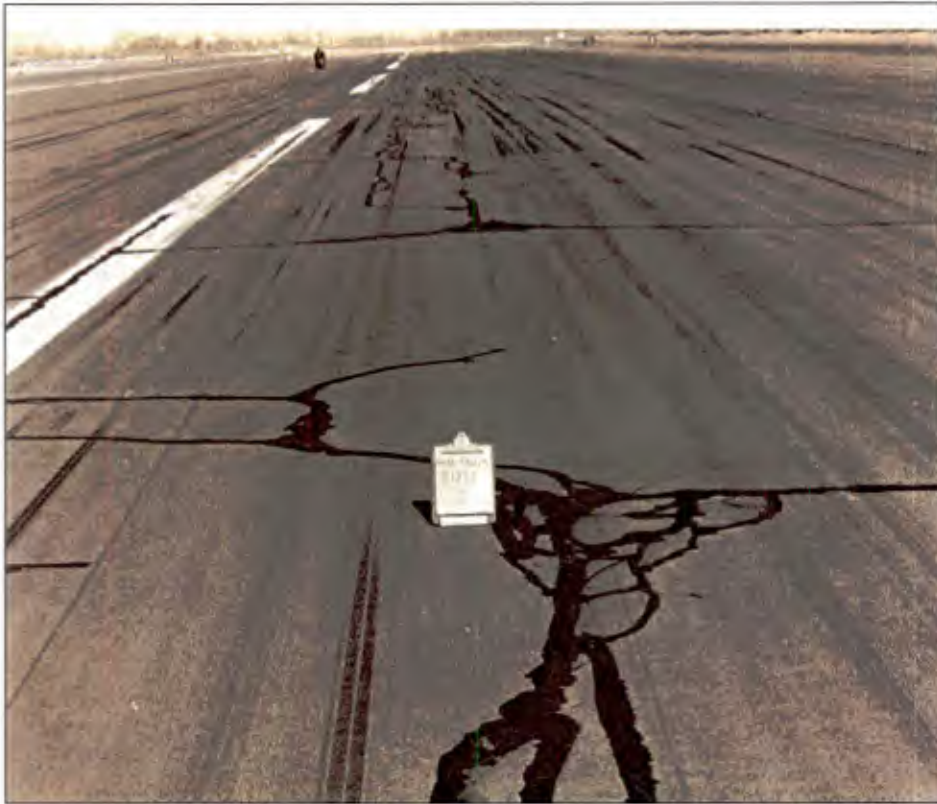
Figure 1. NAS Fallon Runway R13-31, Crack Sealed (August 1970) [3]. Note transverse cracking of the pavement spaced at large distances which is indicative of thermal cracking. Such cracking has been recognized for a number of decades and has been studied extensively.

Figure 1. NAS Fallon Runway R13-31, crack sealed (1970).

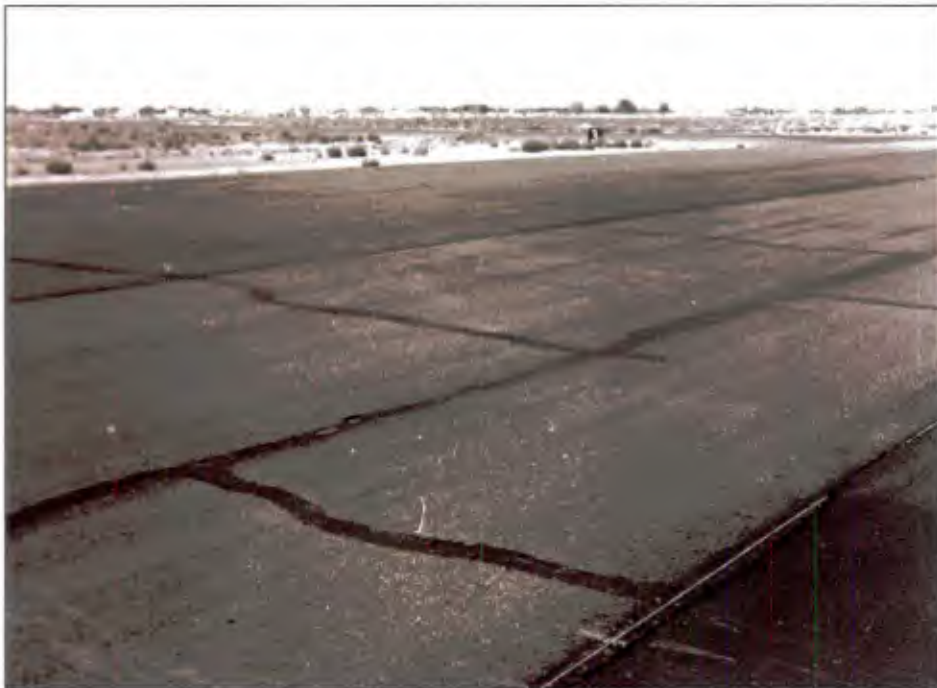
Figure 2. NAS Fallon Runway R13-31, Existing Cracks and New Overlay (lower right) (26 August 1986). Note existing crack pattern, which is very similar to that present in 1970. Alligator cracking due to aircraft loading is absent. Only cracking due to environmental conditions are visible. A new overlay being installed can be seen in the lower right corner.

Figure 2. NAS Fallon Runway R13-31, existing cracks and new overlay (lower right) (26 August 1986).

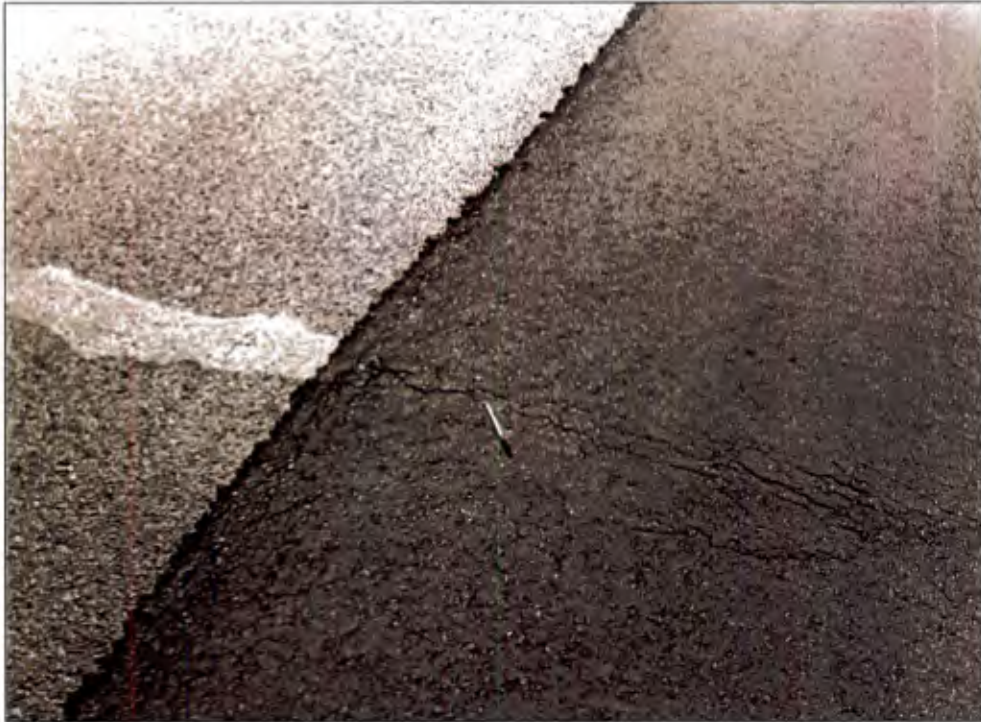
Figure 3. NAS Fallon Runway R13-31, Existing Cracks with Sealant and Cracking in New overlay (26 August 1986). Overlay being installed in August 1986 cracked almost immediately.

Figure 3. NAS Fallon Runway R13-31, existing cracks with sealant and cracking in new overlay (26 August 1986).

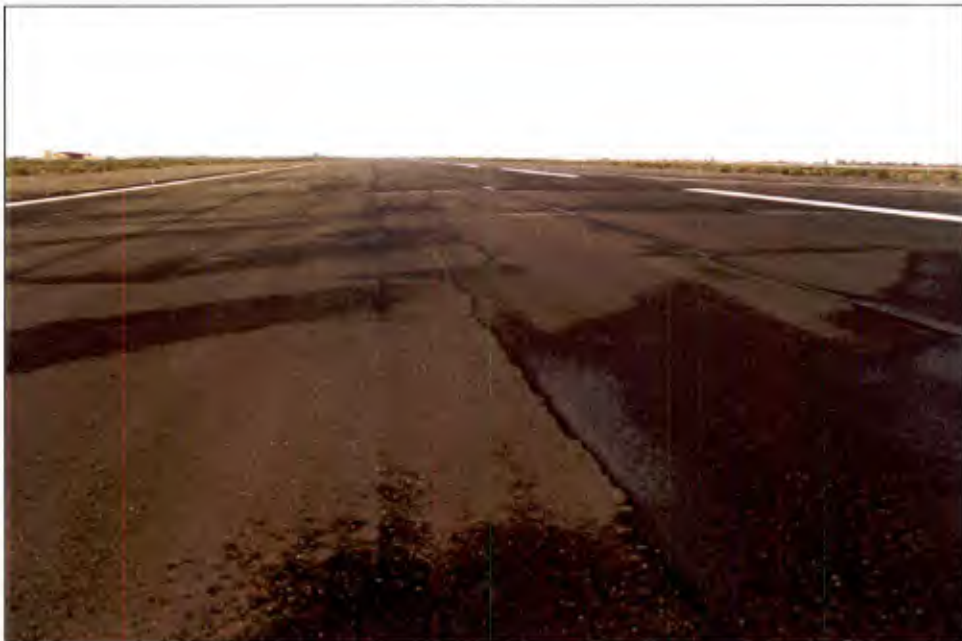
Figure 4. NAS Fallon Runway R13R-31L, Cracking Pattern in Present Overlay (22 April 1999). Cracking pattern in the present overlay is very similar to that present in 1970 and after two overlays prior to 1986. The occurrence of the cracks is almost certain to be due to reflection of existing cracks in the underlying pavement layers.

These figures illustrate the fact that if an AC overlay is installed on previously thermally cracked pavements, the existing cracks will reflect through the overlay. Regardless of treatments made to the cracks prior to applying the overlay, the cracks reflect through. As examples:

Figure 4. NAS Fallon Runway 13R-31L, cracking pattern in present overlay (22 April 1999).

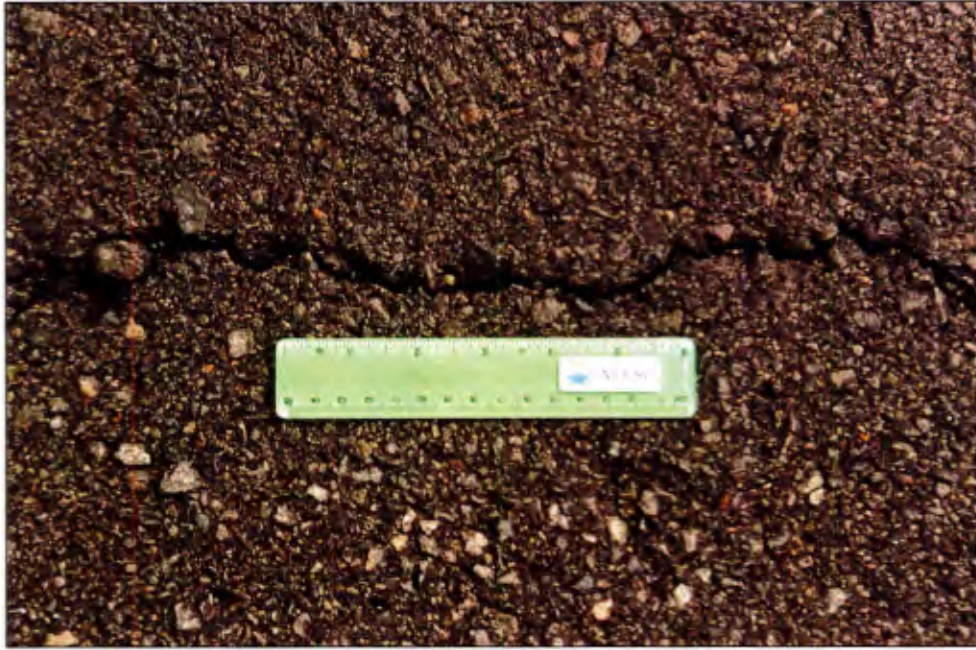
Runway 13R-31L was visually inspected for general crack patterns and any other pavement distresses in April 1999. Figure 5 shows a typical crack observed during this inspection. The runway was constructed using approximately 17' widths for each pass or lane. The longitudinal construction joint between paving lanes has the appearance of not being “tight,” resulting in longitudinal cracking. Based on observations at several locations along the longitudinal joints, it appears that the roller rolled too close to the edge of the paving lane. This caused the outer edges of the paving lane to be depressed resulting in longitudinal “bird baths” at many locations, some of which are visible in Figure 4. Some of these joints now exhibit low severity raveling.

locations along the entire length and width of the runway using a crack comparator. Crack widths measured between 0.01 inch to 0.20 inch with the vast majority between 0.06 inch and 0.12 inch (1/16 inch and 1/8 inch). The larger cracks are beginning to have aggregate dislodged from the crack opening. The dislodging appears to be more common under areas with aircraft traffic. Although it appears dislodgment of aggregate from the cracks have occurred, no loose aggregate was observed along the entire length of the runway during this inspection.

Figure 5. NAS Fallon Runway 13R-31L, close-up of typical crack (22 April 1999).

1. Rout and seal cracks that are 1/4 inch wide or wider as they appear.
2. Apply a fog seal every three years beginning in 1999 to retard oxidation and inhibit raveling. (A fog and other surface seals will affect the frictional characteristics. Therefore, care must be taken to insure skid resistant levels are maintained.)
3. Upgrade runway and taxiway shoulders to meet requirements of MIL-HDBK 1021/1.

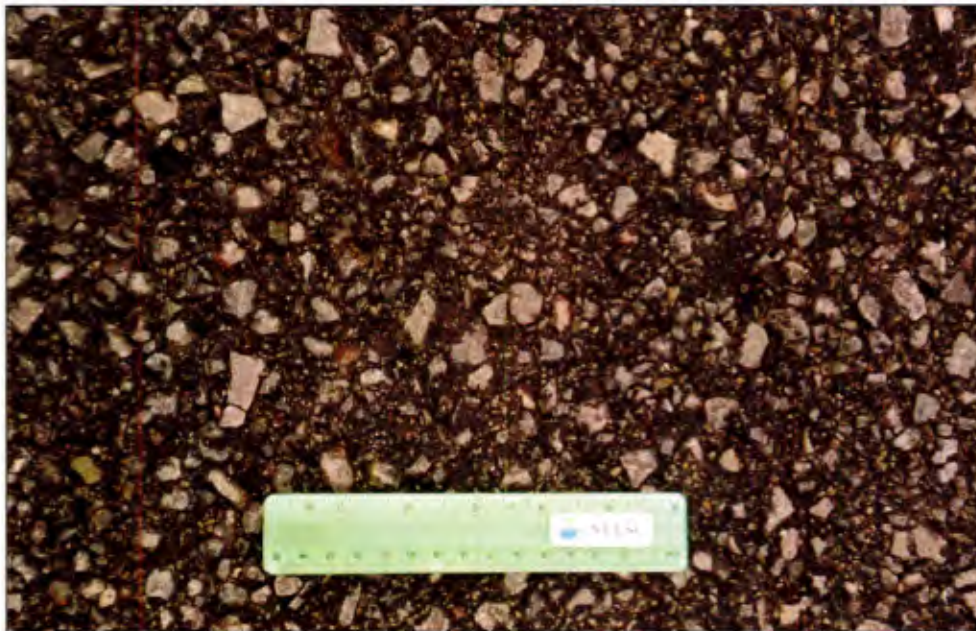
Surface wear has also occurred within the center 100 feet of the runway, which appears to be the result of raveling. There are several small locations that could be considered near high severity. This is only apparent in the main gear wheel path and is more apparent towards the south end of the runway. One of these areas with exposed aggregate is shown in Figure 6. The occurrence of exposed aggregate suggests that stripping or asphalt deficiency may be the cause.

Figure 6. NAS Fallon Runway 13R-31L, close-up of surface with exposed aggregate due to stripping or asphalt deficiency.

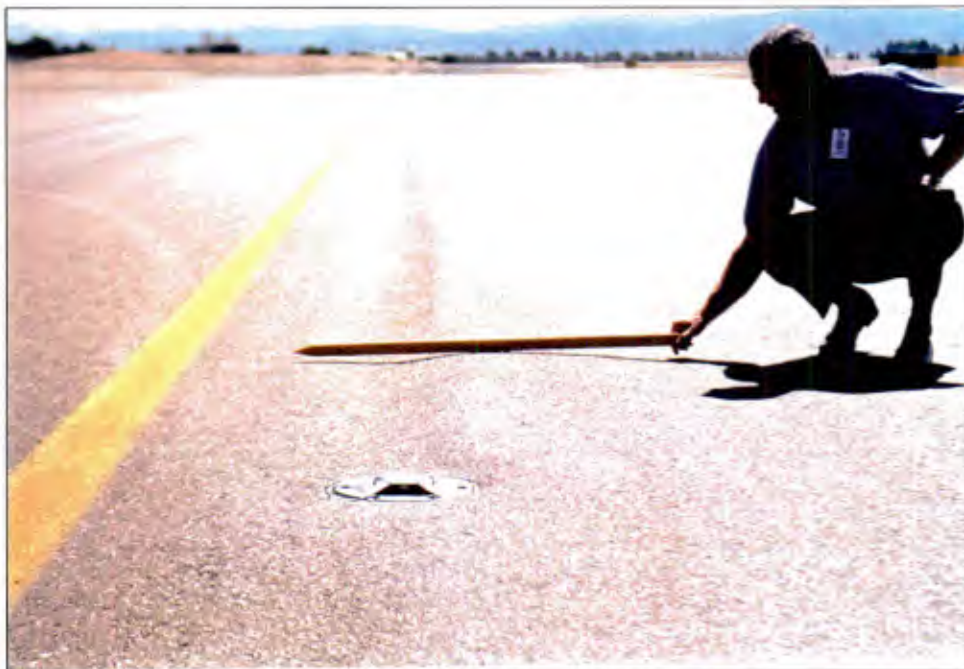
Figure 11. Rutting of asphalt pavement taxiway at McCarran International Airport.

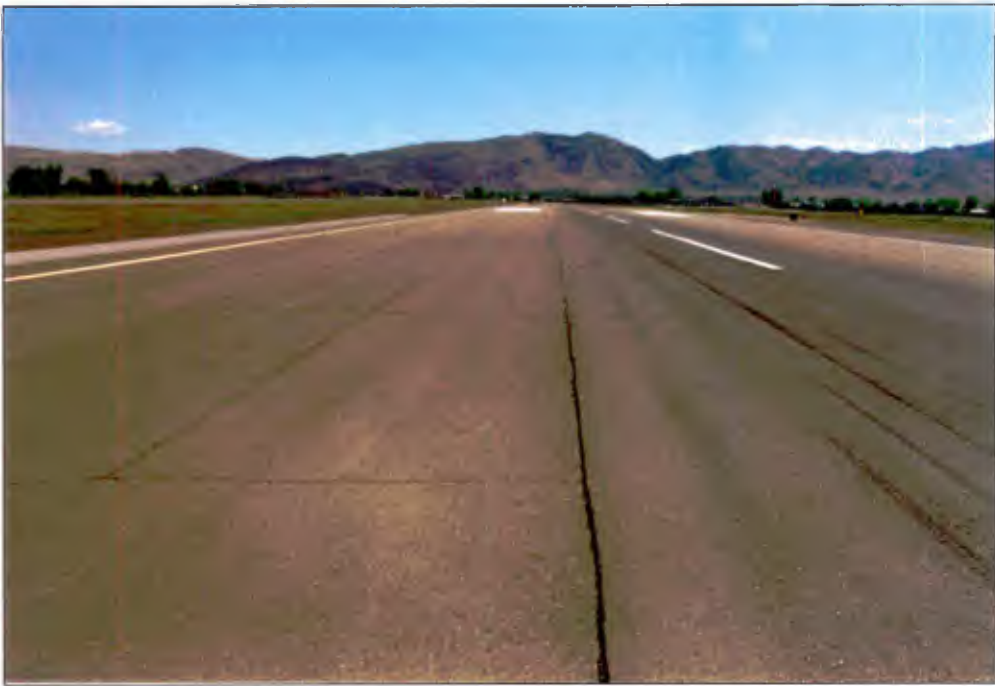
Figure 14. Low temperature thermal cracked asphalt pavement, Reno International Airport.

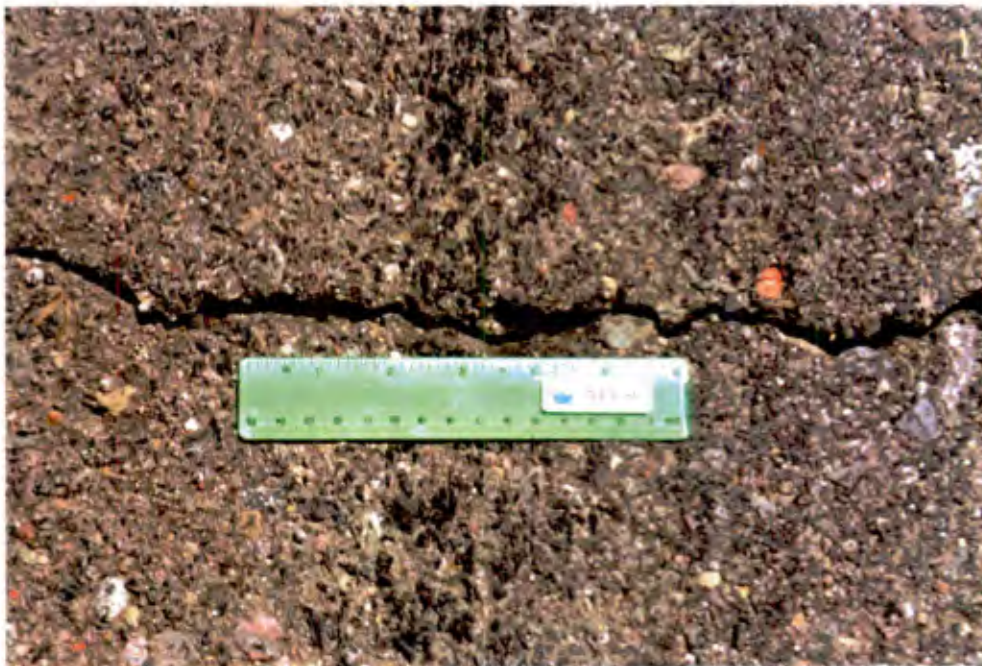
Figure 15. Low temperature induced thermal crack in AC, Reno International Airport.

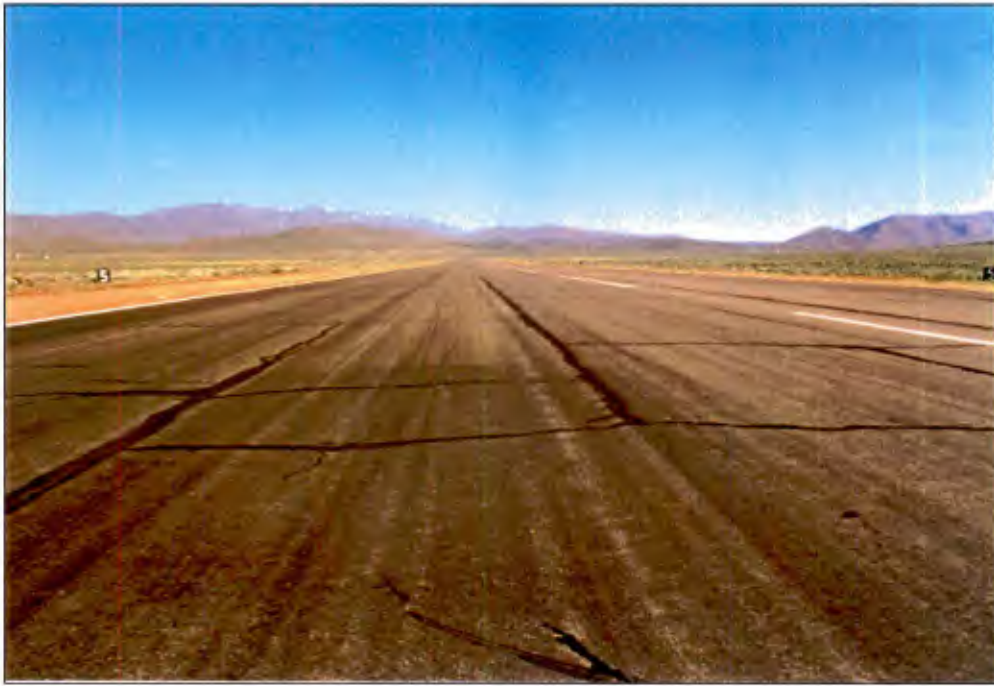
Figure 16. Low temperature thermal cracked AC pavement, Runway 14, Reno-Stead Airport.

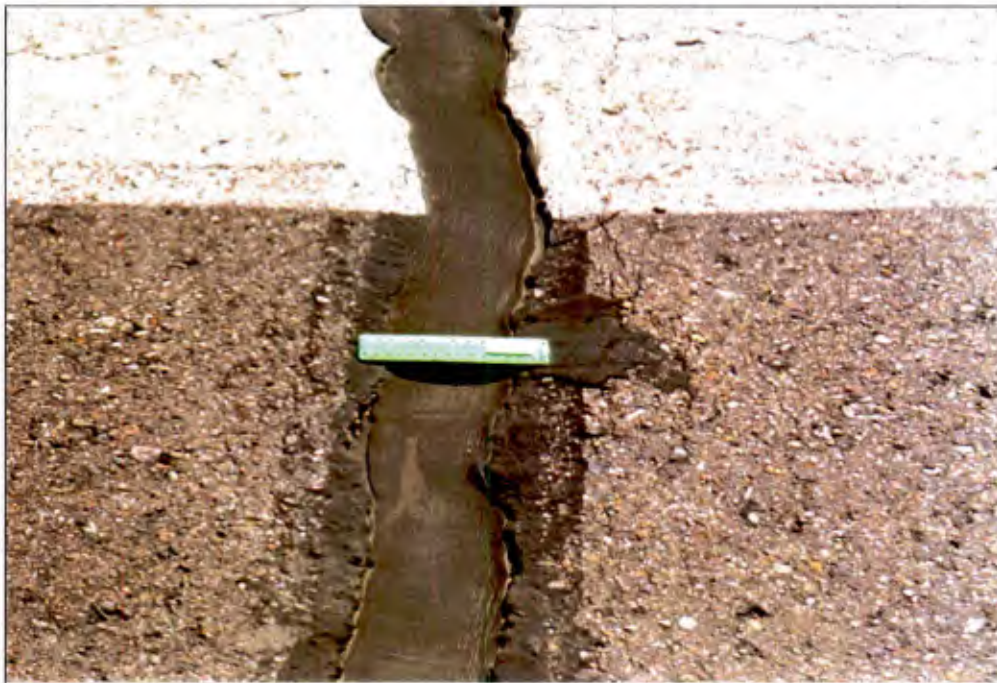
Figure 17. Sealed thermal crack in AC pavement, Runway 14-32, Reno-Stead Airport.

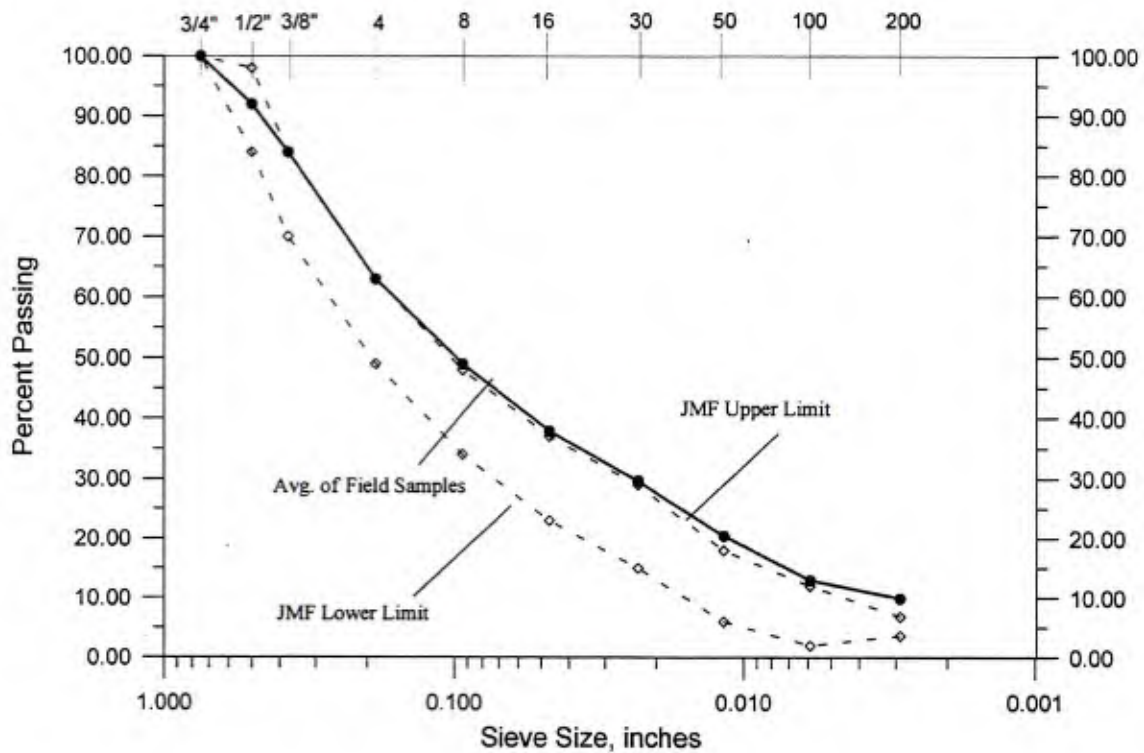
Figure 5. Comparison field sample test results to the tolerances prescribed by the JMF.

Sieve	JMF Tolerances (percent passing)	Avg. of Field Sample (percent passing)
3/4 in.	100	100
1/2 in.	84 – 98	92
3/8 in.	70 – 84	84
No. 4	49 – 63	63
No. 8	34 – 48	<u>49</u>
No. 16	23 – 37	<u>37.9</u>
No. 30	15 – 29	<u>29.7</u>
No. 50	6 – 18	<u>20.5</u>
No. 100	2 – 12	<u>13</u>
No. 200	3.6 – 6.8	<u>9.9</u>

Note: Underlined data are outside of gradation band.
