## **Seismic Testing of an Indigenous Material Troop Constructible Building**

James Wilcoski

September 2019

Final Technical Report (TR)

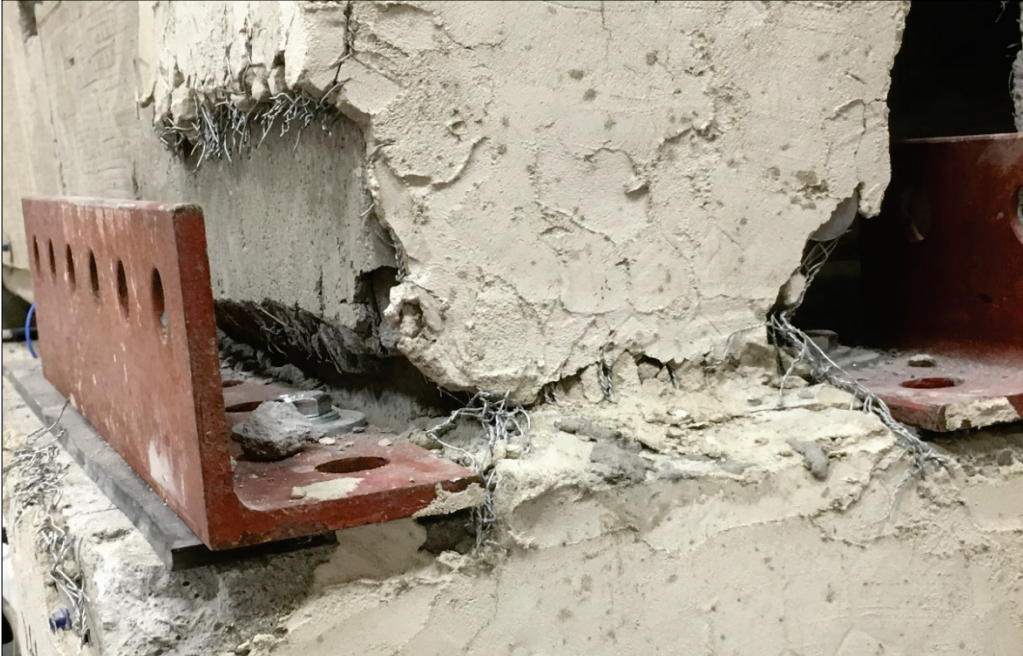
Figure 27. Stucco damage at the southeast column to footing connection, 25% test.

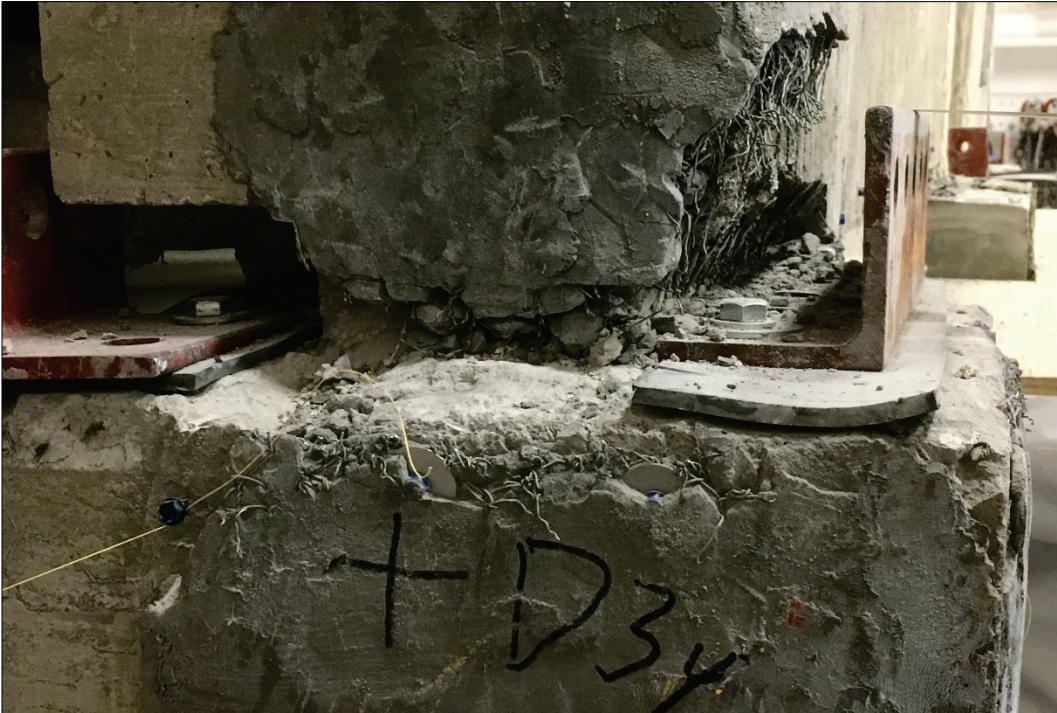
Figure 28. Stucco damage at the southwest column to footing connection, 25% test.

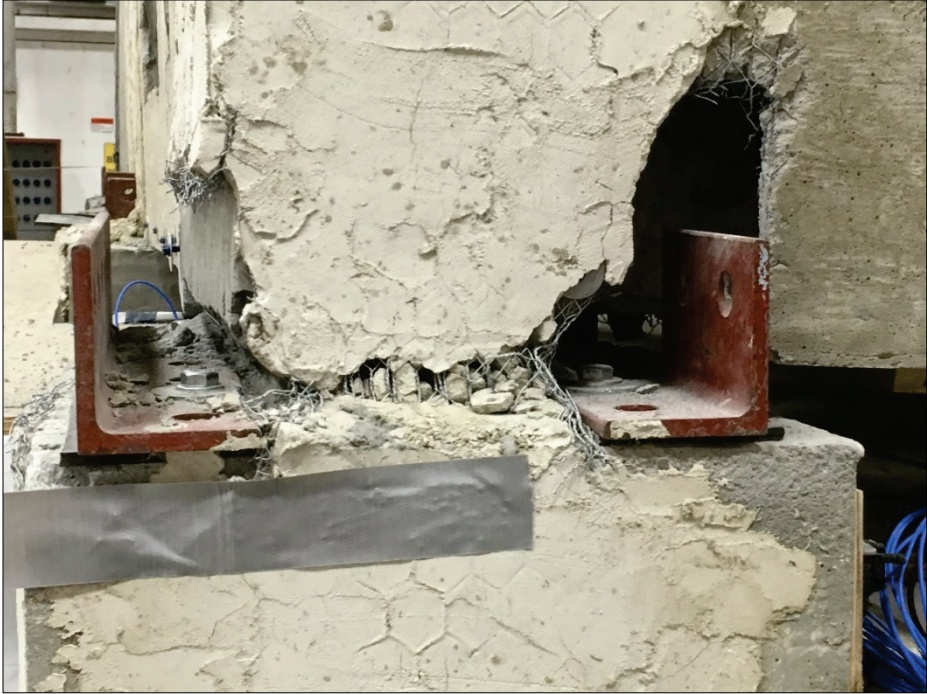
The 50% seismic test caused much greater damage to the stucco, plus some cracking to the corner columns where they connect to their footings. Figures 31 and 32 show significant damage to the stucco and Figure 32 appears to show cracking in the column where it connects to the footing. Figure 33 shows limited damage to the stucco where the interior of the north door frame connects to its footing.

Figure 31. Stucco damage at the southeast column to footing connection, 50% test.

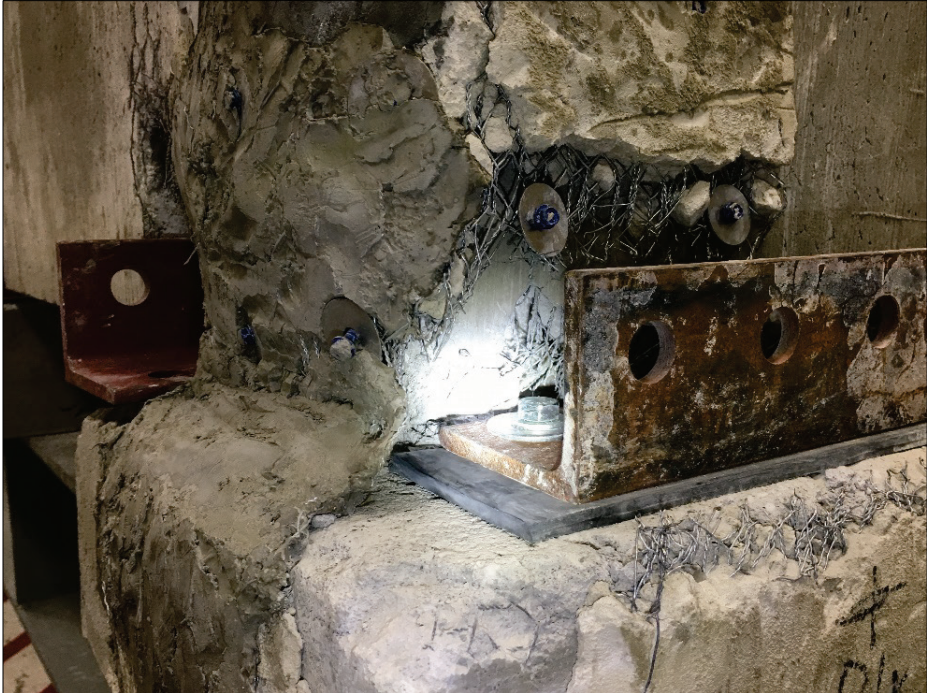
Figure 32. Stucco damage at the northeast column to footing connection, 50% test.

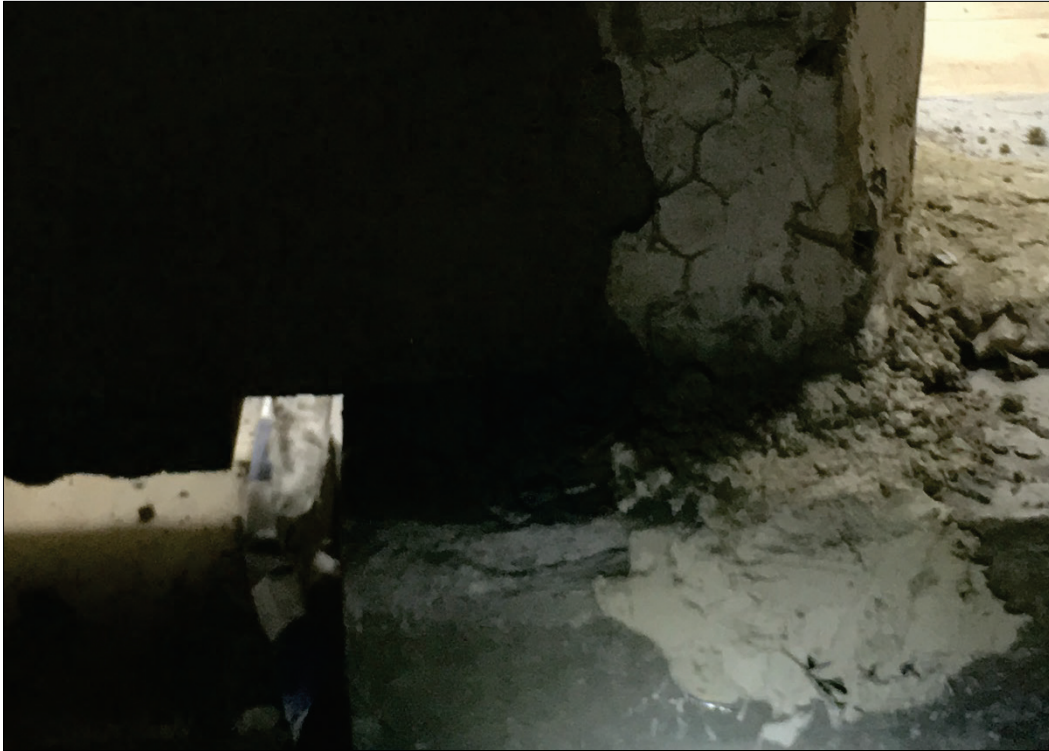
Figure 33. Limited damage to stucco at interior of North door frame column to footing connection, 50% test.

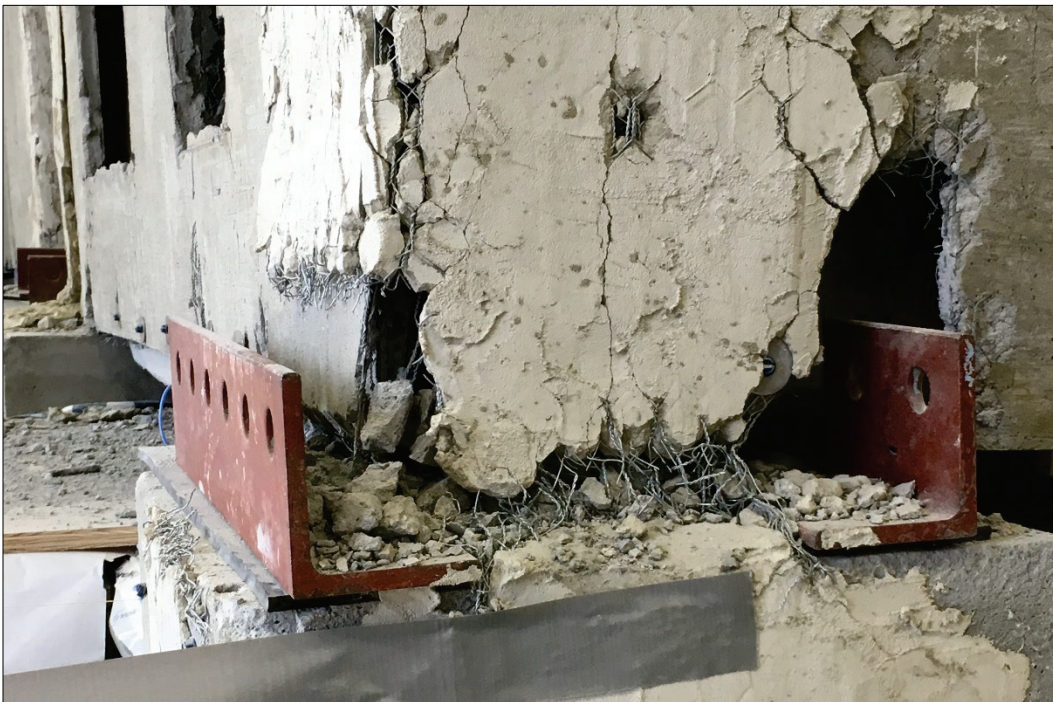
In the 100% seismic test, the four columns at the corners of the building completely failed in shear just above their footings. The corner columns failed in shear in the short direction of the building, where the cracks opened with large offsets in the Y-axis of the building early in this test. The columns 4 ft. to the interior, and almost immediately after all the columns along the long east and west walls failed in shear in the long X-axis of the building. Before the corner columns failed, the interior columns would have been more heavily loaded in the Y-axis of the building, which is the strong or stiffer axis of the frames. Once the corner columns failed and offset, the rigid long walls transferred significant load in shear to these interior columns in the X-axis. This progression of failure and offsets was seen in video files of the test. At the end of this test, the concrete along the top of the footings was crushed into golf ball and smaller sized rubble with a three-dimensional chicken wire mesh holding the rubble together. Many of the wires were also fractured, as seen at the southeast corner in Figure 36, southwest corner in Figure 37, and west face in Figure 38.

**Figure 36. Bottom of column at Southeast corner showing concrete rubble and partly fracture chicken mesh, 100% test.**

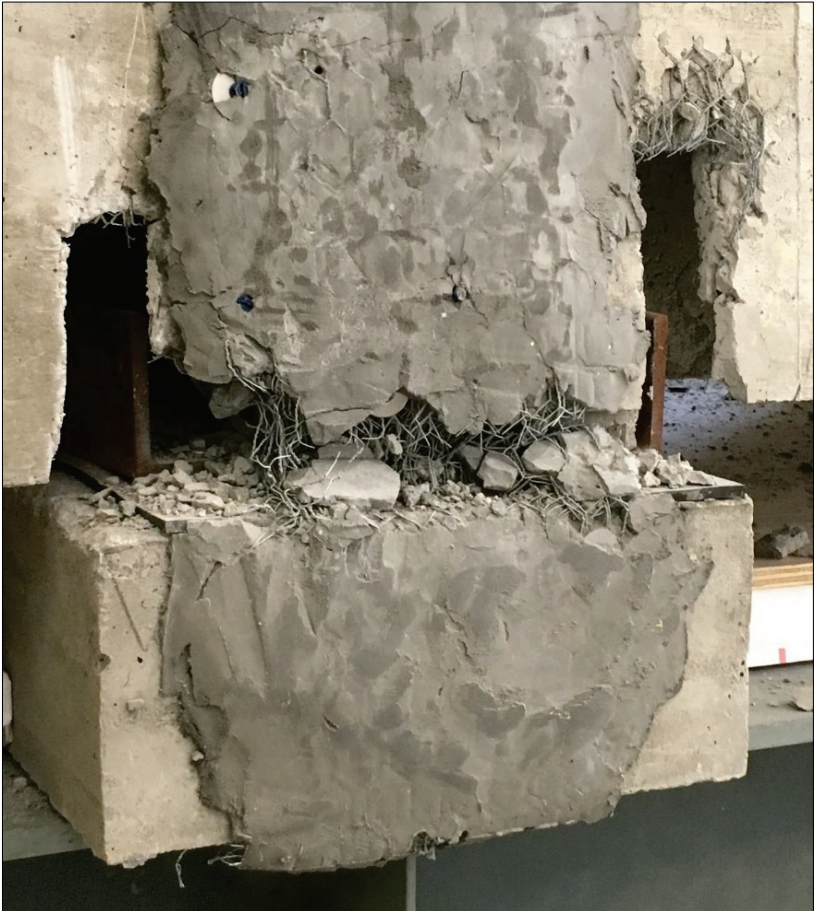
Figure 38. Bottom column at the west face, 100% test.

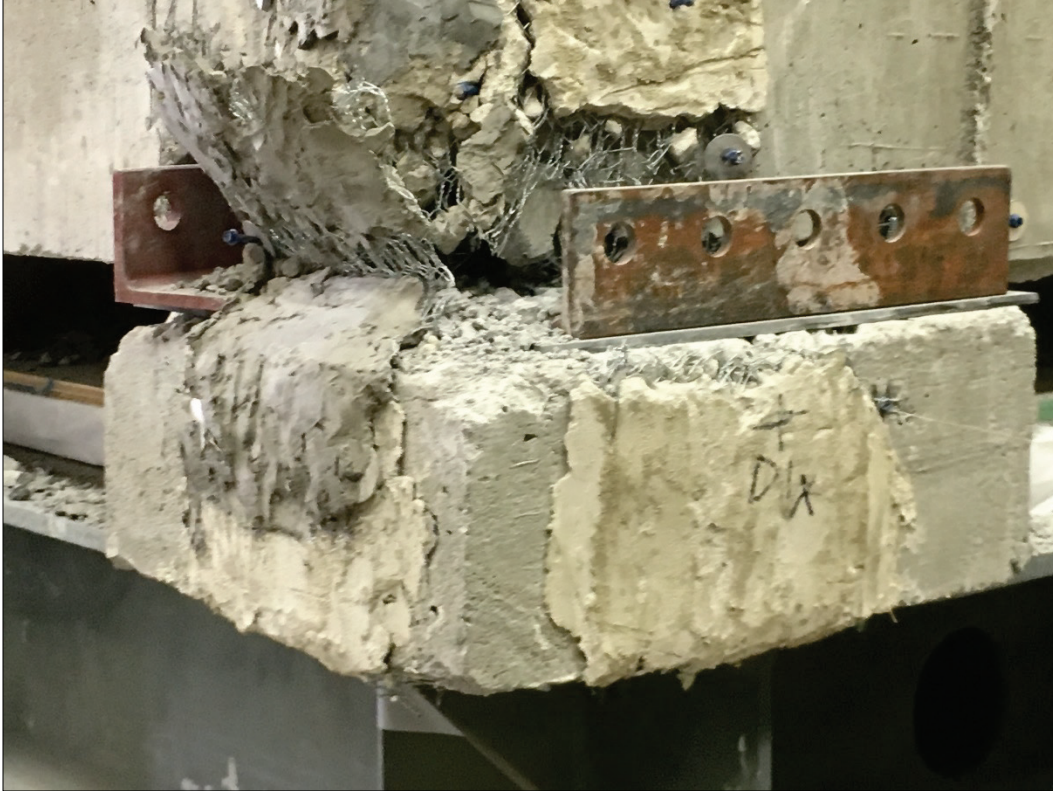
Figures 39, 40, 41, and 42, show severe damage to the stucco and chicken wire mesh at the northeast column and northwest column.

Figure 39. Bottom of northeast column, 100% test.

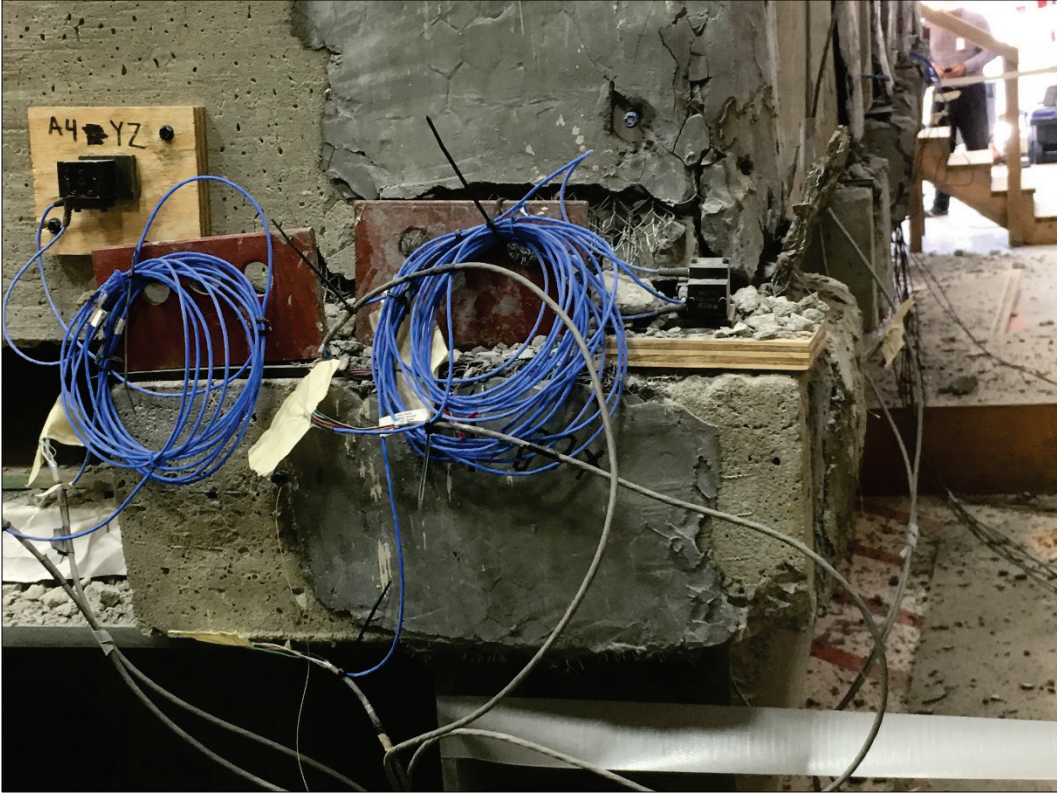
Figure 41. Bottom of northwest column, 100% test.

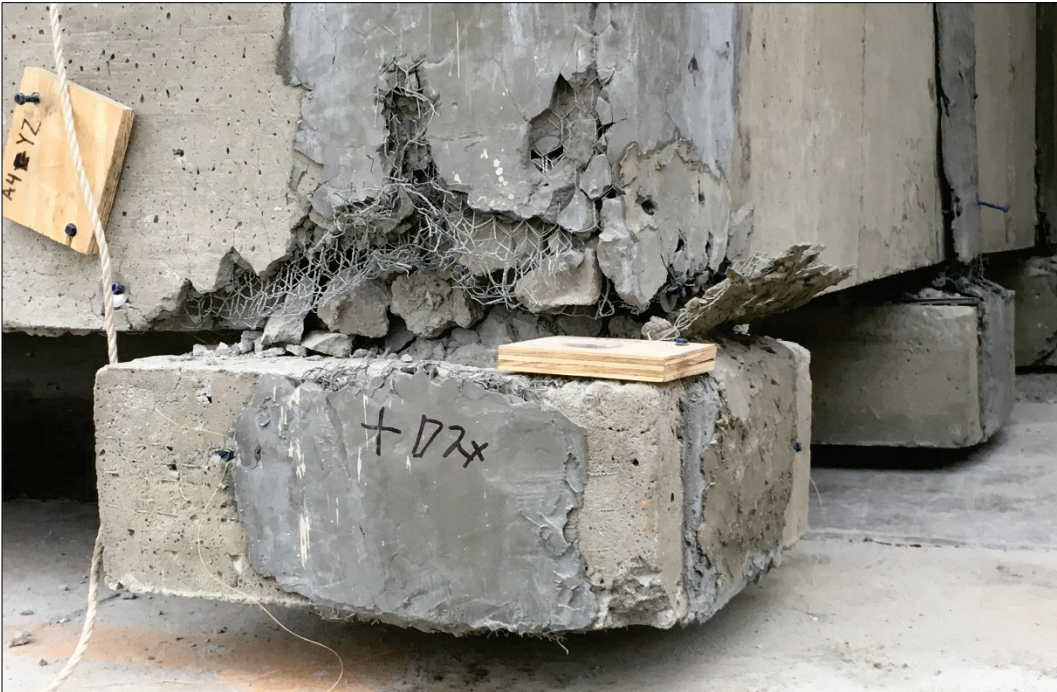
Figure 42. Bottom of northwest column, after removing the building from the test fixture, 100% test.

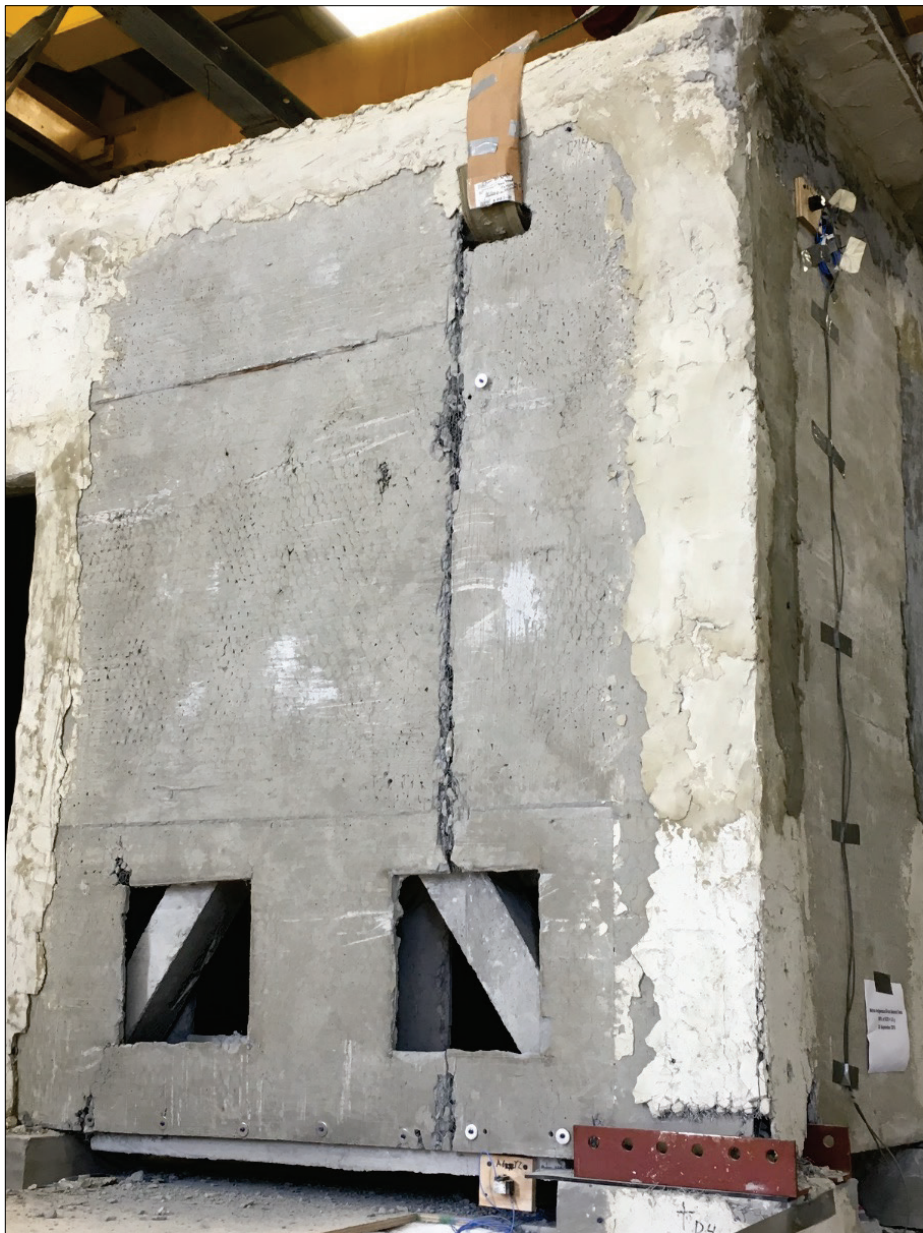
The small columns of the door frames, at the center of the north and south walls were badly damaged but did not completely fail. The braces especially at the south door frame in the short direction (Y-axis) partly failed at the connection to these columns and the short axis wall panel connections to the door frame columns also partly failed. Figures 43 and 44 show damage to the south wall door frame column and vertical crack in the wall panel near the southeast corner. Figure 45 shows an interior view of the north wall door frame column with a large vertical crack in the stucco and all panel.

Figure 43. East side of south short wall, where brace and wall panel connections partly failed at the bottom left corner of picture – note the vertical crack in the wall panel, 100% test.

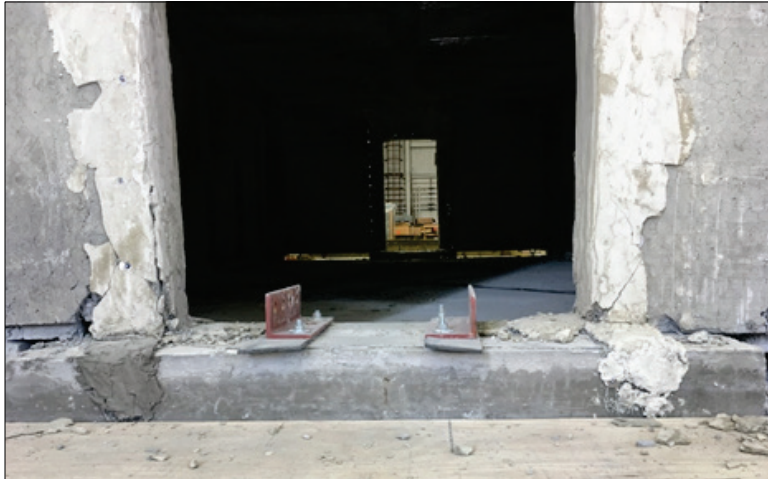
Figure 44. Bottom of south wall door frame columns with large cracks, 100% test.

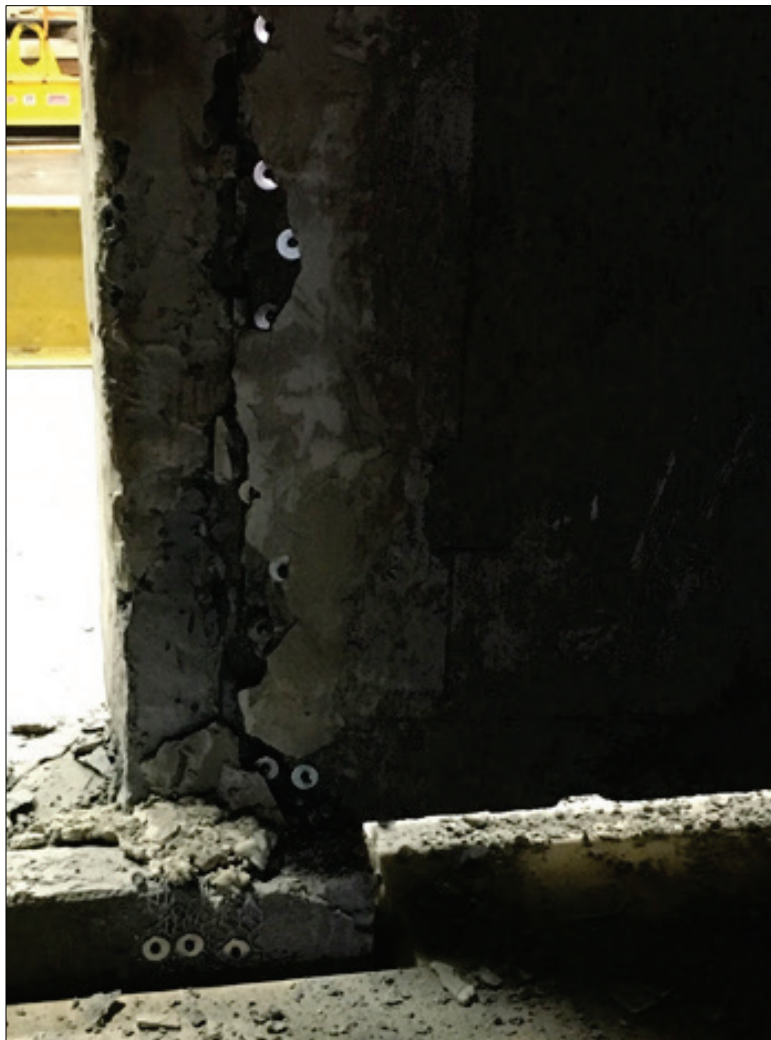
Figure 45. Interior view of North door frame column shows cracks in stucco and wall panel, 100% test.
