**OFFICE OF THE SPECIAL INSPECTOR GENERAL
FOR AFGHANISTAN RECONSTRUCTION**

**INSPECTION OF FARUKH SHAH SCHOOL CONSTRUCTION
PROJECT IN KAPISA PROVINCE:**

**PROJECT COMPLETION APPROVED BEFORE ALL
CONTRACT REQUIREMENTS MET**

SUBJECT: SIGAR Inspection Report 10-1: Inspection of Farukh Shah School Construction Project, Kapisa Province: Project Completion Approved Before All Contract Requirements Met

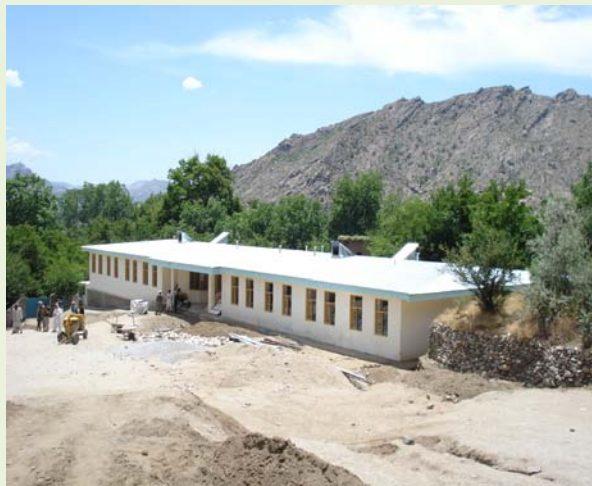
Views of the rear portion of the perimeter wall which is inadequate to protect the Farukh Shah School compound from rock slides on left, and improper grading on right that places the school compound at risk. (Photos provided by SIGAR).

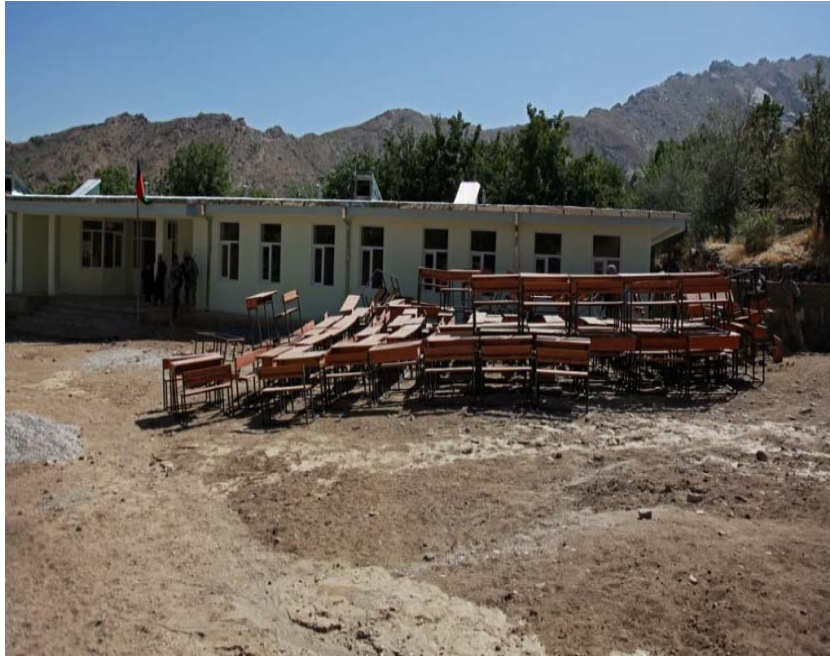
SIGAR noted that the school compound had not been adequately cleared of debris and rubbish left over from construction activities. Additionally, old student desks that were apparently not needed by the school administration were placed in two large piles on either end of the school. It is unclear when or if these materials will be removed.

Site photo 5: View of discarded old school desks outside of the main school building. (Photo provided by SIGAR).

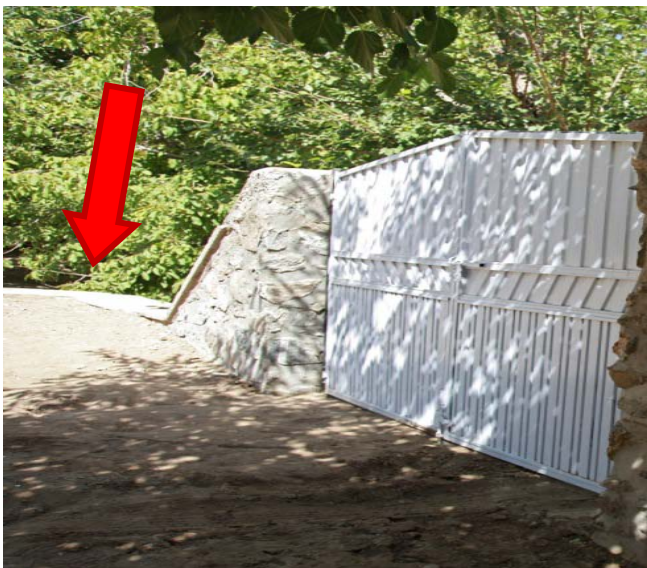
Second, SIGAR also found that although the perimeter wall appeared to be solidly built and in accordance with the statement of work, it mostly serves as a retaining wall due to the nature of the school grounds topography. SIGAR notes this is potentially dangerous since the perimeter wall was not built to retaining wall standards which require a much larger and stronger foundation base. Given the nature of the area's topography with evidence of recent rockslides and erosion, the possibility exists that areas of the perimeter wall may suffer washout and collapse unless it is further reinforced. (See Site Photos 7 and 8).

Site Photo 9: The top of the 2 meter perimeter wall can be seen (indicated by red arrow). During the site grading, soil was placed against the perimeter wall, bringing the grade elevation up to the top of the wall in some areas. (Photo provided by SIGAR)
