NAVY DEPARTMENT BUREAU OF ENGINEERING

Test on Controller and Pulsators for Truck and Screened Speed Lights.

Navy Yard Portsmouth, N.H.

NAVAL RESEARCH LABORATORY ANACOSTIA STATION WASHINGTON, D.C.

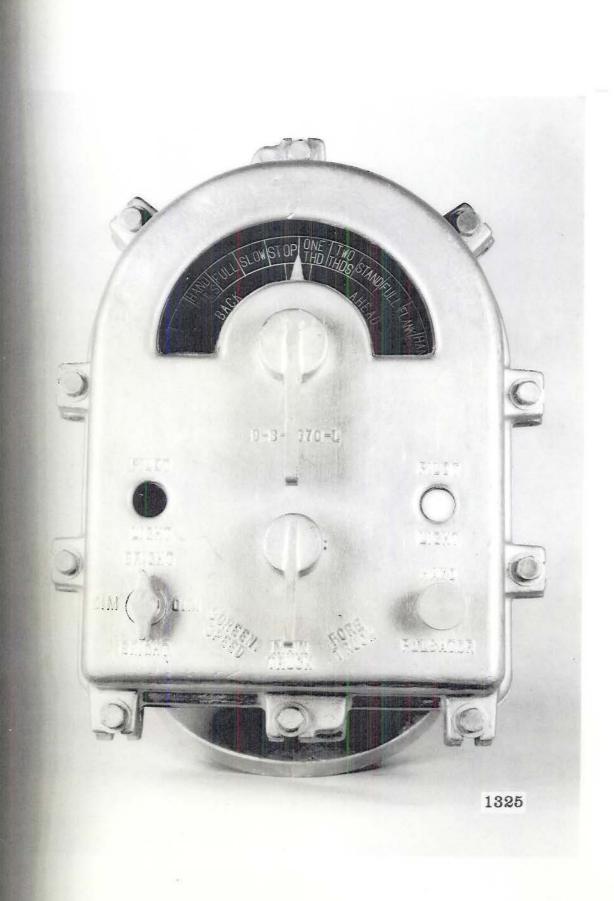
- 23. The locking device, for contact adjusting screws on pulsators, should be modified so as to firmly hold the screw after the adjustment is made.
- 24. The present controller handle is difficult to grasp and operate and should be modified.

- 25. The controller dial is now illuminated with Navy Type VG-2 neon lamps. For proper illumination the dial should be painted with radium luminous paint of the 20 micro-lambert grade, using the proper coverage, and activated with Navy type VG-2A lamps.

- 26. In order to conserve the life of the radium luminous paint on the controller dial, the activating Navy Type VG2-A lamps should be cut off with double pole switches when the instrument is not in use.

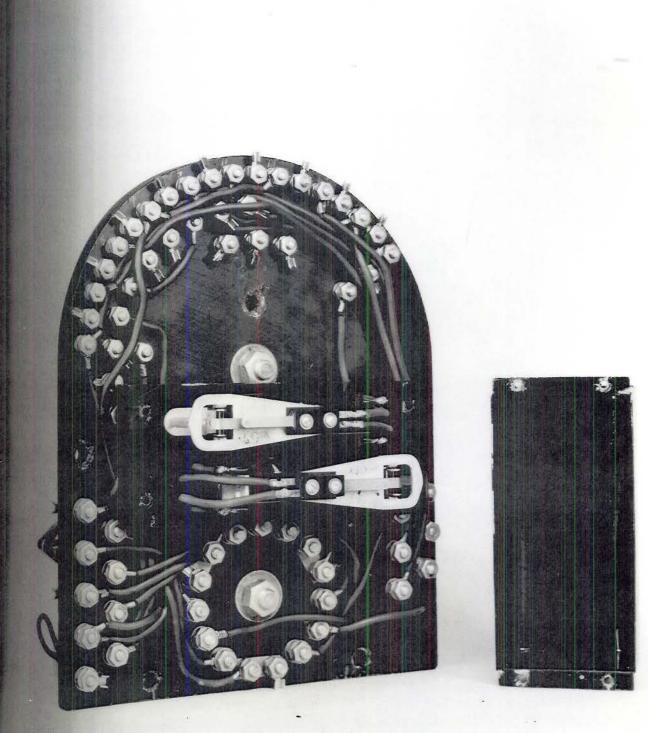
- 20. During the endurance test, both relays, when operating on either D.C. or A.C., were unreliable and frequently failed to operate the pilot lamps. This condition is due to the failure of the armatures to return to their normal positions at the time the current is interrupted by the pulsator. Although there is a brass insert provided for each armature for the residual air gap, the spring, if given sufficient tension to overcome the residual magnetism produced by maximum current, will prevent the armature from operating at minimum current. Relays having sufficient torque for positive operation at minimum current should be substituted. The pilot lights are the only means of indicating that the truck light circuit is functioning correctly, and for that reason, this laboratory cannot over-stress the importance of providing dependable relays.

- 21. The pilot light relays, in their present location, are inaccessible and some method should be provided whereby the relays could be reached for making adjustments without necessitating the removal of the controller case cover and panel. A cover of sufficient size, located on the under side of the controller case, would allow better access to the relays and their removal, if necessary, providing the relays were equipped with flexible lead wires of sufficient length. A better method would be to remove the relays from the controller case and install them in a water-tight case, with removal cover attached to the controller pedestal.

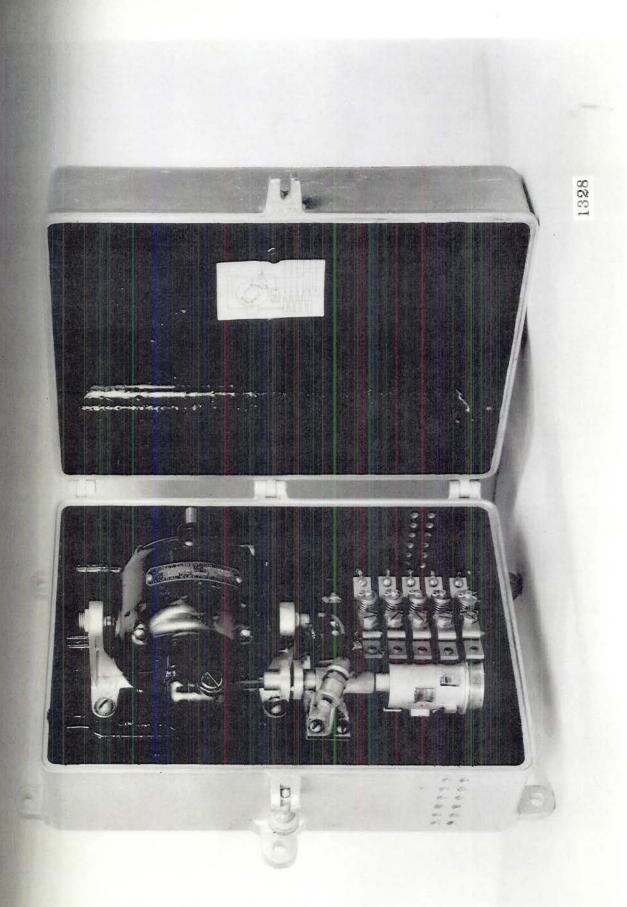
19. Both pulsators operated satisfactorily on all tests.
