ARL-TN-1107 • FEB 2022

# Fracture Analysis of a Laminated Window Structure

by Jeffrey J Swab and Parimal J Patel

Jeffrey J Swab and Parimal J Patel  
*DEVCOM Army Research Laboratory*

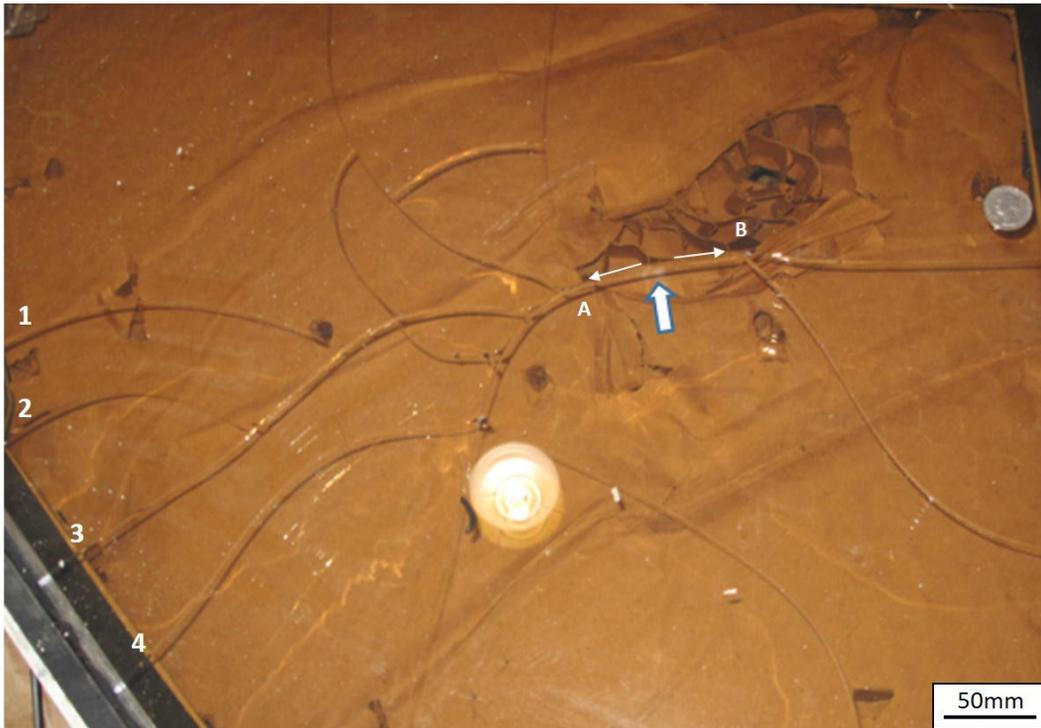
The examination included a visual examination of the crack branching pattern in the glass on an intact laminated window as well as a more detailed examination using a handheld magnifying glass. This window was large and heavy so normal fractographic tools, such optical and scanning electron microscopes, could not be used. The crack branching pattern observed in the visual examination showed that fracture initiated in the glass layer at the location highlighted by the large white arrow in Fig. 1. The crack propagated from this location approximately 50–60 mm in both directions (small white arrows in Fig. 1), and then crack branching began at points A and B. Once the branching began, the subsequent cracks tended to meander and curve, which is an indication of a thermally driven fracture process (thermal stresses from the diurnal weathering were driving the crack growth). What stresses are present or develop in the laminated structure and their potential role in the crack growth behavior is unknown. There appears to be some level of tensile stress near the edge of the laminated window as the cracks labeled 1–4 in Fig. 1 all stop curving at approximately the same distance from the window edge and then propagate straight to the edge.

**Fig. 1 Overall crack pattern in the glass surface of the window. Fracture initiates at the location highlighted by the large white arrow and propagates in both directions from this point (small white arrows). Crack branching occurs at points A and B.**

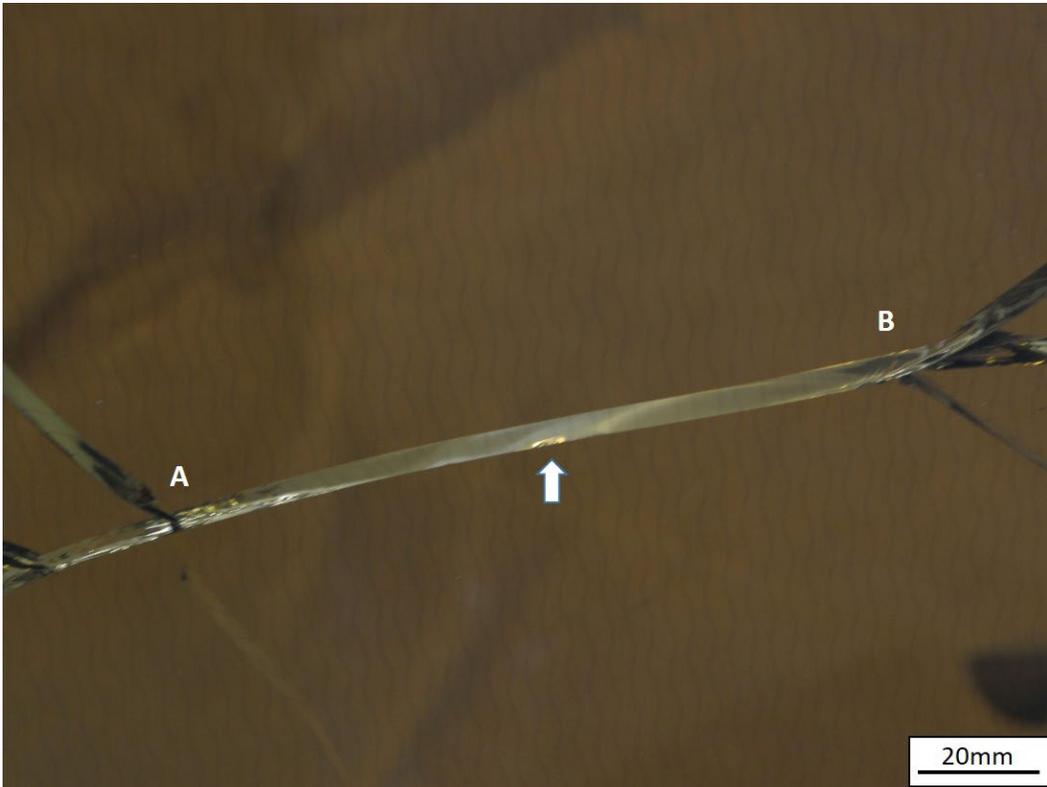
Further examination of the primary crack, shown in Fig. 1, with a handheld magnifying glass and lighting at different angles to the crack front revealed an anomalous feature (white arrow in Fig. 2) that appears to be where the fracture origin is located. There was no evidence on the glass surface anywhere in the vicinity of the primary crack indicating that an impact event occurred, corroborating the eyewitness reports. The flaw size inside this white feature is difficult to measure accurately since the glass layer and the window are both still intact, but it is estimated to be approximately 0.5 mm deep and 1 mm wide.

**Fig. 2** Close-up of the likely fracture origin (white arrow) in the glass layer and the crack branching locations A and B

Knowing the approximate depth ( $a$ ) of the flaw and that the fracture toughness ( $K_{Ic}$ ) of borosilicate float glass when tested in air is  $0.61\text{MPa}\sqrt{\text{m}}$ ,<sup>2</sup> fracture mechanics [ $\sigma = K_{Ic}/(Y\sqrt{a})$ ] was used to estimate the level of stress ( $\sigma$ ) that initiated fracture. Since the geometry of the flaw in Fig. 2 approximates a semicircle, a value of  $1.17$ <sup>[3]</sup> was used as the shape factor ( $Y$ ) in the fracture mechanics equation. The flaw depth could not be accurately measured since the glass layer was still intact; Table 1 shows the estimated fracture stress based on different flaw depths between  $0.02$  and  $1\text{ mm}$  ( $20$  and  $1000\ \mu\text{m}$ ).

The equibiaxial flexure strength of a borosilicate float glass has been shown to be approximately 125 MPa for the air side and approximately 160 MPa for the tin side.<sup>4</sup> These strength values are higher than any of the estimated values listed in Table 1 and are appreciably higher than the 23 MPa estimated for a 0.5-mm-deep flaw. However, the reported strength of both the air and tin side of borosilicate float glass drops significantly, to approximately 40 MPa, once a scratch has been introduced on the glass surface.<sup>5</sup> This value is much more in line with many of the estimated strength values in Table 1.

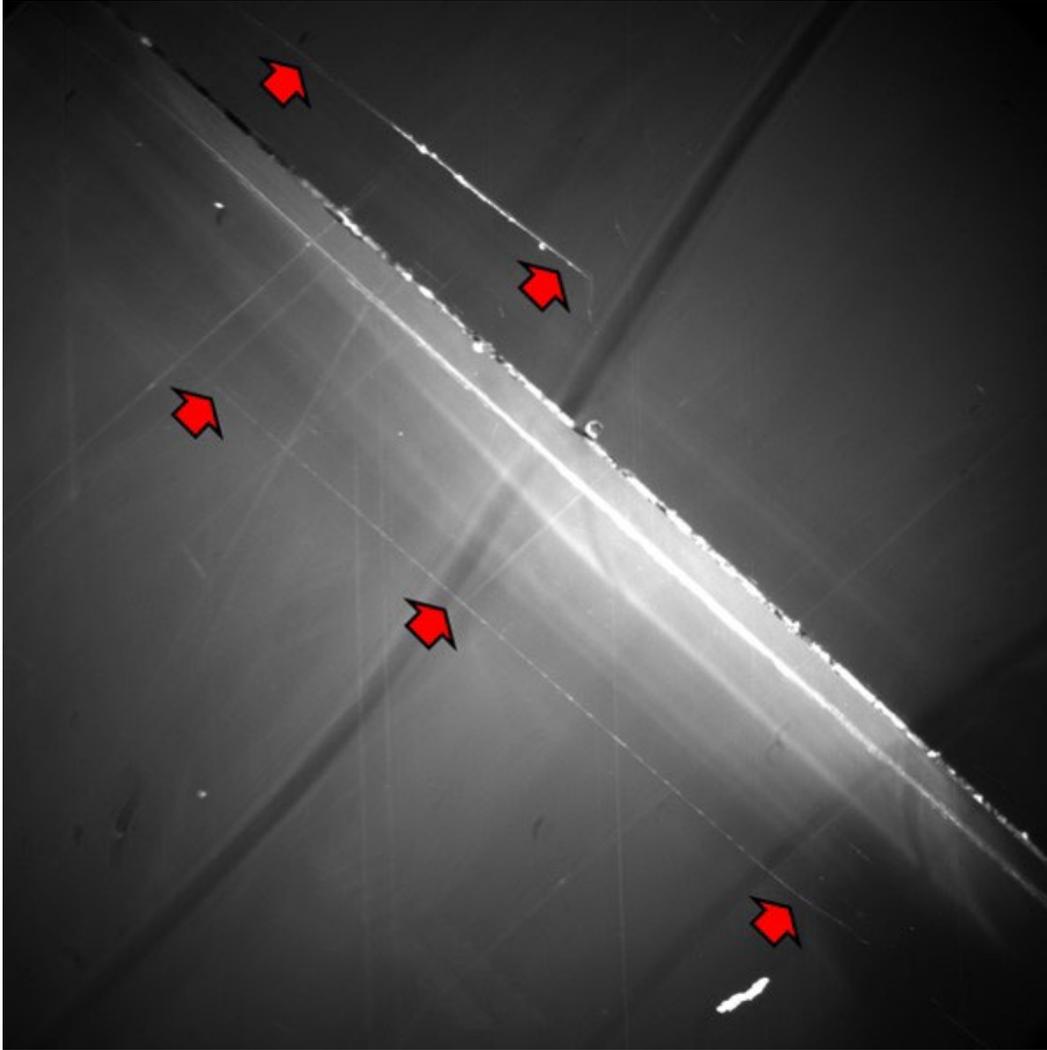
Further optical examination of the window shows that there are numerous scratches on the glass surface, red arrows in Fig. 3. Many of these scratches run parallel to each other in an arc across the window as well as being parallel to the path of the primary crack. It is possible that these scratches were created by the action of the wiper blades pulling/pushing grit, sand, or small rocks that got trapped under the blade, across the glass surface when they were in use. The hardness of float glass is very low ( $\text{HK1} = 4.3 \text{ GPa}$ )<sup>1</sup>, thus it can be scratched or damaged easily by these items. The creation of scratches in glass can generate a significant amount of damage on the glass surface; this damage penetrates to varying depths beneath the surface.

**Fig. 3 Red arrows highlight additional scratches observed on the glass surface**

The glass outer layer of numerous laminated window structures experienced an unexplained fracture. A fractographic examination of one of these intact windows was able to identify where fracture originated in the glass layer and revealed that damage from a scratch, probably created by the action of the wiper blades pulling/pushing an unknown hard item across the glass surface, resulted in the formation of a strength-limiting feature approximately 0.5 mm deep. Based on the crack growth behavior, it appears that the crack propagation was driven, at least in part, by thermal stresses that were generated during normal diurnal weathering conditions. The estimated stress at fracture was computed over a range of flaw depths using the fracture toughness of borosilicate float glass in the fracture mechanics equation. The resulting stress estimates were in line with values reported after a borosilicate float glass plate is scratched and then loaded in tension under controlled laboratory conditions. This confirms that the scratch created by the wiper blades pulling a hard item across the glass surface coupled with the diurnal weather environment lead to the fracture of the glass layer of this window. This analysis is critical to understanding the problem in order to effectively mitigate potential future fractures.
