NRL Report No. R-1606

Calibration Analyses of First Naval District

Shore Direction Finder Stations

NAVAL RESEARCH LABORATORY
ANACOSTIA STATION
WASHINGTON, D. C.

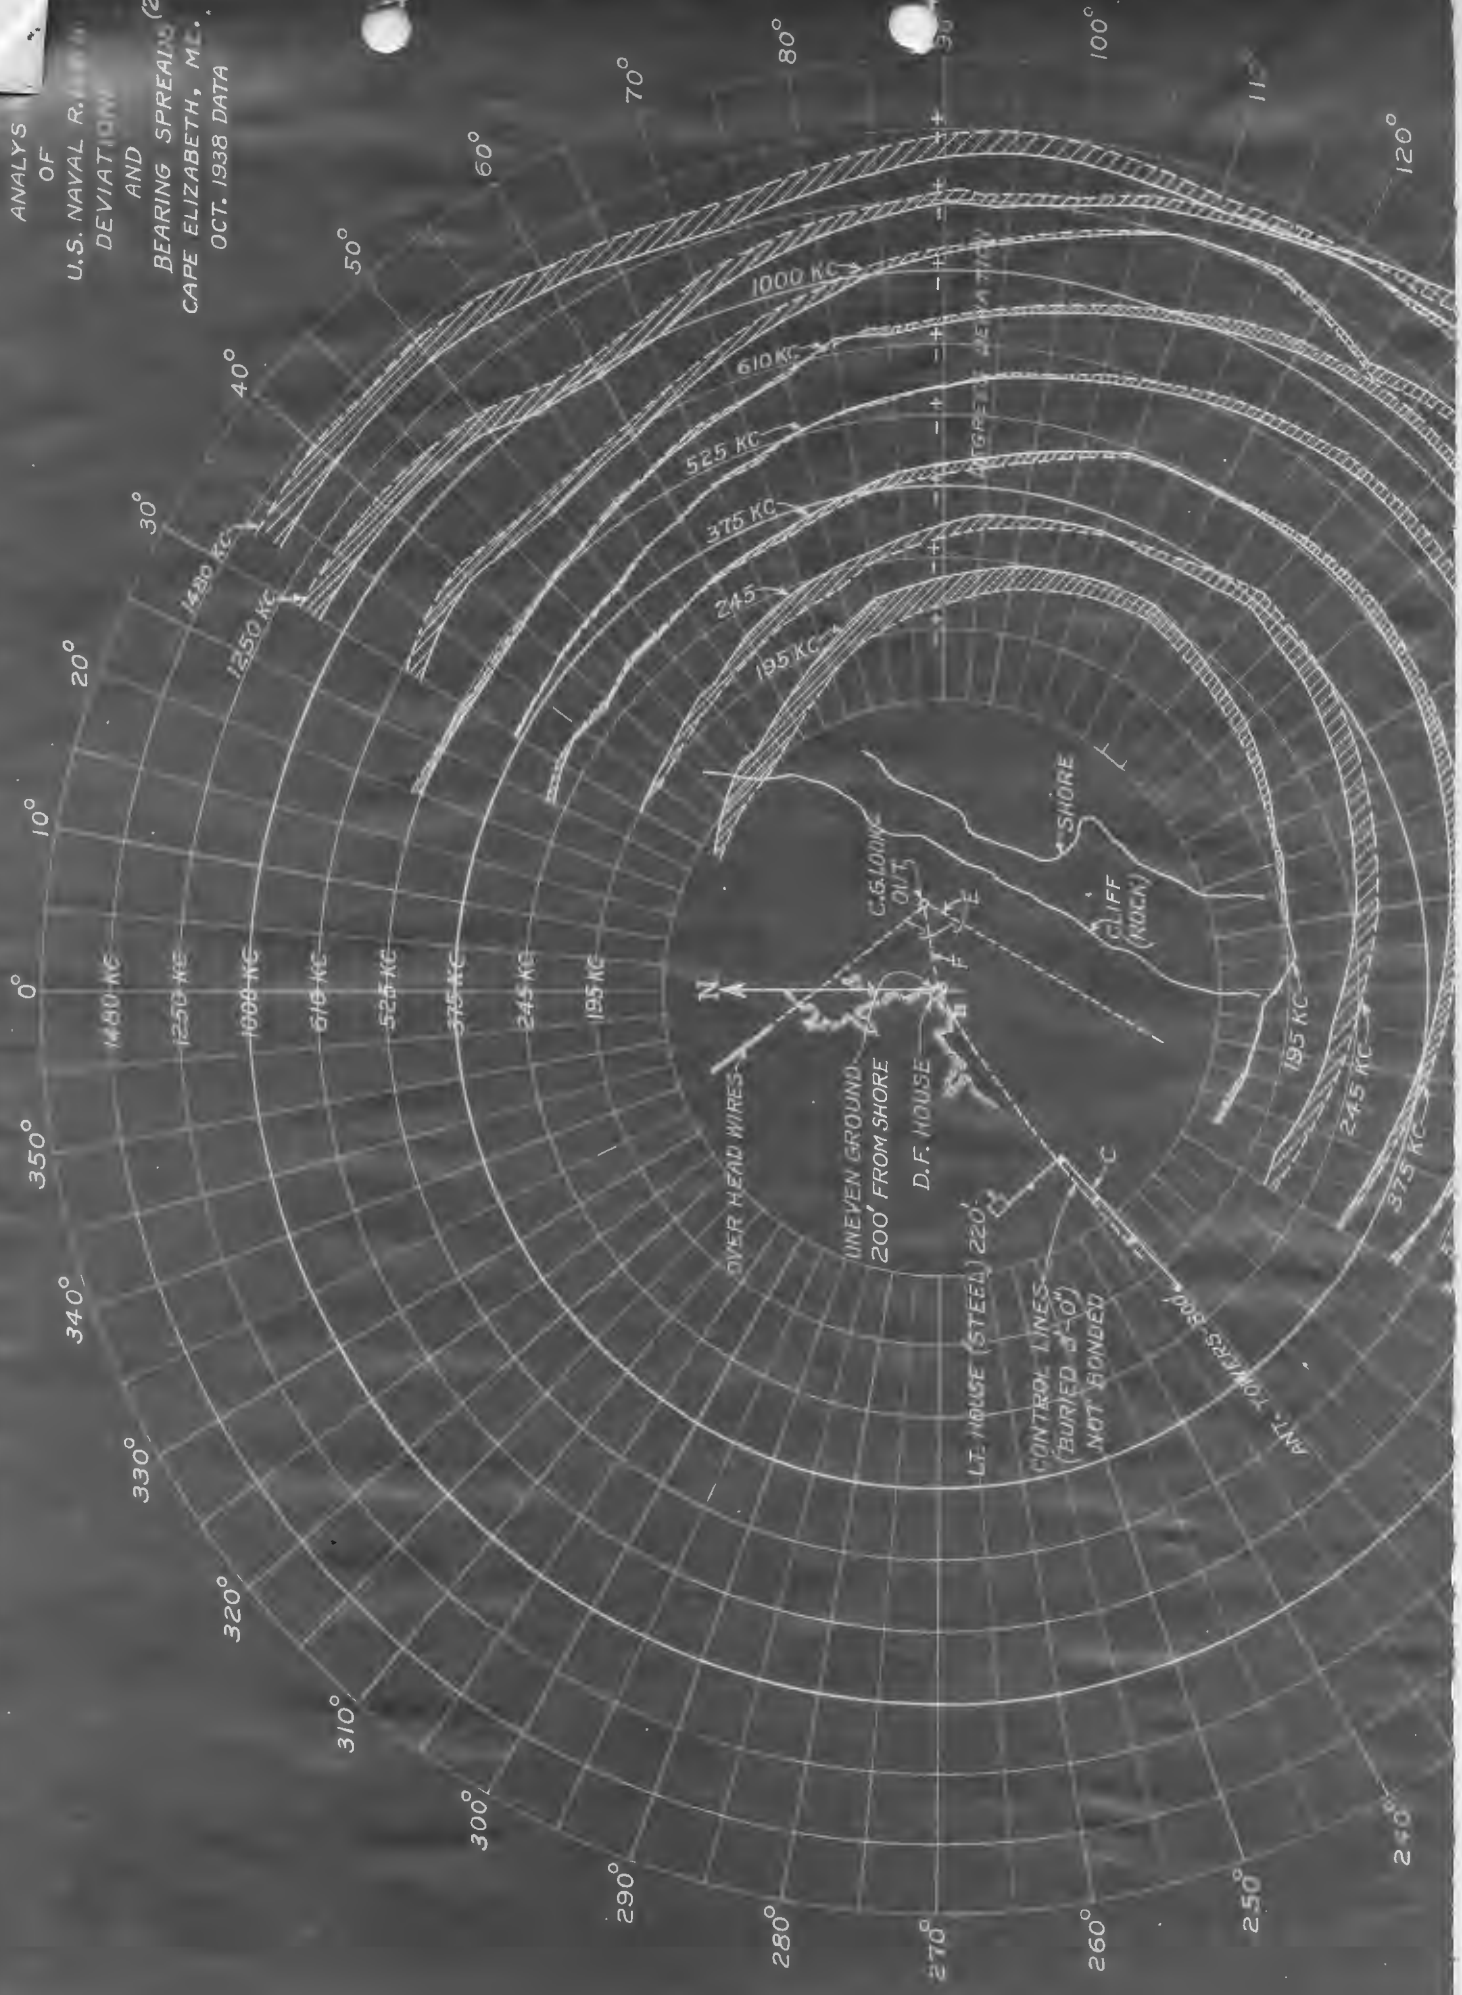
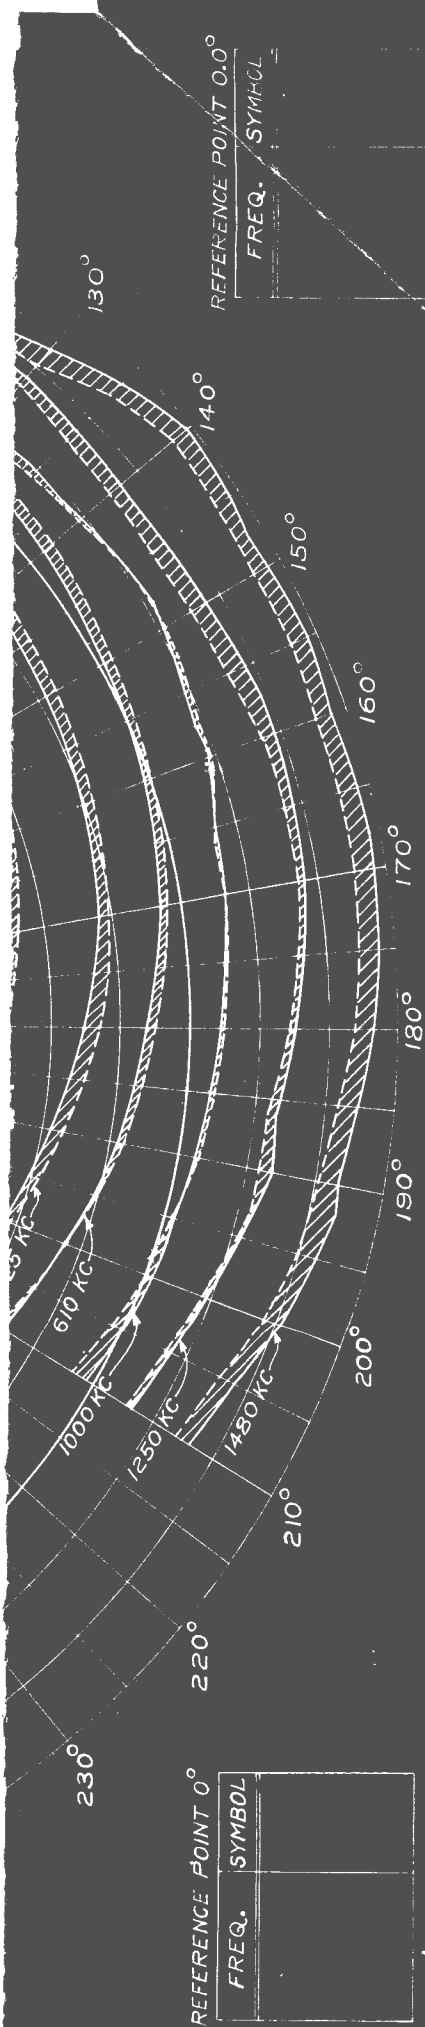
ANALYSIS
OF
U.S. NAVAL R. 11870
DEVIATION
AND
BEARING SPREADS (2)
CAPE ELIZABETH, M.E.
OCT. 1938 DATA

21. The polar composite chart, Plate 1, gives a striking summarization of the deviation and balancer variations and simultaneously permits their maximum coordination with the components of the "Station Layout" most responsible for their cause. Increasing the scale of the chart increases the accuracy of the analyses as well as assisting in its clarification.

24. It is recommended:
- (a) That the polar composite chart (see Plate 1) be utilized and adopted for analyzing irregularities in radio direction finder station calibrations.

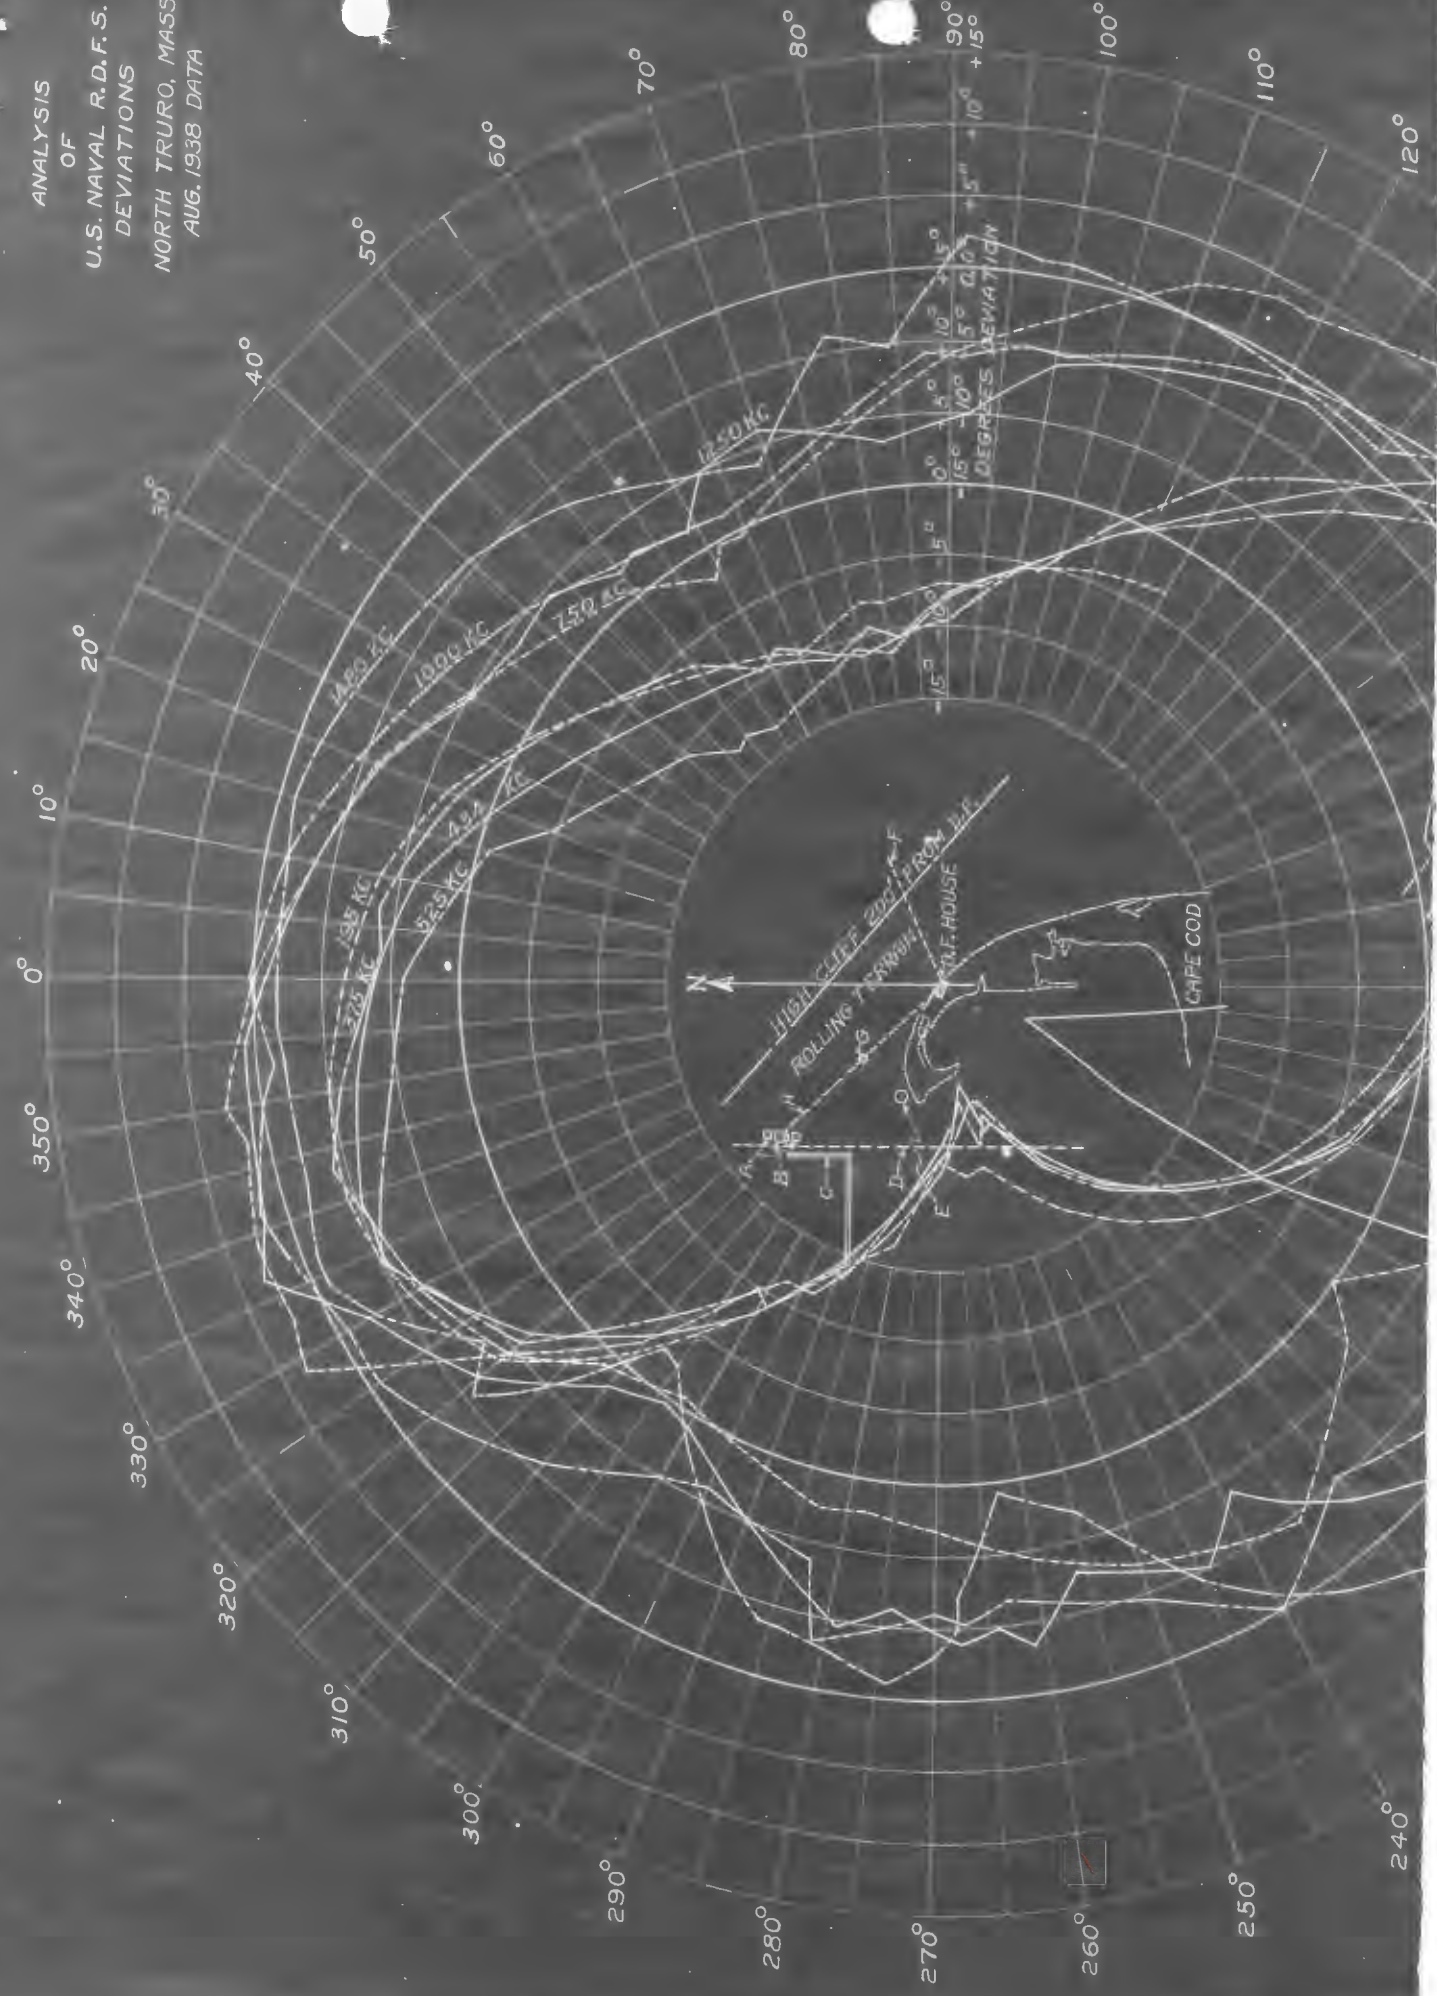
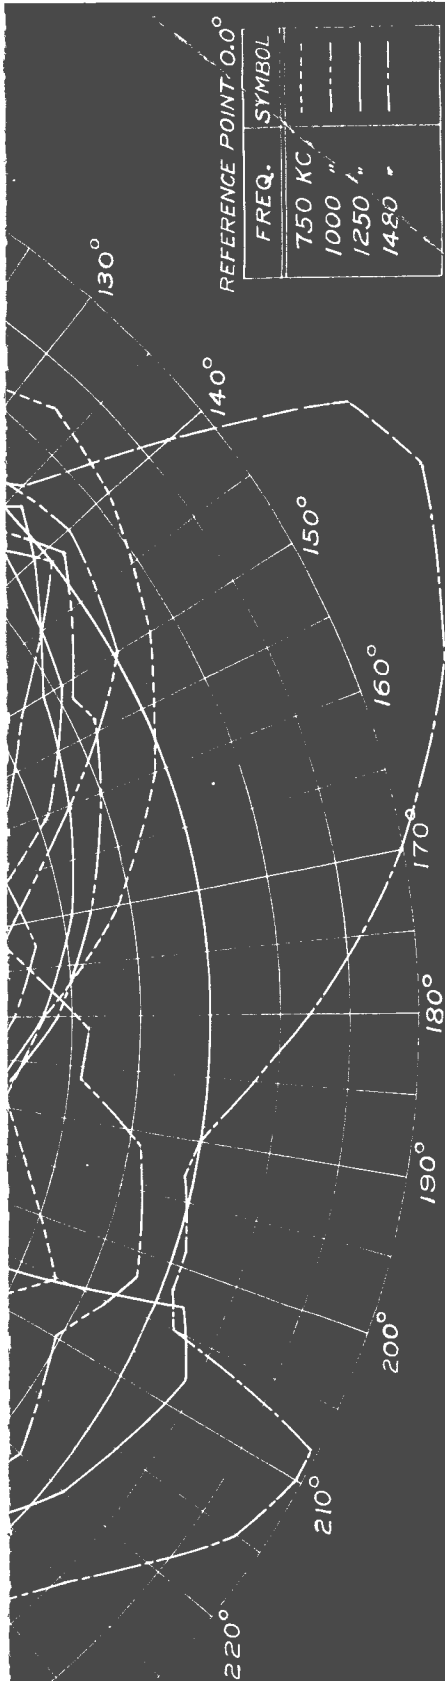
OF
U.S. NAVAL R.D.F.S.
DEVIATIONS
NORTH TRURO, MASS.
AUG. 1938 DATA

(c) Probable Causes. Structure G (radio beacon tower 100 feet high, 200 feet from direction finder) and structure H (control cable 700 feet long and connecting to direction finder house) have an approximate direction along $135 - 315^\circ$ which is the maximum coupling position for the loop taking bearings at the 45 and 225° azimuths. The change of magnitude and sign of the balancer settings with frequency indicates an additional or superimposed minimum coupling effect with the further suggestion that resonance of one of these structures is indicated by the sudden and large changes in phase of their reradiated field between 525 and 750 kilocycles. Structure F (a corrector wire laid in 1937) has an approximate length of 300 feet at an azimuth of 65° . It connects to the direction finder house and it may act as a form of Beverage antenna to account for the superimposed minimum coupling effect mentioned.

(c) Probable Causes. Structure F (a corrector wire laid in 1937) has an approximate length of 300 feet, connects to the direction finder house, and has a direction along 65° , which is the maximum coupling position to the loop taking bearings at approximate 155 and 335° azimuths. The increasing and off scale values of balancer required in this sector add confirmation* and further indicate a resonance of this structure near the higher frequencies.

(a) The 1250 kilocycle deviation curve is very erratic in this sector. Bearings are indefinite and deviations greater than -45° exist. The balance curve is at a peaked maximum and even at this setting, it is inadequate in sharpening the minimum. Tables 1 and 2 would indicate a minimum coupling as well as a resonant frequency characteristic of nearby structures.

(c) Probable Causes. Structures A and D (transmitting antenna, and a one mile long control line) have a direction of 0 - 180° which may act as a Beverage antenna with minimum coupling to the loop at the 180° azimuth. Since A is a 200 foot antenna which has a quarter wave resonance at about 1225 kilocycles, it may account for the tremendous change in deviation at this frequency and in this sector.

Structure E (lighthouse building) is along the 110 - 290° direction. This is a direction that a reradiated field from E can cause maximum deviation to a loop taking bearings at 20° or 200°; hence a 1225 kilocycle resonance of a structure within E can also possibly be the cause of the disturbance in calibration. Receiving antennas resonant in the broadcast band in this building may be responsible.

- (b) That in view of the greater ease and accuracy permitted by the polar composite method of determining the factors most responsible for deviation and balance irregularities, a serious investigation be made at one of the stations having very pronounced irregular deviation and balance curves in an effort to determine definite and satisfactory means for reducing the seriousness of the more unstable deviation influences. Radio direction finder station North Truro is recommended for such an investigation.

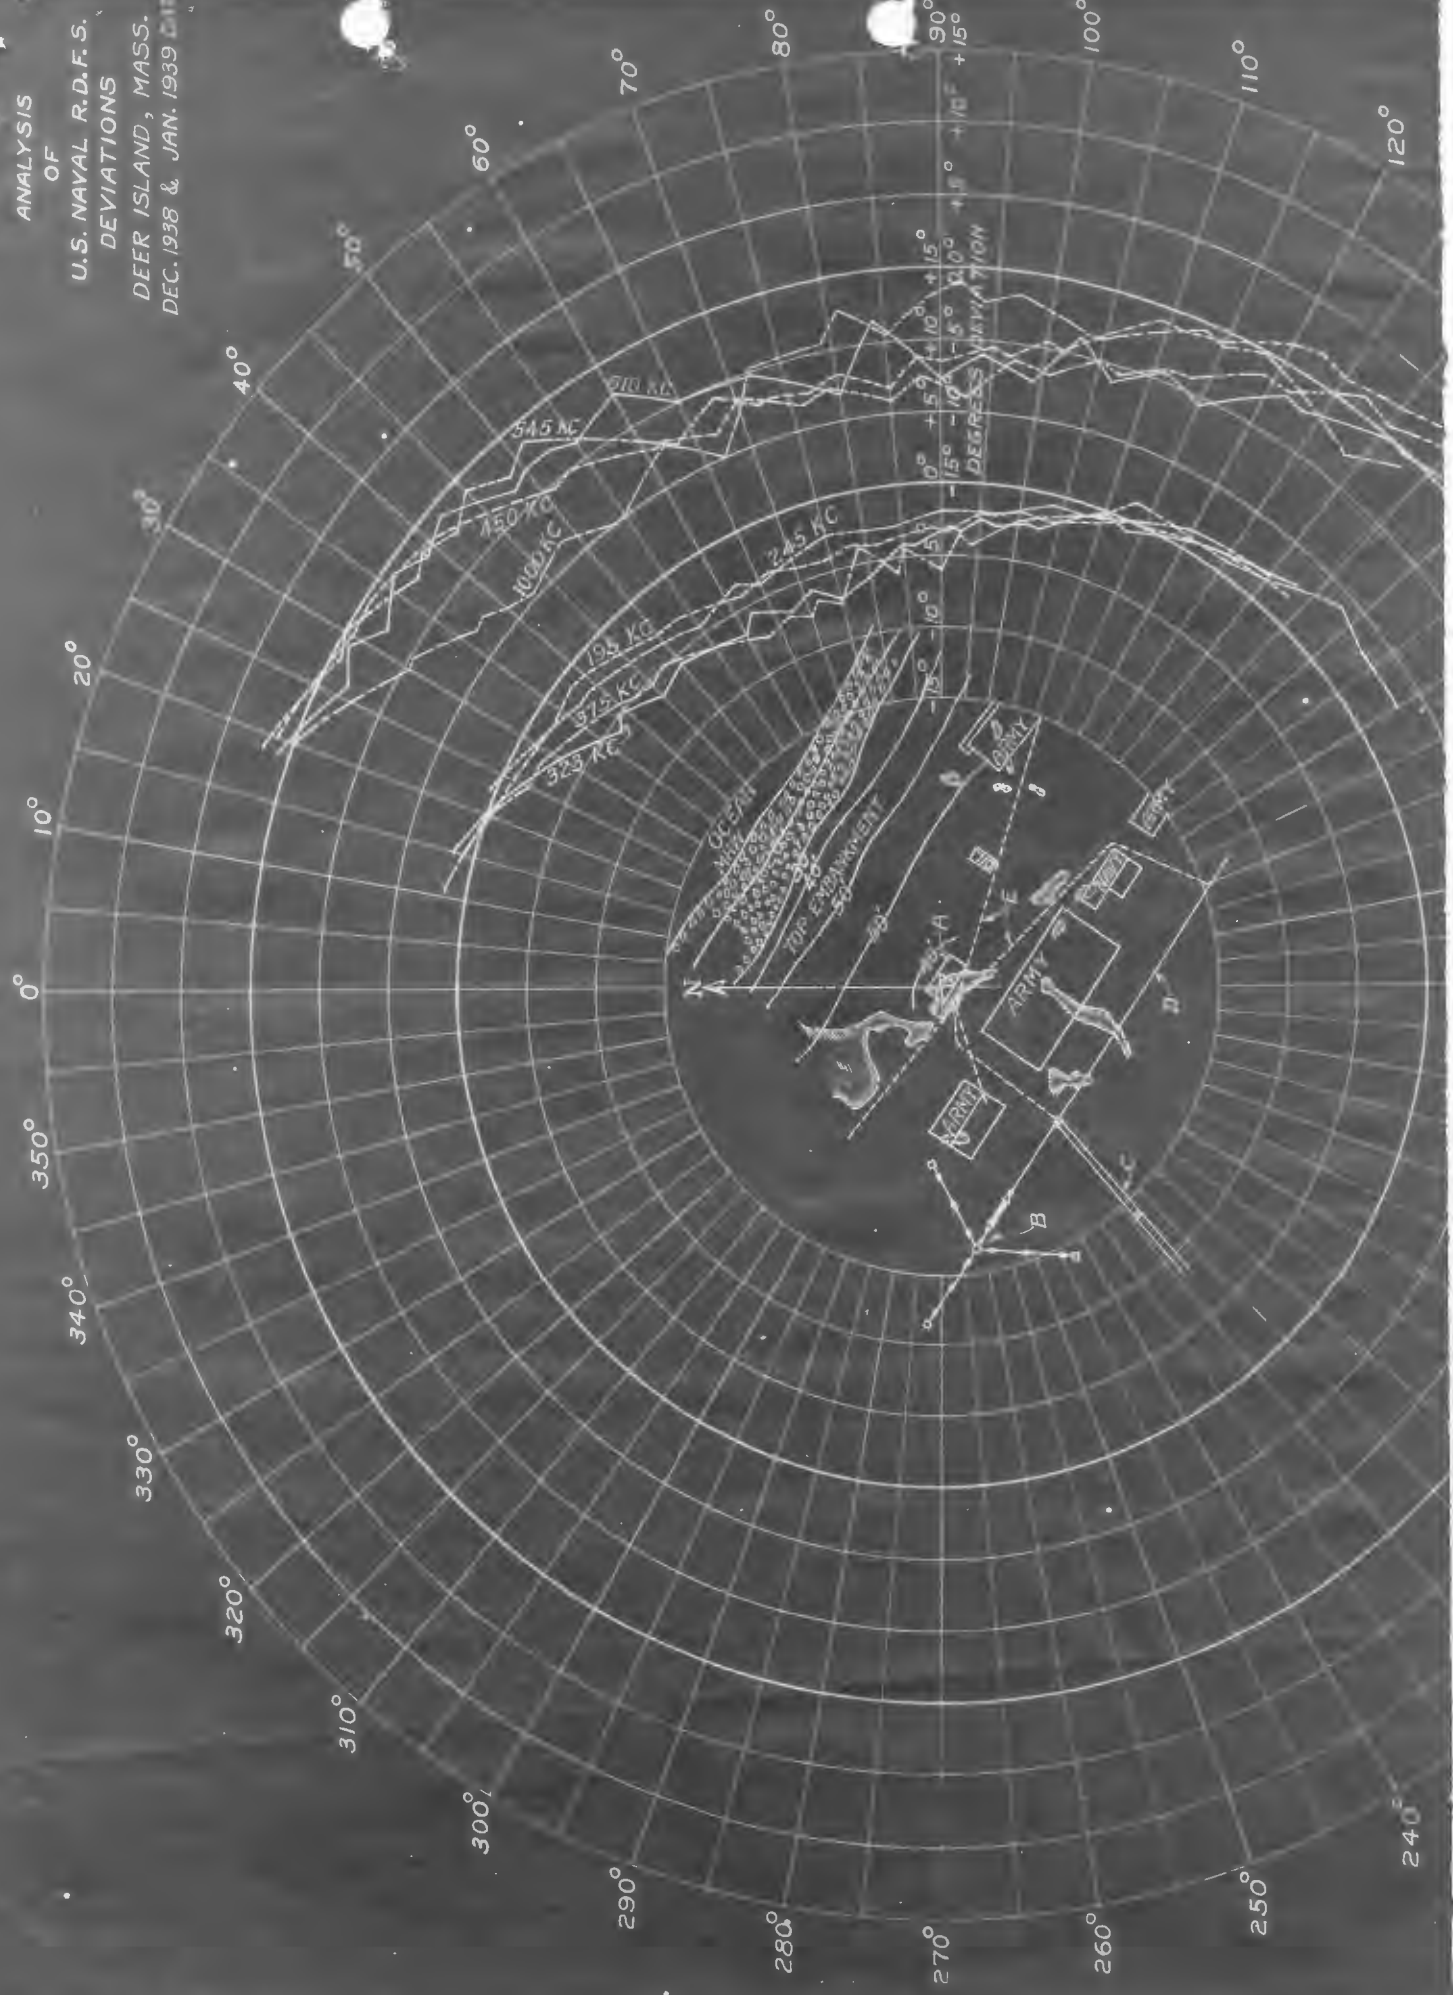
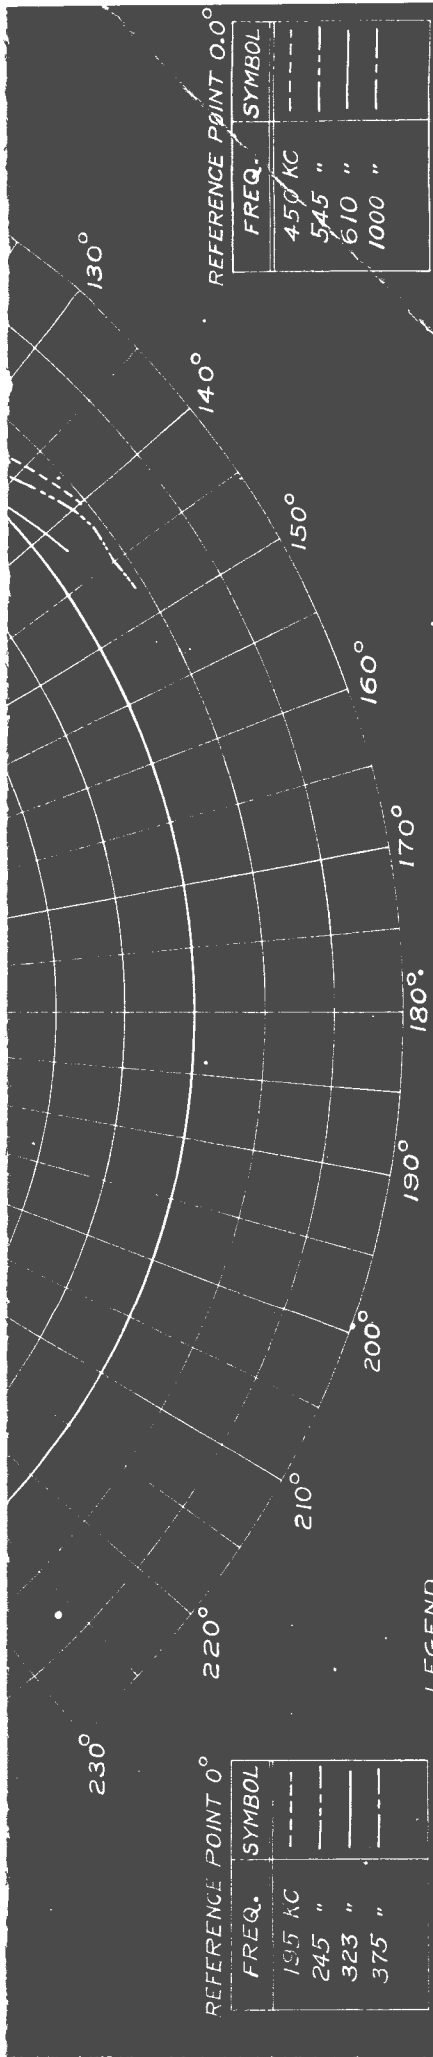
ANALYSIS
OF
U.S. NAVAL R.D.F.S.
DEVIATIONS
DEER ISLAND, MASS.
DEC. 1938 & JAN. 1939 DATA

"13. From the excellent curves obtained at Deer Island it would seem that the previous much discussed and recommended radial copper wire ground system around the D.F. house would be of assistance after all. As this station now has an extensive radial network an entirely different problem is presented compared to a station layout with only a one wire control system. "
