STUDIES OF THE NATURE OF WEAR

Vernon C. Westcott, et al

Trans-Sonics, Incorporated

4. DESCRIPTIVE NOTES (Type of report and inclusive dates) Progress Report 1 December 1973 to 30 June 1974		
5. AUTHOR(S) (First name, middle initial, last name) Vernon C. Westcott - Douglas Scott - John L. Middleton - Robert A. White

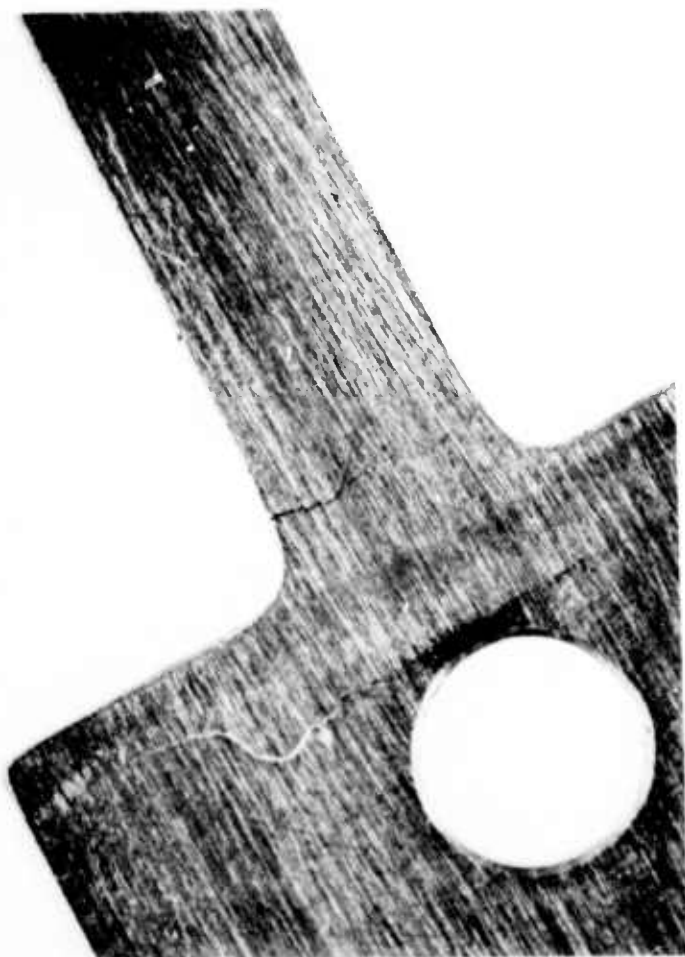
PHOTO NO. 3.1-1      DATE May 74

SEM photomicrograph of specimen  
at end of test. Fatigue crack  
is visible.

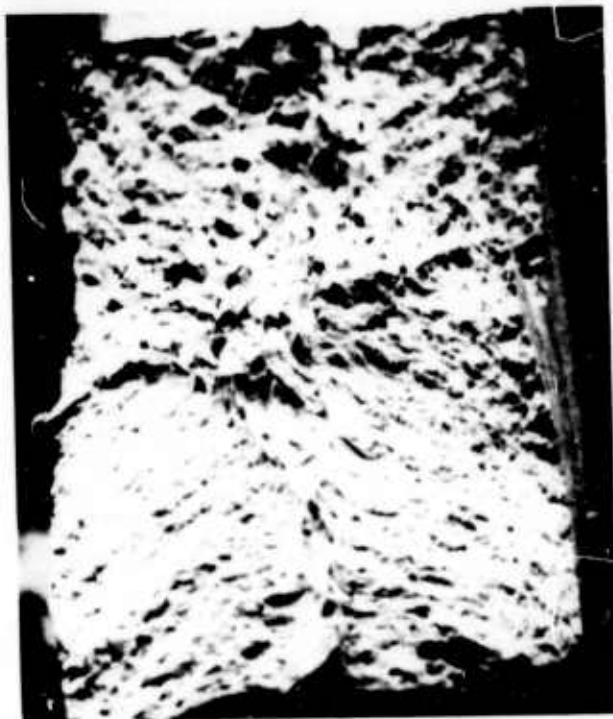
PHOTO NO. 3.1-2      DATE May 74

Wall of crack seen above. General  
view of fracture surface. Fracture  
initiated in lower left corner.

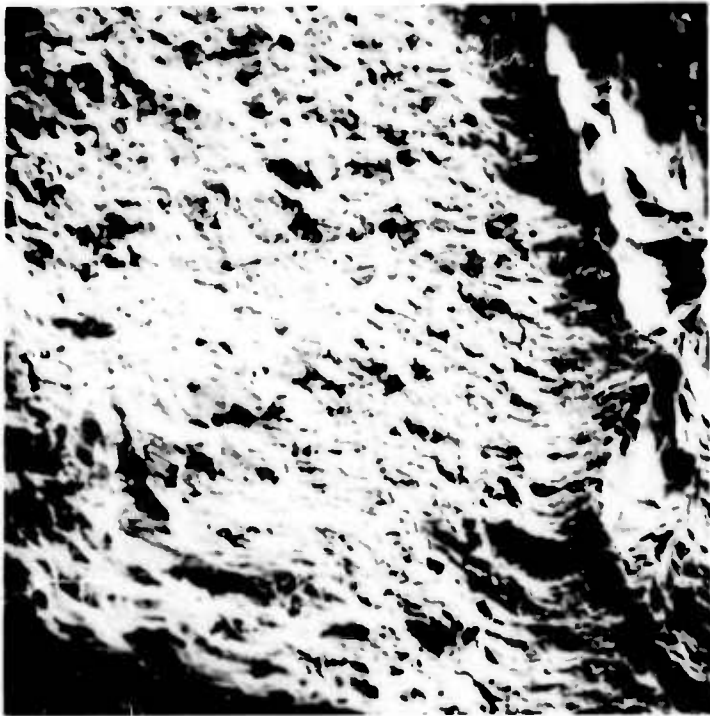
PHOTO NO. 3.1-3      DATE May 74

Initiation area of the fatigue fracture. View is of lower left corner of photo 3.1-2.

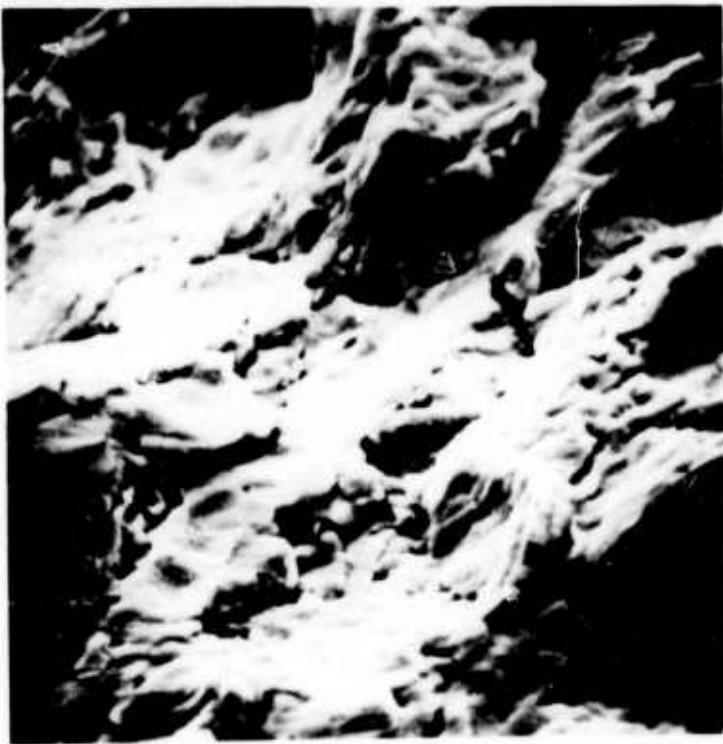
PHOTO NO. 3.1-4      DATE May 74

Same view as above with increased magnification. Note the surface shows evidence of rubbing wear.

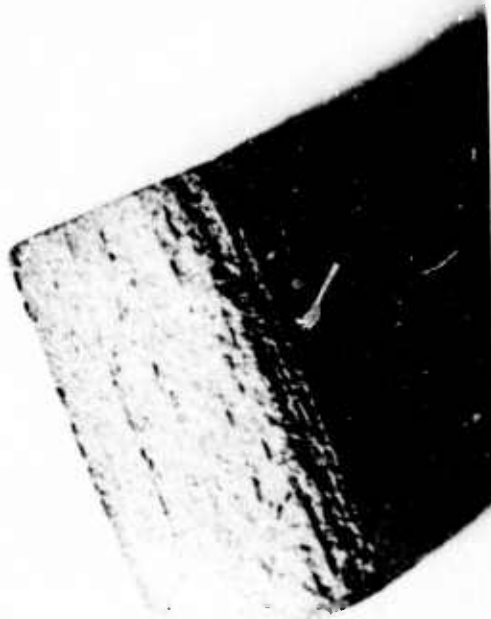
PHOTO NO. 3.1-6      DATE May 74

Enlarge view of fracture initiation  
area.

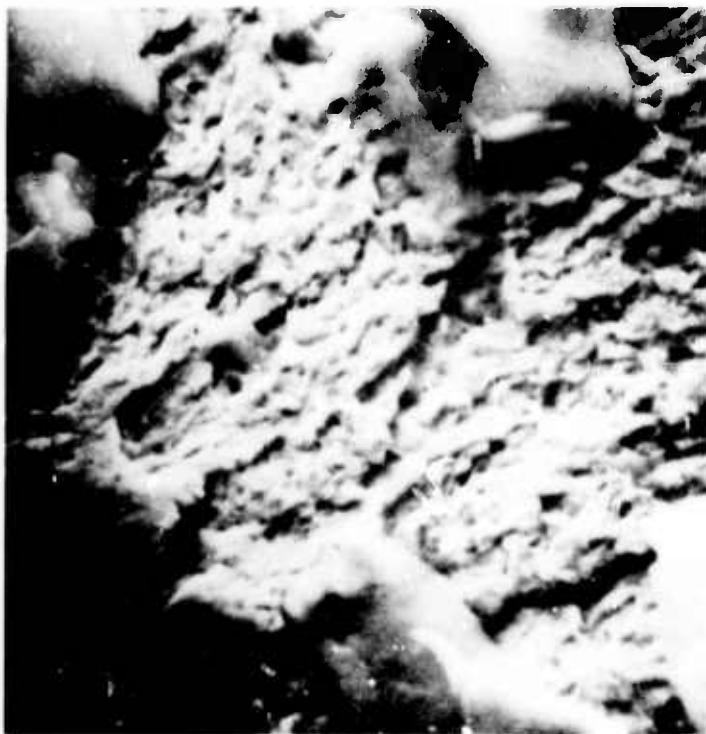
PHOTO NO. 3.1-7      DATE May 74

Rubbing marks and surface debris  
at fracture initiation surface.  
Some of the surface material is  
oxidized.

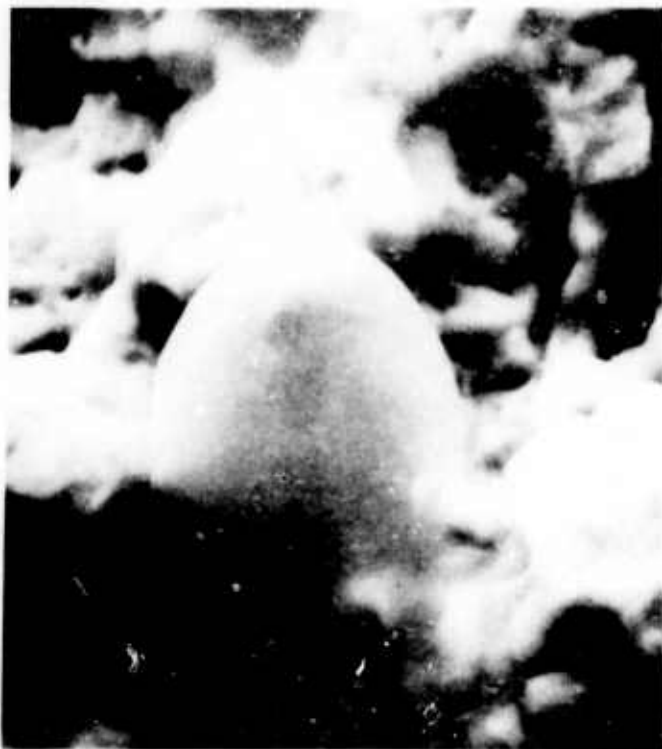
PHOTO NO. 3.1-8      DATE May 74

A spherical particle found on  
the surface. X-ray energy analysis  
shows it is likely an inclusion in  
the steel. It contains Cl, P, Ca,  
and only a trace of Fe.

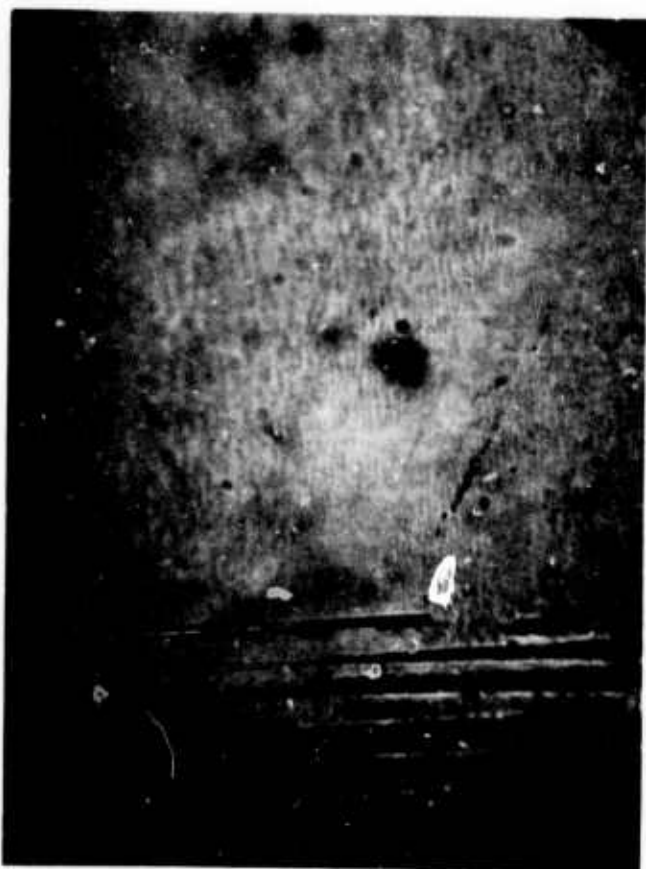
PHOTO NO. 3.2-2      DATE 5/6/74

Test No. 4102. Wear scar on the  
static race.

The extreme smoothness of the wear  
surface is evident. Note the  
"cornices" of metal formed over  
the grinding grooves at the edge  
of the scar. Metal is flowing  
from bottom to top.

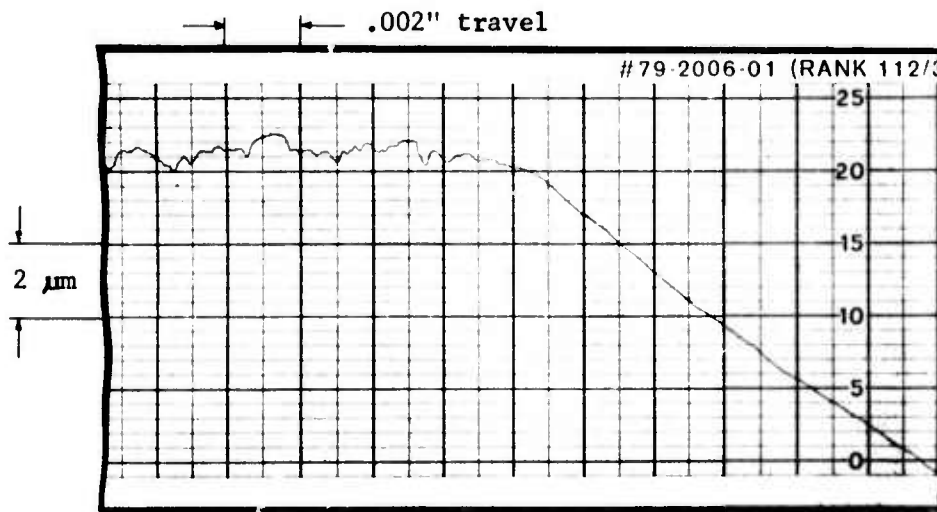
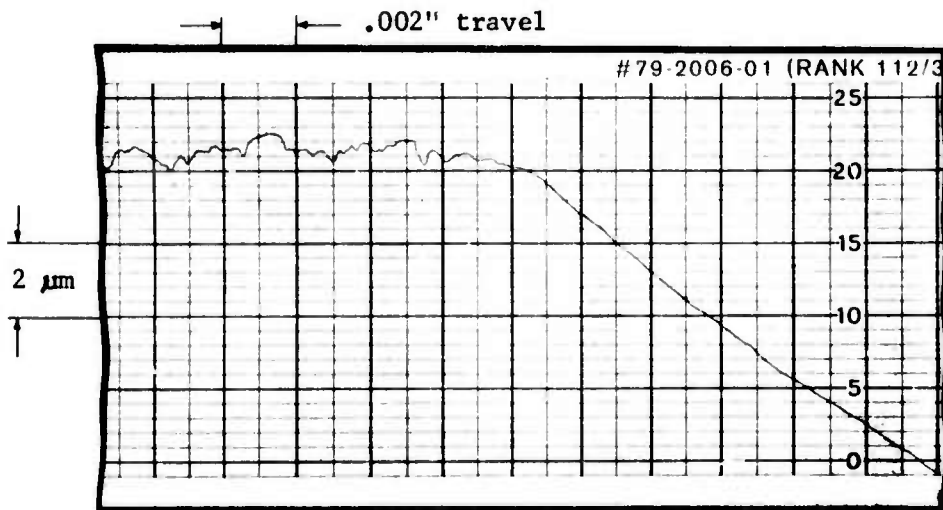
Figure 3.2-5c. A Tally surf trace of the wear surface of the static piece from test no. 4093 after wearing.

An interesting aspect of these wear tests is the astonishing smoothness of the wear scar surface on the static piece. When examined optically at high magnification (700X), the wear surface appears polished. The highly reflecting optical quality surface is devoid of irregularities as if formed from the molten state, Photomicrographs 3.2-2,-3,-4. A Tallysurf measurement shows the surface to be better than 0.2  $\mu\text{m}$  in peak to peak surface finish, Figure 3.2-5.

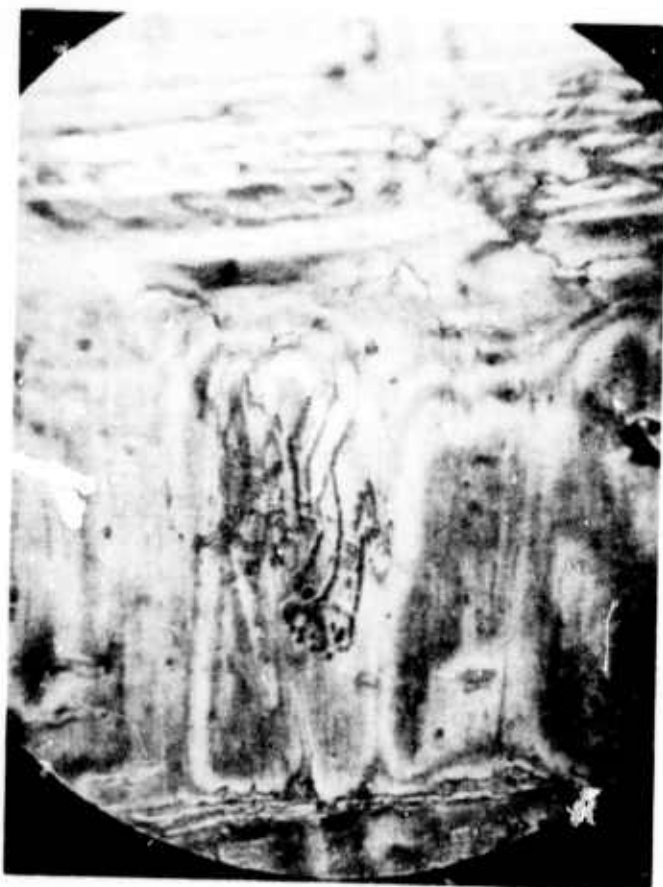
PHOTO NO. 3.3-4      DATE JULY 74

Optical photomicrograph of dark pit  
network. Note parallel curved strings.

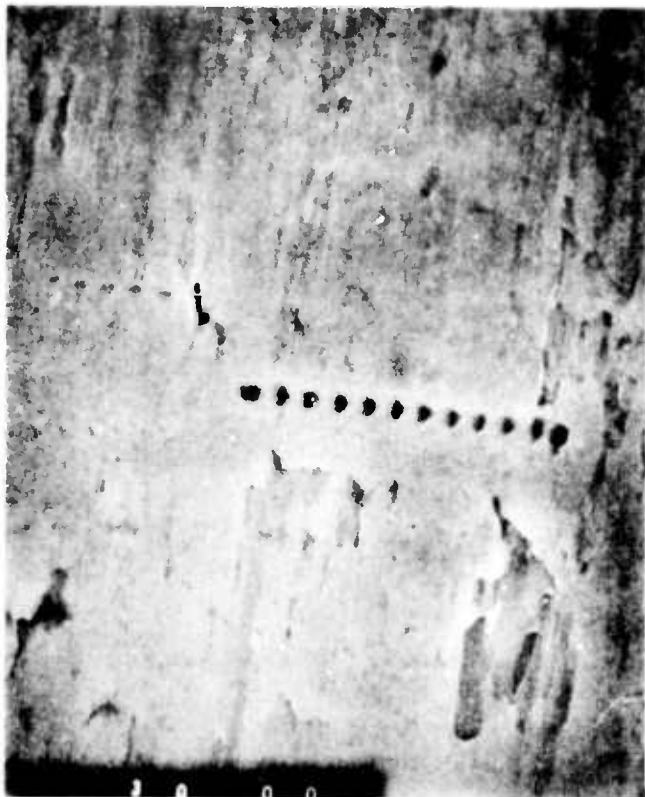
PHOTO NO. 3.3-5 DATE JULY 74

S.E.M. photomicrograph showing  
typical lines of pits. Note  
triangular shape of pits.

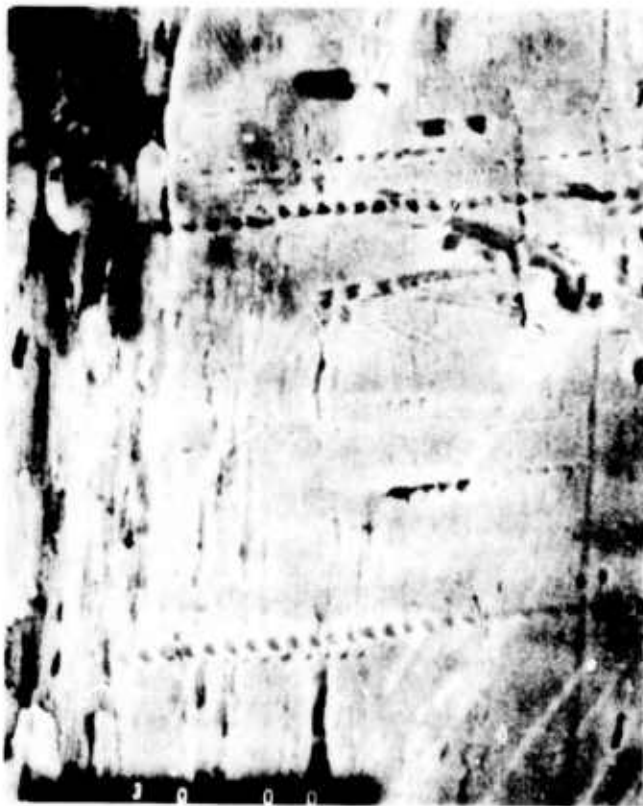
PHOTO NO. 3.3.6 DATE JULY 74

S.E.M. photomicrograph showing  
parallel strings and parallel  
curved strings.

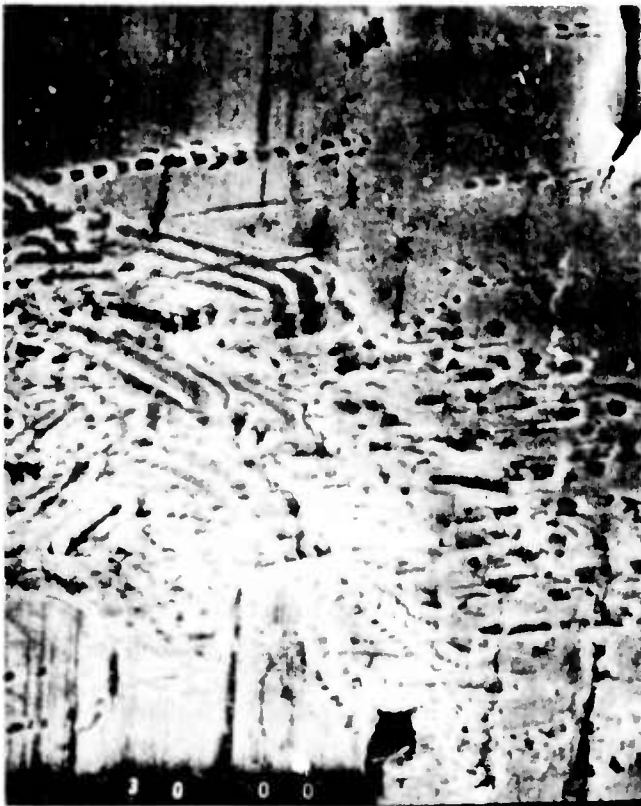
PHOTO NO. 3.3-7      DATE JULY 74

S.E.M. photomicrograph showing network of pits.
