THE MAN-MADE MC MURDO ICE WHARF--  
HISTORY, CONSTRUCTION AND PERFORMANCE

J. L. Barthelemy

Civil Engineering Laboratory (Navy)  
Port Hueneme, California

February 1975

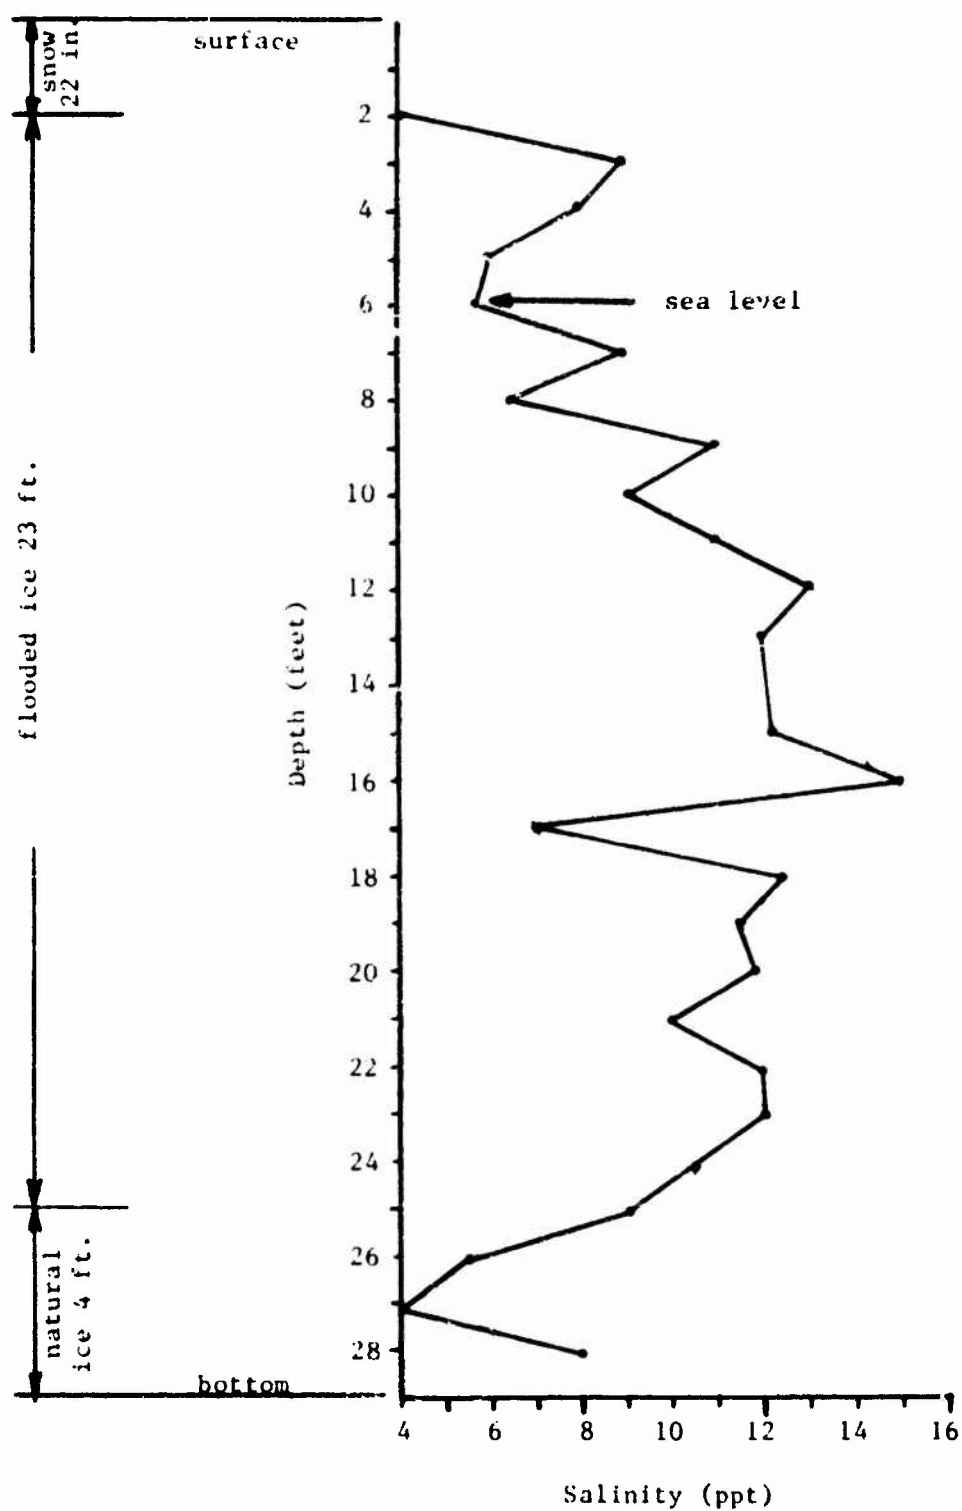
The results of the salinity measurements made at 1-foot intervals are shown in Figure 6. The highest salinity measure was 15 parts per thousand (ppt) with an average of 9.7 ppt. This was about twice the average salinity for 1-year-old sea ice but again was considered normal for the flooded ice at that time.

Figure 6. Salinity profile of core extracted from surface-flooded ice wharf, 25 November 1973.

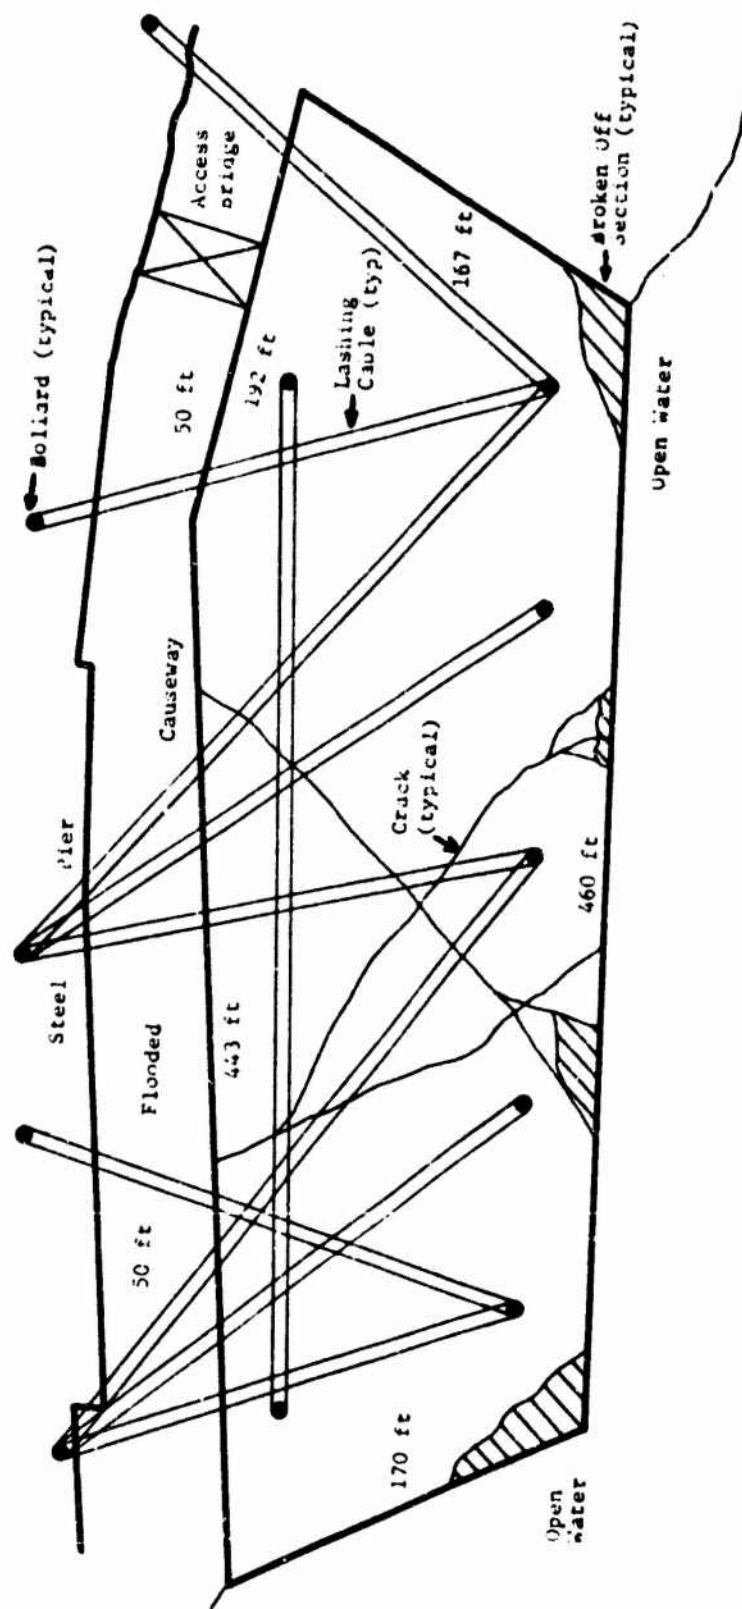
The ice breaker *USCG Staten Island* moved into Winter Quarters Bay on 15 January to remove ice from the vicinity of the wharf. Initial passes were intended to break up the annual ice at some distance from the structure. Even so, a crack which began in the annual ice continued to propagate through the wharf, all the way to the tidal crack. In addition to this major full-depth crack, there were other hairline fractures. Operations were halted and two bollards installed in order to tie the two sections together.

The next day the ice breaker resumed maneuvers. It made good progress on clearing the wharf face. On the last pass, however, the ship moved too closely, and the resulting impact opened up several new full-width, full-depth cracks. Also, an end piece totally separated and floated away. The remaining sections were large and worth saving; two additional bollards (for a total of seven) were added, and the entire network lashed together. Figure 8 presents a sketch which shows crack and bollard configuration at the time of cargo unloading.

Figure 8. Surface-flooded McMurdo ice wharf during breakout, 16 January 1974.
