378' WHEC EXPANSION JOINT INSTALLATION
AND PERFORMANCE EVALUATION

Coast Guard Research and Development Center

1. Report No. CG-D-67-75		2. Government Accession No.		3. Recipient's Catalog No. AD-A007876	
4. Title and Subtitle 378' WHEC EXPANSION JOINT INSTALLATION AND PERFORMANCE EVALUATION				5. Report Date July 1974

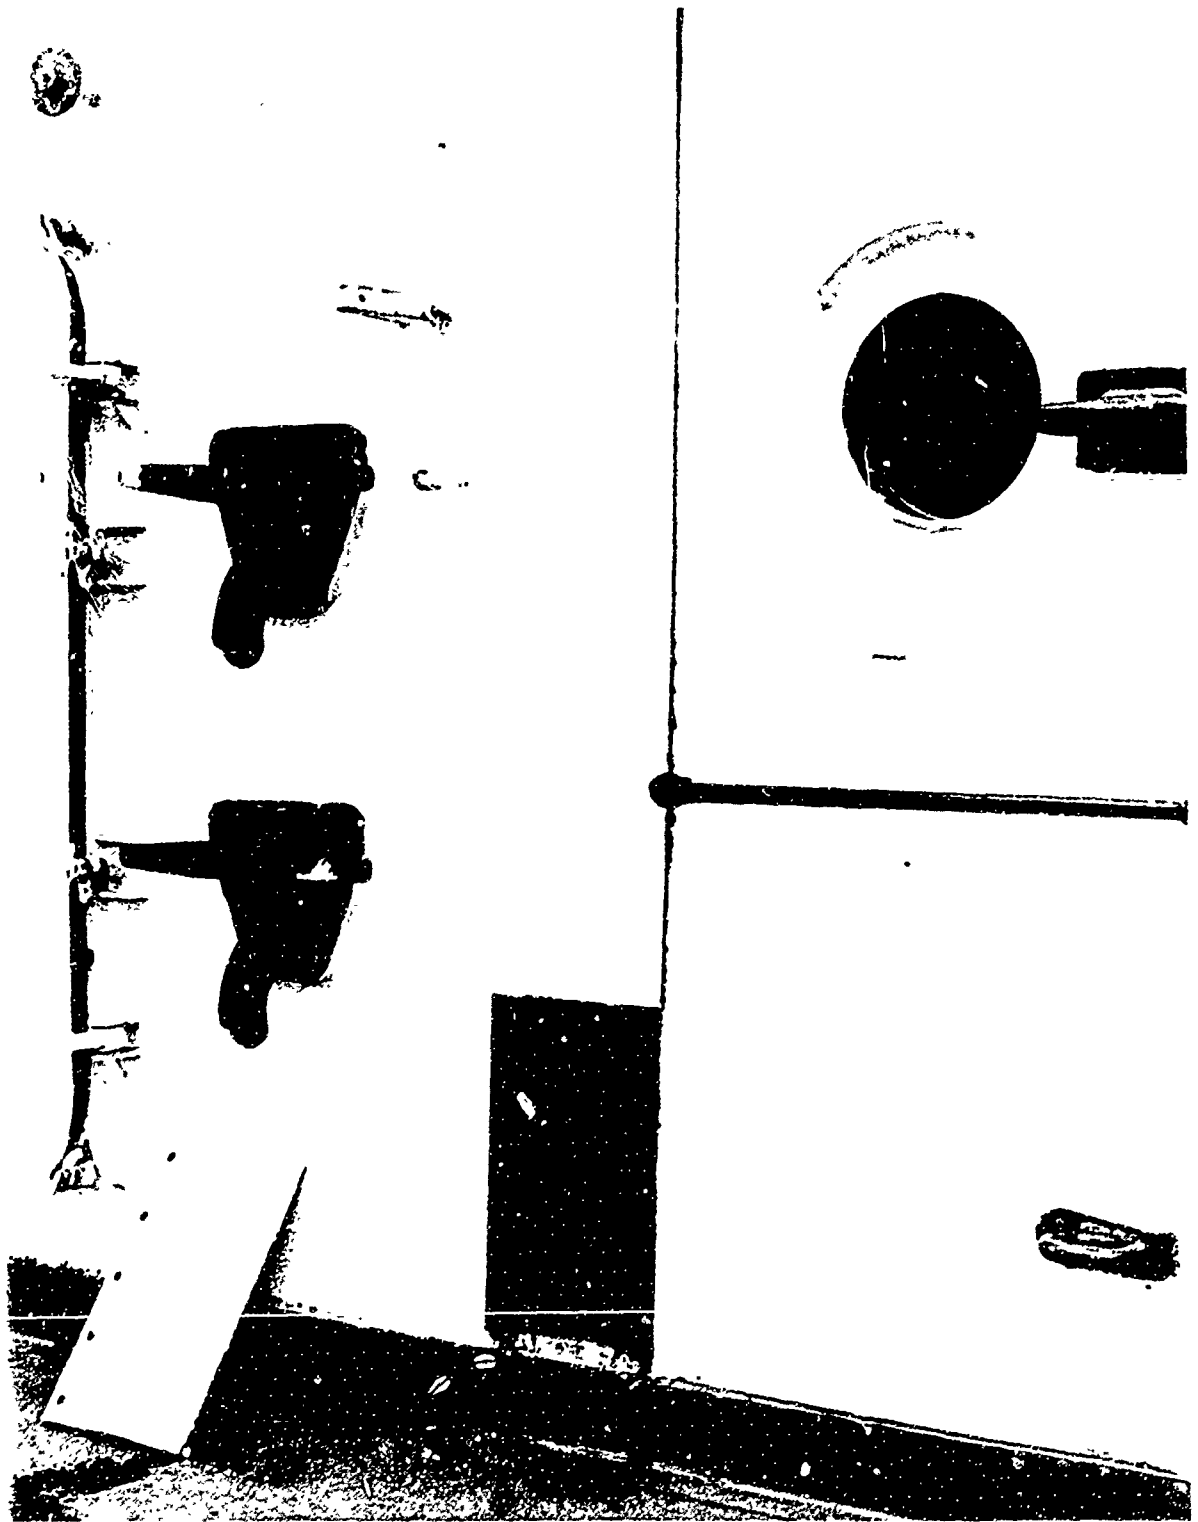
A conventional expansion joint failure (WHEC 327' class) is illustrated in Figures 2 and 3. As might be expected, the sharp radius at the base of the expansion joint concentrated the longitudinal and shear strains in the deckhouse side resulting in a crack at the "hinge" of the joint.

Figure 2. Main deckhouse side of 327' WHEC vessel showing expansion joint.

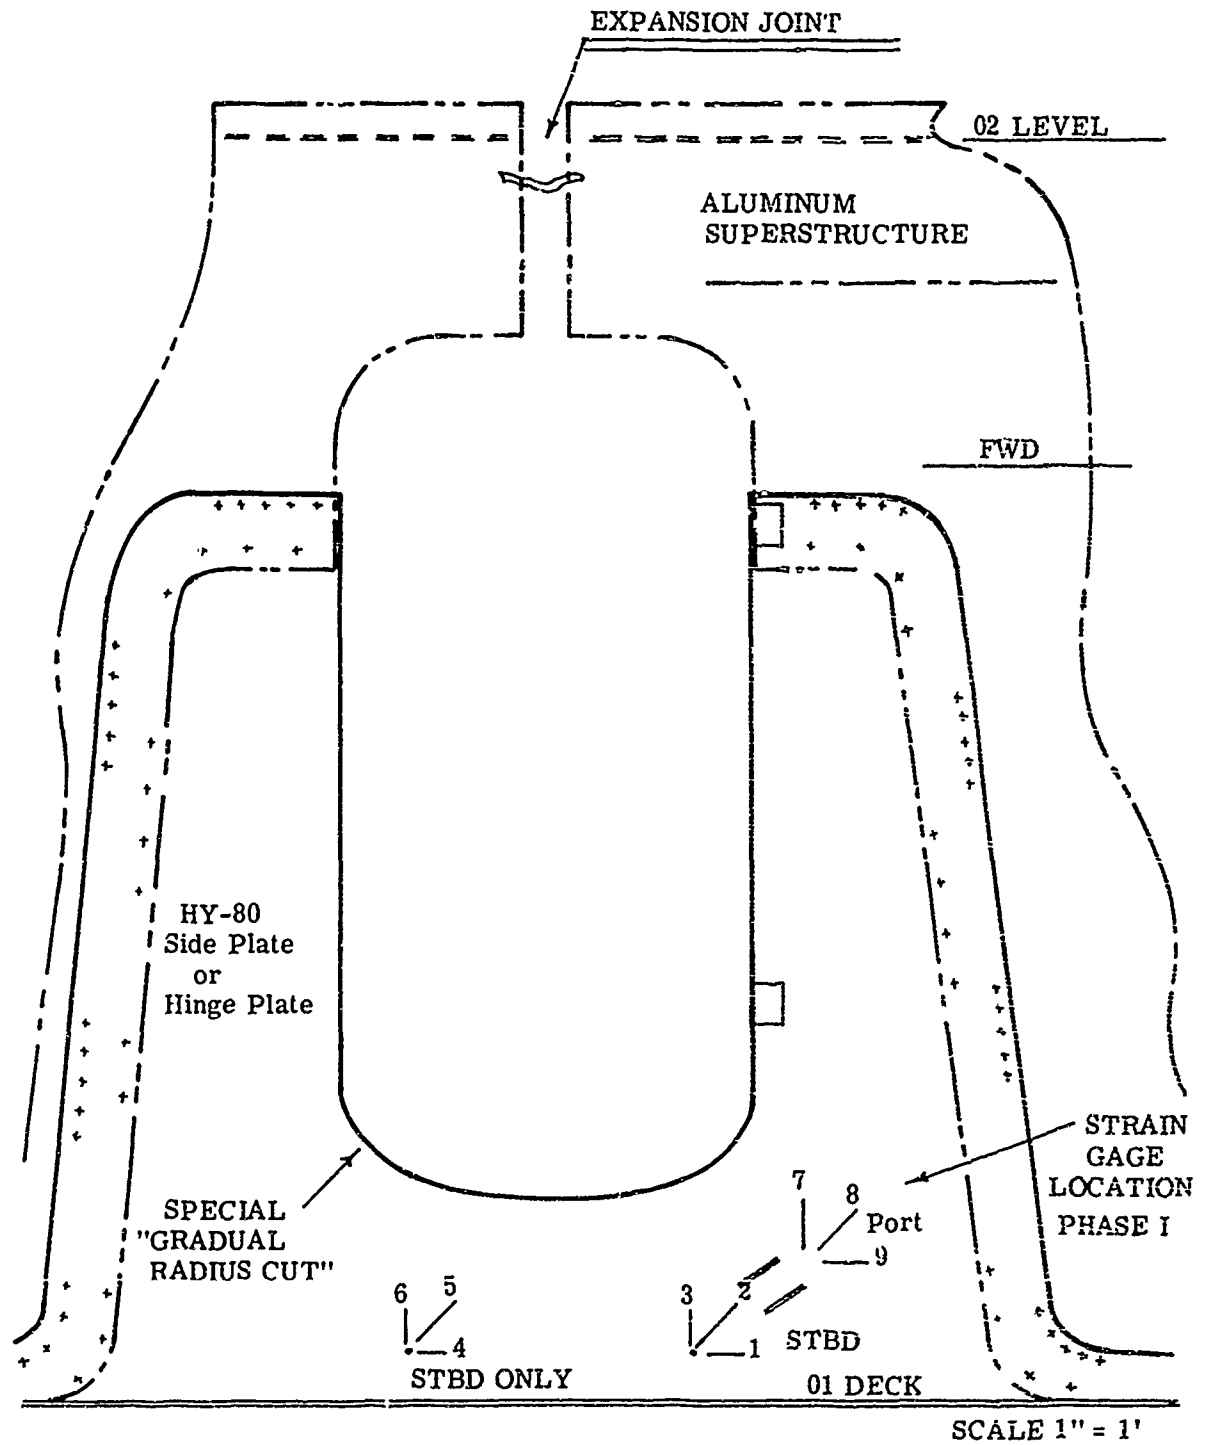
Figure 7. Diagram of hinge plate showing strain gage locations.

In the initial phase for the stress at the hinge, three rosettes (Figure 8, gauges #1 - #9) were mounted on the HY-80 side on the hinge plate as shown in Figure 7. Two of these rosettes were on the starboard side and one on the port side. For the stress in the shear curtain a single 45° rosette was installed at Frame 288 (Figure 8, gauges #19 - #21). A single strain gauge (Figure 8, gauge #10) was mounted on the transverse beam directly below the expansion joint to ascertain the magnitude of vertical reactions generated by the expansion joint. The remainder of the gauges in Figure 8 were to provide sufficient information to reaffirm the effectiveness of the O1 deck as previously ascertained by NSRDC (reference (1)) on the same class of vessel without the expansion joint. Due to the failure of weather deck gauges #13 and #14 this was not possible during Phase I.

Examination of the data presented in Table 1 reveals that the highest recorded peak-to-peak variation in principal stress at the hinge of the expansion joint is slightly in excess of 12,000 psi. It is important to note here that peak-to-peak readings include tensile stress imposed by hogging plus compressive stress imposed by sagging. Since the calculated hogging stress for this type vessel is approximately .55 of the peak-to-peak stress it follows that the maximum tensile stress experienced during the tests is of the order of 6600 psi. Considering the high yield strength (80,000 psi) and notch toughness of the HY-80 hinge plate, it is apparent that there is ample reserve to account for the higher strains that can be expected at the edge of the cut where the radius becomes finite. Ample safety margin exists even for the mild steel deck in the area.

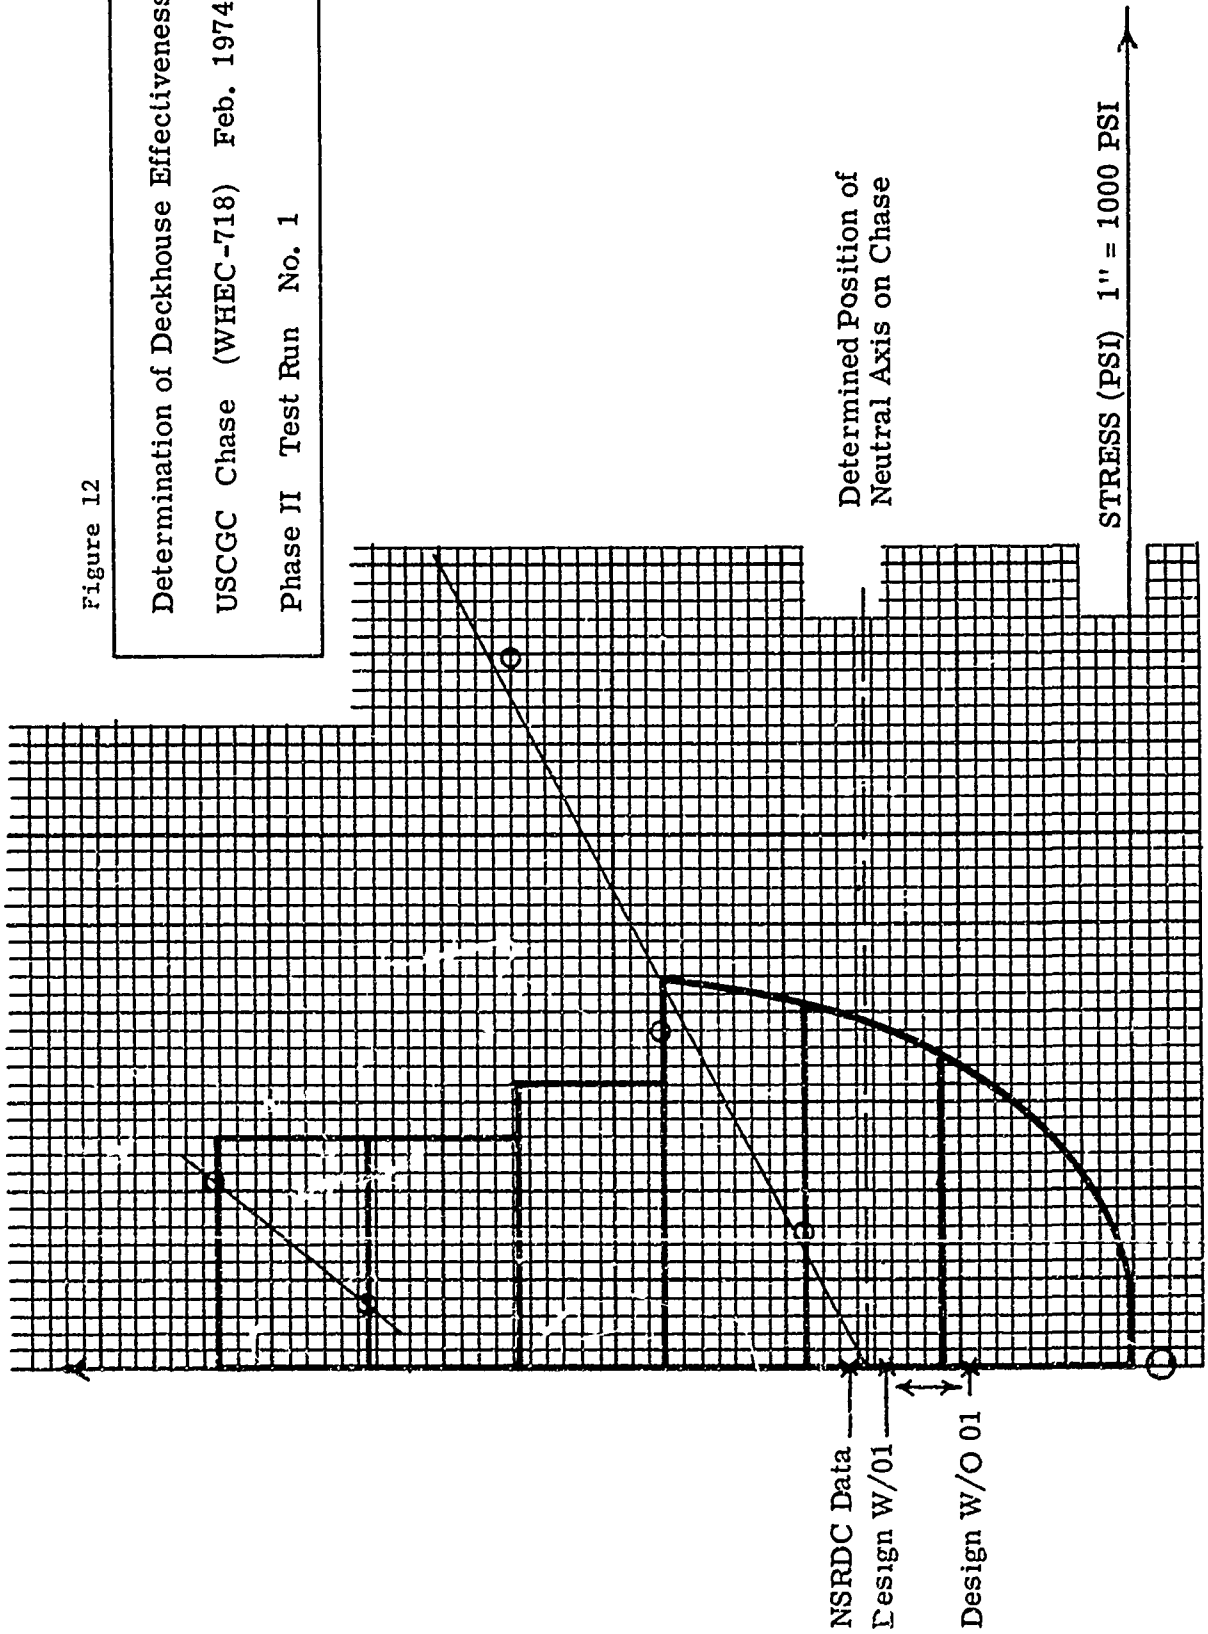
This can be seen in these results in both Figures 12 and 13 where the intersection of the stress distribution line and the ship's centerline is approximately 15 feet from the keel. This result is reasonable in comparison with the original design calculated position of the neutral axis (reference (2)). As can be seen in either Figure 12 or 13, the design position of the neutral axis considering the 01 deck as part of the hull girder is 14.2 feet from the keel and the position of the neutral axis disregarding the 01 deck is a mere 9.3 feet. Since the forward portion of the 02 deck is influencing the hull girder, it can be expected that any measured neutral axis position would be higher than a design calculation disregarding the 02 deck.
