TOTAL AIRFRAME FATIGUE TEST F 104 G  
FINAL REPORT

TOTAL AIRFRAME FATIGUE TEST F 104 G FINAL REPORT

By: Schütz

Source: Gesamtzellen-Ermüdungsversuch F 104 G,  
Abschlussbericht, Bericht Nr. TF 81/20,  
15 March 1974, pp. 1-106.

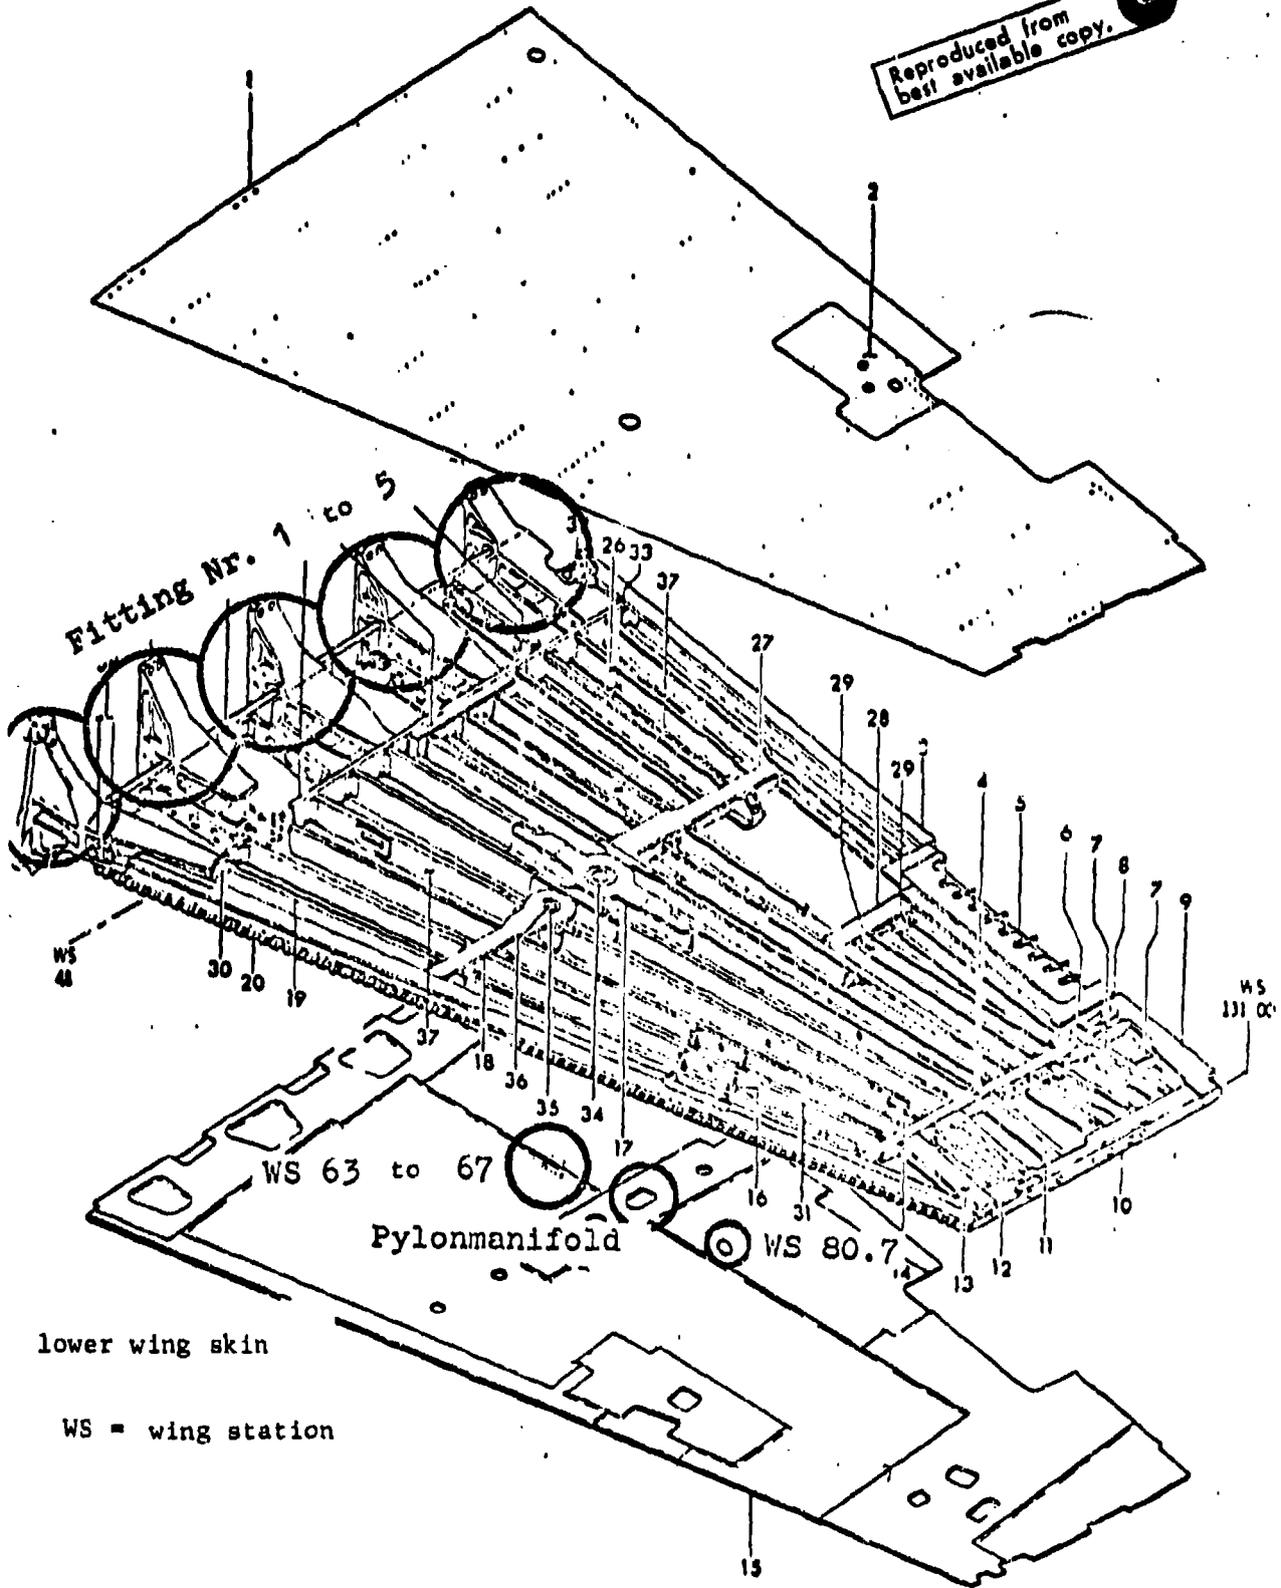
Figure 6. Summary of wing damage of category X.

Damage No.	Report No.	Wing*	Damage Location
F10, F12, F13, F14, F15, F22, F28, F42, F46, F67, F68, F64	81/21.8	B	wing connection fittings (fittings)
RF4, RF5, RF6, RF7, RF8, RF9, RF10, RF11, RF12, RF16	81/21.9	R	wing connection fittings (fittings)
F40, F44	81/21.4	B	lower wing skin pylon fitting con- nection
RF21, RF22	81/21.5	R	(WS 63.7 WS 66)
F1, F31	81/21.4	B**	lower wing skin, opening for the aileron servo (WS 80.7)
F 49	81/21.4	B	lower wing skin pylon manifold
RF15, RF41	81/21.5	R	(WS 73.5)

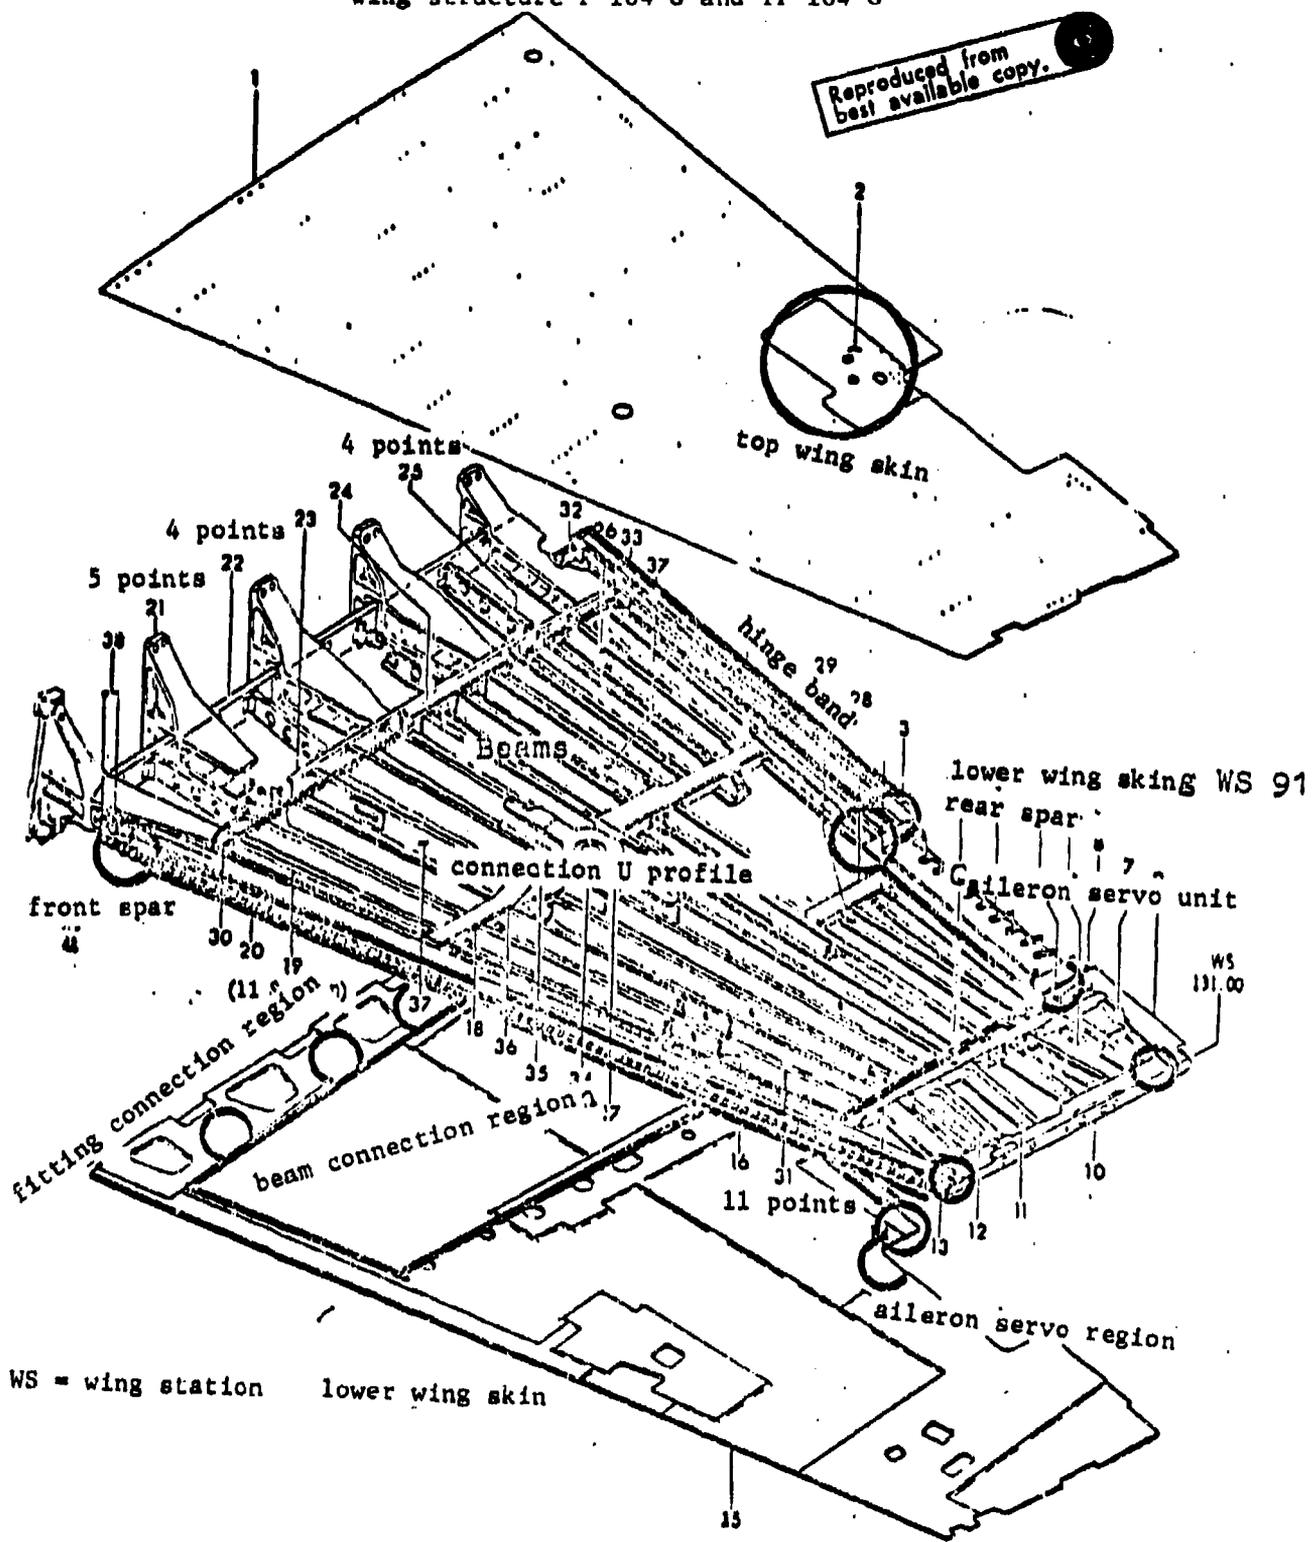
Figure 7. Wing damage summary, categories A and B.

Damage No.	Report No.	Wing*	Damage Location
F16, F17, F44, F24, F27, F58, F65	81/21	B	Lower wing skin countersunk hole in the connection region of the fittings (WS 36 — 48)
RF23, RF 24, RF38	81/21.5	R	
F41, F44, F55, F60, F61, F65, F66	81/21.4	B	Lower wing skin countersunk hole in the interior wing region of the beam screw attachment (WS 48 — 74)
RF 33	81/21.5	R	
F19, F35, F39	81/21.10	B	Rear spar in the transition region from the Double-T to the U profile (WS 91)
RF 31	81/21.7	R	
RF13, RF14	81/21.7	R	Hinge band on the side of the wing for the landing flap connection
F 9	81/21.4	B	Lower wing skin opening for tip tank jettison arming switch (WS 117)
F 59	81/21.4	B	Lower wing skin attachment hole for the aileron servo

Damage No.	Report No.	Wing*	Damage Location
F20, F30, F43	81/21.10	B	Lower wing skin, milled radius in the connection region of the rear spar and of the landing flap hinge, respectively (WS 91)
RF27, RF34	81/21.5	R	
F2, F33, F48	81/21.4	B	Top skin and cover at the opening of the aileron servo
RF2, RF18	81/21.5	R	
F3, F23, F51, F7, F29, F26, F32, F63	81/21.7	B	Connection U profile
RF3, RF17	81/21.7	R	
F37, F52, F53, F54	81/21.10	B	End rib, milled edge of flange web
RF25, RF30	81/21.7	R	front spar, rounding radius and hinge ring on the flap side
RF19, RF36, RF44	81/21.7		
RF20, RF35, RF37, RF43	81/21.7	R	hinges of the flaps
RF 40	81/21.7	R	Beams
RF29, RF32, RF39	81/21.5 81/21.7	R	Aileron servo block and connections with the lower skin

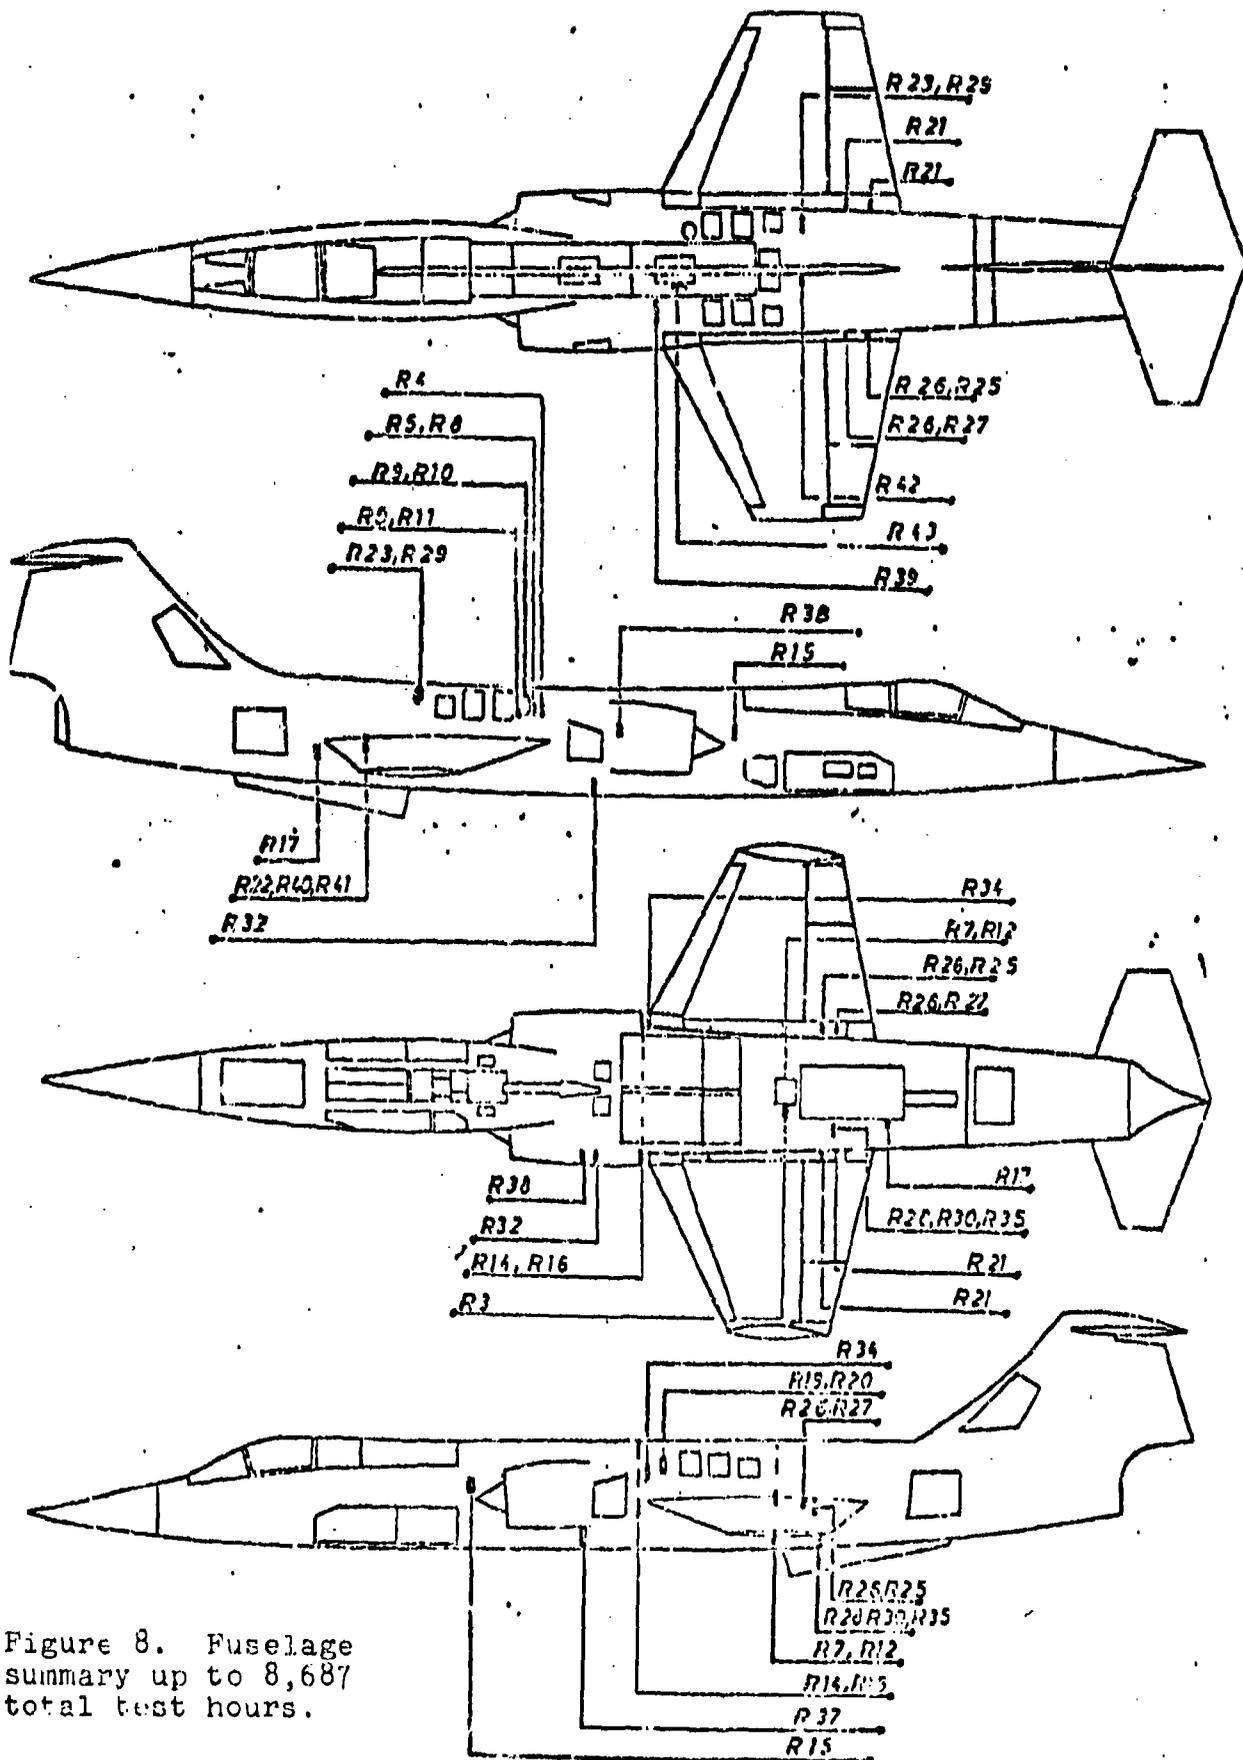
Figure 8. Fuselage summary up to 8,687 total test hours.

Damage Number	Report Number	Damage Location	
R7, R12	81/21.3	Firewall (FS 505)	
R14, R16, R49	81/21.3 81/21.11	Angle Profile (FS 422)	
R 55	81/21.11	Upper longitudinal support (FS 422)	
R2, R6, R24	81/21.2	Hydraulic flap opening (FS 520)	
R67, R77	81/21.11	Main spar No. 5 Skin for main spar No. 5 (FS 520.5)	
R4, R5, R8, R9, R10, R11, R19, R20	81/21.3	Cracks along the rivets of the sheet metal field M13 in the span direction at the upper side of the air inlet channel	FS 444 and FS440.6 FS
R21, R25, R26, R27	81/21.3	Cracks at the bulge of the right and left landing flap actuator	FS 527 and FS 538
R22, R40, R41	81/21.3	Cracks in the sheet metal field M30 at the rivets with the main spar No. 5	FS 520

Damage Number	Report Number	Damage Location	
R23, R29	81/21.3	Cracks in the upper and lower radius of the ground cooling door	FS 558 and FS546.5
R28, R30, R35	81/21.3	Cracks in the sheet metal field M31 above the hydraulic flap	FS 529 and FS 530
R32, R37, R50, R53	81/21.3 81/21.11	Cracks in the sheet metal M5 and M6 at the rivet point	FS399.6 and FS405.8
R42, R45, R59, R60, R73, R74, R75, R76	81/21.3	Cracks in the doubler below the sheet metal field M53 and in the sheet metal field M53	FS 493.3 to FS 514
R 1	81/21.1	Covers in the rear fuselage tank	
R 43	81/21.3	Cracks in the upper longitudinal support of the rear fuel container space	FS 438.4
R58, R68, R71	81/21.11	Cracks in the reinforcement for the passage for the air removal line	FS 479.5
R62, R63, R64	81/21.11	Cracks in the lower longitudinal support in the landing gear channel in the left and right profile plate	FS 444

Damage Number	Report Number	Damage Location	
R69, R70 R72	81/21.11	Cracks in the outer reinforcement of the basic longitudinal support for attaching the main spar Nos. 3 and 4	FS 489.5 and FS 505

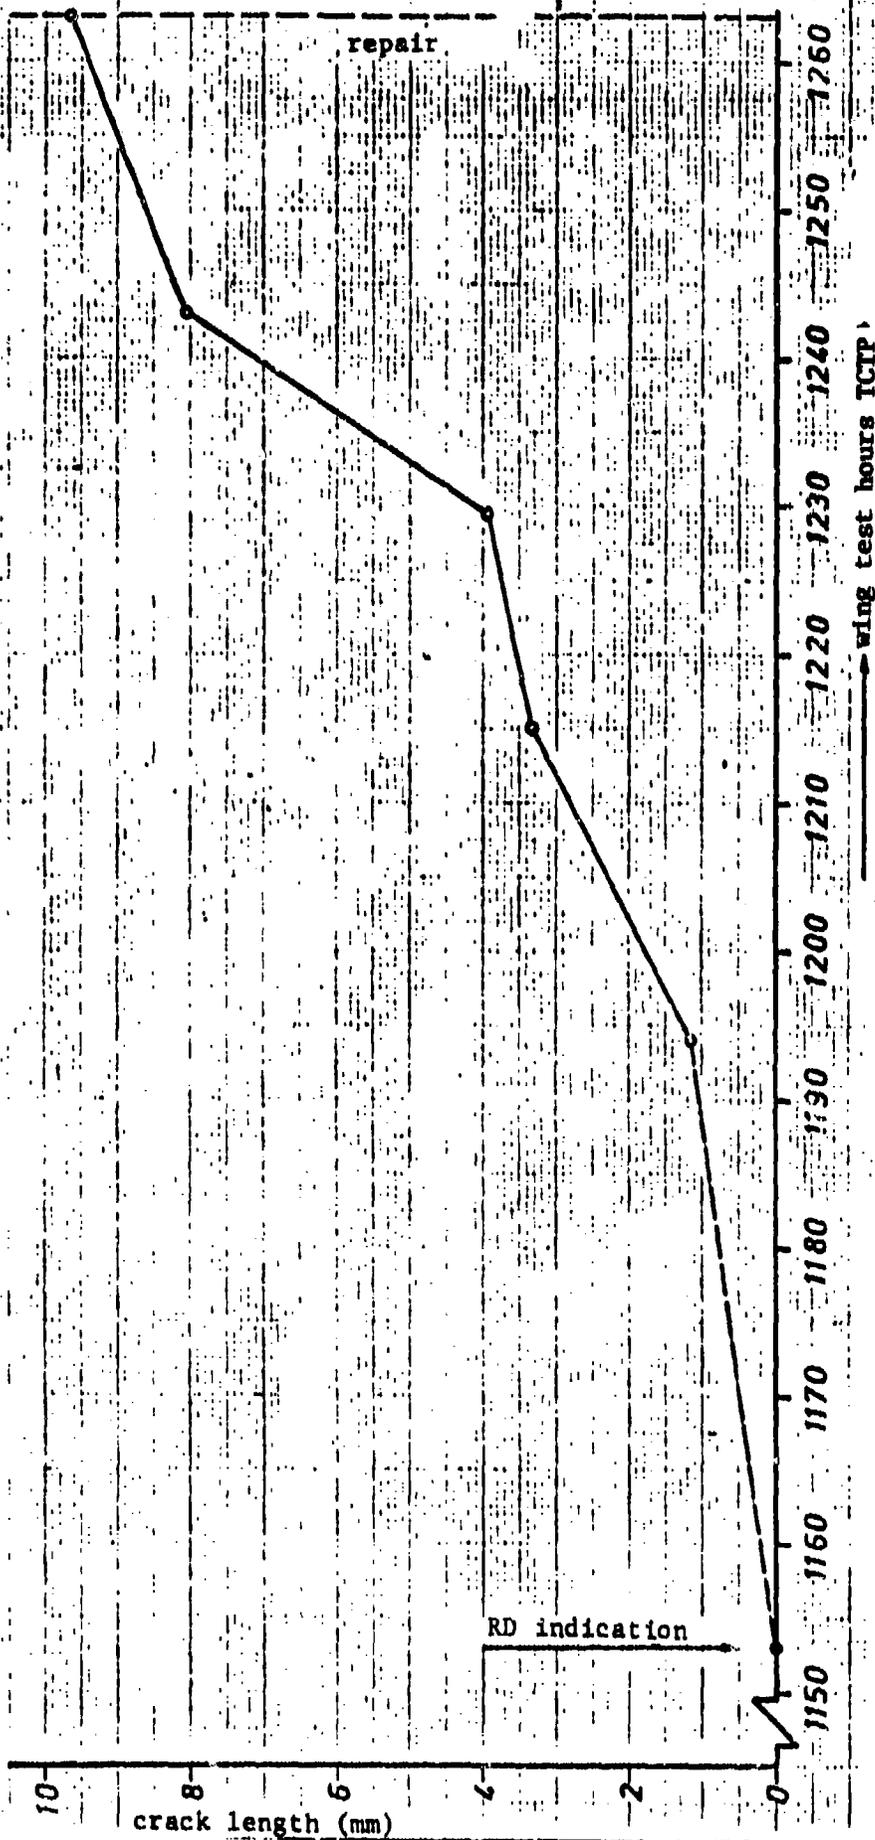
The damage was first established after about a calculated 1156 TCTP component test hours and propagated along a length of 10 mm (see Figure 10) up to 1,263 TCTP component test hours. A crack at a similar position in a troop aircraft stationed in the USA led to total damage. The openings mentioned have, in the meantime, been found to be superfluous because of construction changes and all lower wing skins are now being closed in succession, or these openings are no longer made in new surfaces.

Figure 10. Crack advance variation for opening at the aileron servo. Damage No. F1 (right wing lower side, WS 80.7).

— Special measures were taken early for the critical damage in the lower skin of the wing assembly in the region of the aileron servo (WS 80.7), which occurred very early during the fatigue experiment (see point 4.4.3) and which led to the loss of an aircraft at Luke.\*

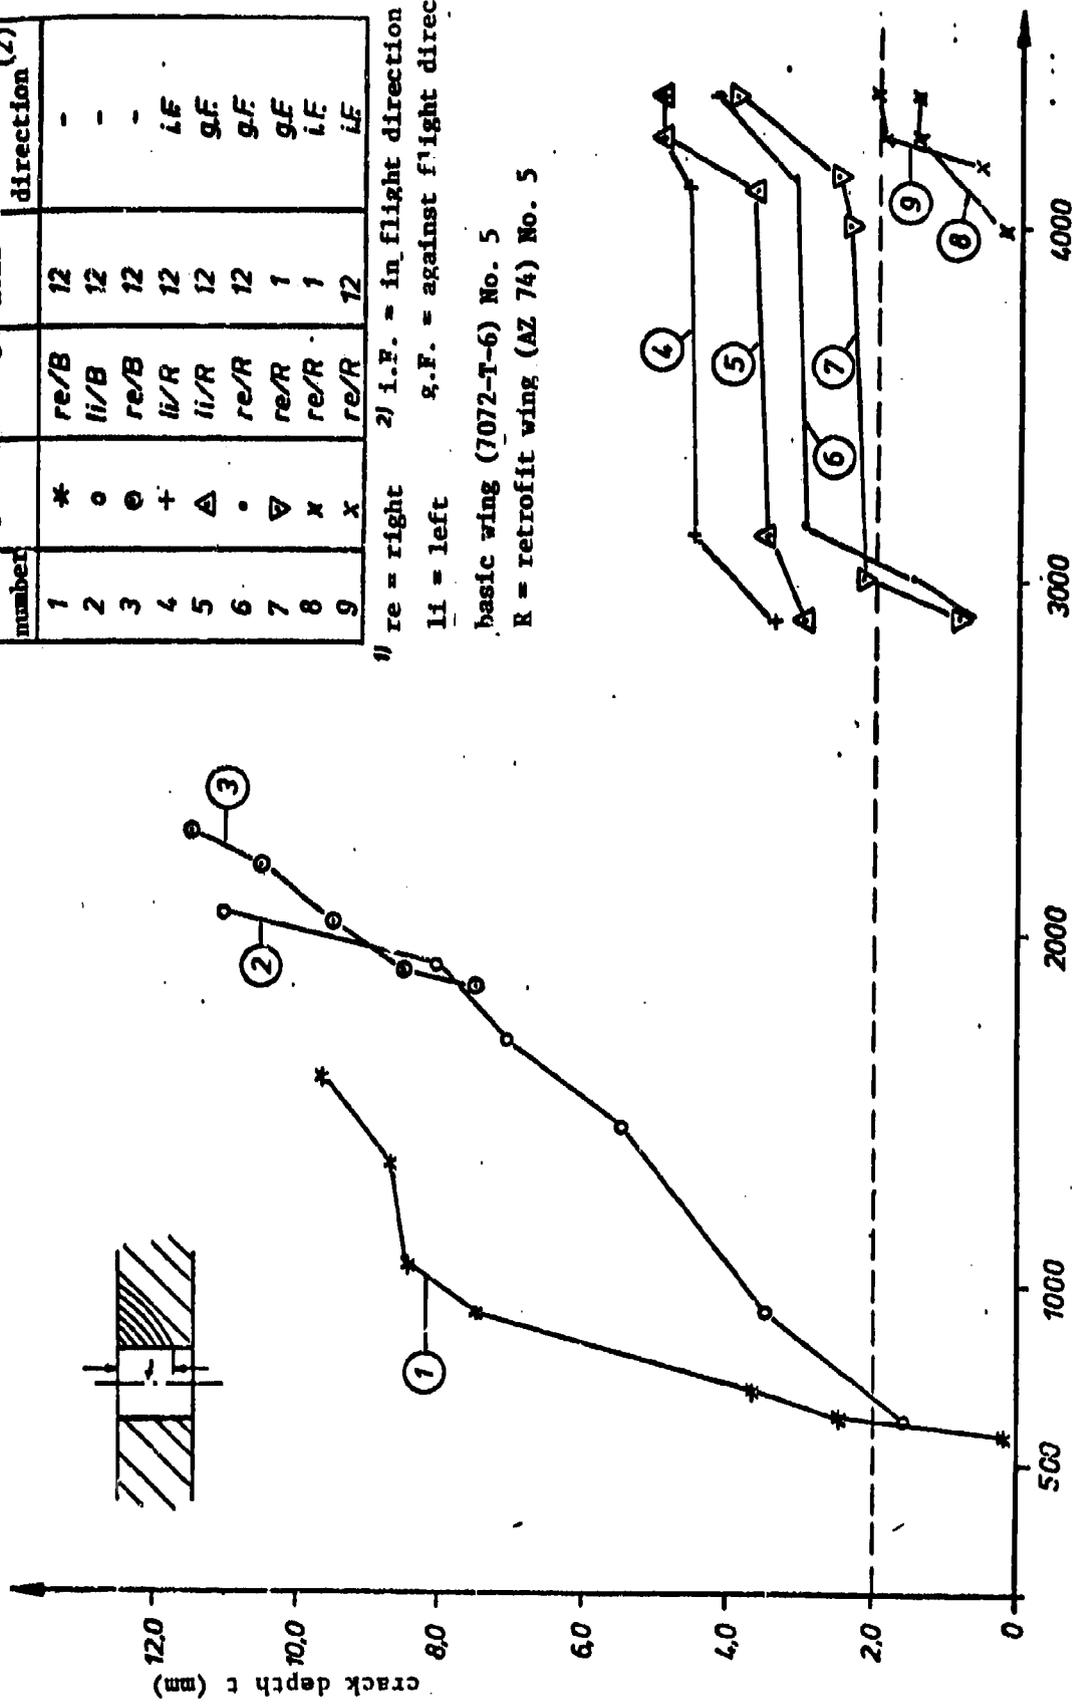
During the total airframe fatigue test with the basic wing, in addition to a large number of fatigue cracks, we found four total fractures in a total of 31 fittings. Of these total fractures, three occurred in fitting 5 after 1,728 2,246, and 2,280 TCTP component hours, respectively, as well as a consecutive fracture in fitting 4. The most significant cracks and fractures occurred primarily in the first hole rows on the side of the fuselage. After modifying the fittings (material change from 7079 or 7075, respectively, to AZ 74, thickening of the flange, and widening) within the framework of the retrofit program, we find a considerable improvement in the fatigue properties (see Figure 11).

Figure 11. Crack propagation fitting No. 5 AZ 74.

— In addition to the damage mentioned above at WS 80.7, the wing connection fittings and especially fitting No. 5 must be considered as critical components. Therefore, special measures were formulated for these relatively early. The fittings were investigated for initial cracks in the critical hole 12 using a special eddy current method developed by the IABG. In these investigations, we detected initial cracks in a number of fittings before the maximum operational time interval for these components had been reached, which is fixed at 1500 flight hours (exchange within the framework of the retrofit program). Just as before, the fittings should be immediately exchanged in such cases.

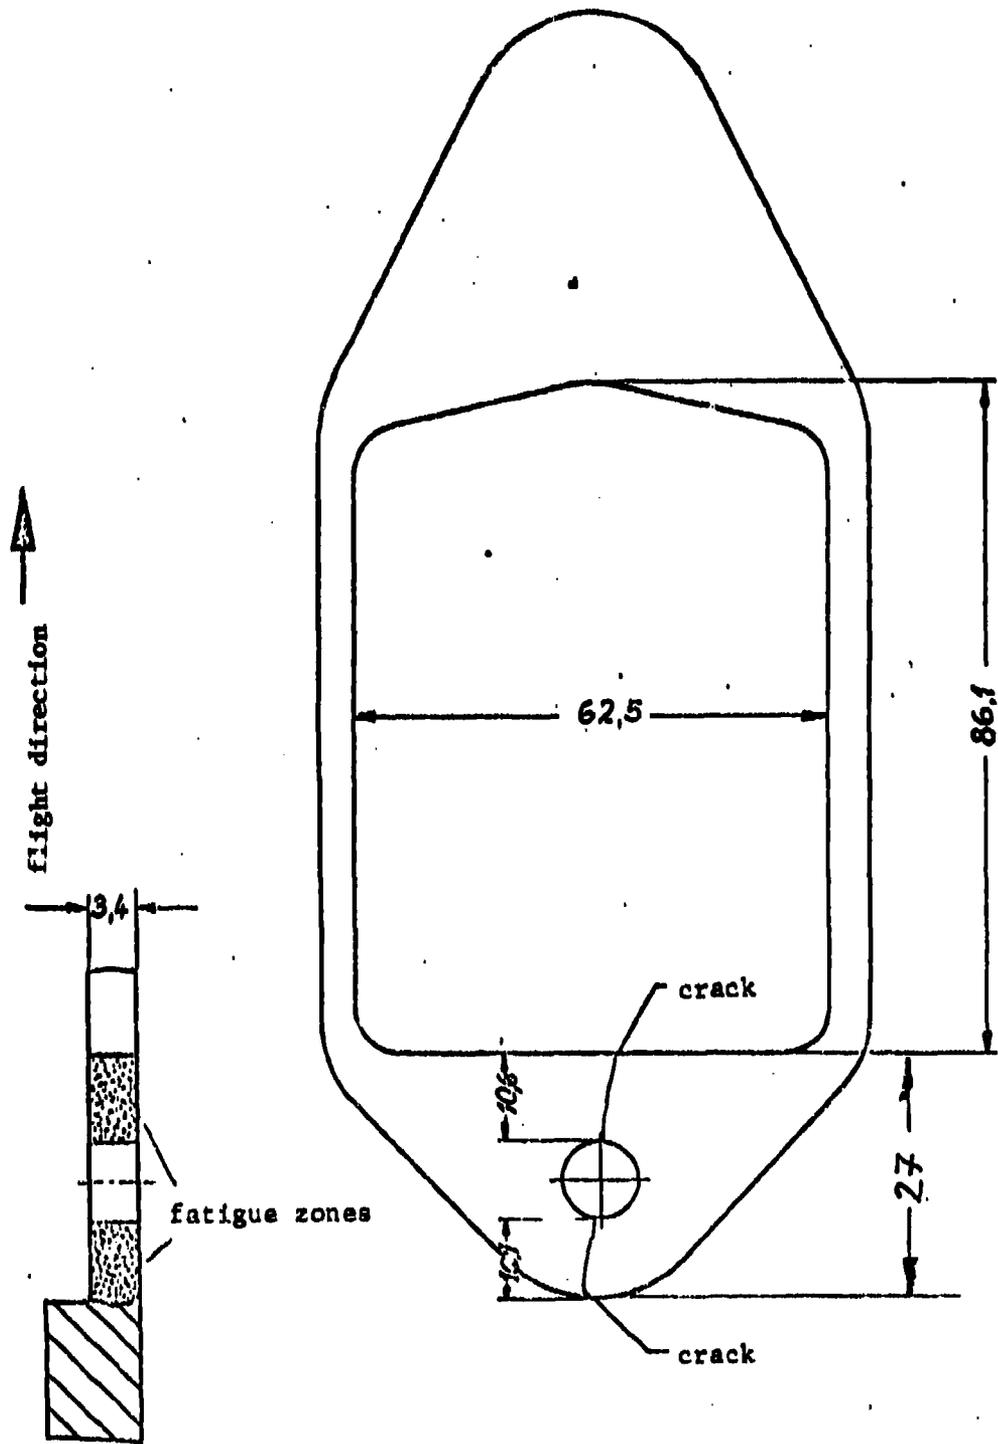
At 4,971 TCTP wing test hours, we detected a crack with a total length of about 27 mm (see Figure 13) at the attachment hole for the fuel connection cover in the lower wing skin of the basic wing. After 4,015 TCTP wing test hours, we found cracks with a length of 0.5 to 2.5 mm in the region of the attachment holes at the left and right retrofit wings. These became enlarged up to the end of the experiment after 14,869 total test hours, corresponding to 6,182 TCTP component test hours, up to 10.3 mm. The skin thickness in this region is the same for the retrofit wing and the basic wing.

Figure 13. Small crack in the holes on the pylon manifold at WS 74 for the basic wing for 4,971 TCTP wing hours.

— After the conclusion of the investigations with the basic wing, we found that the regions WS 63/67 (inner pylon fitting connection) and the region of WS 74 (pylon manifold) were found to be the most critical for the lower skin. The total lifetime reached in the experiment was about 5,000 TCTP wing test hours. Assuming that a softer load spectrum will occur for troop operation which, on the average, will correspond to the MFG program (lifetime increase factor about 1.7 compared with TCTP) as flight measurements showed, we believe that no special measures are necessary within the framework of the retrofit program up to the specified exchange time of the lower skin.
