SEAFLOOR CONSTRUCTION EXPERIMENT, SEACON I
AN INTEGRATED EVALUATION OF SEAFLOOR CONSTRUCTION
EQUIPMENT AND TECHNIQUES

CIVIL ENGINEERING LABORATORY (NAVY)

FEBRUARY 1975

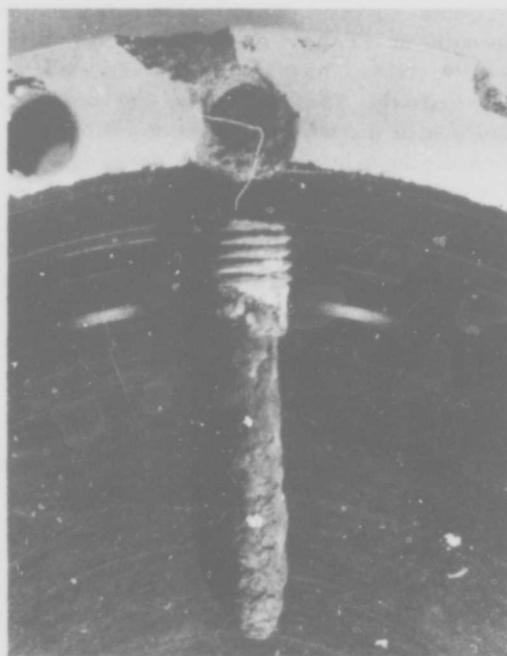
parts of the current meters had to be replaced and all of the other parts had to be refurbished. The steel mounting brackets and steel shackles that supported the aluminum current meter cases proved to be detrimental. The meters had small screw-in anodes installed, but they were ineffective against the galvanic corrosion set up between the case and the brackets (Figure 2.2.5).

Figure 2.2.5. Impurities in sacrificial anode of oceanographic array no. 1 reversed the galvanic cell and caused severe corrosion of aluminum parts.

Corrosion was a serious problem on the first array. All three meters experienced deep pitting due to the galvanic cell set-up between the steel brackets, wire, and array hardware and the aluminum meter cases. The screw-in anodes supplied with these meters failed to function. An analysis of the composition of these anodes showed them to be standard zinc castings with impurities rather than pure zinc, which may account for their poor performance. After properly isolating and cathodically protecting these meters they were essentially free of corrosion after being used on arrays two and three. The only other corrosion problems experienced were on the new CCTD. Upon retrieval, the rotor was found to be loose in its housing. A closer examination disclosed that the bearing on one end plate was missing. In spite of an anode being mounted on the outer side of this end plate, the area around the bearing corroded and the bearing fell out.

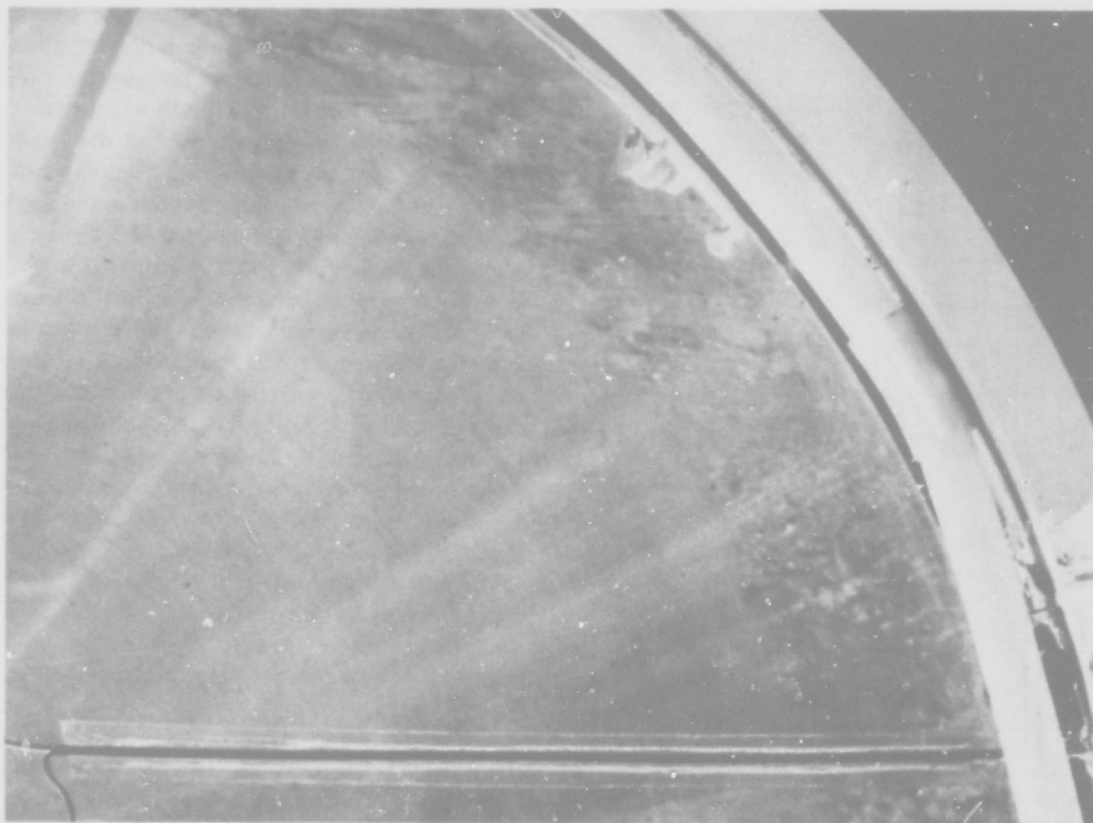
Figure 4.4.5. Scratches caused by window brush.

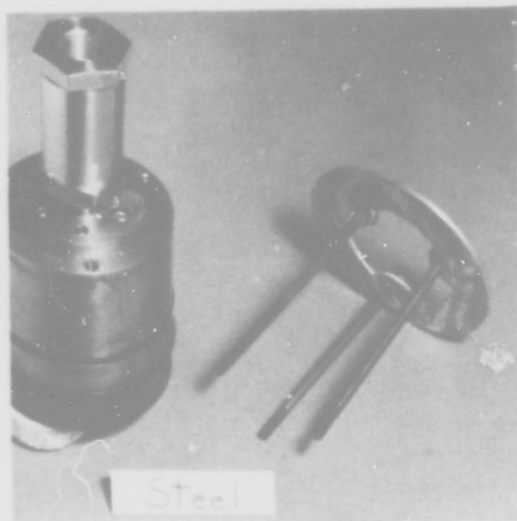
Figure 4.5.7. Carbon steel penetrator plug and pressure relief valve after exposure.

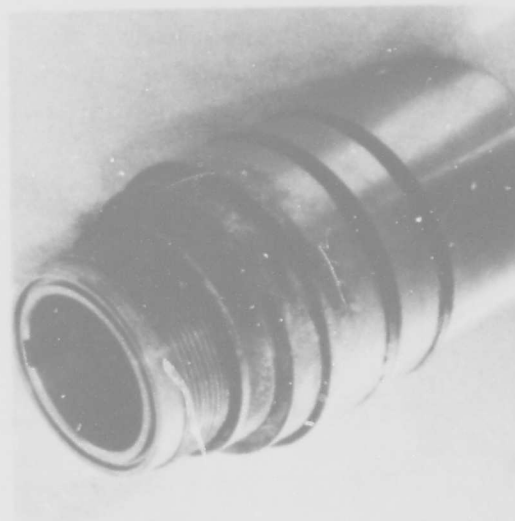
Figure 4.5.8. Nickel-chromium-molybdenum alloy 625 penetrator plug and sump-pump check valve after exposure.

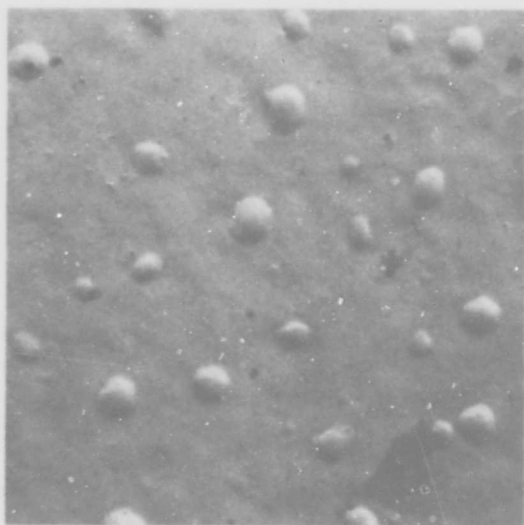
Figure 4.6.1. Paint blistering on steel structure upon recovery.

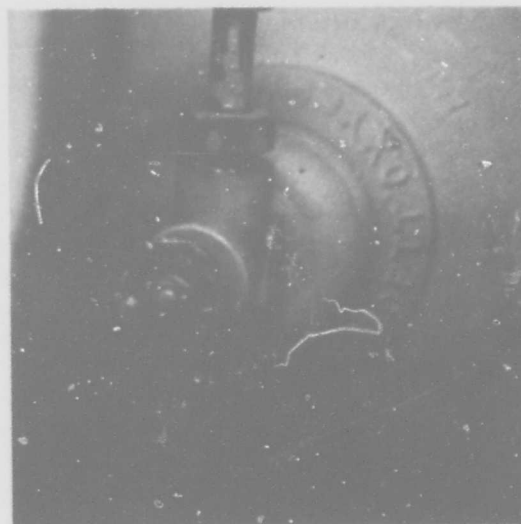
Figure 4.6.4. Condition of bronze ballast control valve after recovery.

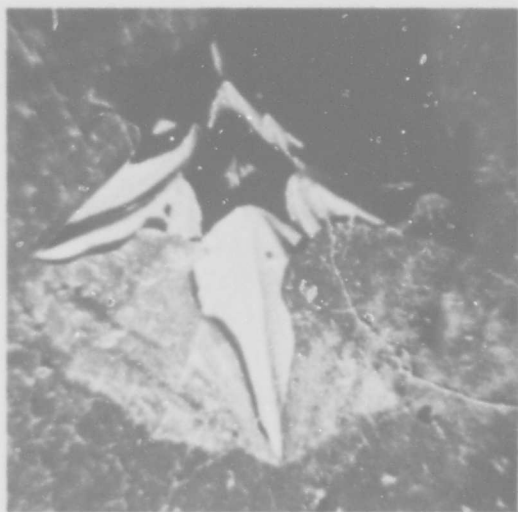
Figure 4.7.1. Sharp edges of barnacle shell, cutting through and lifting paint coating on sub-surface buoy.

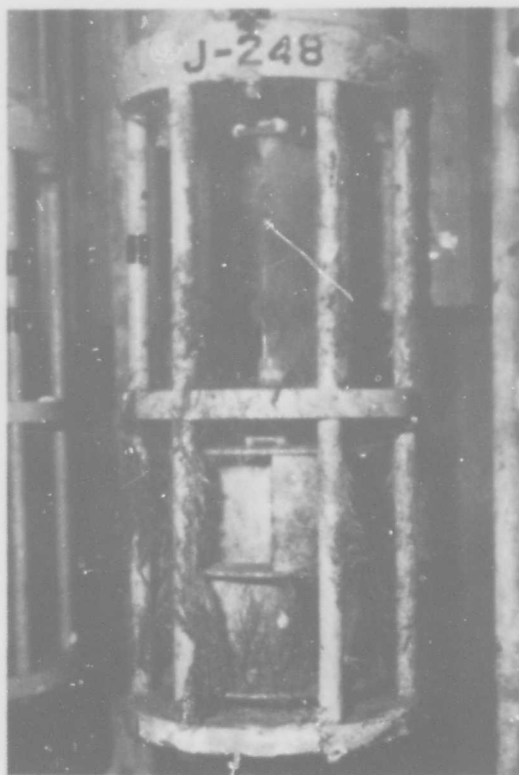
Fouling was detrimental to array number one as it caused the top meter's rotor and vane to stop rotating after 54 days. The application of antifouling paints on the rotors, vanes, and housings eliminated the fouling problem on arrays number two and three.

Figure 4.7.2. Rotor of current meter, showing fouling by hydroids and barnacles at depth of 50 feet.

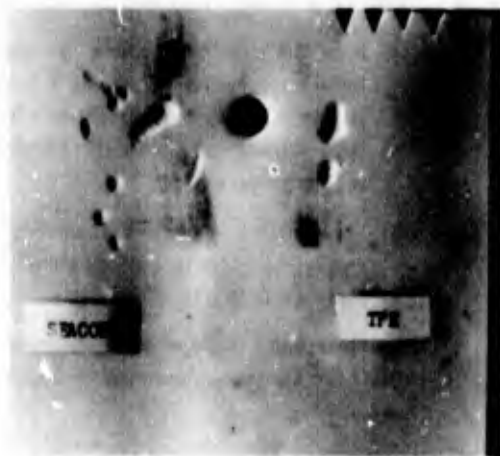
Figure 4.7.6. PTFE (Teflon) panel exposed at 600 feet, showing pitting produced by marine borers where wood was in contact with plastic panel.

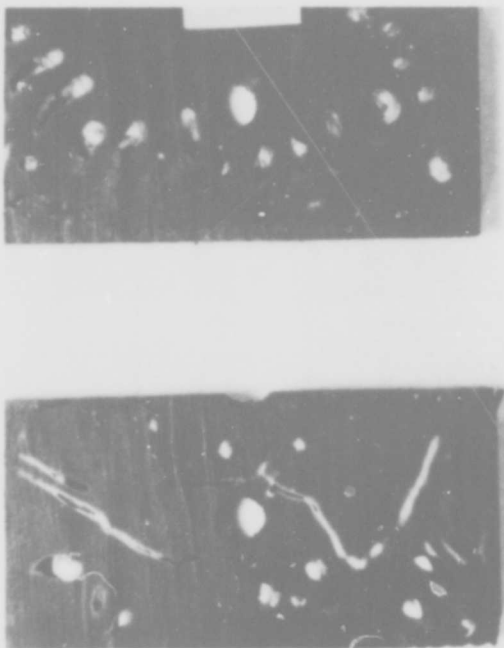
Figure 4.7.7. Untreated wood panels exposed at 600 feet for 6 months, showing damage caused by marine borers *Xylophaga washingtoni* and *Bankia setacea* (elongated tunnels).
