UH-1 BALLISTIC AND BIRD IMPACT TEST STUDY

AMMRC CYR 75-7

Final Report

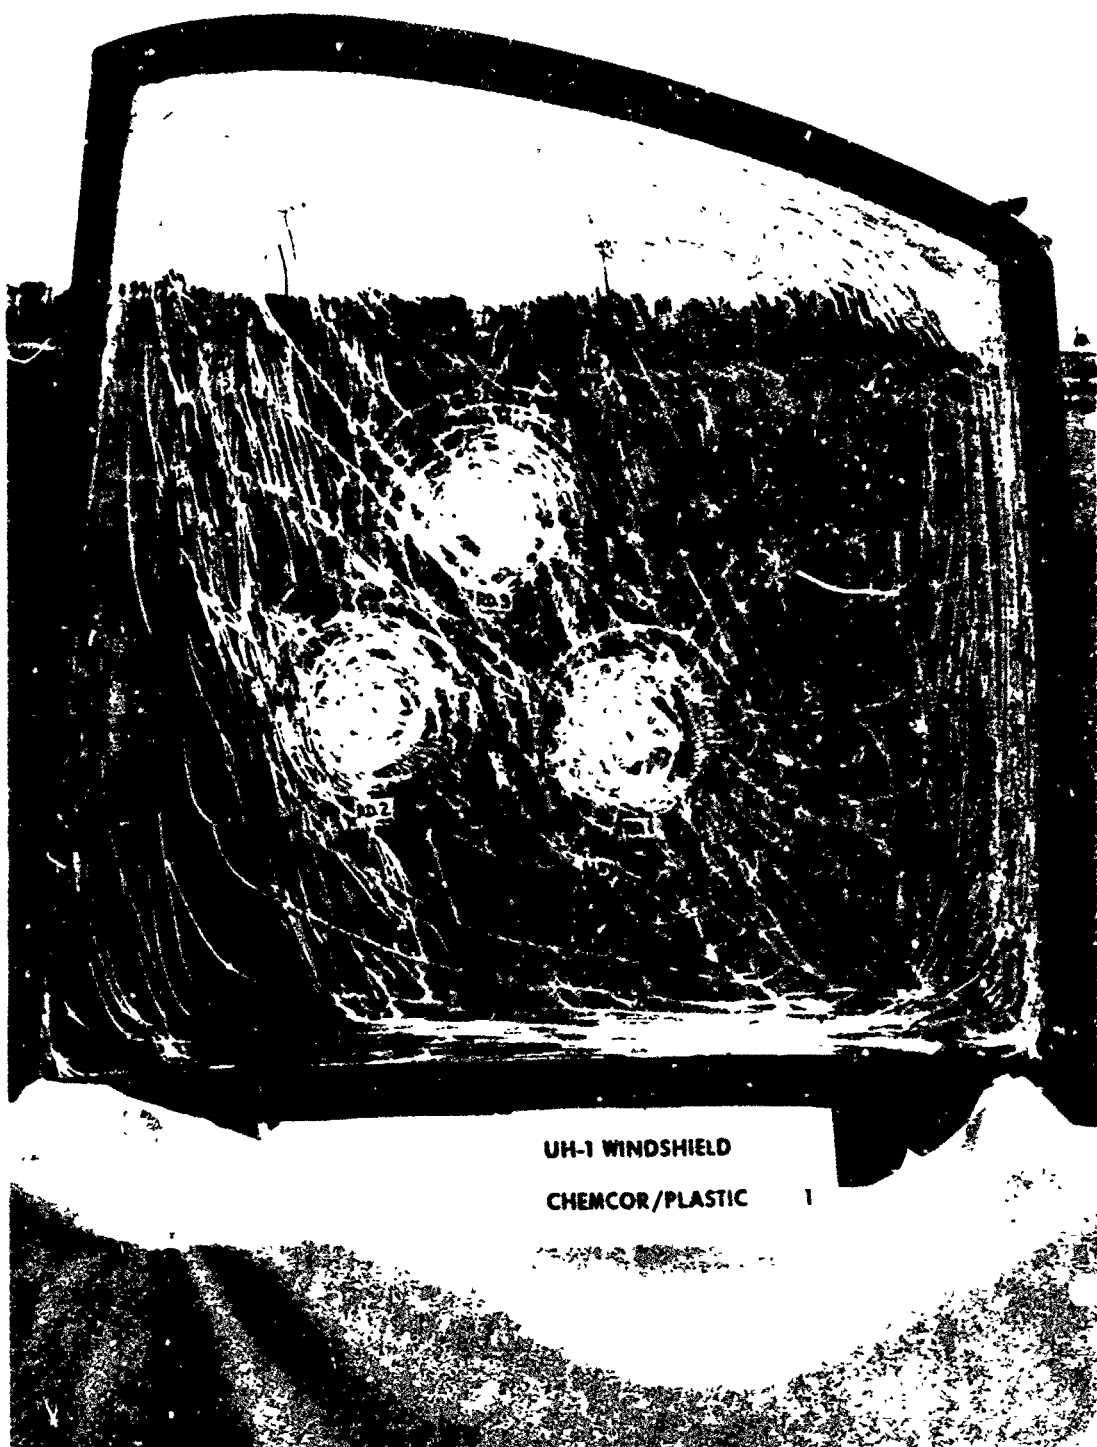
The ballistic penetration of this windshield generated many spall particles, a number of which had potentially lethal penetrating characteristics. These penetrating particles are probably both glass and bullet fragments.

Figure 7 - UH-1 Chemcor-Plastic Windshield, Ballistic Test Article,
Post-Test Display

The glass outer layer acts to partially break up the projectile. The glass particles and bullet fragments, both having relatively high density, comprise the most hazardous spall. The ductility of the plastic backing ply restricts the dispersion of the spall. The higher-density glass and bullet spall strike the witness sheet at nearly the same instant as the bullet.

This is followed by a cloud of slower, extremely fine particles consisting mostly of glass. The post-hit structural integrity and vision qualities of the windshield appear adequate.

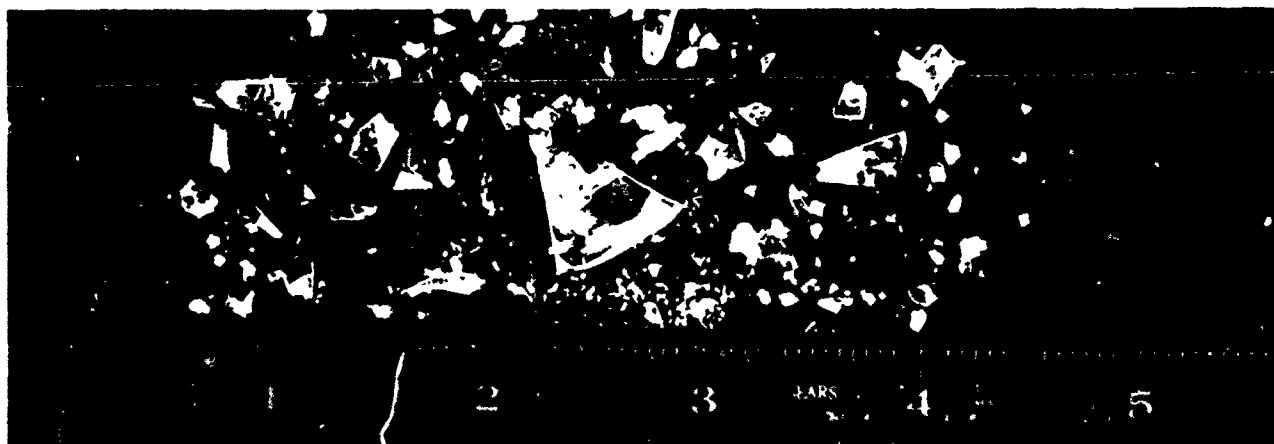
Typical back side spall particles collected following one ballistic penetration of each type of windshield are illustrated in Figure 17. The particles from the Chemcor-plastic composite which perforated the witness sheet were not collected and therefore are not included in Figure 17.

Figure 17 - Typical Ballistic Spall Particles, Single Penetration
