BOATING ACCIDENT INVESTIGATIONS 1974, FIRE AND
EXPLOSION

Report No. CG-D-119-75

BOATING ACCIDENT INVESTIGATIONS 1974

FIRE AND EXPLOSION

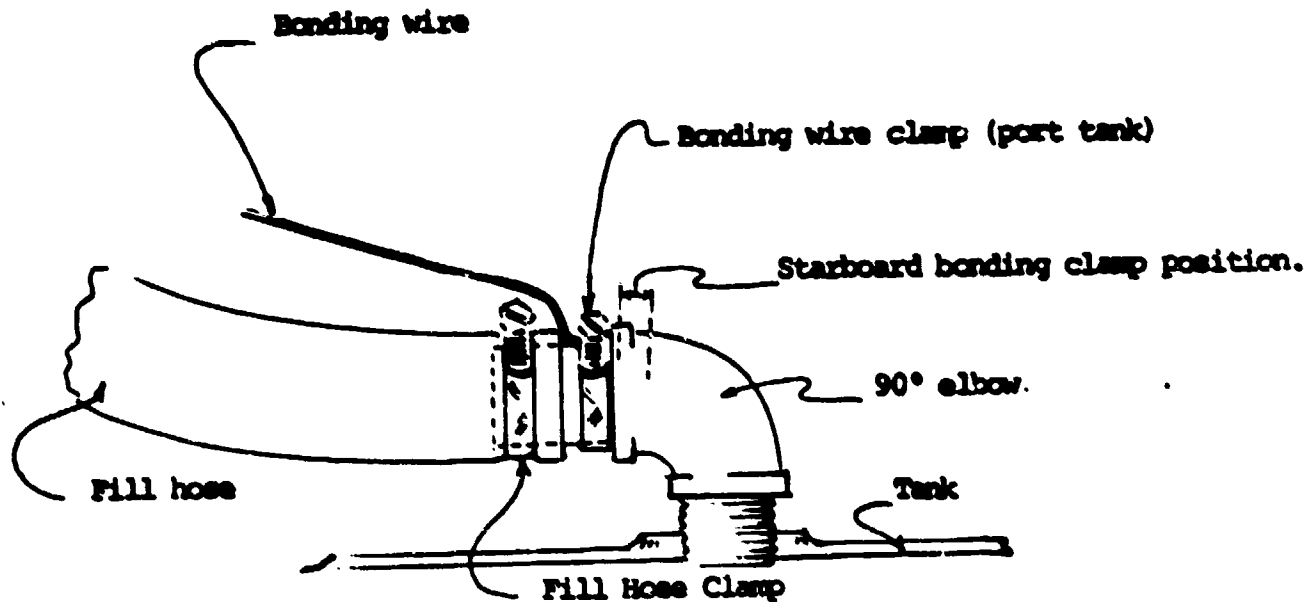
Case 3 1974

In this case, a bonding wire was clamped to the short pipe provided for attachment of the fill hose. Because of the very limited length of pipe left for clamping, the hose slipped off and when the tank was filled, the fuel was pumped onto the tank top instead of into the tank.

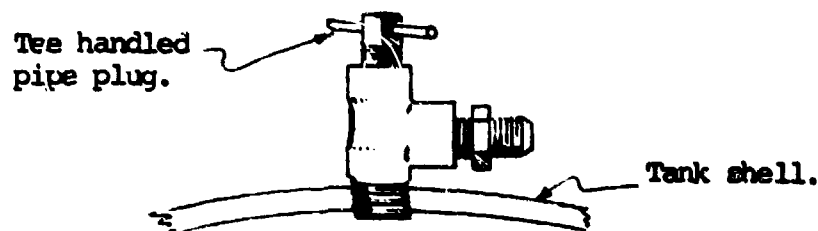
Figure No. 2

- a. Fuel Fill - The port fuel fill pipe was badly burned but was apparently still liquid tight after the fire. Only part of the fill system could be pressure checked. The multilayer fabric reinforced hose was double clamped and was provided with a bonding strap to the deck plate. The system could hold a maximum of 2/10 gallons, based on the location of the vent discharge.
- b. Vent System - Both fuel tanks were vented with 1/2 inch OD copper tubing through the hull side just below the sheer line. The vent discharge was about 18 inches above the tank top. The vent line was connected with a flare fitting to a tee fitting at the tank. See Figure No. 2.

When inspected, the tee handle plug was missing from the port fuel tank and is considered to be the source of fuel for the fire. The missing plug could not be located.

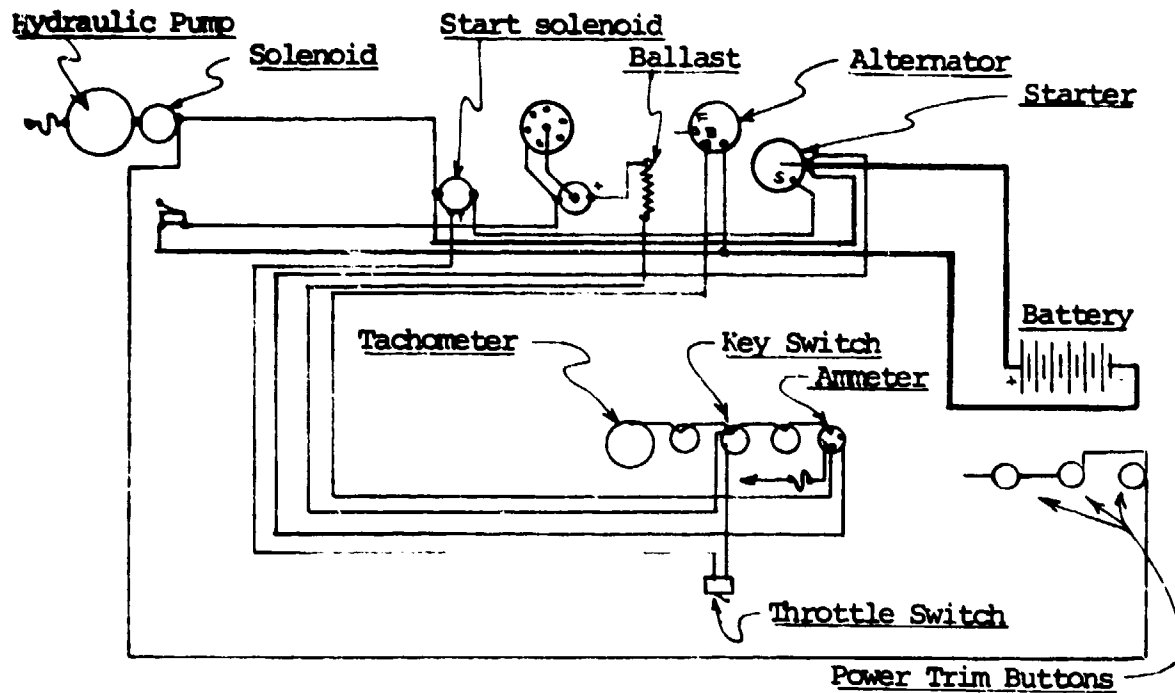
Figure 2

The lack of adequate overcurrent protection is considered a probable major factor in not being able to extinguish the fire with portable equipment. The wire insulation materials are easily and quickly ignited by any fire and it can be expected that secondary short circuits will and must occur.

In this particular boat if the lead between the alternator battery terminal and the ammeter shorts to ground, the red and white wire from the engine space all the way to the instrument panel would probably ignite and burn since it is not protected. The resulting fire would then cause a second short in the unprotected lead from the ammeter to the starter, in the hot leads to all instruments and in the unprotected conductors to the power trim control. See Figure No. 2.
