EXPLOSIVE TESTS OF BLAST CELL,
NAVAL TORPEDO STATION, BANGOR ANNEX

J. M. Ferritto

Technical Report

R 823

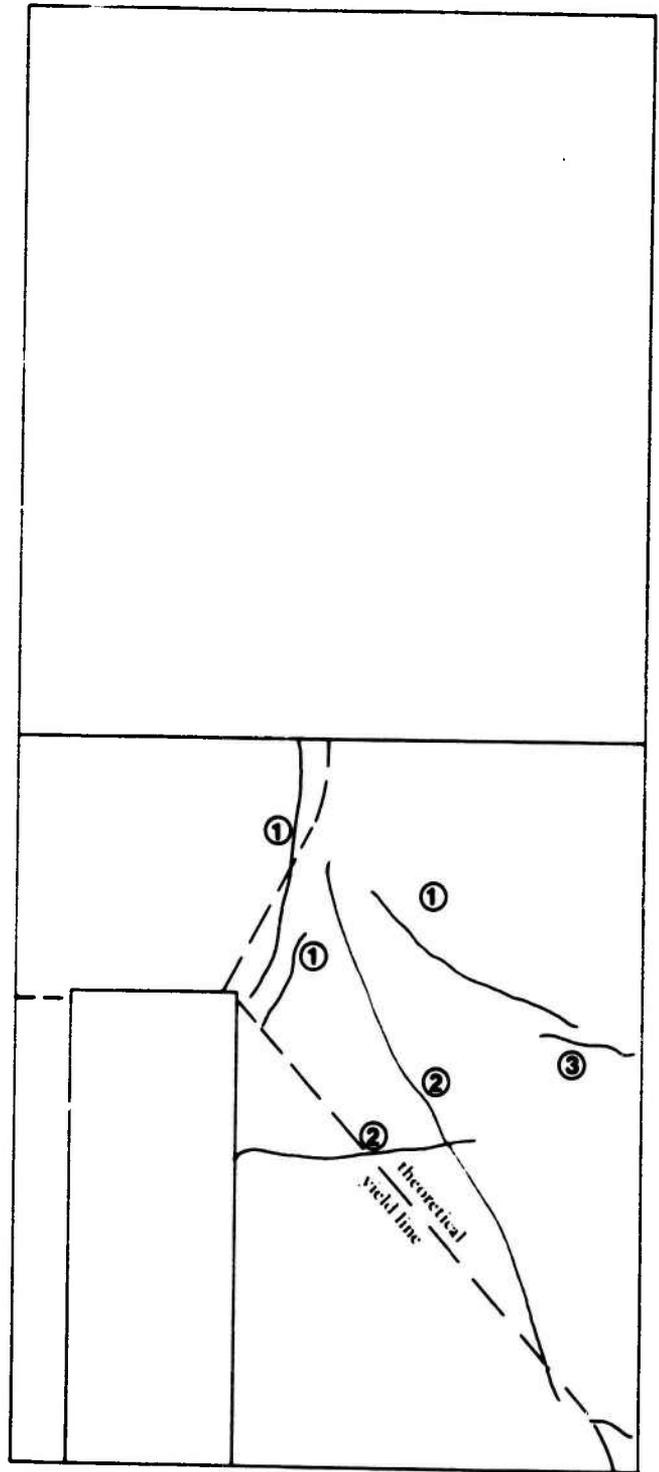
Permanent deflections of the sidewalls were measured to be about 3/16 inch outward. No permanent deflection could be measured in the blast door or passthrough door. Window breakage is shown in Figure 9. Figure 10 shows the crack pattern observed in the blast cell walls. The numbers correspond to shot numbers. No evidence was observed of shear failure of the door frame.

was blown off, leaving an opening into the next cell. The rebound supports of the blast door failed. Cracking of the floor was noted. Figure 12 shows post-shot damage. Figure 10 shows additional cracking to the cell walls; no additional permanent deflection was observed.

Shot 4 - 10 Pounds, Cell 1. The fourth shot duplicated the position of shot 2. This shot caused additional roof and ceiling damage. Figure 13 shows photographs after the shot. Additional cell-wall cracking is shown in Figure 10.

This equation is independent of concrete strength. For large detonations, ultimate strengths have been accurately represented by this equation. Concrete cracking in areas of tensile stress occurs. However, in the relatively low level of loading in this test, failure was not being approached; large-scale cracking and ultimate behavior did not occur. The uncracked concrete load capacity (assuming up to 10% of the compression strength in tension) of the cell walls was 2.4 times the capacity of that from the steel alone. This capacity and its associated stiffness would exist only until the load level was reached to crack the concrete in tension, then the load capacity would revert to that given by the equation. Using the increased capacity of the uncracked wall section, response of the cell walls was calculated (Table 4). These values agree more closely with the observed permanent deflection, assuming very little elastic recovery. However, an important area of difference is shown in Figures 10 and 15; differences exist between the theoretical yield line predicted by analysis and the observed crack pattern.

Figure 10. Crack patterns in walls of cell 1 after 10-pound detonation.

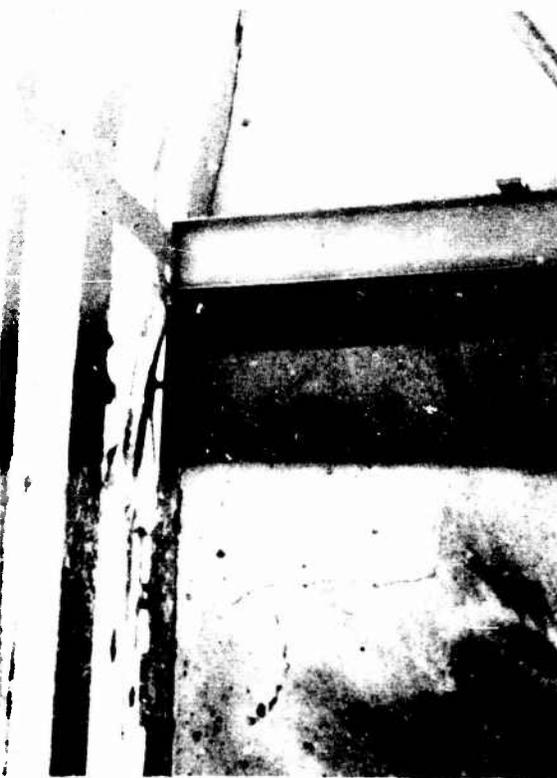
Cracks in sidewall.

Damage in sidewall.

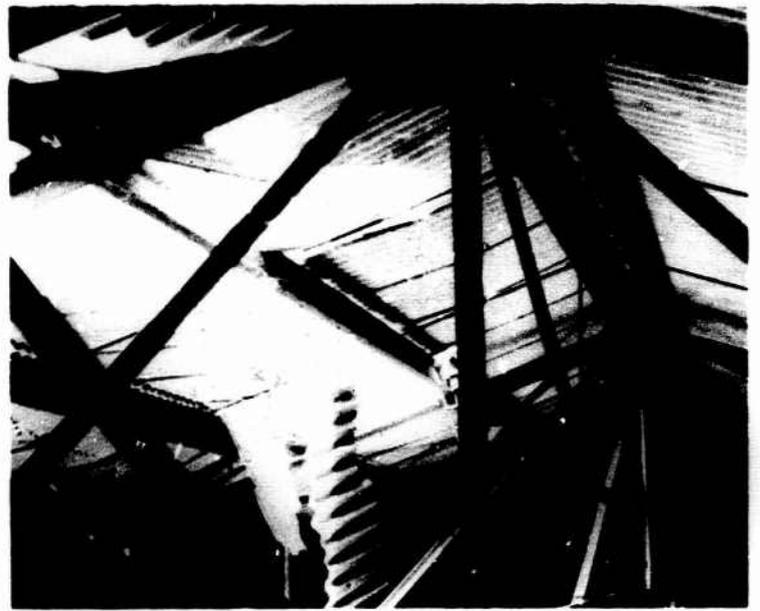
Interior roof failure.

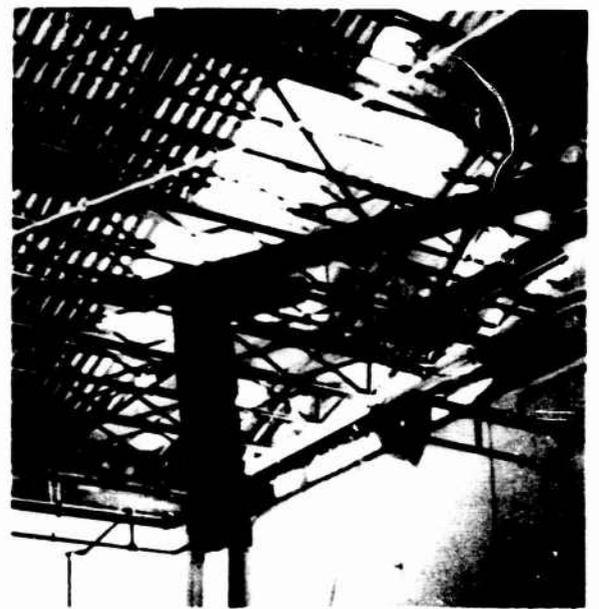
Roof damage of middle bay.

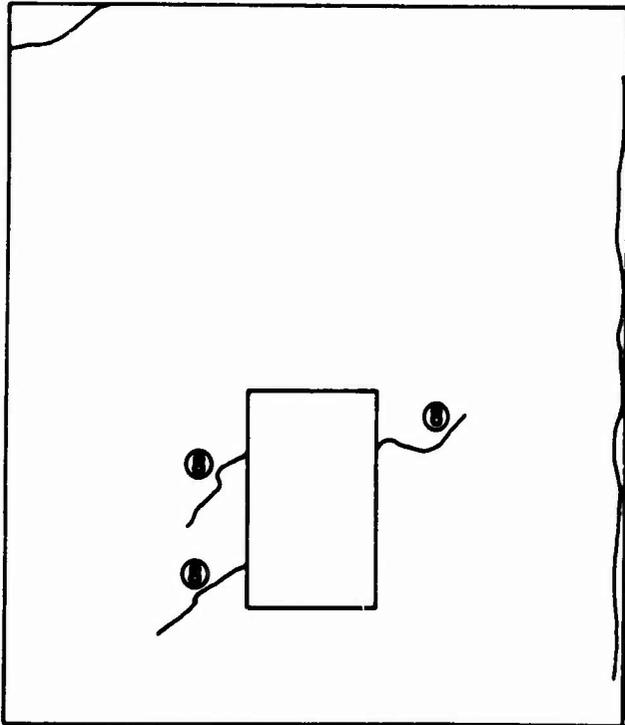
door was still operable. Figure 14 shows photographs after the shot; Figure 15 shows cracks in the cell walls. Window breakage is shown in Figure 16.

Figure 15. Crack patterns in the walls of cell 3 after 20-pound detonation

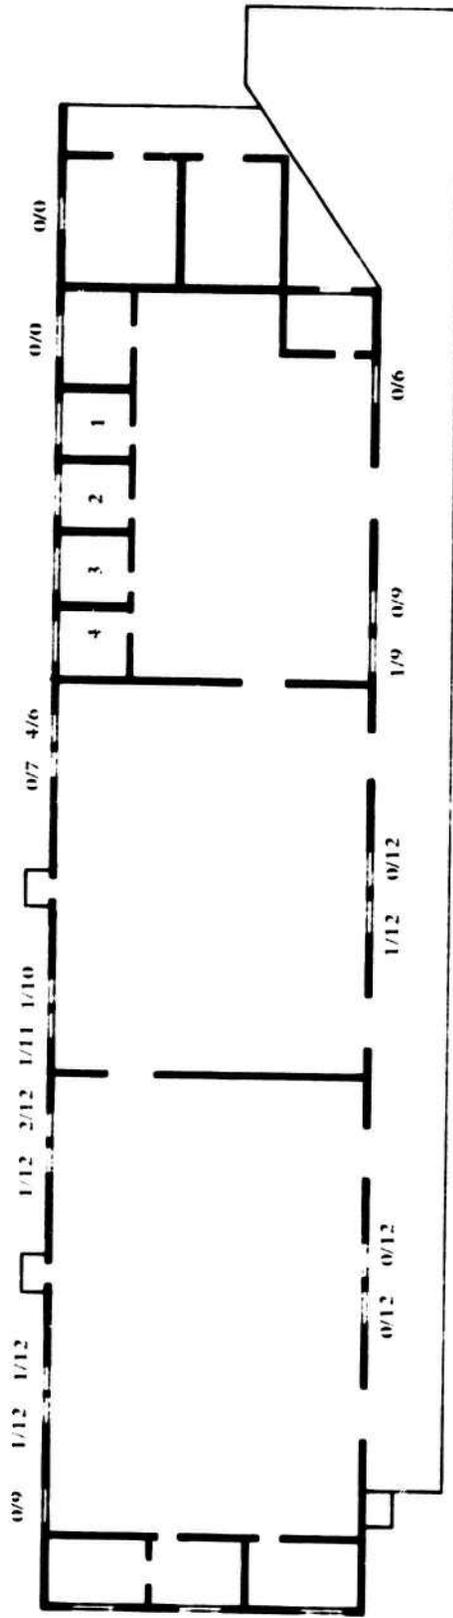
Figure 16. Window breakage after shot 6.
