3000-HP ROLLER GEAR TRANSMISSION DEVELOPMENT PROGRAM.
VOLUME V AIRCRAFT TIEDOWN TESTING

3000-HP ROLLER GEAR TRANSMISSION DEVELOPMENT PROGRAM
Volume V - Aircraft Tiedown Testing

Sikorsky Aircraft
Division of United Technologies Corporation
Stratford, Conn. 06602

Final Report

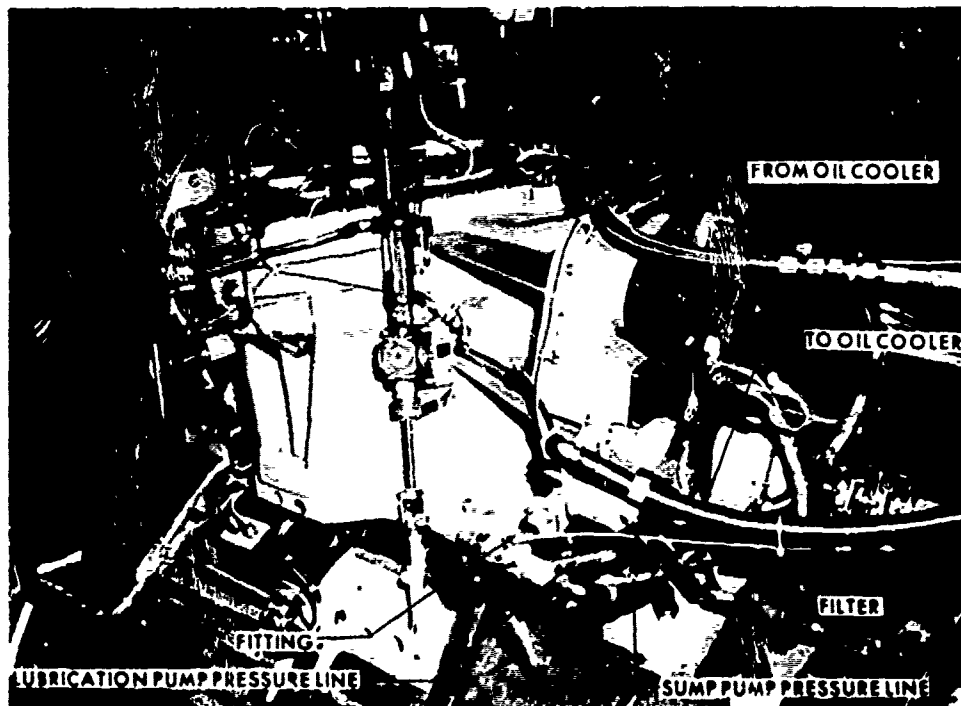
Figure 45. Lubrication Components, Roller Gear Transmission

The main gearbox "Air Maze" filter was checked after 13.6 hours of test. After reinstallation, it began to leak due to distortion of the filter cover. A new cover was installed and the problem was eliminated. Figure 45 shows the location of this filter and the lube oil fitting which leaked oil at 29.5 test hours, when the fitting threads were found to be stripped due to too shallow engagement. The problem was solved by reworking the fitting to ensure deeper thread engagement. No further leakage occurred.

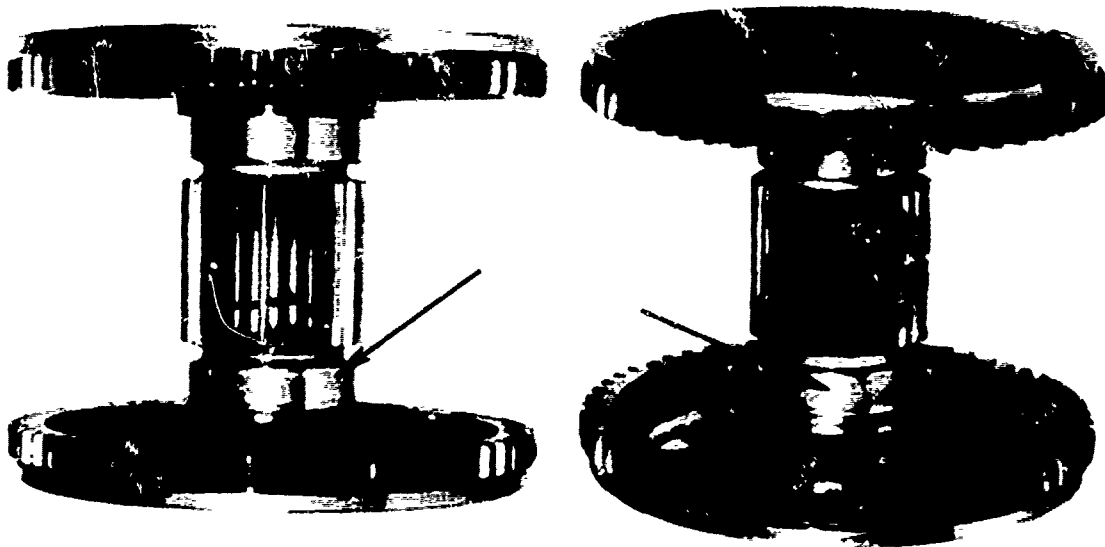
Figure 46. Frosted Roller Surface, First-Row Pinion

Visual inspection of the roller gear components revealed slight surface distress on the lower small-diameter rollers of first-row pinions serial numbers 55 and 56 (Figure 46). As seen from Figure 47, which shows the assembled location of the roller gear components, the identity of the bearings and post within the second-row gear and the appropriate thermocouple (T number), the second-row gear, serial number 60, mated with these pinions. The second-row gear rollers showed only faint markings due to the rolling action with these pinions. Examination of the first-row pinion distressed area revealed a frosted surface approximately 0.12 inch wide around the circumference. This area started on the roller surface where the crown relief of the second-row roller commenced.
