FAA-RD-75-118

ANALYSIS OF THE EFFECT OF CONCORDE AIRCRAFT NOISE ON HISTORIC STRUCTURES

Robert L. Hershey
Russ J. Kevala
Sharon L. Burns

July 1975
Final Report

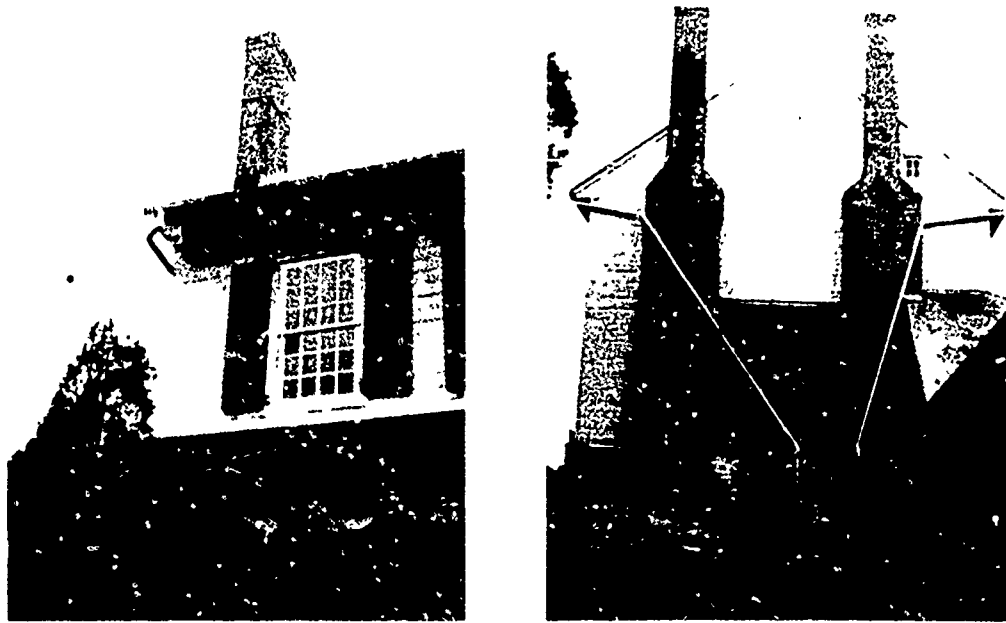
FIGURE III-3
Chimneys and Pent Wall
at Sully Plantation

There are two massive twin chimneys and brick pent wall on the west side of the house as shown in Figure III-3. Today the chimneys have been partially reconstructed at two different times due to damage from lightning. The mortar was basically composed of lime mortar, crushed oyster shells and sand used from the surrounding area. The foundation is original and made of Virginia red sandstone. The mortar used in the foundation is identical to that used in the chimneys. Originally the partial basement had a tamped dirt floor.

In analyzing the breakage probabilities of the chimneys they were modeled as cantilever beams with additional support from the brace as shown in Figure III-3. The type of failure which was considered was the first cracking of the mortar from an overturning force from lateral vibration. The approach of Chapter II yielded an estimate of the probability of failure of 7.9×10^{-10} for each Concorde overflight on each chimney. Considering the proposed Concorde schedule and the fact that there are two such chimneys, the failure of a chimney from Concorde noise has a probability of occurrence of 2.3×10^{-6} per year. This is equivalent to an estimate of 440,000 years between failures.

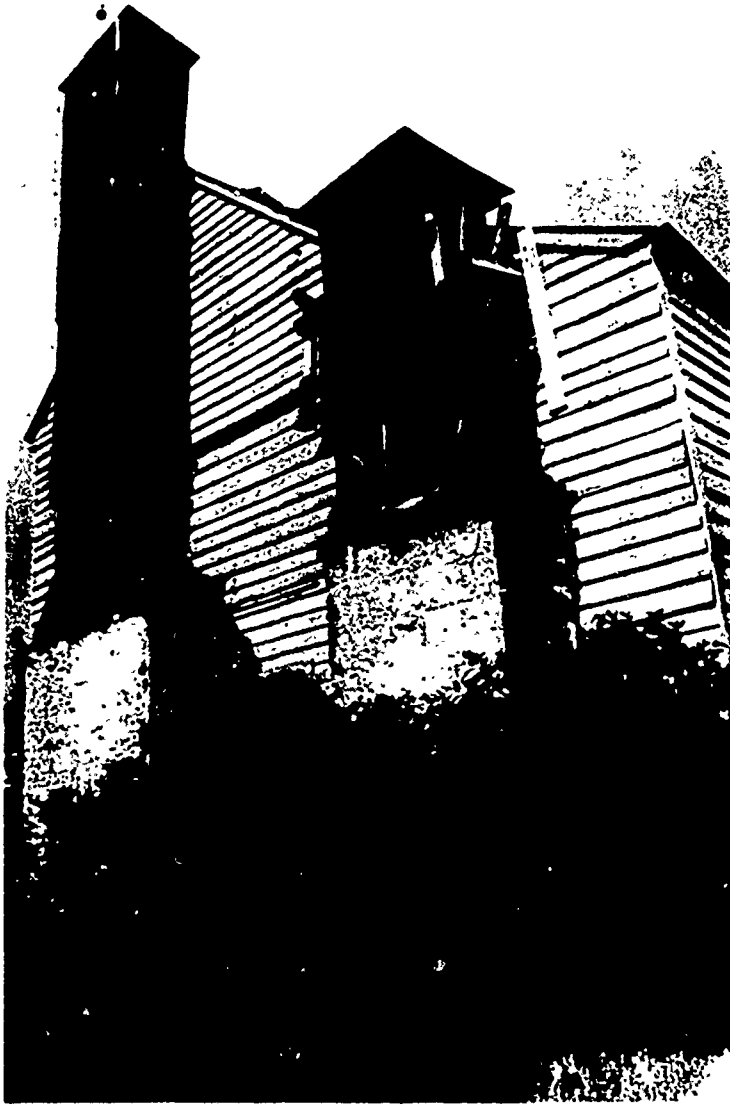
FIGURE IV-2
Unrestored Chimneys at
Dranesville Tavern

The Tavern has four chimneys of stone and mortar construction. All the chimneys are in a very unsound condition and the chimneys on the west side are held together temporarily by wooden scaffolding (Figure IV-2). The eastern chimney appears today as it did in the earliest period. The west chimneys were completed c. 1850, and the taller kitchen chimney appears to be made of two distinct sections, with the stonework above the present roof level not as well and carefully constructed as the work below. This chimney is the one most likely to suffer damage from Concorde overflights. It has an unsupported height of 20.67 feet above the shoulder at the first story level.

One of the mechanisms of failure of the chimney would be caused by excessive tension in those portions of the mortar that are not under any compressive loads due to the unevenness of the stone layers.

The mean value of breaking strength of mortar under tension is 6134 psf. Equating this to the maximum bending stress, the overpressure required for failure is obtained as 29.3 psf.

Using the method outlined in Chapter II for chimneys, the probability of failure of the kitchen chimney is 1.2×10^{-15} per Concorde overflight, or once in 5.8×10^{11} years. The probabilities for failure of the other three chimneys will be lower because of the lower induced stresses in them.

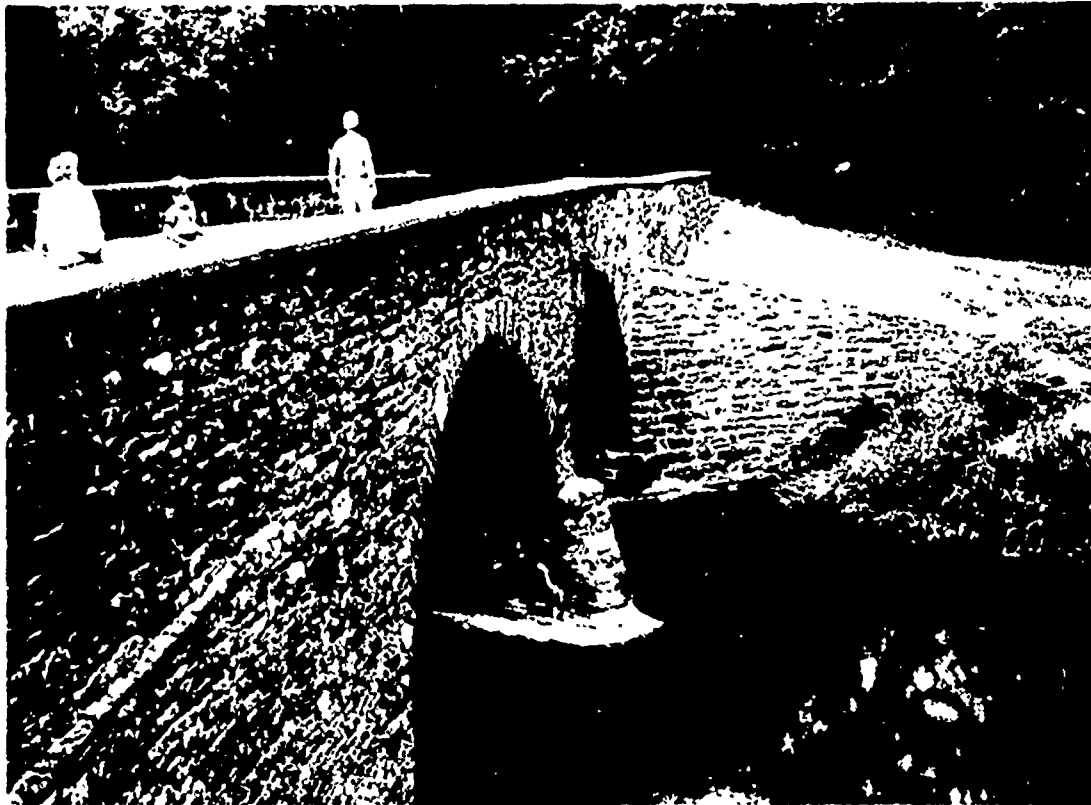
FIGURE VI-2
Stone Bridge in Restored Condition

The Stone Bridge is located in the Manassas National Battlefield Park. It spans Bull Run over the Warrenton Turnpike and was built in 1814. Figure VI-2 shows the Stone Bridge in its restored condition. The bridge became famous during the Civil War Battle, First Manassas. It was there that the first battle shots were fired on the morning of July 21, 1861. During that evening, a portion of the Union Army retreated across the bridge. During the battle of Second Manassas, the Stone Bridge served not only as the main avenue of the Federal advance but, more significantly, as the key escape route in the retreat. Stone Bridge was partially destroyed by Federal troops during their retreat at the battle of Second Manassas the night of August 30, 1862.

In 1961, Stone Bridge was restored by the National Park Service. The roadbed was removed, and all the rubble fill was cleared from the center of the bridge. The east wall was rebuilt and mortar repaired inside and out.

Hurricane Agnes damaged the roadbed and flat stone capping of the bridge in 1970. These were subsequently repaired.

The historical data available for this bridge indicates that the Union Army had considerable difficulty in destroying the bridge after their retreat. Hence, the probability of damage to the bridge due to aircraft noise is extremely small.
