AFFDL-TR-75-27
ADA 018 751

STATIC AND FATIGUE TESTS OF F-111B BORON WING TIP

JUNE 1975

TECHNICAL REPORT AFFDL-TR-75-27
FINAL REPORT FOR PERIOD JUNE 1969 – DECEMBER 1969

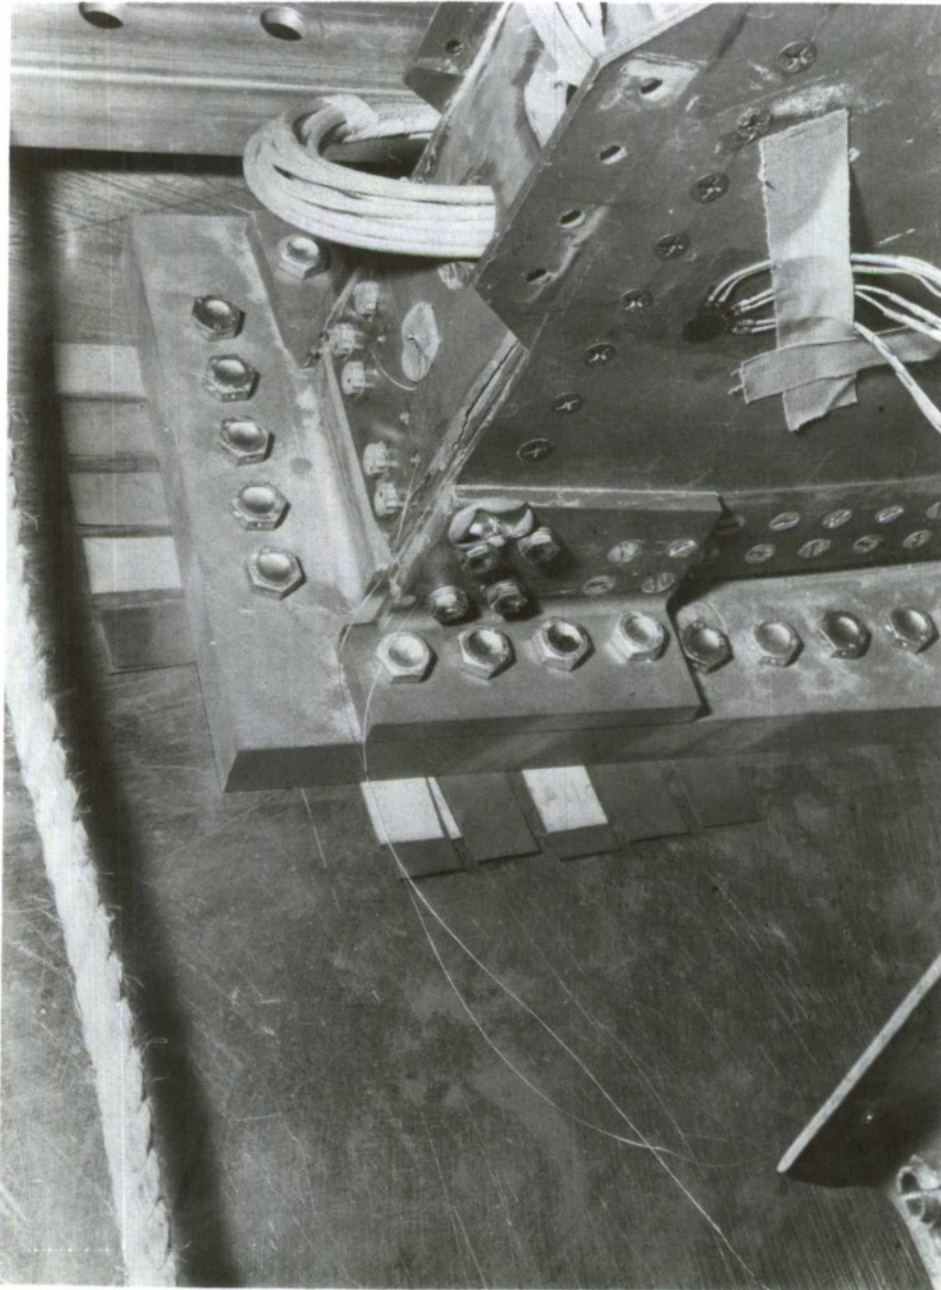
(3) The forward and aft faces of the boron web of the front spar had become unbonded from the core under the titanium doubler plate at the inboard end. Figure 13 shows some of the debonding.

Figure 13. Block 21 Failure Showing Unbonding of Front Spar Doubler

The front spar failures No. 1, 3, 4, 5 and 6 were repaired by adding a 5/16 inch thick aluminum doubler plate which reinforced all the damaged areas on the front spar. Figure 15 shows this doubler plate installed.

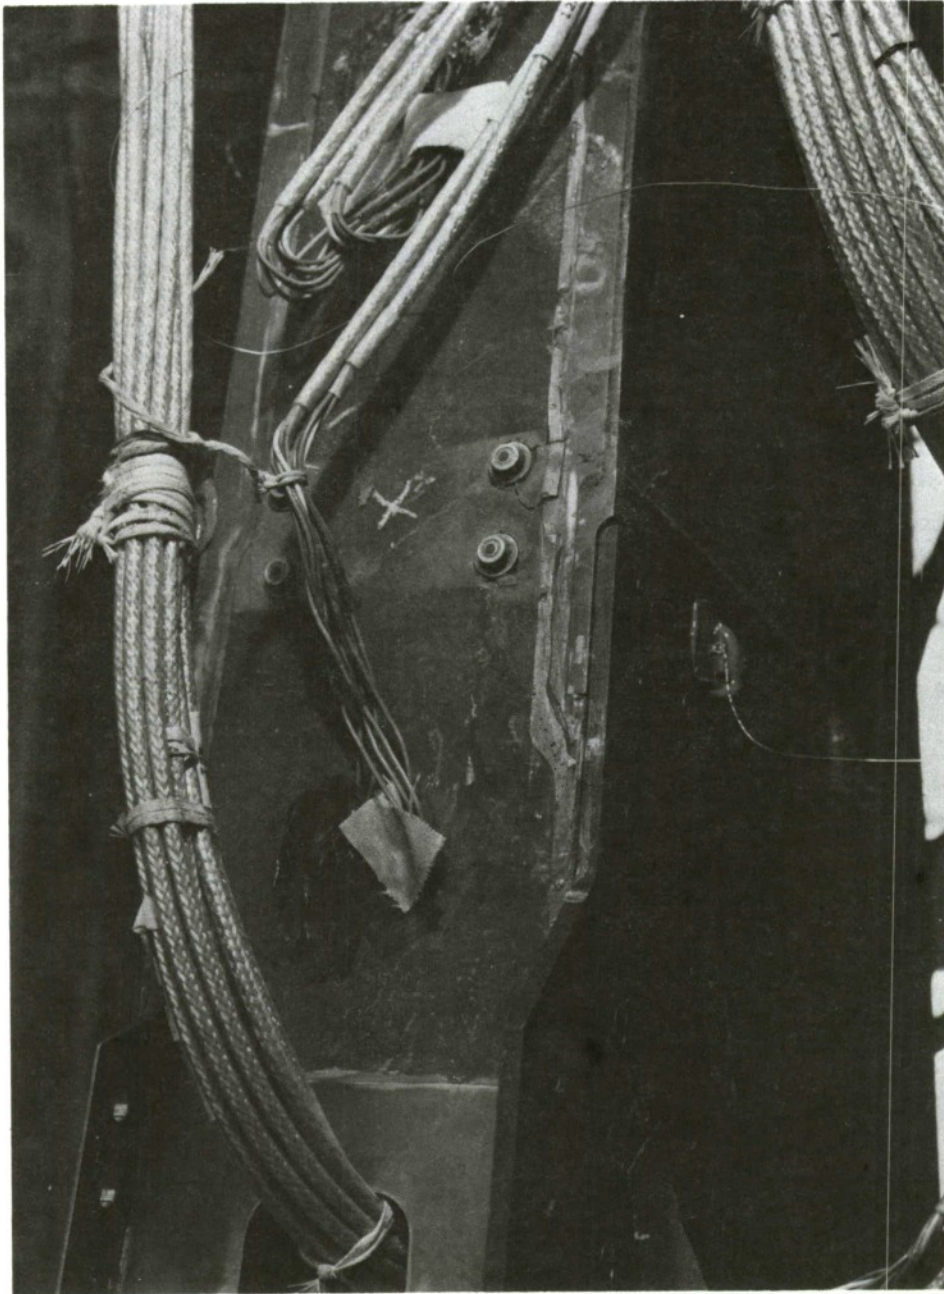
(5) A crack was found in the forward face of the front spar boron web at the mid rib. Figure 14 shows this damage.

Figure 14. Block 21 Failure Showing Cracked Boron on Front Spar at Mid Rib

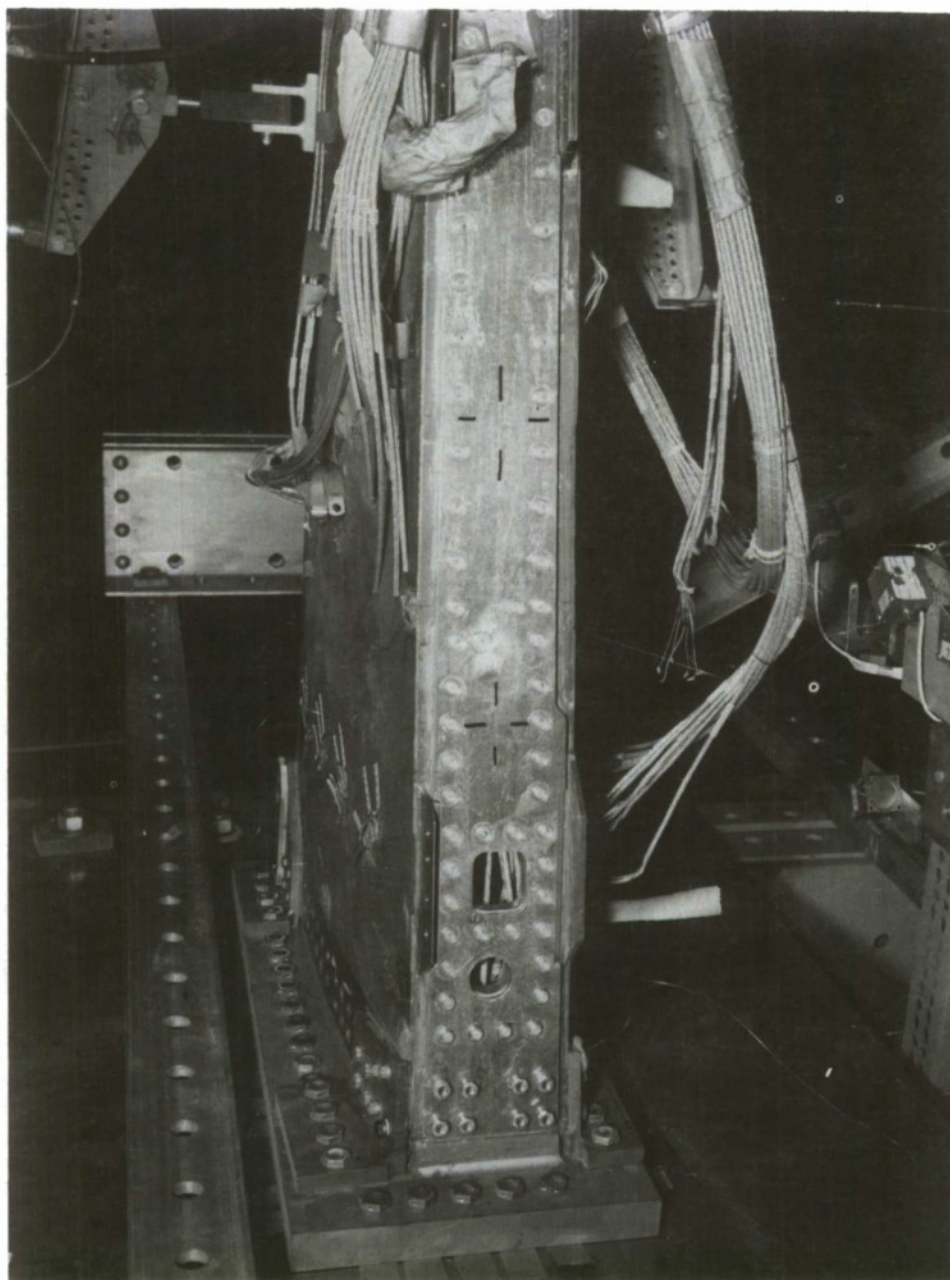
Figure 15. Repair Doubler Installed on Front Spar After Block 21 Failure

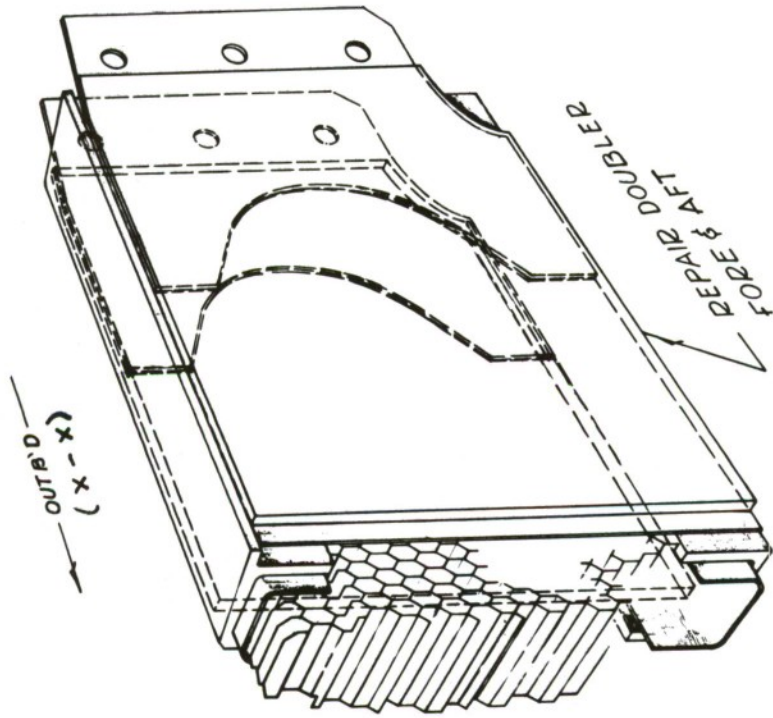
Figure 16. Repair Doubler Added to Center Spar After Block 21 Failure

The mid rib debonding was repaired by adding an 0.060 inch aluminum doubler. Figure 16 shows this repair.

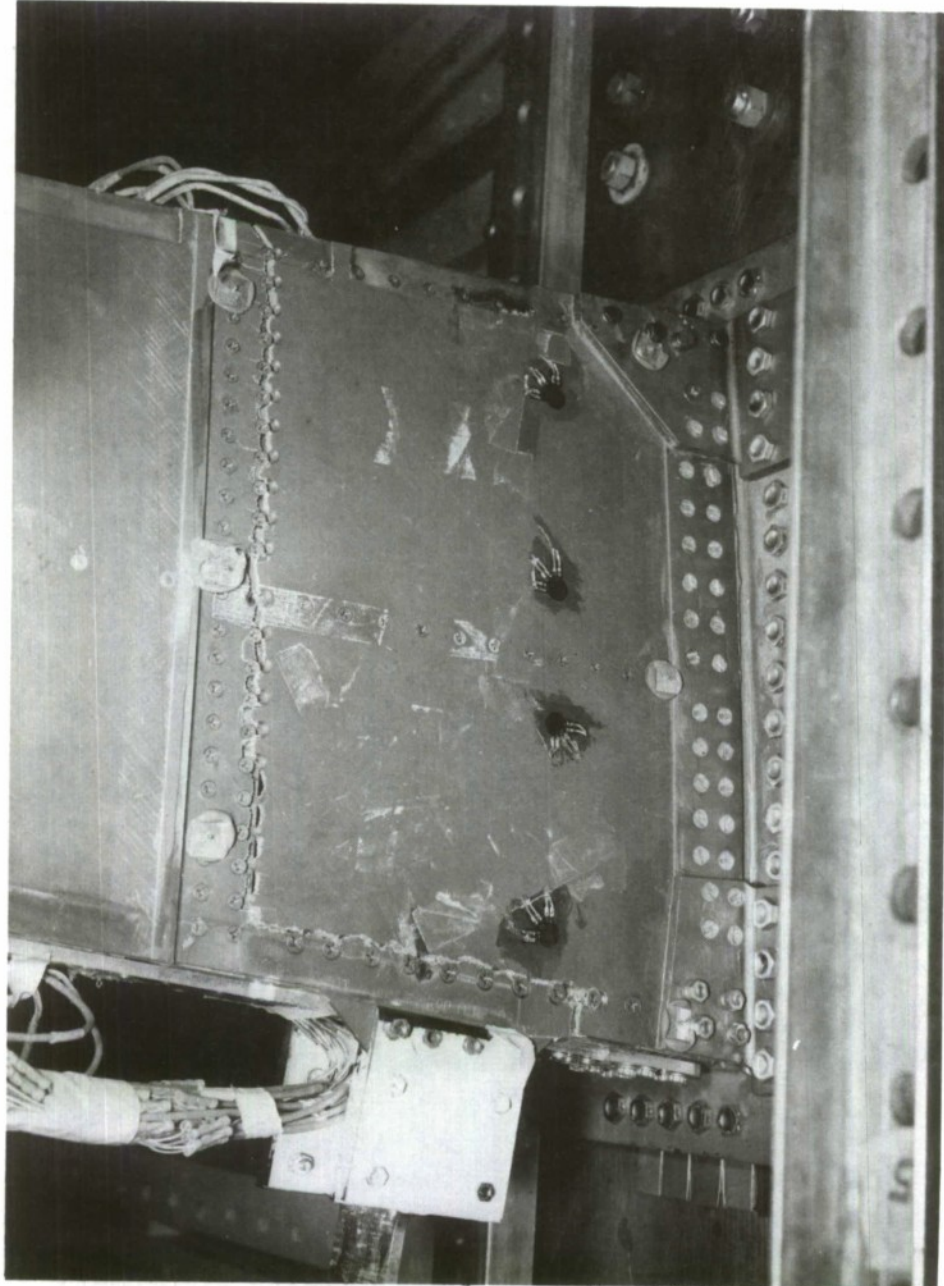
The wing tip successfully sustained 150% DLL for the forward CP positive and aft CP cases with no apparent damage. The forward CP loads were then applied in 10% increments to 125% DLL and 5% increments from then on to failure. The load was held 15 seconds at each increment and the instrumentation was read during the last five seconds. Final failure occurred at 179% DLL through the lower cover at Rib B through the inboard row of fasteners and through the front and rear spars. Figures No. 17, 18 and 19 show the final failure.

Figure 17. Final Failure of Lower Cover

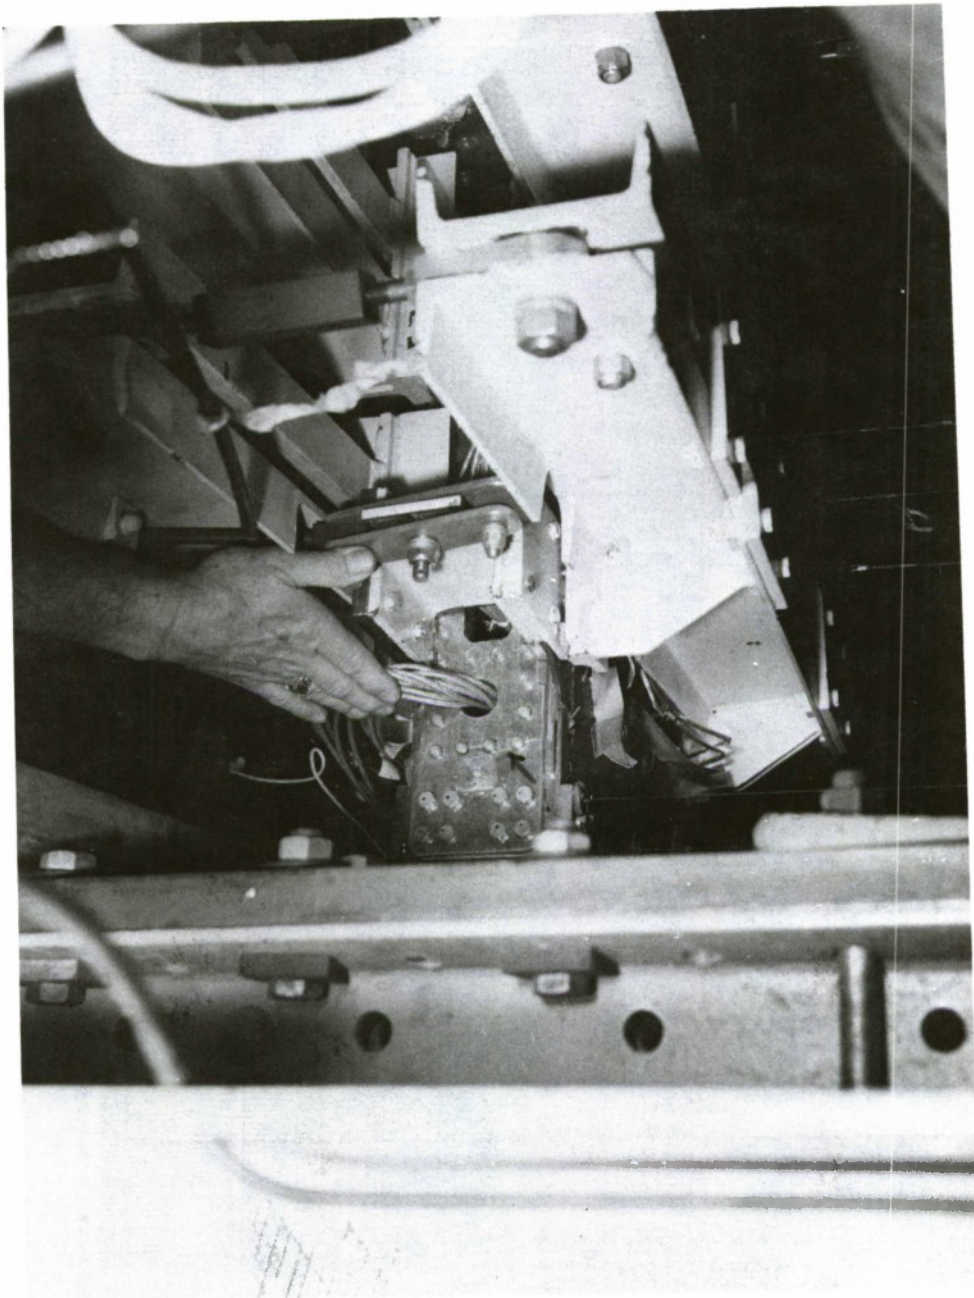
Figure 18. Final Failure of Front Spar Doubler Added After Block 21 Failure

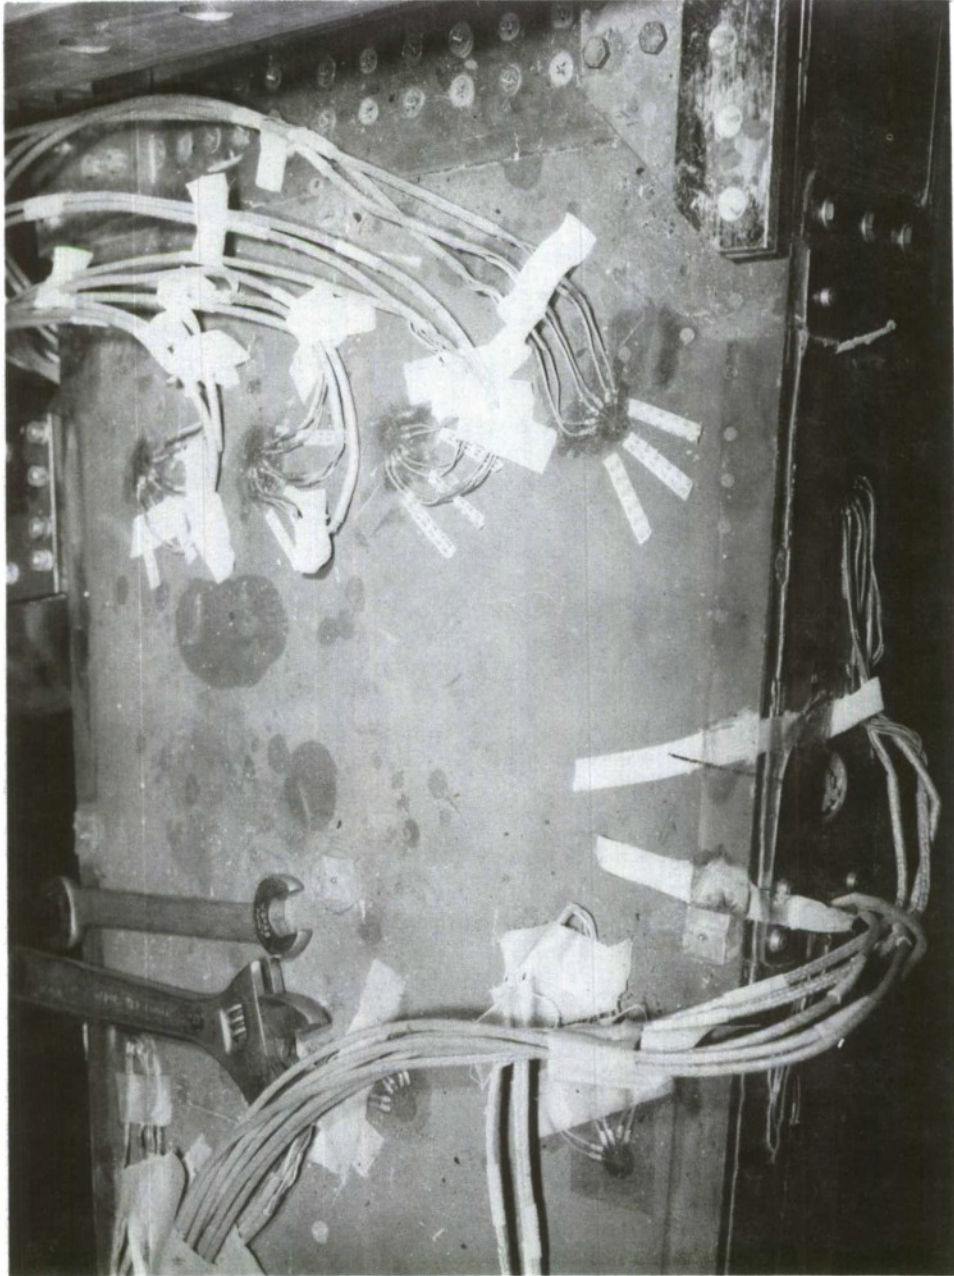
Figure 19. Final Failure of Rear Spar Showing the Core Failure
