## LOW FRICTION HULL COATINGS FOR ICEBREAKERS

PHASE II, PARTS I AND II

TECHNICAL REPORT

S.J. Calabrese, M.B. Peterson and F.F. Ling

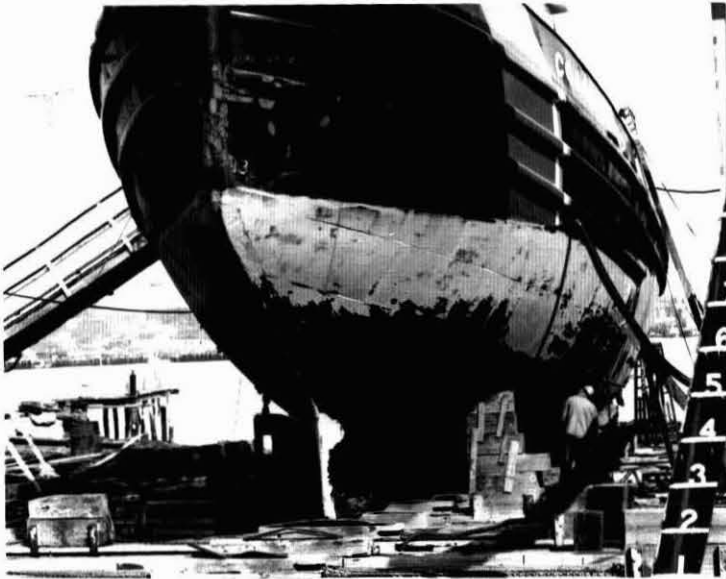
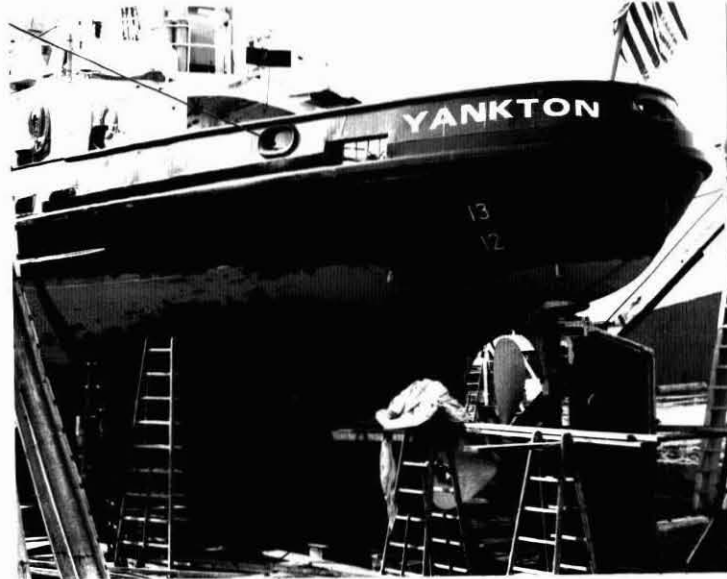
Figure II-1a Condition of the Hull of the US Cutter Yankton before Recoating

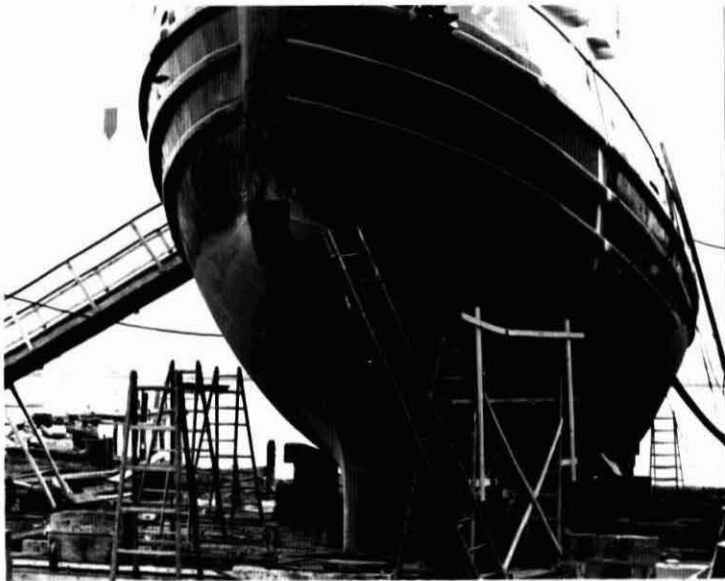
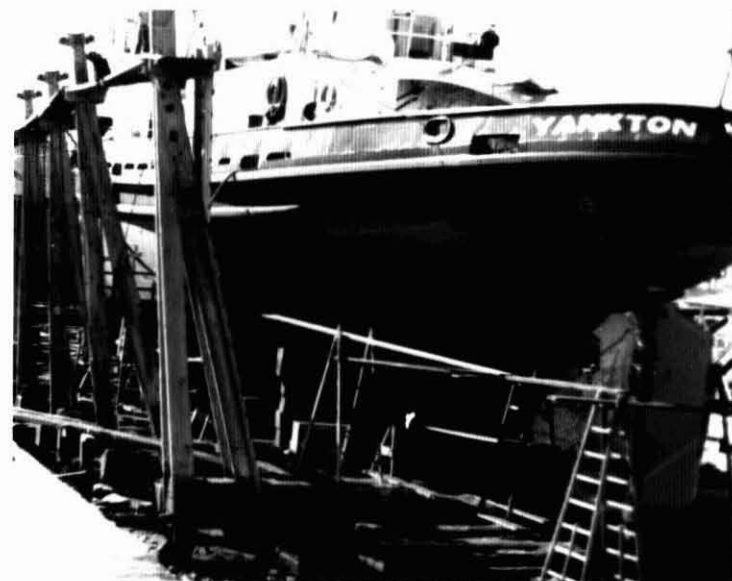
Figure II-1b Condition of the Hull of the US Cutter Yankton after Reactivation of the Primer but before Polyurethane Coating

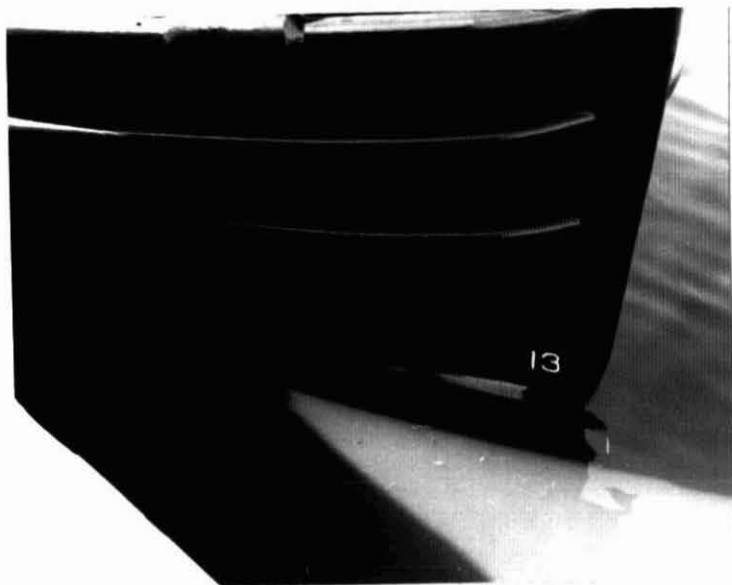
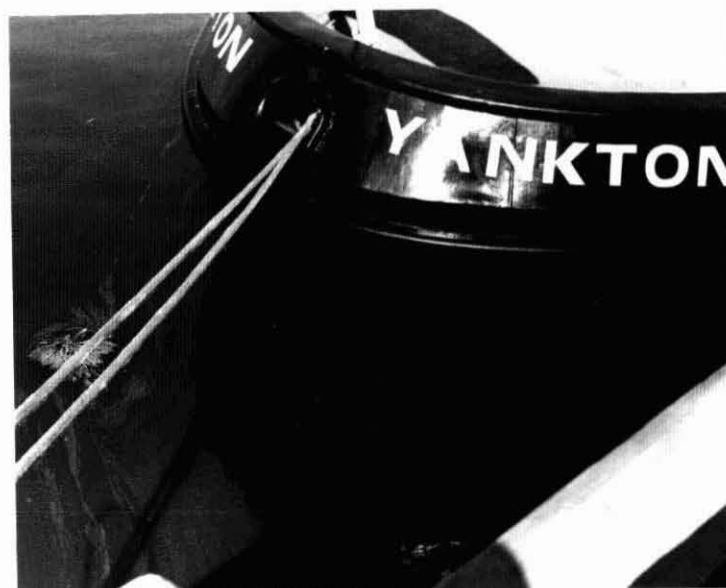
115  
Figure II-4 Photographs of the US Cutter Yankton after Icebreaking Service

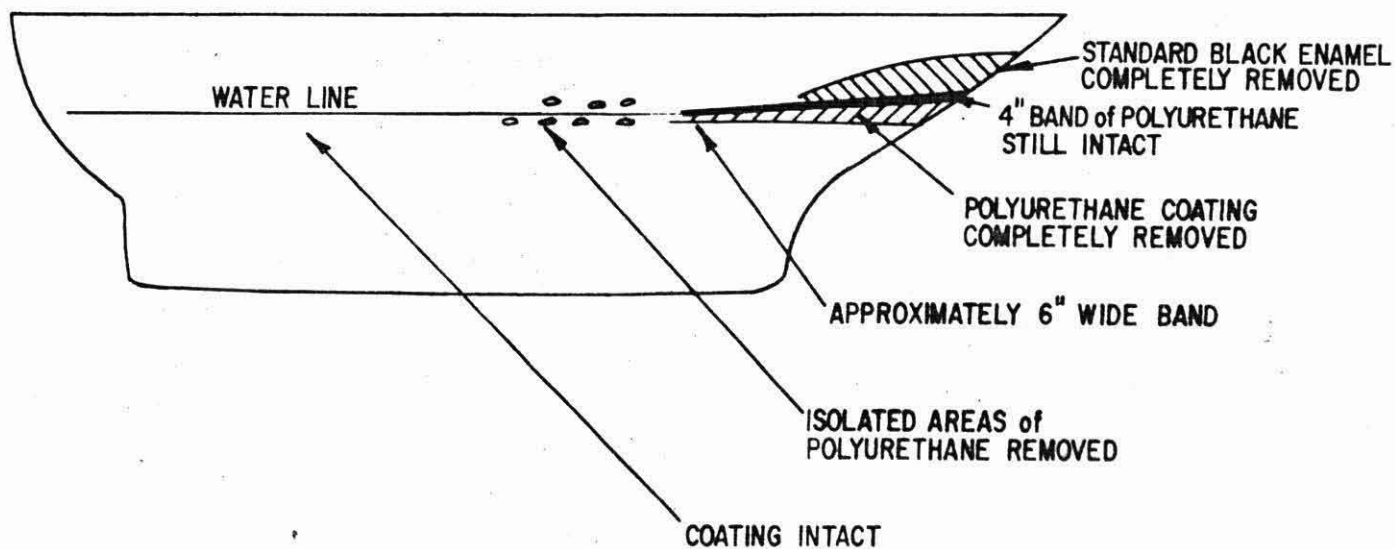
After the ship had been in the "pack ice" it was noticed that a band of polyurethane at the water line and below it was being removed. This is attributed to the erosion or abrasive action of the small particles of ice impinging on the hull. The total width of the urethane being removed at the bow was not visible; however, the width could be seen approximately ten feet from the bow and estimated to be about six inches. About 20 feet back the coating was intact at approximately 90% of the water line. From midship to stern, the coating appeared to be 100% intact at the water line. The diagram below shows the approximate extent and pattern of the damage.

Approximately 90% of the coating was still intact. The only wear problem was seen at the water line. The coating above and below the water line showed no signs of abrasion. The material still remaining on the ship was attacked by fouling, barnacles and a coating of residue or slime. This residue could be wiped off the coating leaving the bright original finish which was seen during the coating application. Photographs of the typical appearance of the hull are seen in Figure II-8.

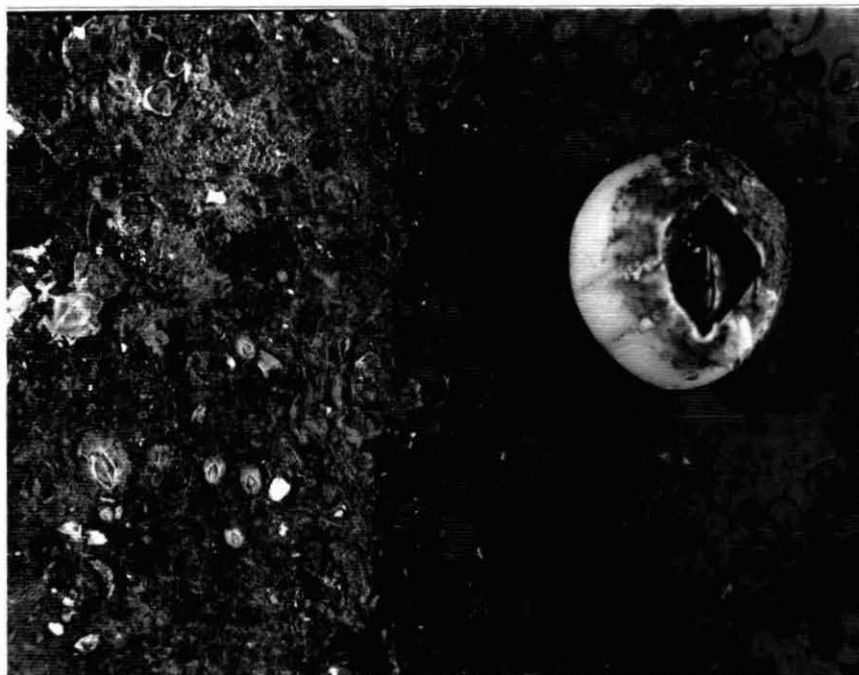
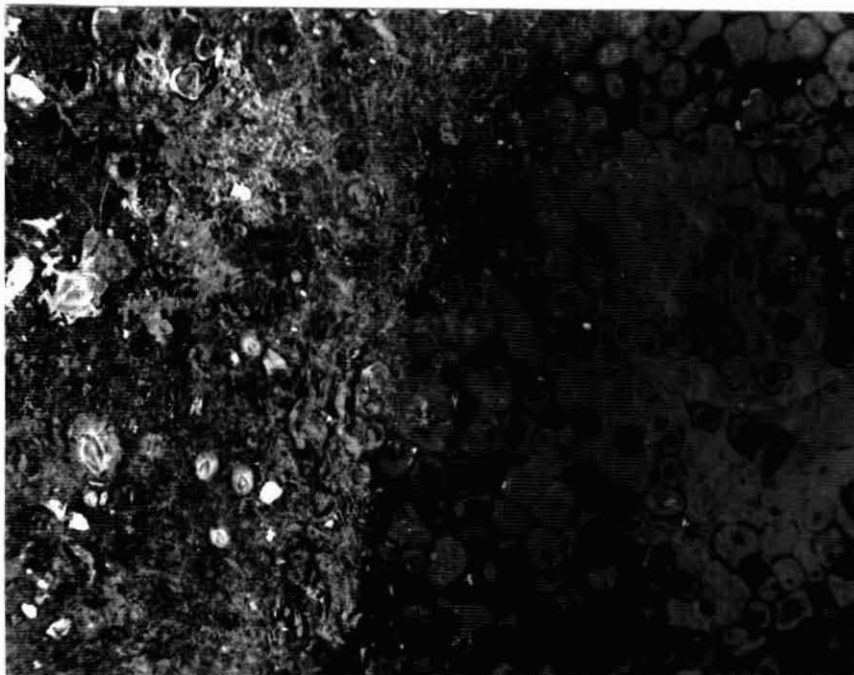
Figure II-10 Surface Condition of the USCG Cutter Sauk Coating before (Left) and after (Right) Washing with Water. Upper photo shows position of a barnacle on the cleaned surface. Lower photo shows the barnacle removed. Magnification 3X.

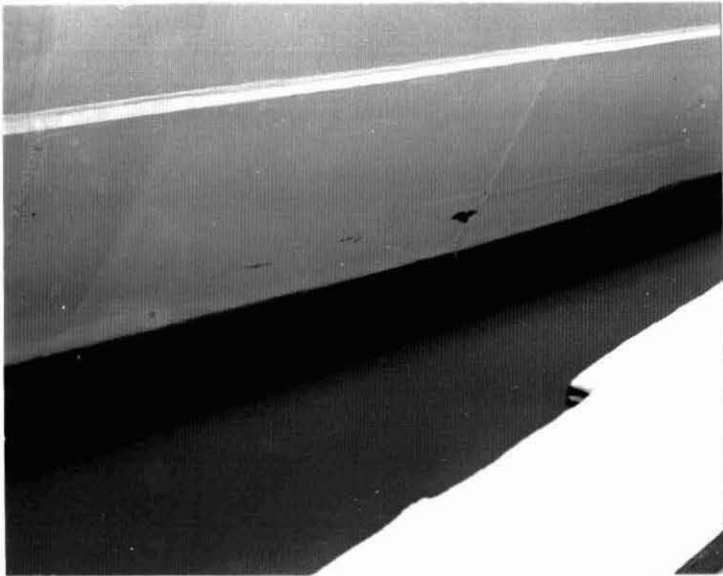
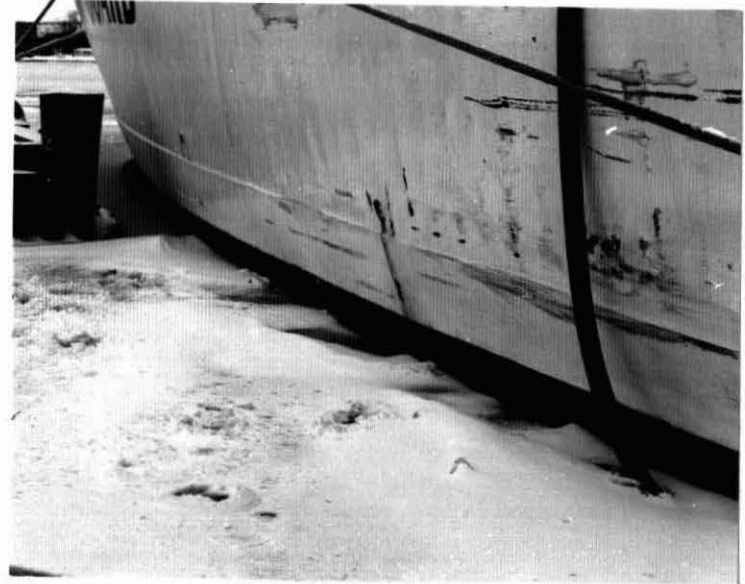
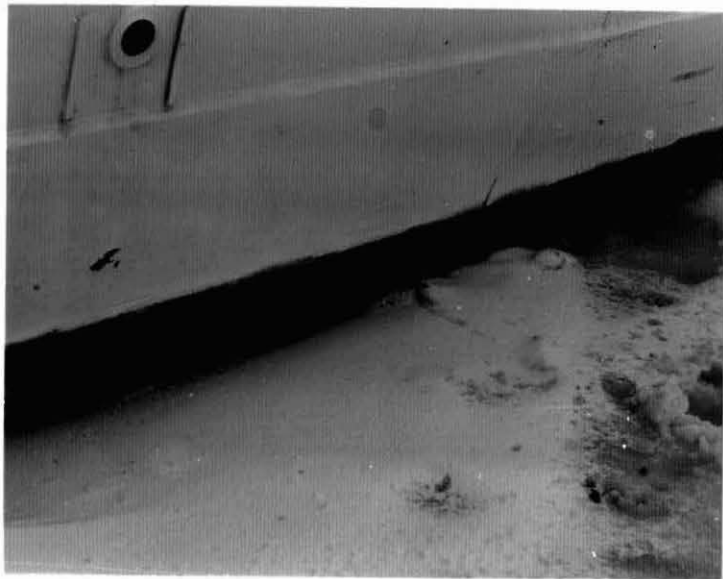
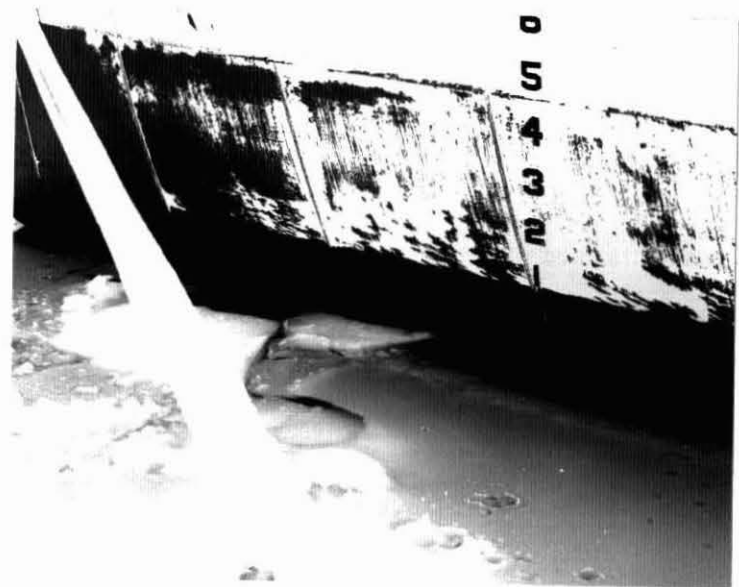
Figure II-15 Photographs of the Ice Line of the Hull of the Cutter Mackinaw after Icebreaking Service

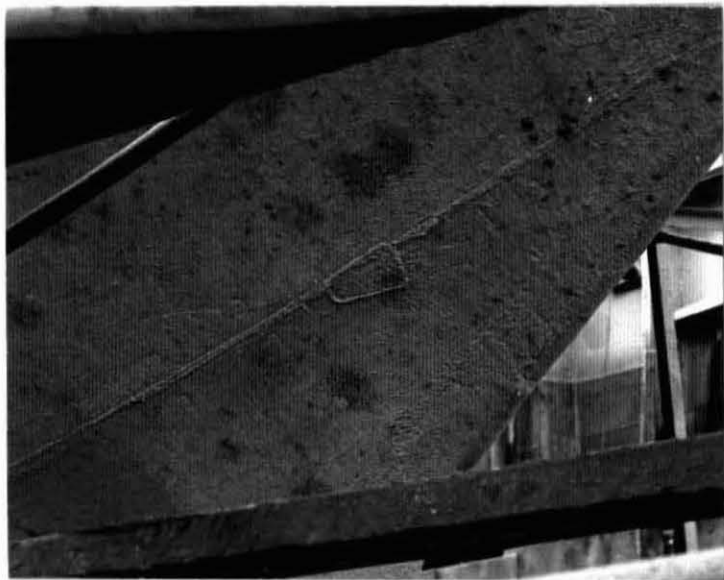
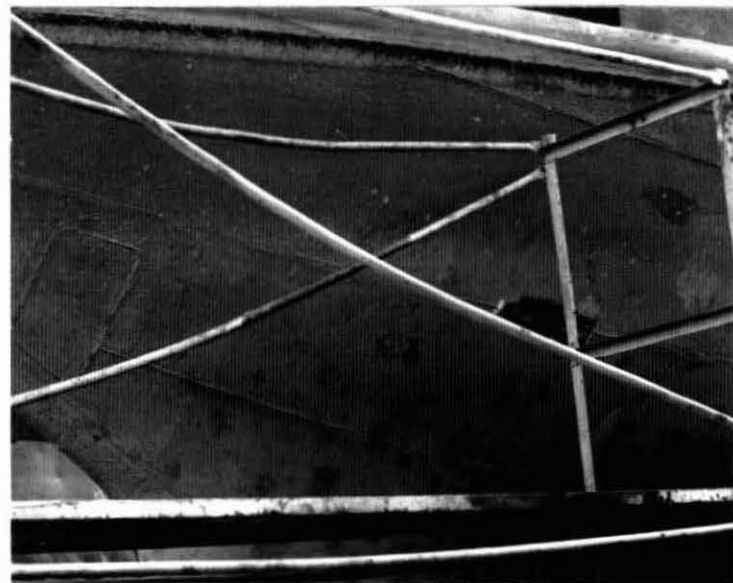
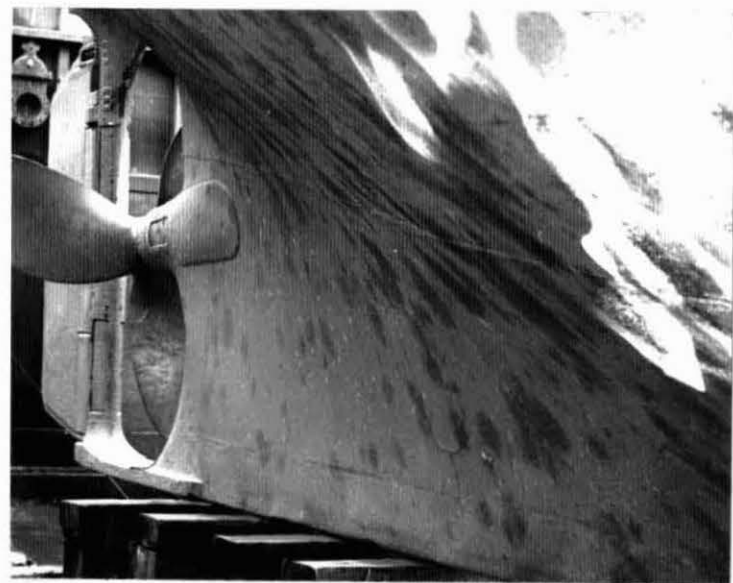
Figure II-21 Condition of Hull of the USCG Cutter Raritan before Cleaning

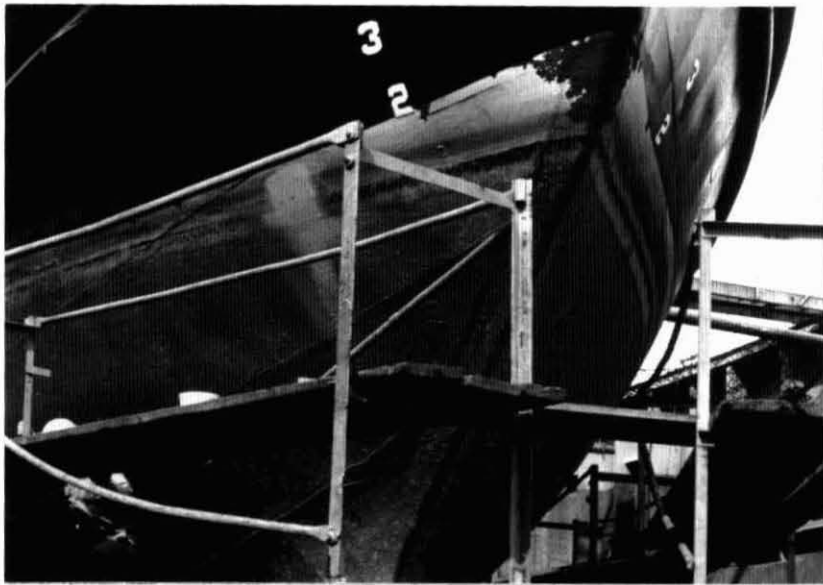
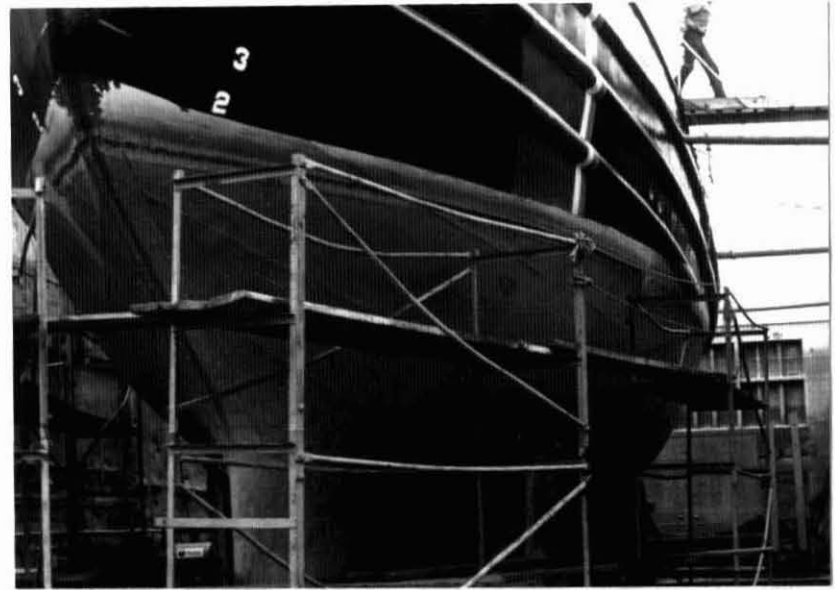
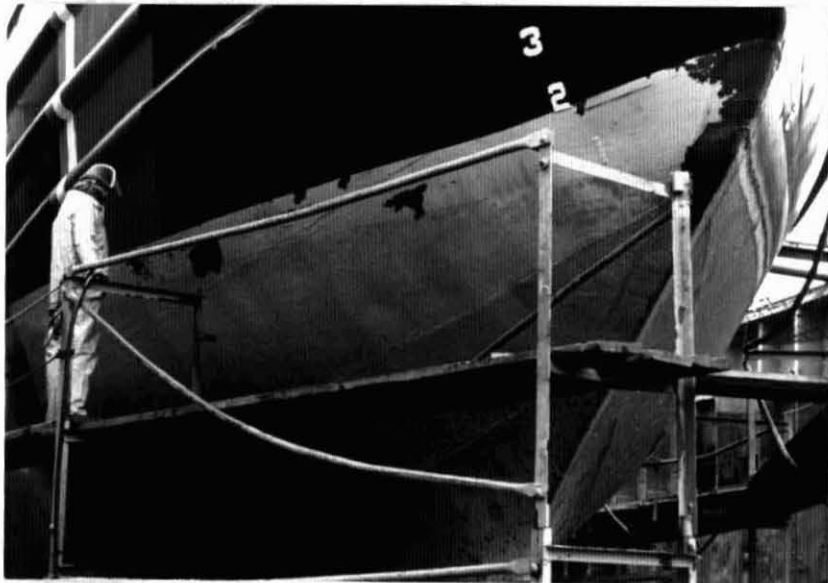
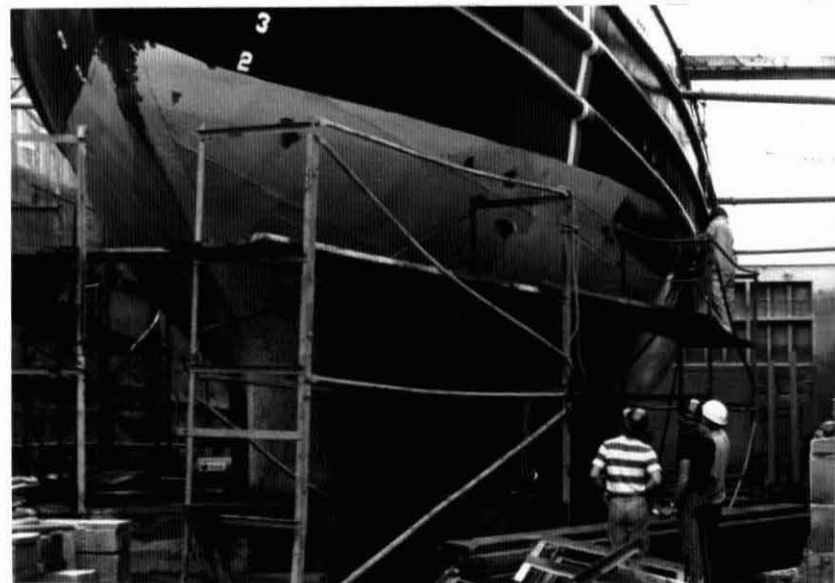
Figure II-22 Bow of the Cutter Raritan before (Top) and after (Lower) Cleaning by Hydroblasting

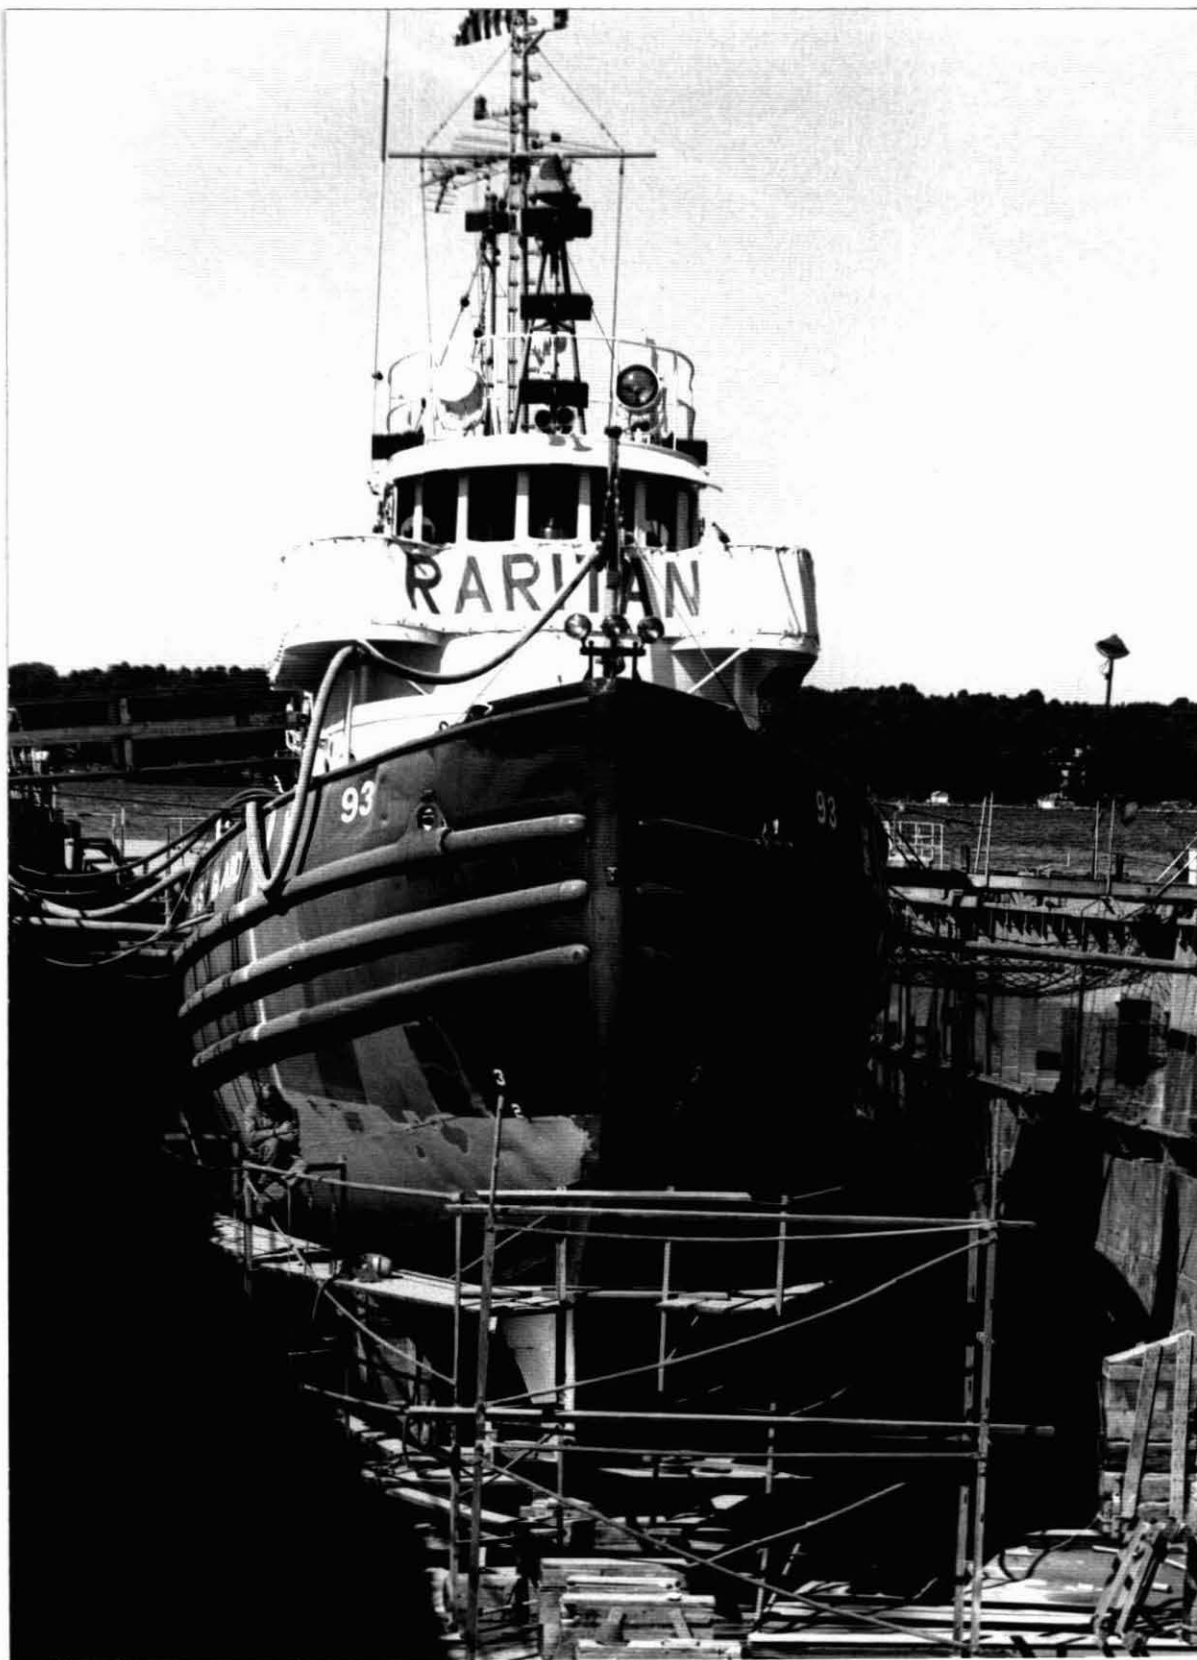
Figure II-23 Condition of the Hull of the Cutter Raritan after Grit Blasting the Damaged Areas for Repair

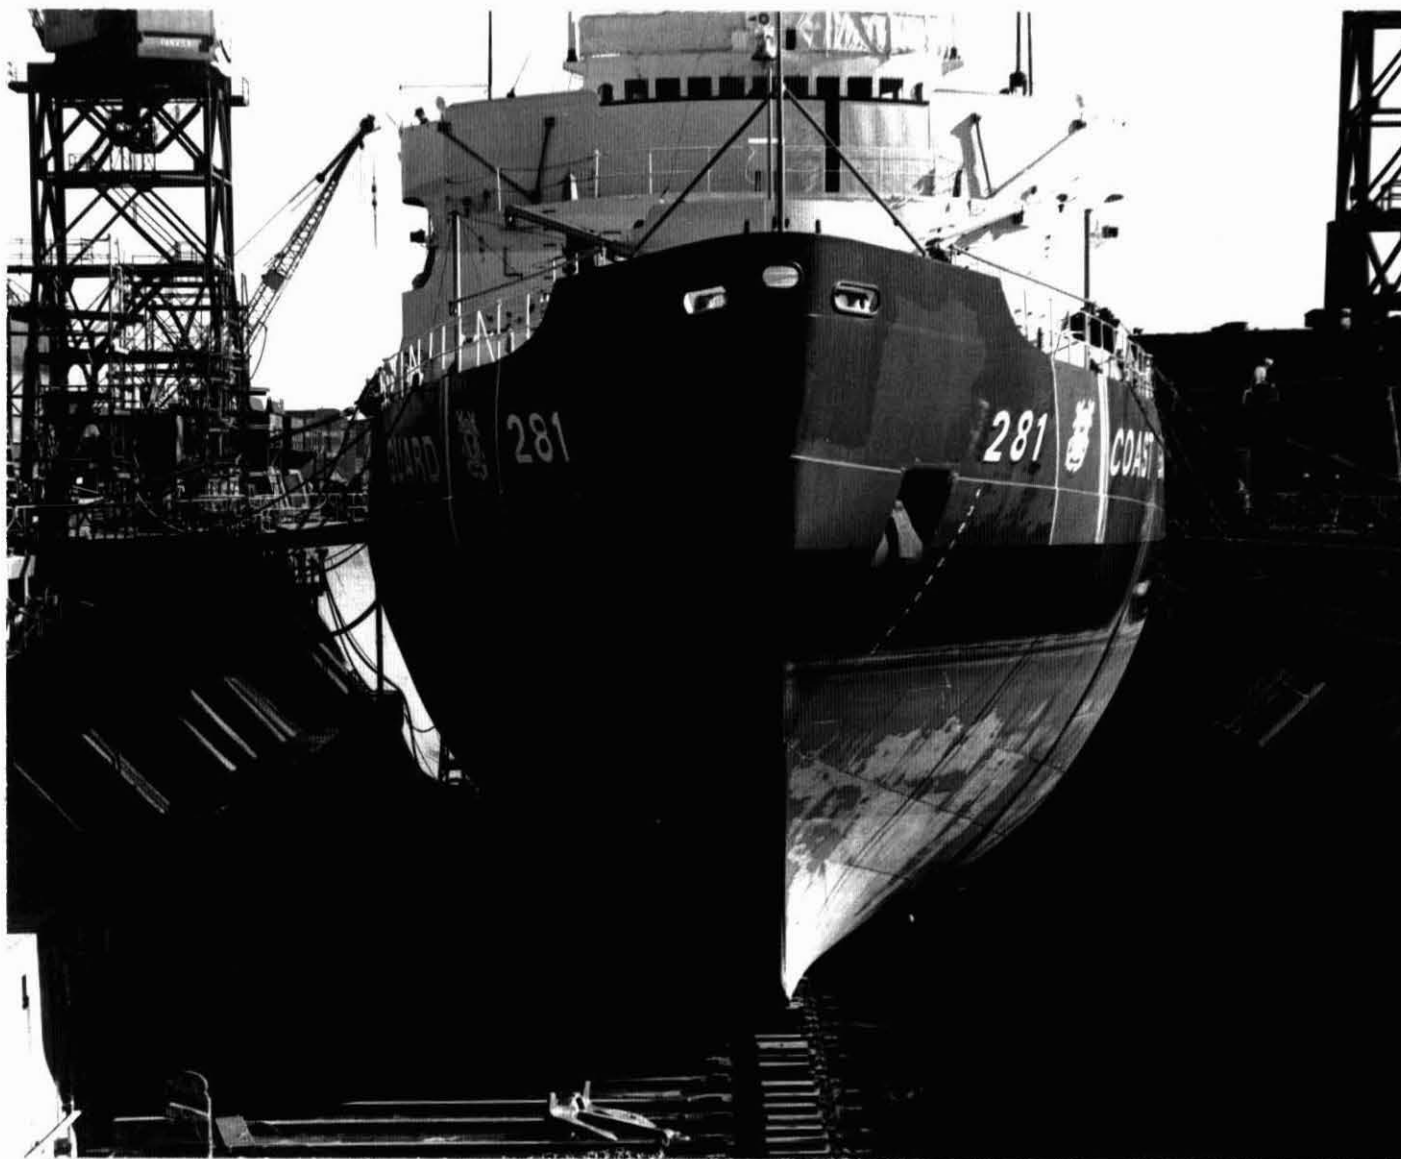
168  
Figure II-26 Condition of the Bow of the USCGC Cutter West Wind after Icebreaking Service. The white areas are the glass flake polyester coating. The grey areas are the steel surface where the coating was removed.

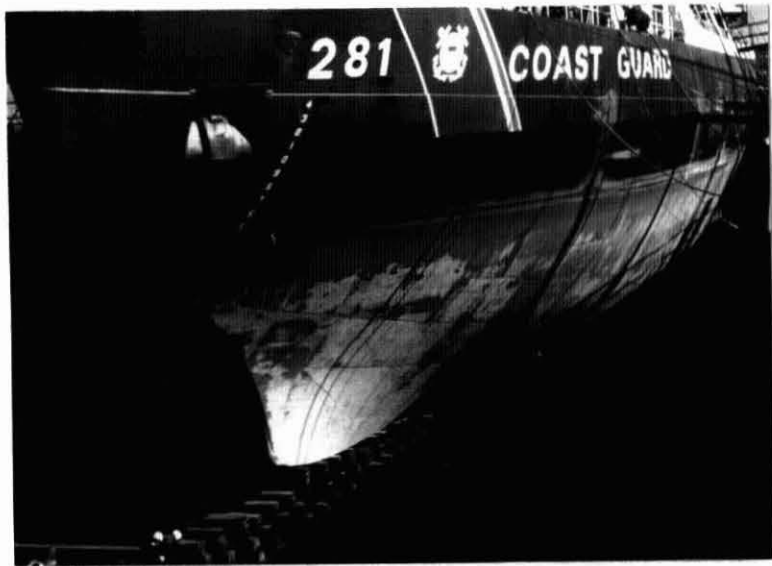
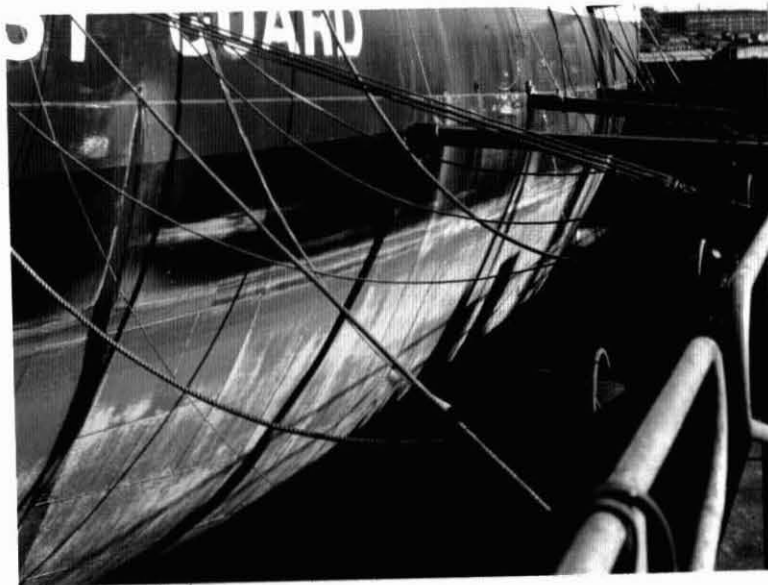
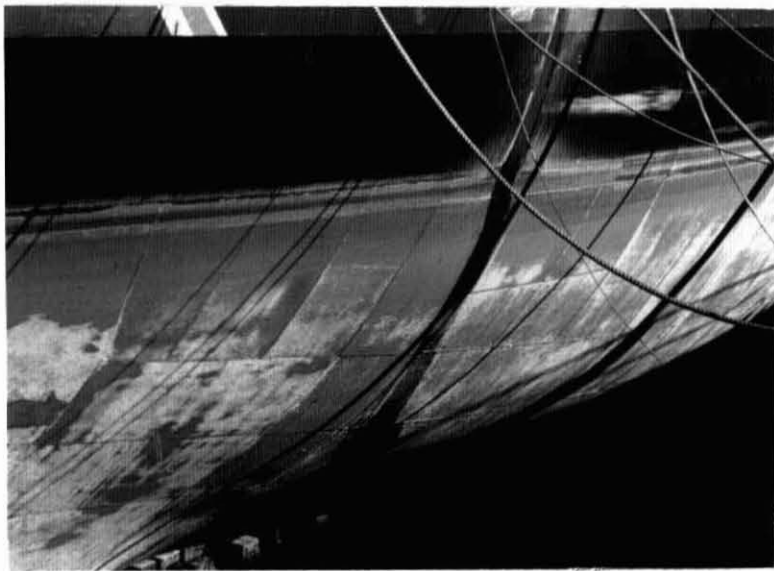
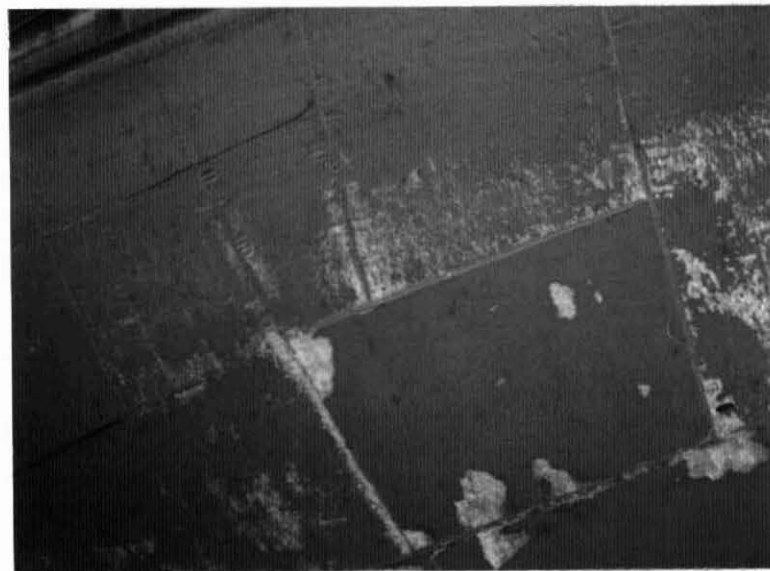
Figure II-27 Condition of the Hull of the USCG Cutter West Wind after Icebreaking Service. Areas shown are from the bow to midship.

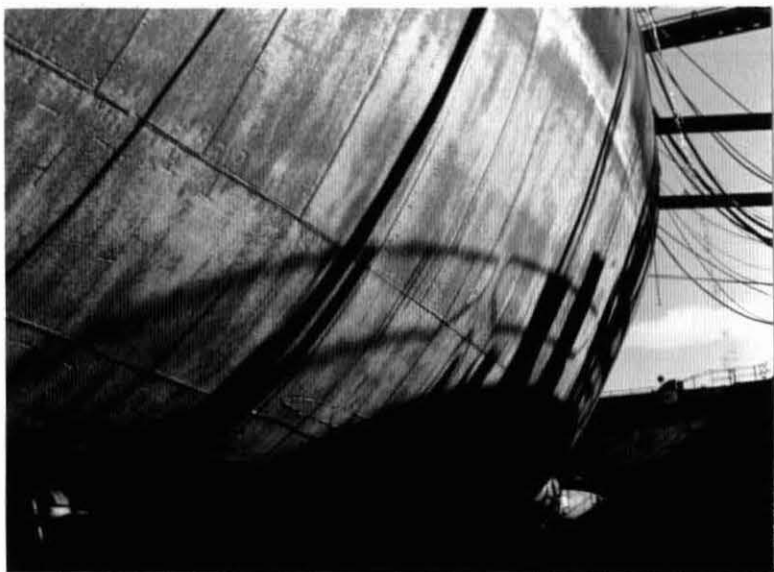
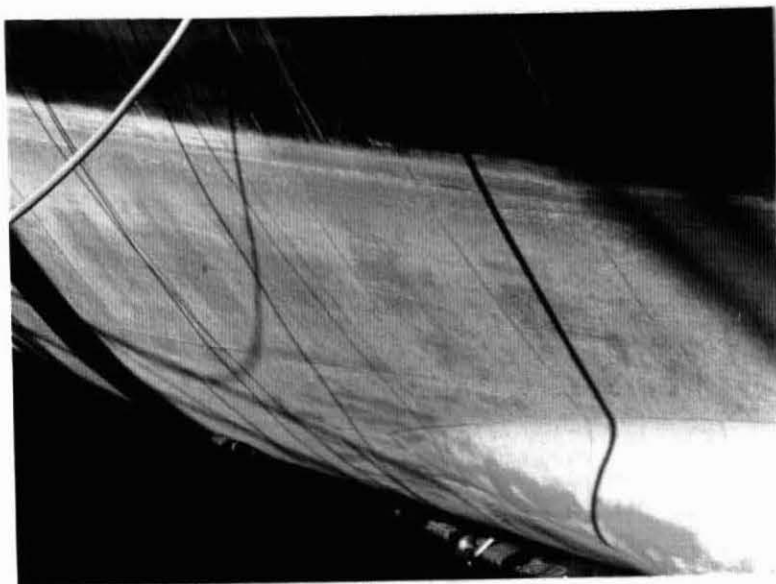
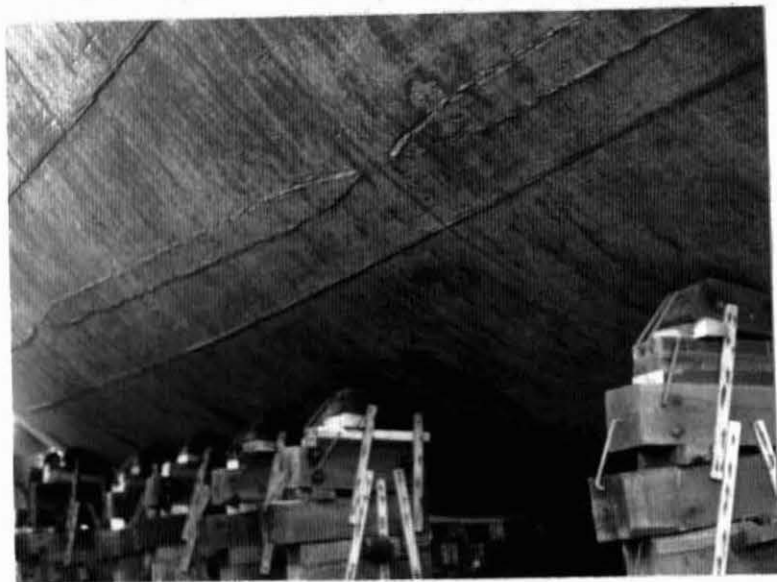
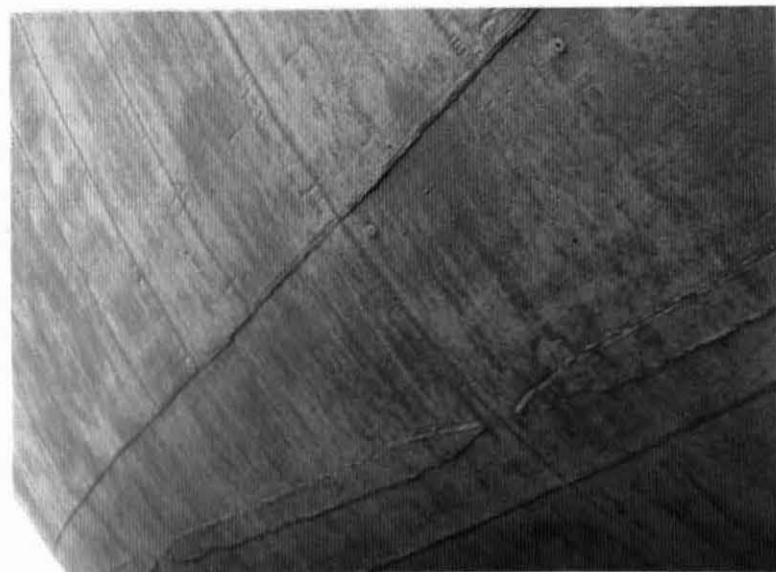
Figure II-28 Condition of the Hull of the USCG Cutter West Wind after Icebreaking Service.  
Areas shown are the stern and underside portion of the hull.

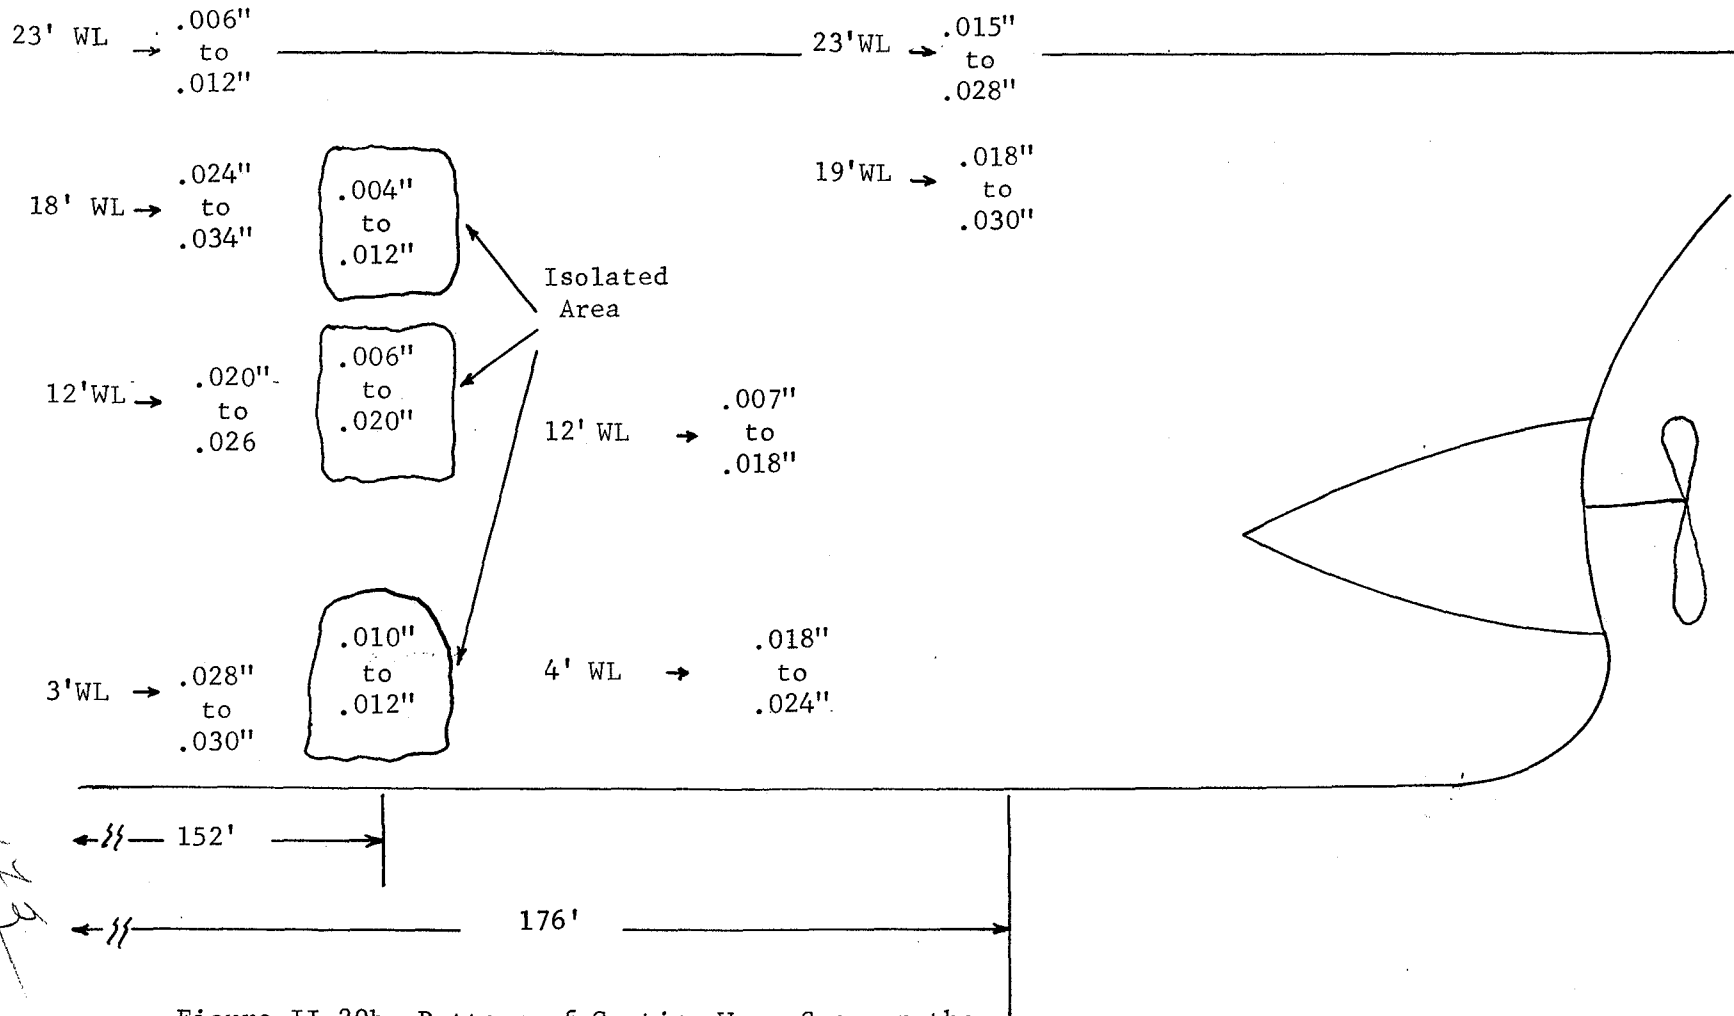
Figure II-29b Pattern of Coating Wear Seen on the USCGC West Wind after Service
