USAARL Report 76-21

REDUCTION OF GLARE FROM THE LANDING LIGHTS OF THE OH-58:  
AN EVALUATION OF FOUR POTENTIAL SOLUTIONS

Final Report

US Army Aeromedical Research Laboratory  
Fort Rucker, Alabama 36362

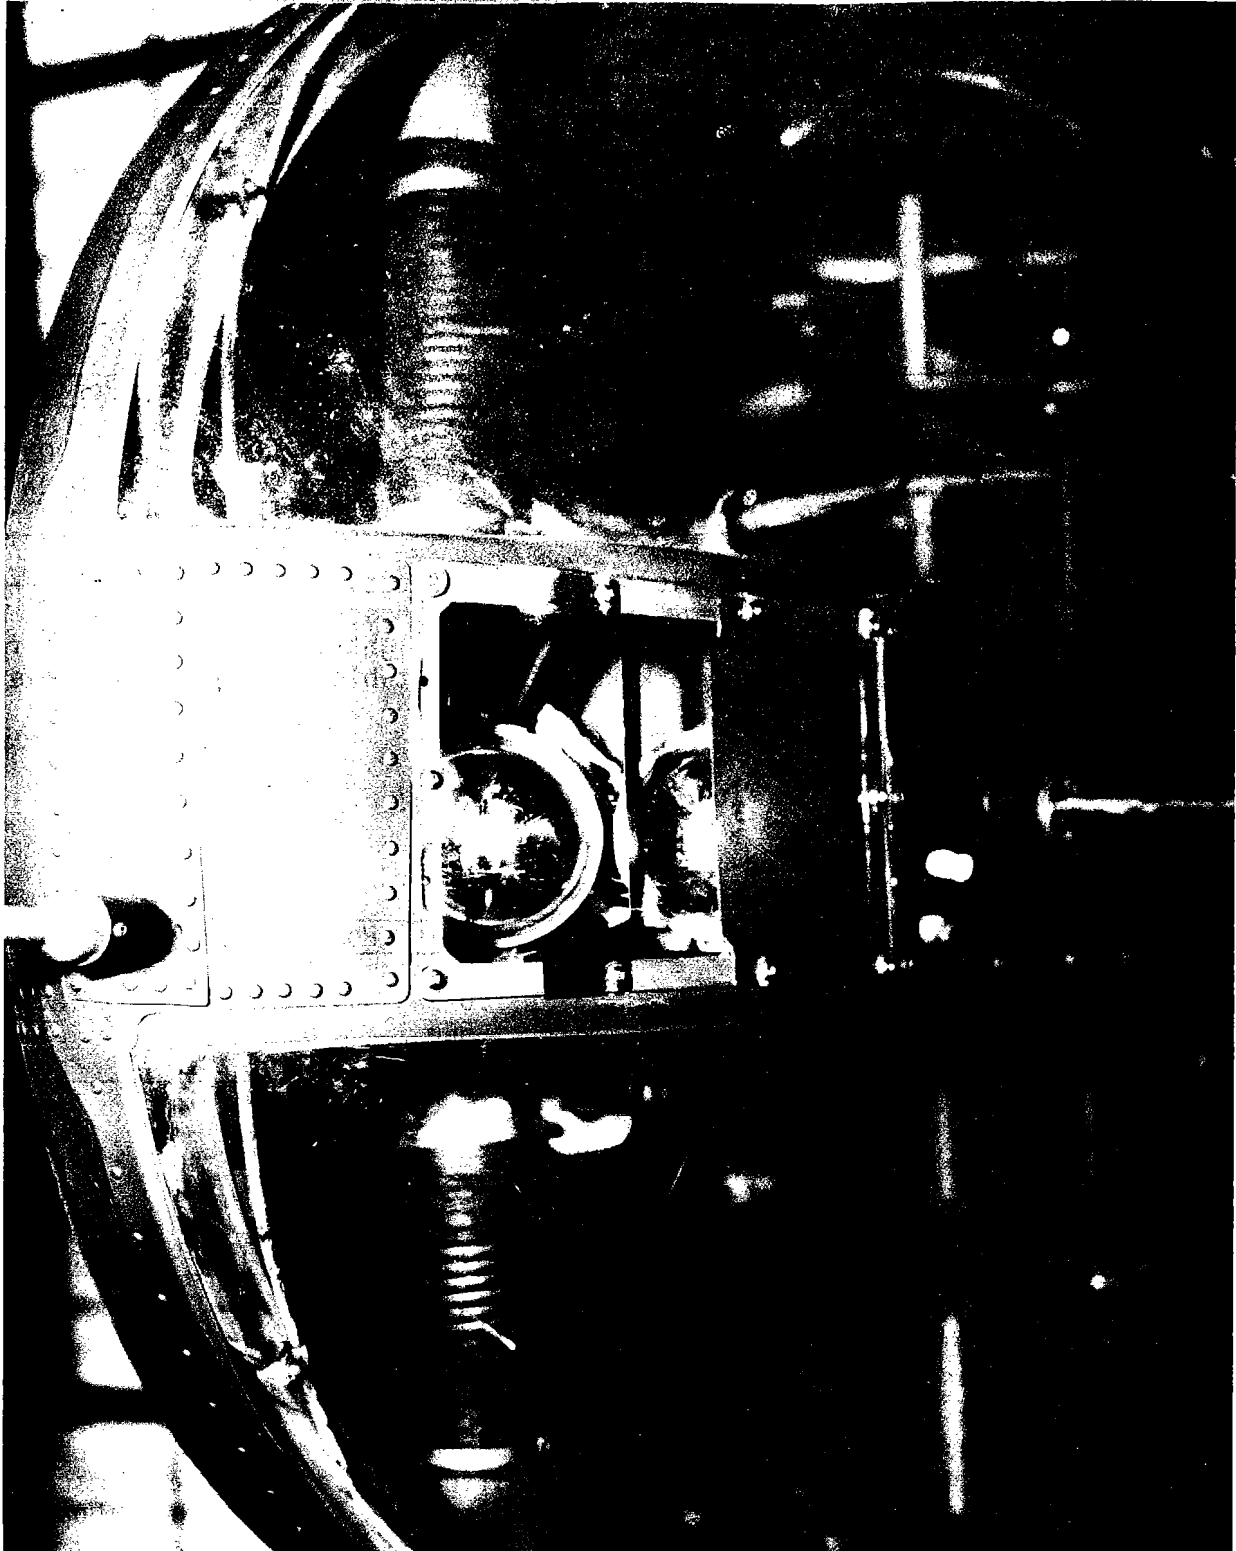
Solutions 1, 2, and 3 were all found to be very effective in reducing glare from the landing lights. The metal shield used in Solution 1, however, became so hot that it burned the protective plexiglass sheet covering the light well. Solution 2 involved a small amount of visibility loss. Solution 3 left a small streak of glare along the lower, outer edge of the ipsilateral windscreen and a large patch of glare in the center of the contralateral windscreen, i.e., the man in the left seat could see a small patch of glare along the lower, outer edge of the left windscreen and a larger glare patch in the center of the right windscreen. The situation was just the reverse for the man in the right seat. Figures 4 through 7 show the glare on the ipsilateral windscreen in the present configuration (no solution applied) and with Solutions 1, 2, and 3 applied. The white rectangles in the background are the runway markers and the windscreen glare is seen superimposed. Tables 1 through 4 show the photometric data for the present configuration and Solutions 1 through 3. It was concluded that if the overheating problem can be solved, Solution 1 together with the rewiring of the switch, is the preferred solution since it involves no visibility loss or additional material inside the cockpit. However, Solution 3 is a very good field-expedient "quick fix."

FIGURE 1. Solution 1 - Metal shield beneath the landing light.

shields beneath the landing lights (Solution 1) since this involved no visibility loss or extra material inside the cockpit. However, the overheating of the plexiglass sheet over the light well caused by these metal shields will have to be overcome before this solution is acceptable. It was also found that the tape over the inside one-half of each chinbubble is a very good field-expedient "quick fix."

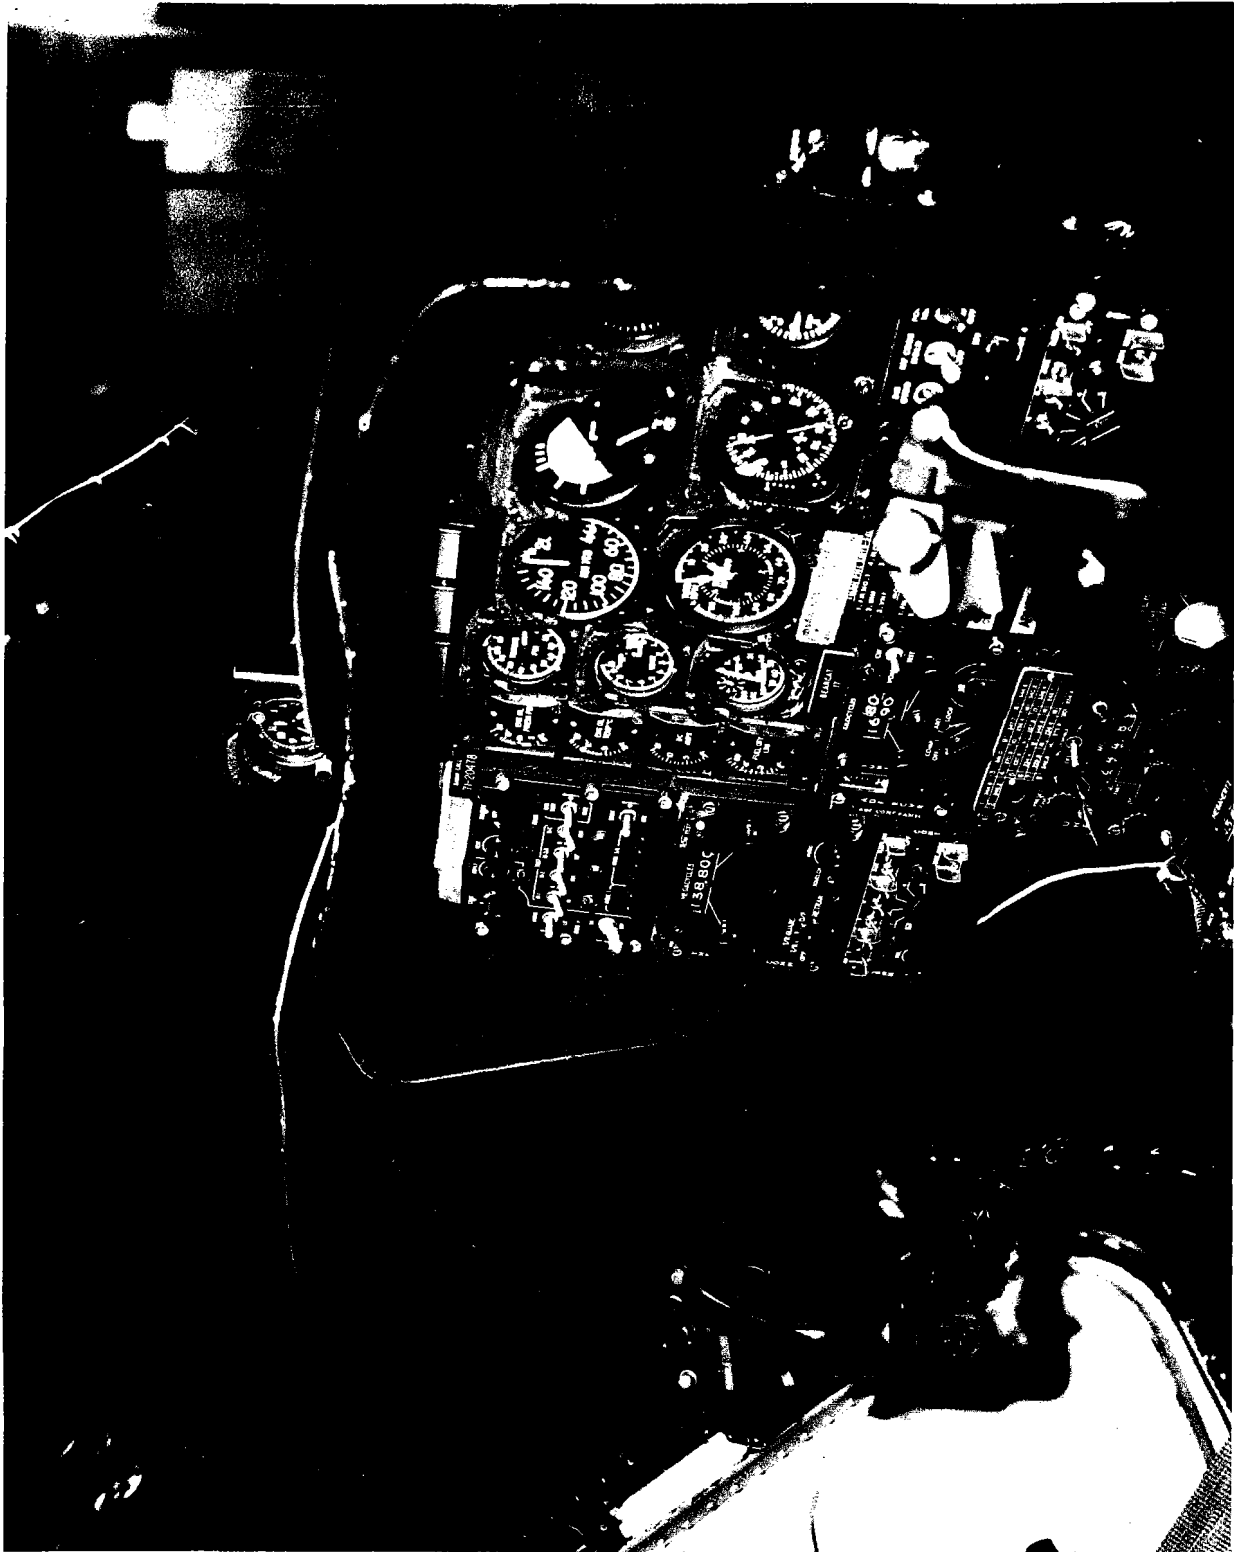
FIGURE 2. Solution 2 - Shields extending out laterally from the top of the instrument panel.

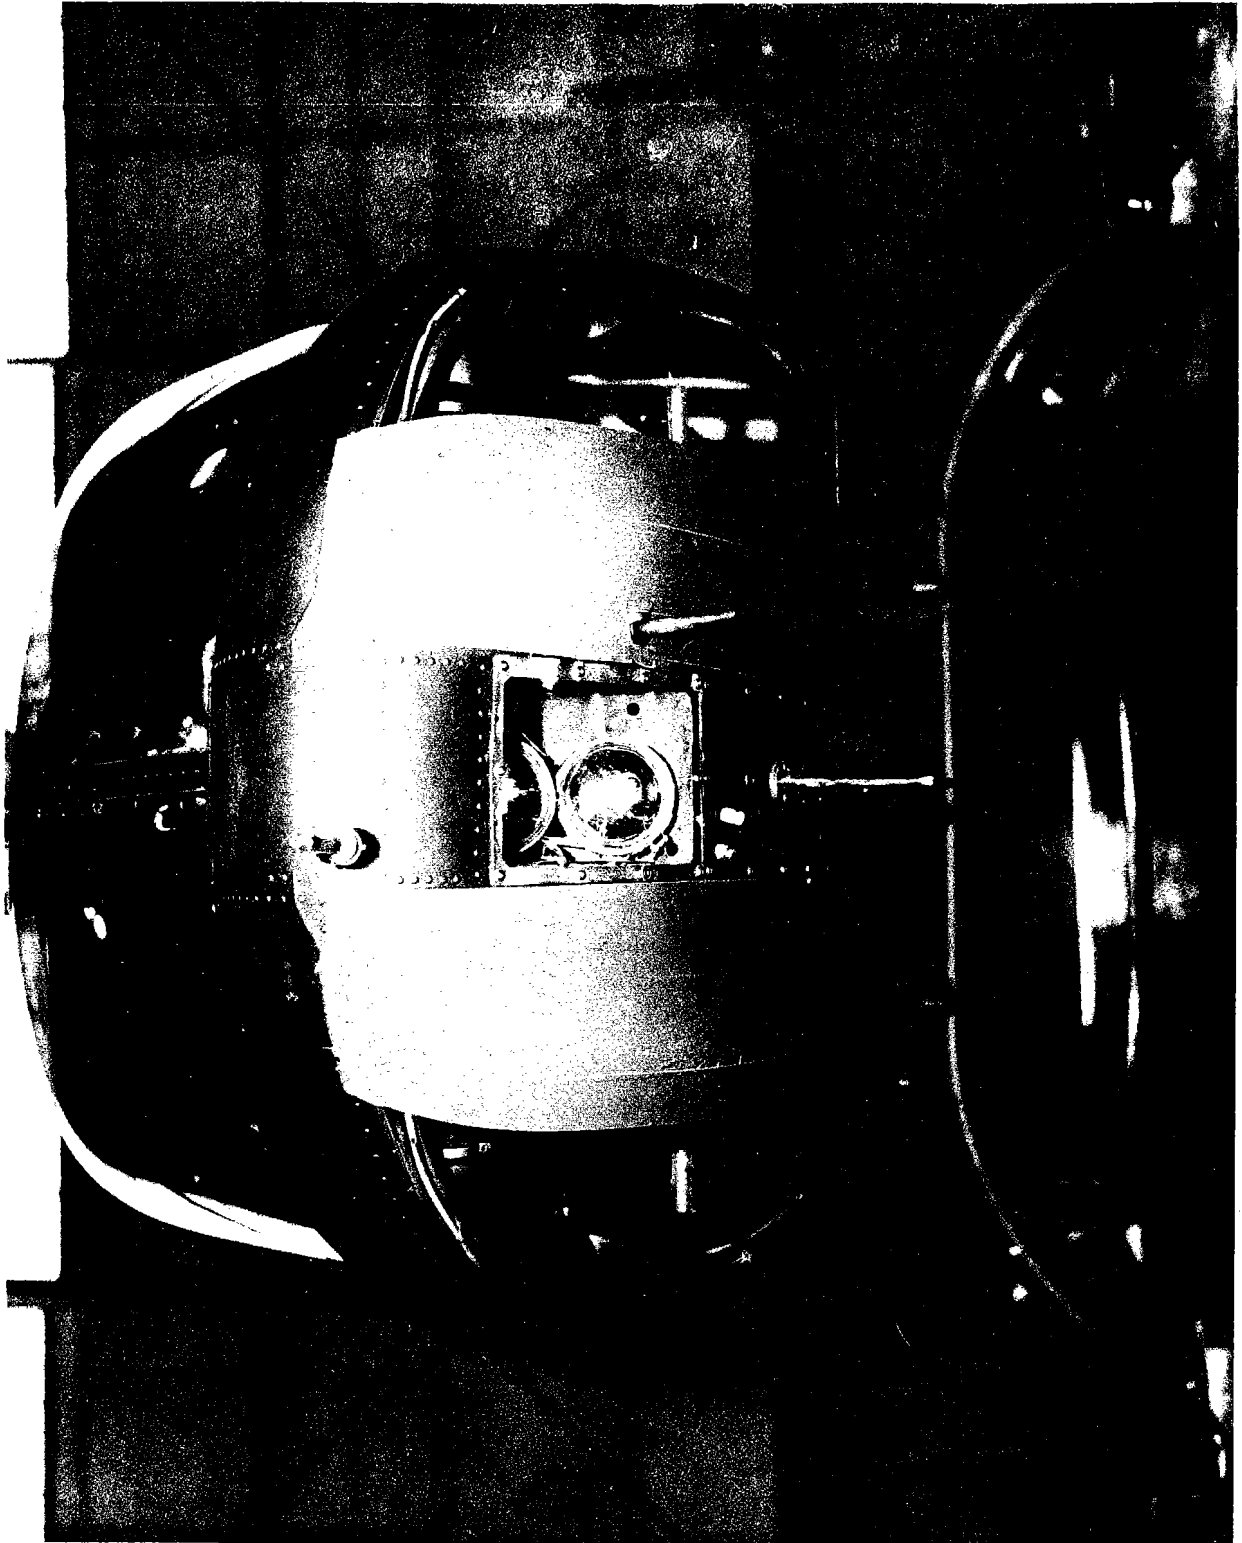
FIGURE 3. Solution 3. - Tape over the inside one-half of the chinbubble.
