# F-III A WING FATIGUE TEST PROGRAM

APRIL 1976

TECHNICAL REPORT AFFDL-TR-76-30  
FINAL REPORT FOR PERIOD 24 MARCH 71 - 10 JULY 74

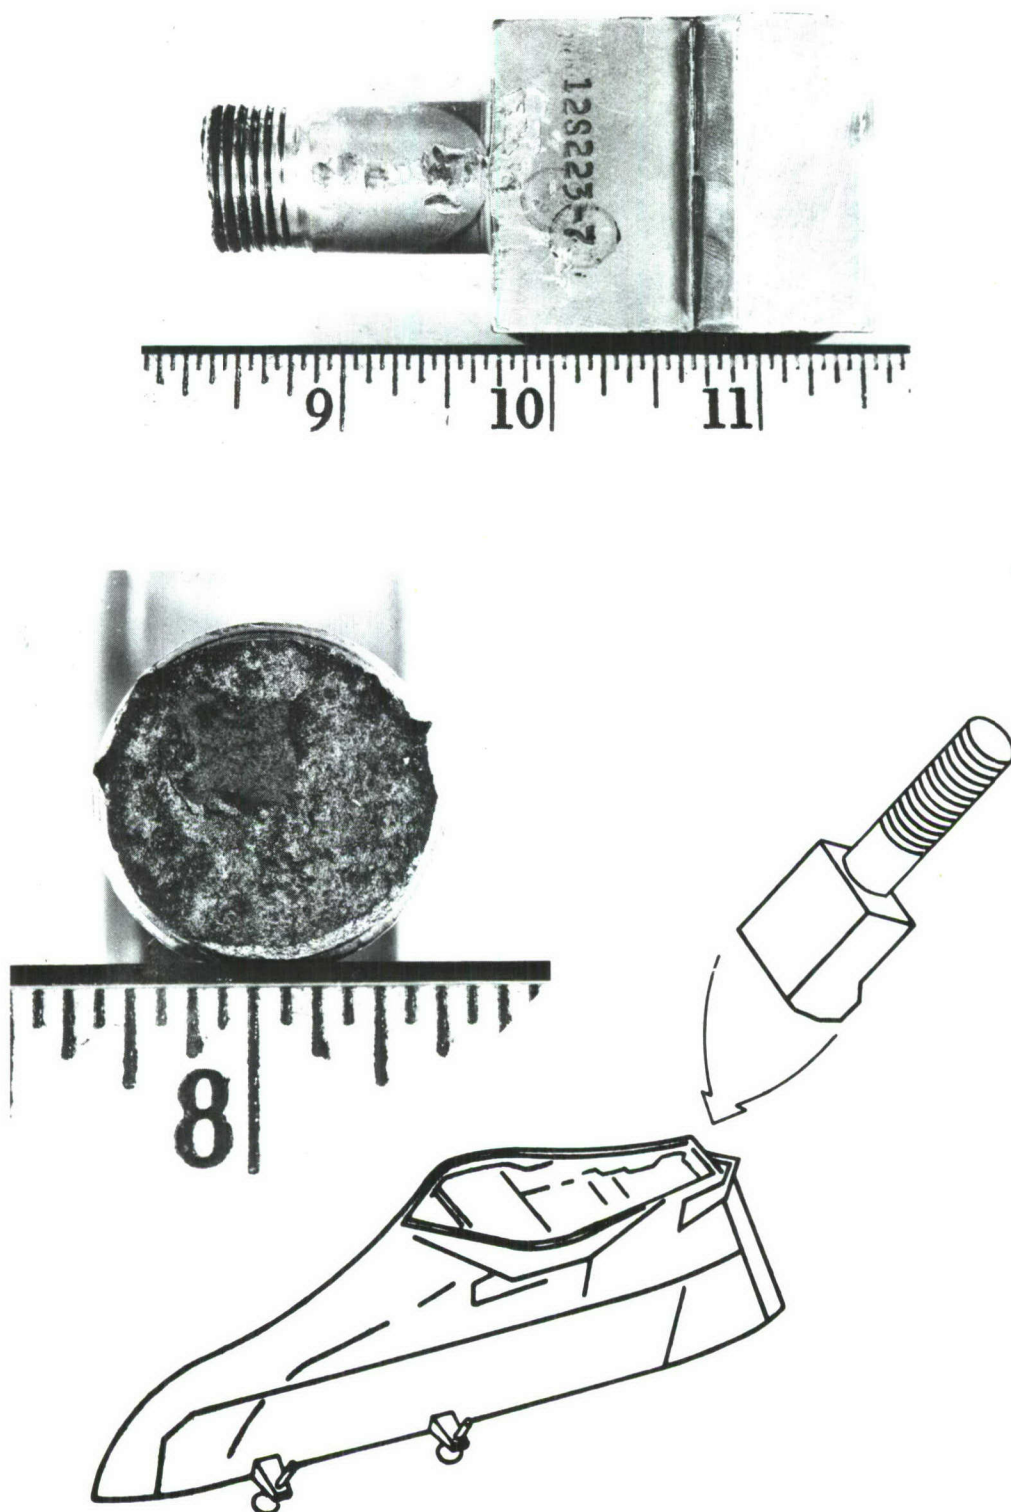
Figure 11. Aft Pylon Attach Bolt Failure

The aft pylon attachment bolt of the outboard fixed pylon failed at 95 percent of the first fatigue lifetime (Figure 11). The fracture occurred in the threaded portion of the attachment bolt. A metallurgical evaluation was conducted by Mr. Alan Gunderson of the Air Force Materials Laboratory to determine the cause and mode of failure. Based on the predominant intergranular fracture, longtime to failure after loading, and the deep crevices between grains, it was concluded that stress corrosion cracking was the primary cause of failure.

The pylon attachment bolt's original heat treat of 260-280 ksi was changed to 200-220 ksi to reduce the susceptibility to stress corrosion cracking and the machining of the threads was changed to rolled threads. After these changes, a satisfactory fatigue life was obtained.

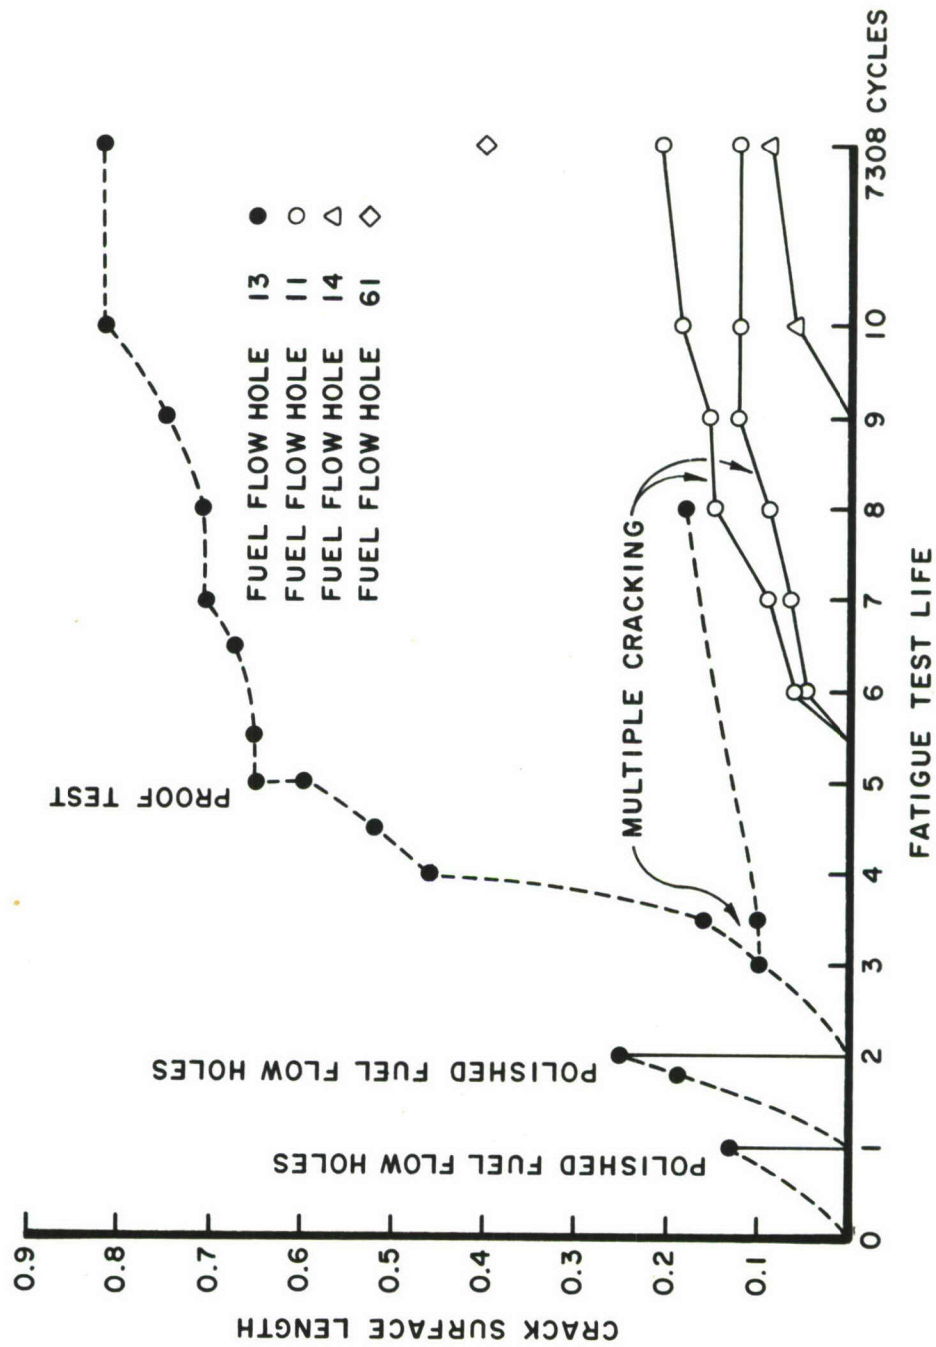
Figure 12. Fuel Flow Hole Crack Length vs. Fatigue Life

A crack was discovered in upper surface fuel flow hole No. 14 after the second lifetime. The crack was polished out at the end of the second lifetime. A crack was discovered in upper surface fuel flow hole No. 11 after the 6th fatigue lifetime; it propagated as shown in Figure 12. A crack was again found in fuel flow hole No. 14 after the 10th fatigue lifetime; it propagated as shown in Figure 12.

- 29 May 1973 - Completed 6th lifetime. Discovered crack in fuel flow hole No. 11. Crack in fuel flow hole No. 13 had propagated very little (Figure 12).

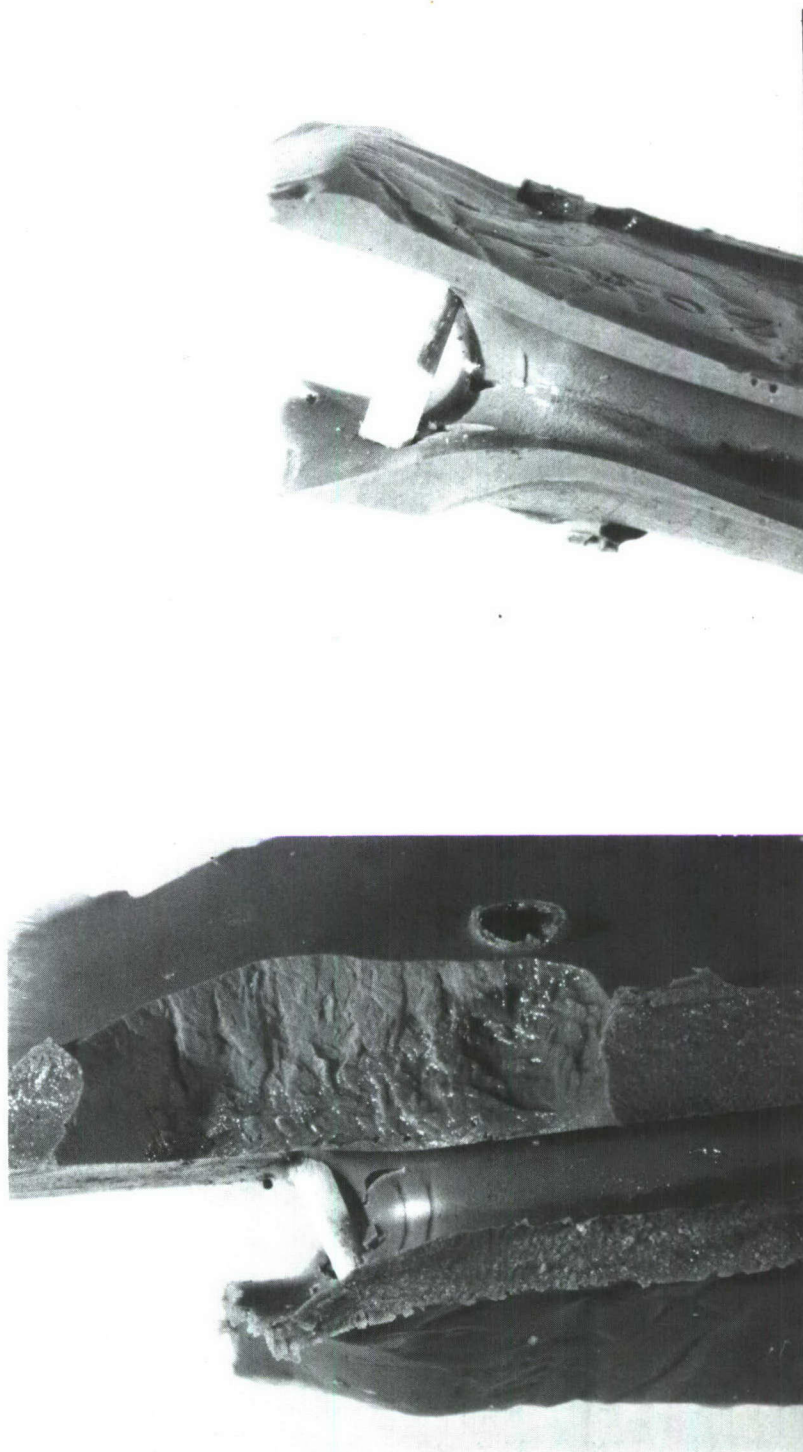
Figure 13. Magnetic Rubber Casts

Magnetic rubber is room temperature vulcanizing rubber with powdered iron in suspension. Casts are made by pouring this solution into molds around the area to be inspected and then applying a magnetic flux. This flux causes a flux field to be set up across the crack or flaw opening, which, in turn, attracts the suspended iron powder. This concentration of iron particles gives a permanent replica of the crack (Figure 13 and 14).

A crack in upper surface fuel flow hole No. 13 was discovered at the end of the first fatigue life. The crack was in the compression surface of the wing (top) and was caused by the large compressive stress (above yield) creating a high tension residual stress in the fuel flow hole. The theory of this type of crack propagation is explained in "The Load Interaction and Sequence on the Fatigue Behavior of Notched Coupons," ASTM STP519 pp 109-132, by J.M. Potter. This crack was polished out after the first life and again after the second life. The crack history is plotted in Figure 12. This plot was generated from magnetic rubber casts taken throughout the program. Typical casts are presented in Figure 13 and 14.

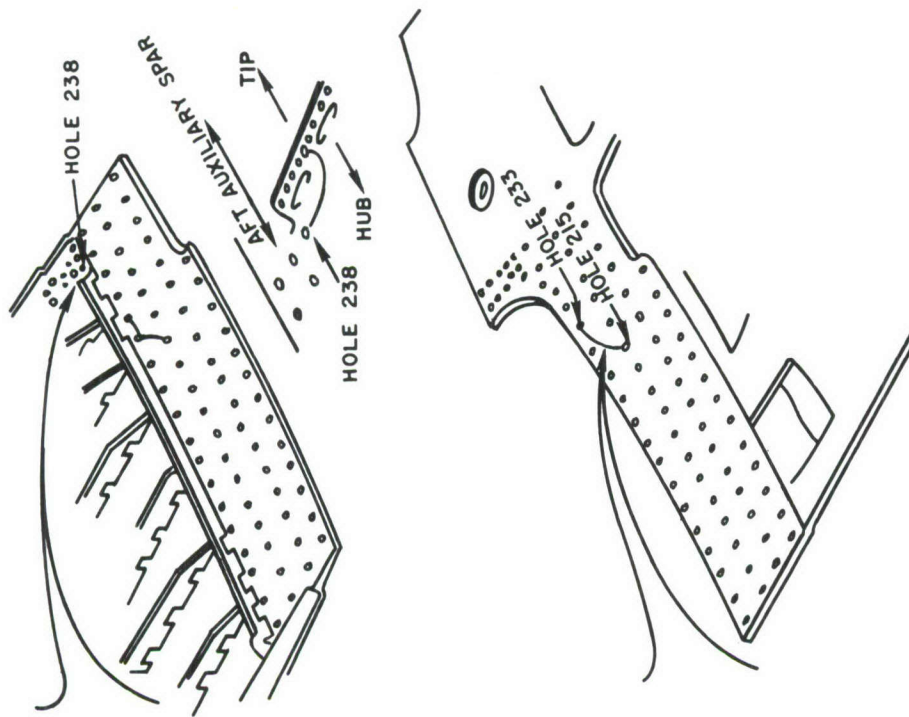
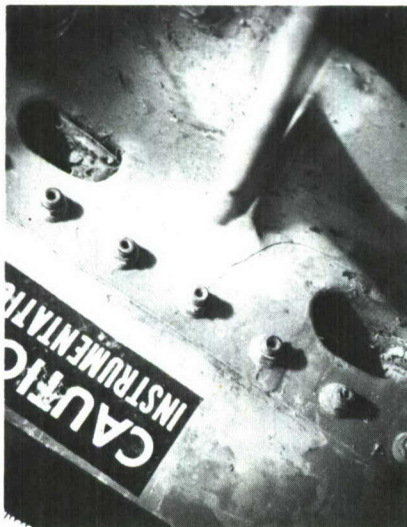
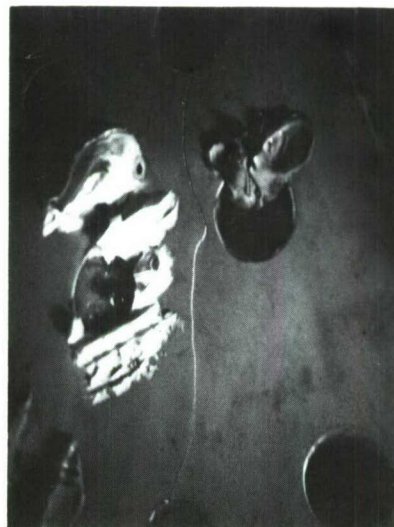
Figure 15. Wing Failure

During the constant amplitude testing, after the 10th lifetime, major cracking occurred in the lower skin transition section. The cracks were discovered after cycle 7308. The transition section is where the D6AC steel pivot plate is joined to the outer aluminum skin. A crack extended from bolt hole No. 233 to bolt hole No. 215 and another started at bolt hole No. 238 and extended to the chordwise stiffener as indicated in Figure 15. This concluded the fatigue testing.
