TR75-118 AMEL

**SIMULATED SOLAR HEAT TESTS OF
M.U.S.T. AIR-INFLATABLE,
DOUBLE-WALL HOSPITAL WARD SHELTERS**

MAY 1974

**UNITED STATES ARMY
NATICK RESEARCH and DEVELOPMENT COMMAND
NATICK, MASSACHUSETTS 01760**

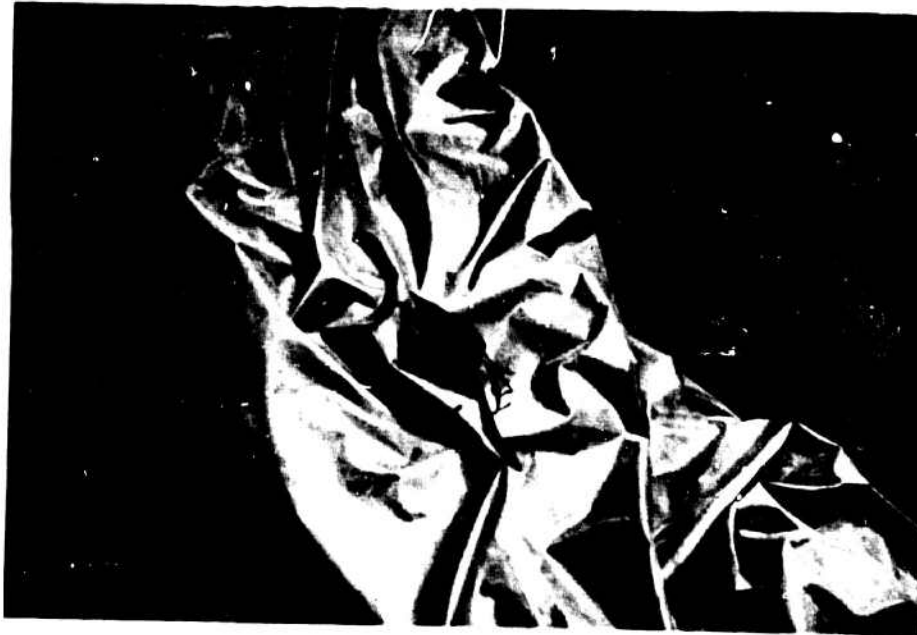
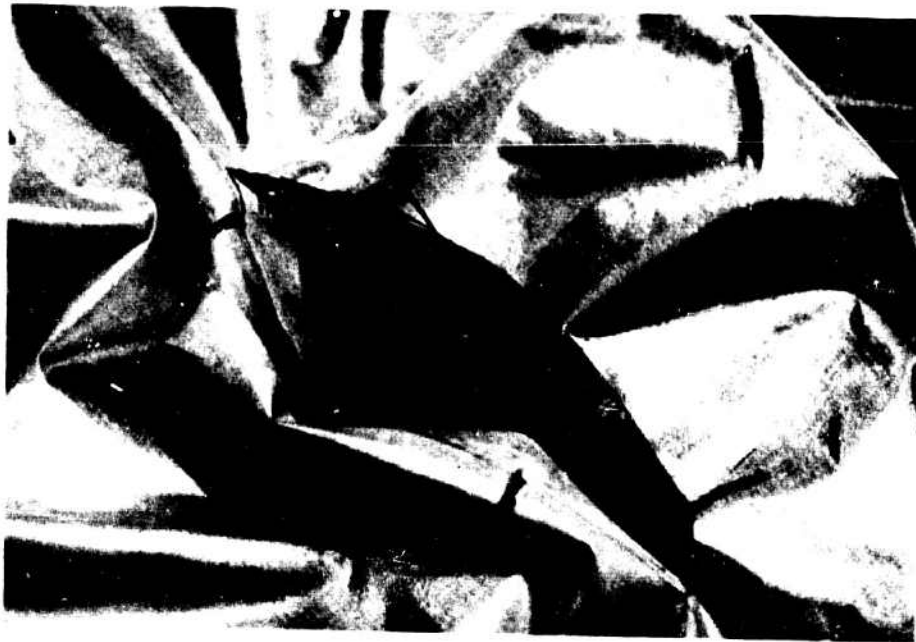
fabric on either side of the rupture was well bonded. The failure is shown in Figures 11 and 12. The rupture was about 7 in. in length. Bladder 10 was leak tested and the only observable leak was near the air inlet valve. The bladders which were removed from air chambers 1 and 10 were replaced by the bladders from air chambers 6 and 5 respectively of shelter section F-1 prior to conducting the second test cycle.

(1) The bladder in air chamber 1 of shelter section F-2 ruptured during the first solar heat load cycle due to an adhesive bond failure between the bonded fabrics.

Figure 11. Ruptured Bladder after Removal from Air Chamber 1 of Shelter Section F-2

Figure 12. Close-Up of Bladder Failure after Removing the Bladder from Air Chamber 1 of Shelter Section F-2

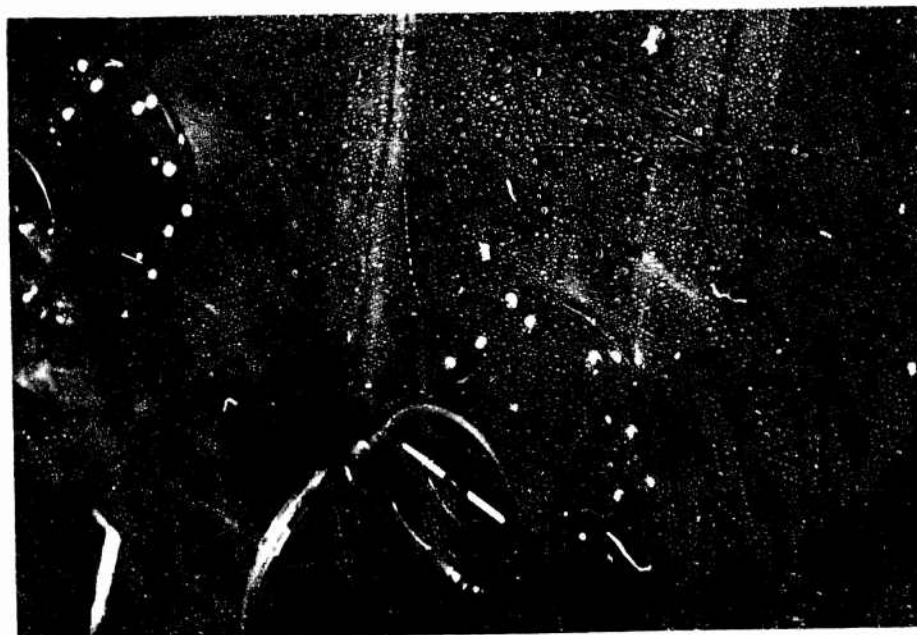
The fabric comprising the air inlet valve ring collar was observed to pull or slip slightly from the original location on all 12 air chambers. This fabric slippage was primarily on the sides rather than at the top and bottom. The slippage on the collar of air chamber 12 was about 3/32" while other slippage ranged from 1/13" to 1/18". Figure 14 shows the fabric slippage for the collars of air chambers 11 and 12. The picture in Figure 14 was taken following the second test cycle but most of the slippage occurred during the first test cycle.

(2) The air inlet valve ring collars on all 12 air chambers of shelter section F-2 were observed to slip somewhat during the solar heat load tests and slight delaminations of the ring collars were observed on air chambers 7 through 12.

Figure 14. Air Inlet Valve Ring Collar Slippage on Air Chambers 11 and 12 of Shelter Section F-2
