TECHNICAL REPORT M-186
August 1976

FAILURE ANALYSIS OF OZARK, ARKANSAS,
POWER PLANT SOCKET-HEAD CAP SCREWS

by
E. P. Cox

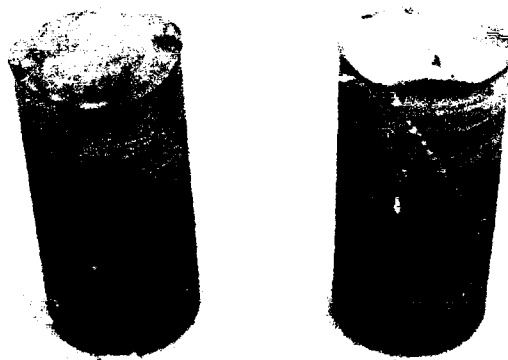
Two of the cap screws were inspected by means of a dye penetrant (Figure 5). The surfaces were first thoroughly cleansed, sprayed with penetrant, wiped clean, and sprayed with developer. This procedure was repeated several times. No cracks or other surface defects were found. The results indicate that fracture resulted from fatigue in the most critical location, i.e., the cap screw fillet. The absence of cracks elsewhere along the cap screw means that the threads are not as severe a stress concentrator as the fillet.

Figure 5. Dye penetrant examination of two cap screws, 0.3x. No cracks were detected on the outer surfaces.

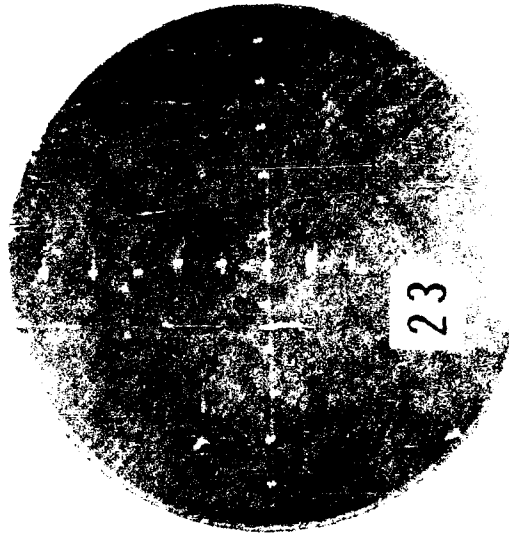
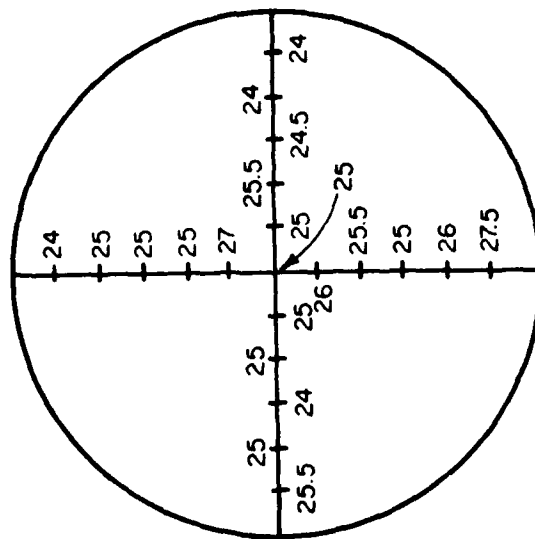
Results of the hardness surveys show that in each case the cap screw was too soft; i.e., hardness was less than the 38 to 45 R_C specified. The hardness over the cross section was generally uniform, with the threaded surfaces being somewhat harder than the centers. The low hardness readings indicate that the cap screws were improperly heat-treated and that manufacturer quality control was lacking.

Figure 6. Rockwell C hardness survey on cap screw #23 (a) and the numerical values (b), 1x.

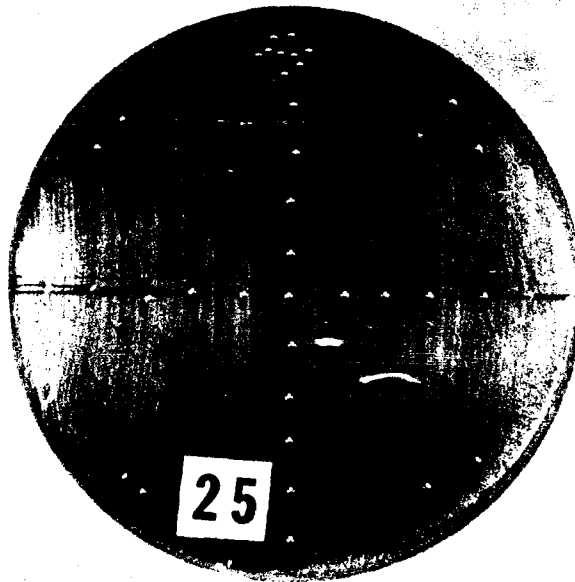
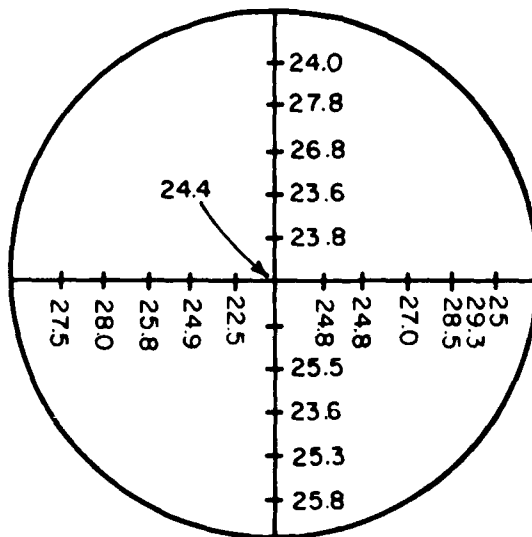
Figure 7. Rockwell C hardness survey on cap screw #25 (a) and the numerical values (b), 1x.

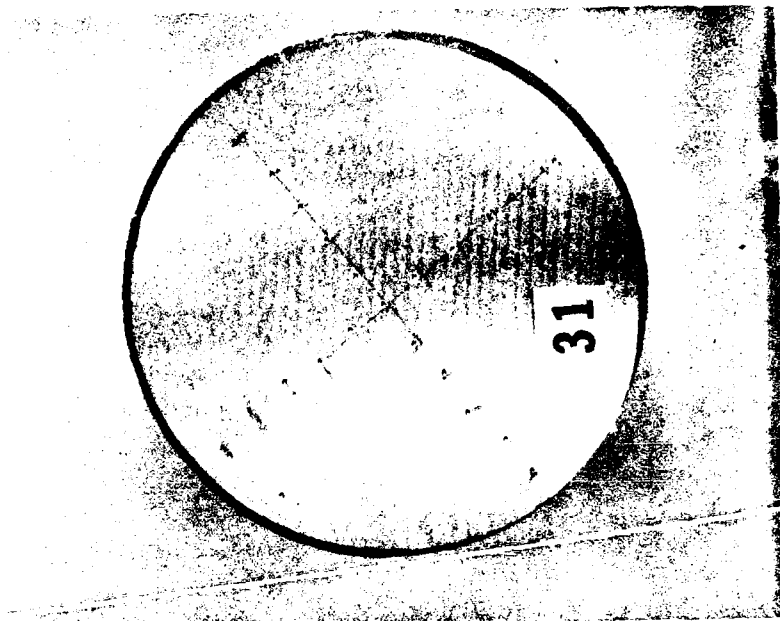
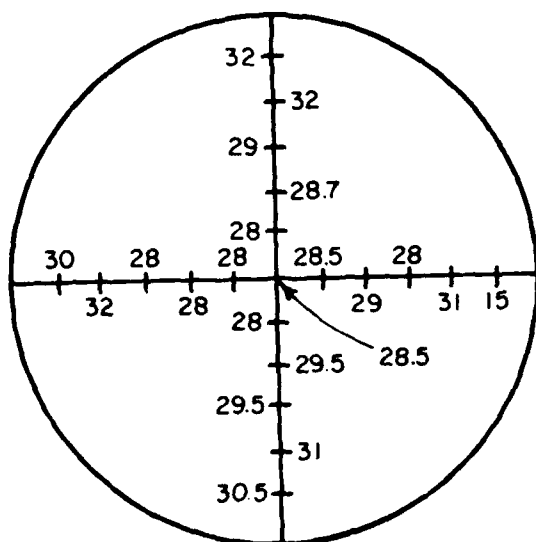
Figure 8. Rockwell C hardness survey on cap screw #31 (a) and the numerical values (b), 1x.

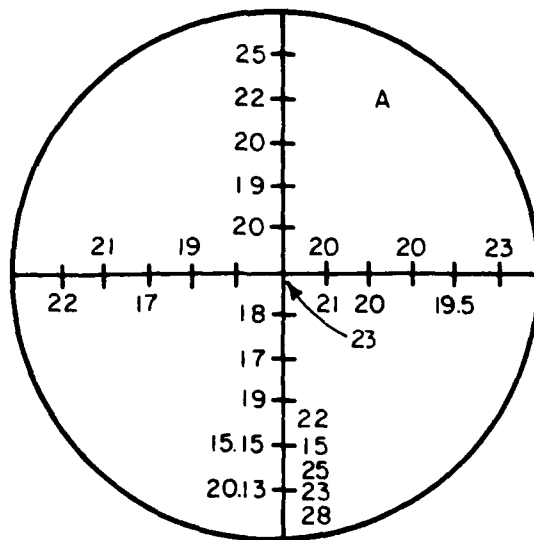
Figure 9. Rockwell C hardness survey on cap screw OZ (a) and the numerical values (b), 1x.

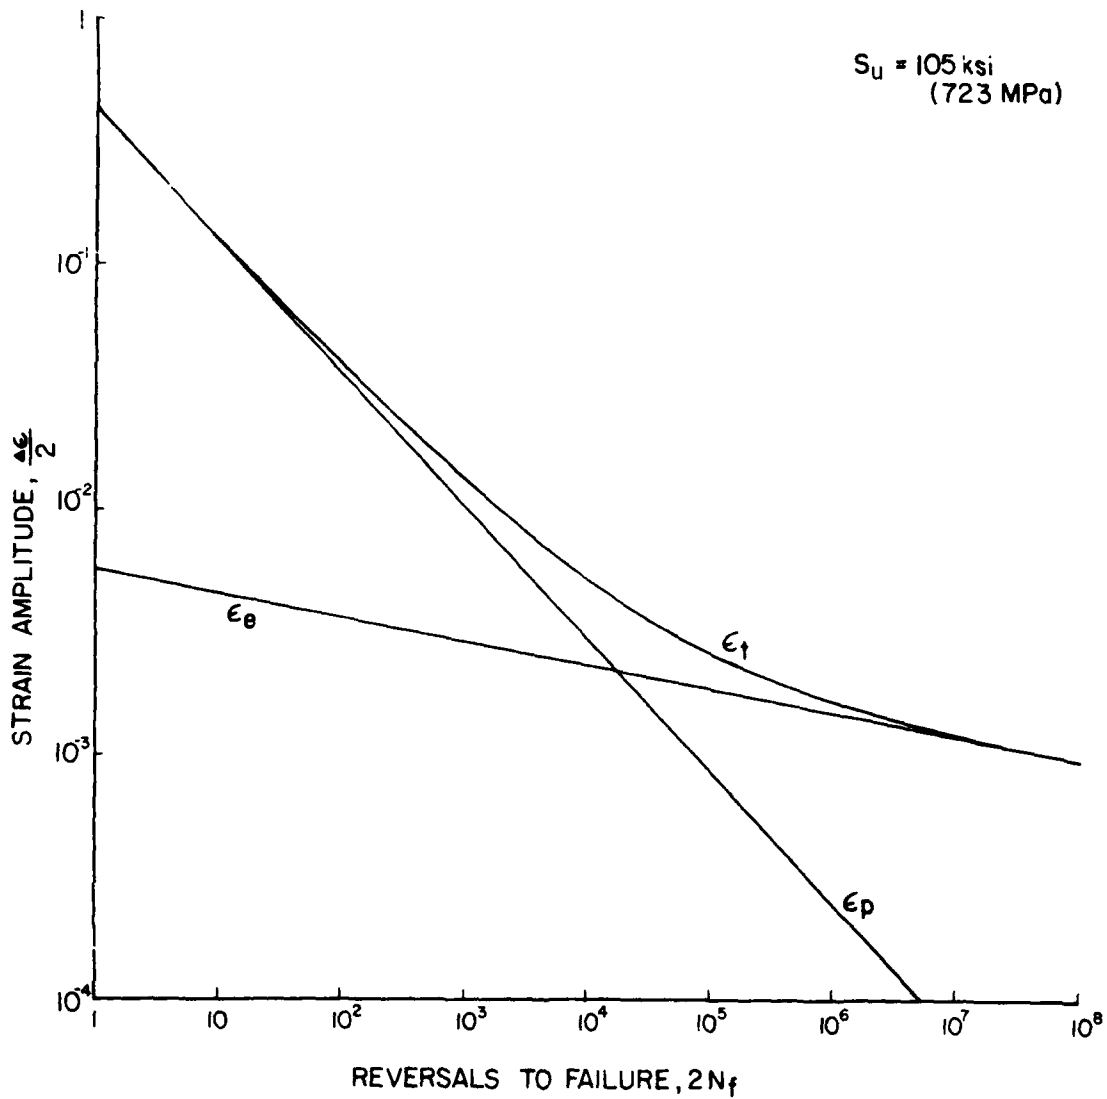
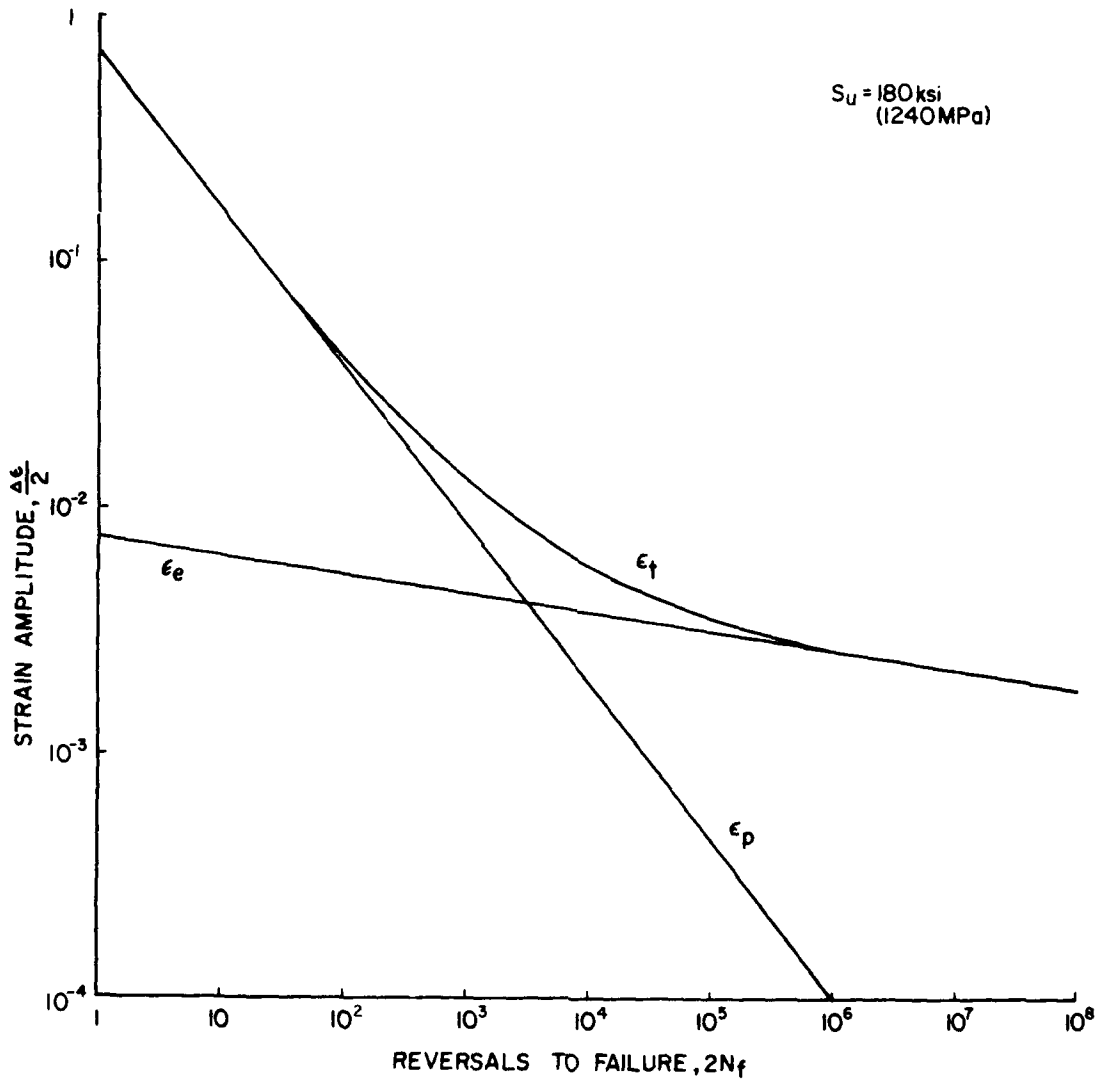
Strain vs. cyclic life data for AISI 4340 steel were found for the hardness of interest in the *Ford Motor Company Databook*.⁷ The strain vs. life curves were modified to account for a mean stress of 25 ksi (172 MPa); these curves are presented in Figure 16 for a hardness of 23 R_c (243 BHN) and in Figure 17 for a hardness of 38 R_c (350 BHN). Using these data, a Neuber analysis of the notch equation (Eq 7) can be used to compile a stress vs. cyclic life curve for a notched member (Figure 18).

best demonstration of how much the proper heat treatment would increase the life can be seen in the difference between the curves for different hardnesses. At a hardness of 38 to 40 R_C ($S_u = 180$ ksi [1240 MPa]), the crack initiation life for a K_f value of 7 would be approximately 10^7 cycles (300 hr); for K_f values of 5 and 3, the predicted lives are virtually infinite.

Figure 16. Strain amplitude vs. fatigue crack initiation life for AISI 4340 steel heat-treated to hardness of 23 R_C and having a 25-ksi (172 MPa) mean stress. (The above data are for smooth specimens.)

Figure 17. Strain amplitude vs. fatigue crack initiation life for AISI 4340 steel heat-treated to hardness of 38 R_C and having a 25 ksi (172 MPa) mean stress. (The above data are for smooth specimens.)

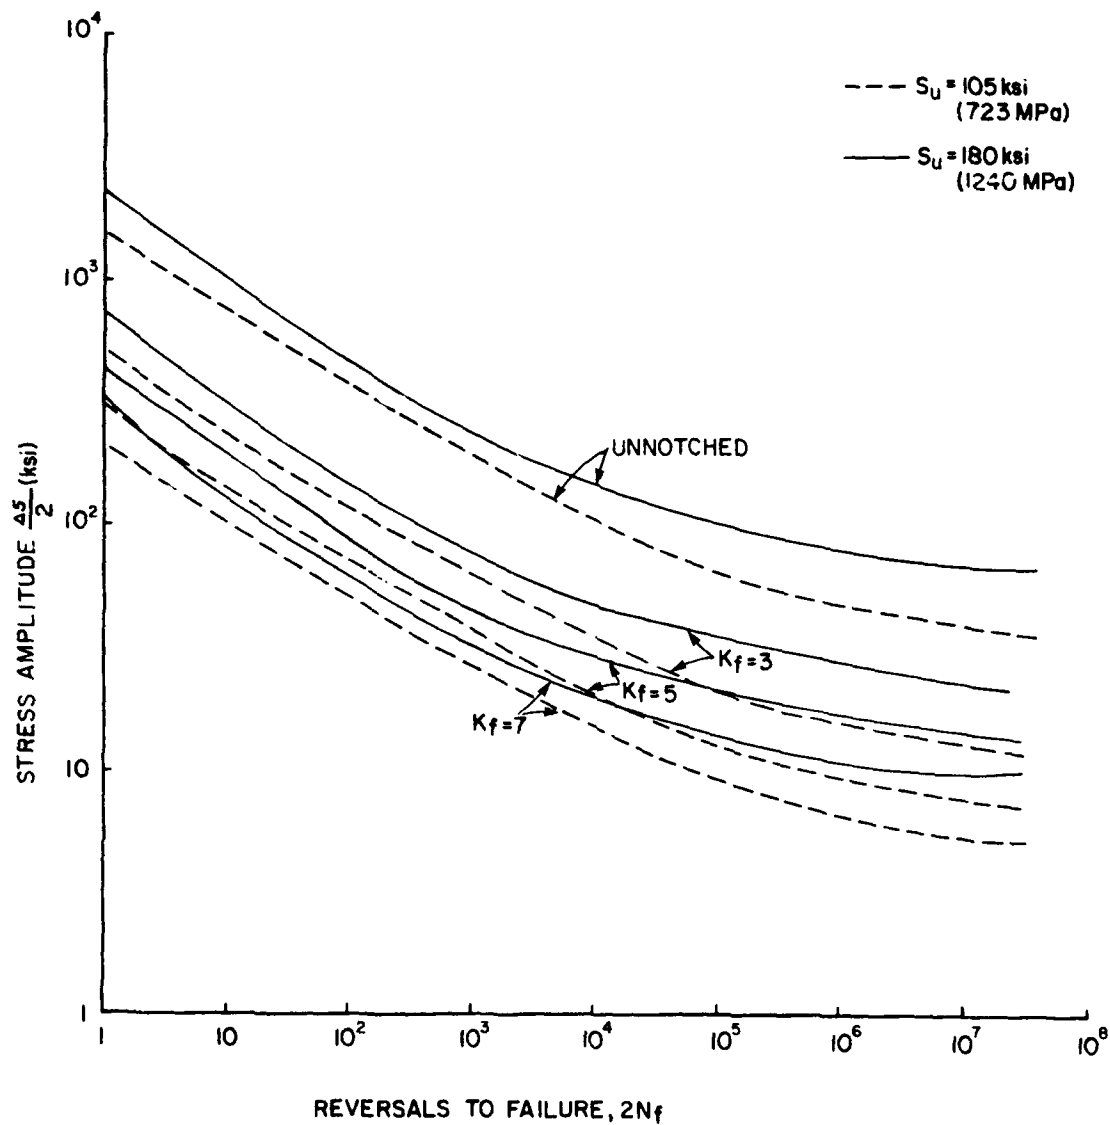
Using this curve, if the cap screw is preloaded to 15 ksi (103 MPa) and then cyclically loaded to 35 ksi (241 MPa) and back to 15 ksi (103 MPa) (i.e., it has mean stress of 25 ksi [172 MPa] and alternating stress of 10 ksi [69 MPa]), the life would definitely depend on the hardness and the value of K_f . That is, for a hardness of 23 R_c (ultimate tensile strength $S_u = 105$ ksi [723 MPa]) and a K_f value of 7, the predicted crack initiation life would be 6×10^4 cycles (2 hr of operation); if the K_f was 5, then the predicted life would be approximately 10^8 cycles (3150 hr). The

Figure 18. Notched specimen fatigue crack initiation life for various stress amplitudes. Unnotched specimen behavior is included for comparison with specimens containing fatigue strength reduction factors (K_f) of 3, 5, and 7. (The data shown are for a cyclic mean stress of 25 ksi [172 MPa].)
