4. TITLE (and Subtitle) Evaluation of Endodontic Instruments as Received From the Manufacturer: The Demand for Quality Control; 5. TYPE OF REPORT & PERIOD COVERED Submission of Paper. Sep 75 - Aug 76

9. PERFORMING ORGANIZATION NAME AND ADDRESS US Army Institute of Dental Research Walter Reed Army Medical Center Washington, D. C. 20012 10. PROGRAM ELEMENT, PROJECT, TASK AREA & WORK UNIT NUMBERS Program Element 62110A Project No. 3A162110A825 Task Area No. 00-Work Unit No.

EVALUATION OF ENDODONTIC INSTRUMENTS AS RECEIVED FROM THE MANUFACTURER:  
 THE DEMAND FOR QUALITY CONTROL

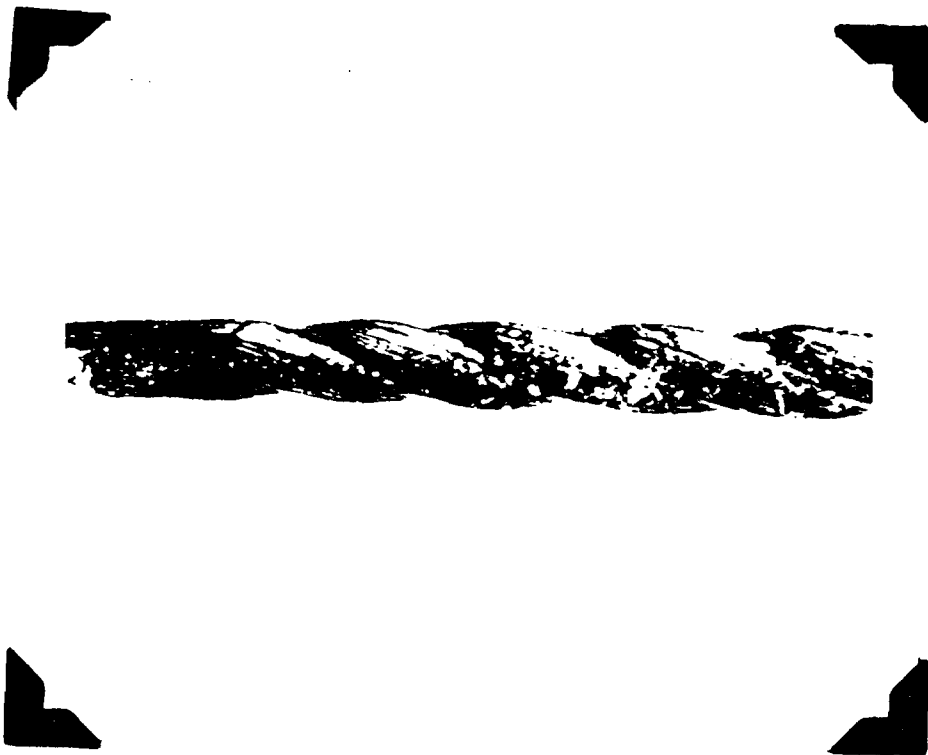
It was observed that company C's instruments had a much greater amount of colloidal debris and a grease or an oil film present (Fig. 2). Plastic from the handle was another common finding within the flutes (Fig. 3). Two Hedstrom files from two different manufacturers had a

- FIGURE 1 Instrument holder designed for orientation of the instruments.
- FIGURE 2 Colloidal debris, grease or oil film found on new instruments (orig mag X37.5)

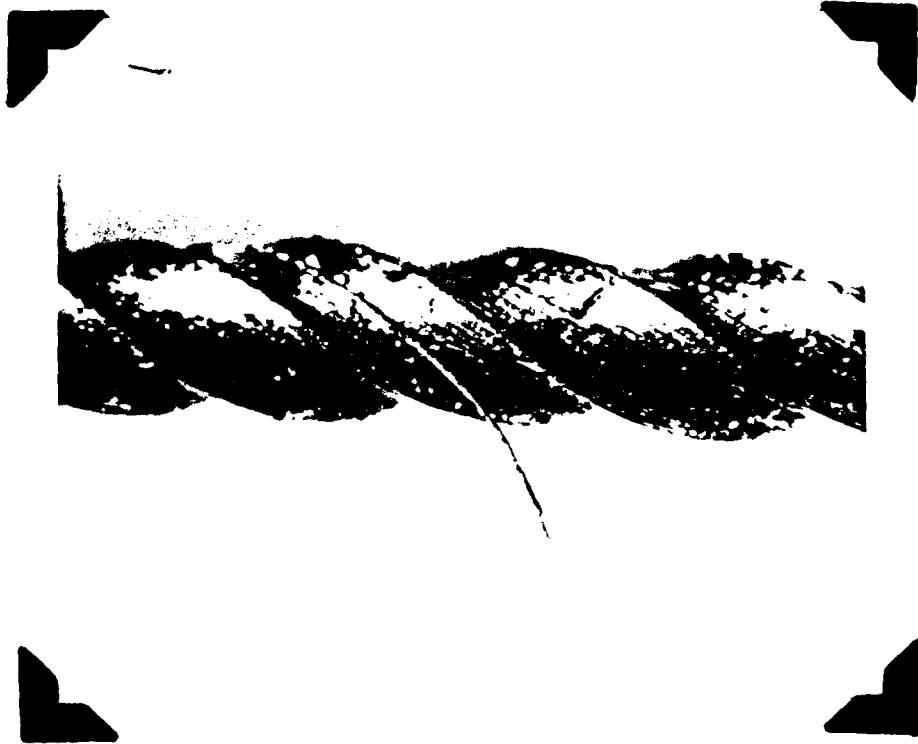
FIGURE 6

Metal spurs appeared to be frequent in all three companies, although more so in files than reamers or Hedstrom files (Fig. 6). Hedstrom files frequently had barbs at their tips (Fig. 7). Other common defects in the instruments were sections of flutes which were either observed to be unwound slightly or wound too tightly. This was seen commonly with the files (Fig. 8). Comparison of similar instruments from the three different manufacturers showed noticeable differences in the space between the flutes and the apparent sharpness of the instruments (Fig. 9).

Evaluation of 270 files, reamers, and Hedstrom files directly out of their packages demonstrated the need to cleanse these instruments prior to being autoclaved. Unfortunately cleansing is extremely difficult and quite time consuming. The plastic and metal spurs represent perhaps the most serious debris. Both have the potential to cause spontaneous blockage of fine radicular canals. Eventual corrosion of the dislodged metal spurs may cause complications; the possibility of which have not been fully investigated.

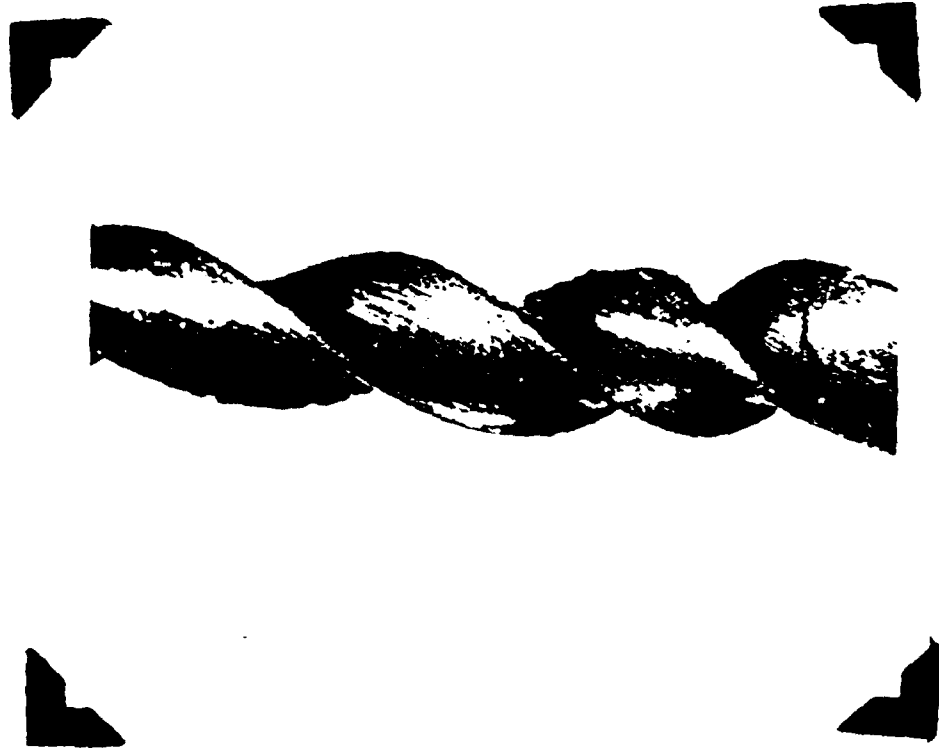
- FIGURE 8b File with too tight of a twist which is an area of possible fracture (orig mag X37.5).
- FIGURE 9 The comparison of reamers from three different manufactures. Notice the variations in flute design (orig mag X9).  
\*Company A; "Company B; 'Company C.

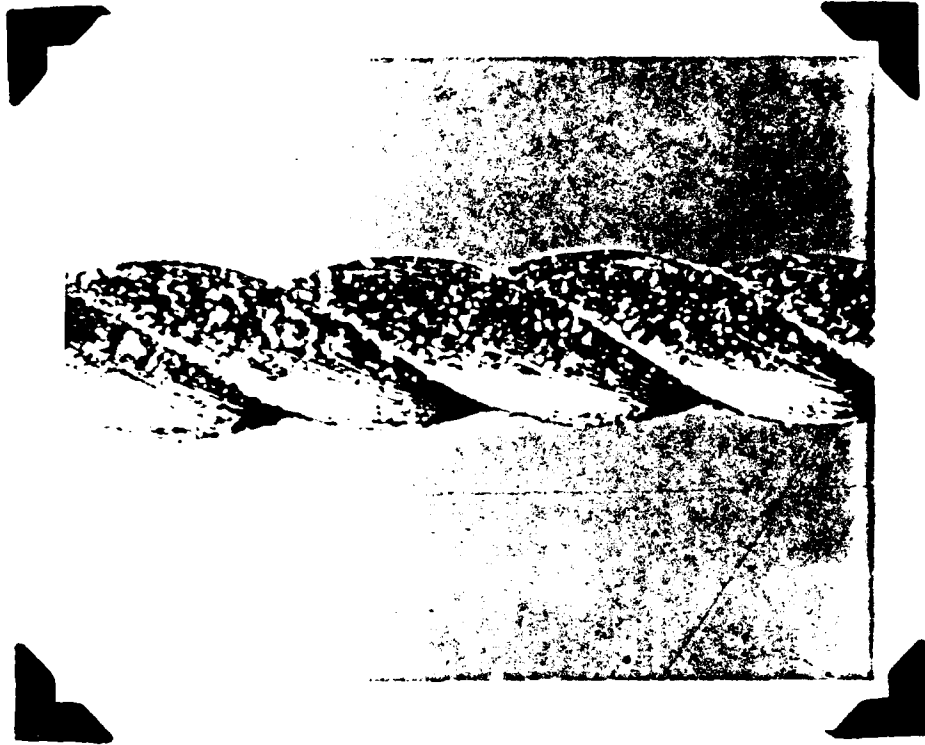
plastic within the flutes. It did not accomplish this but left the flutes coated with salt crystals (Fig.10).

- FIGURE 10 The quantity of salt crystals deposited on the surface of a file during sterilization in the hot salt sterilizer (orig mag X37.5).
